Cilsant
W/12/2832

Tir Gofal Farm Visit Historic Environment Report

REPORT NO. 2002/104
PROJECT RECORD NO. 45631

Cilsant
Tir Gofal Farm Visit Historic Environment Report

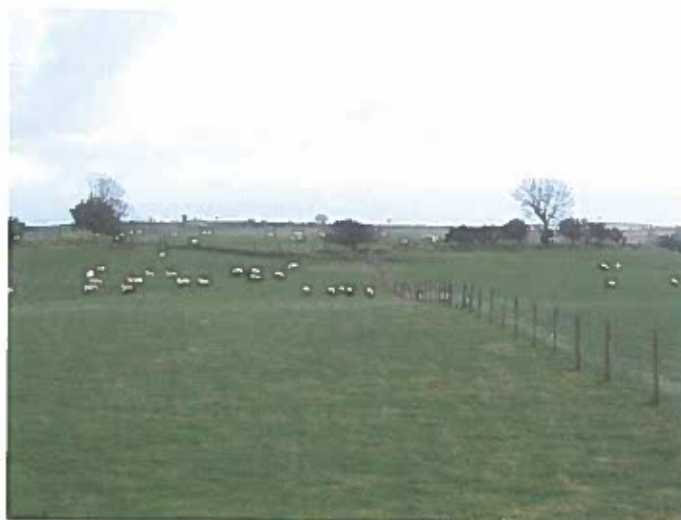
This hillfort sits on the point of a low sloping spur, projecting from the high ground to the west into a valley with an imposing position overlooking the valley to the north, east and south. It survives as a semi-circular bank and platform on the north side of a field boundary which bisects the original plan of the hillfort. The section of hillfort to the south of this boundary has largely been lost (through ploughing?) although traces can just be seen continuing south into the field at the east end. The western section of the surviving northern half remains as a high (c. 1 metre) bank whilst to the east it degenerates to a low break of slope.

Although heavily damaged and eroded this hillfort is an important historic landscape feature which might contain much surviving buried archaeological remains relating to defensive and domestic structures and activities.

Plate 1 – Looking east towards Hillfort PRN 3969

In order to protect any buried archaeological remains no ground breaking activities should take place within the vicinity of this hillfort and no animal feeders should be placed within 15 metres of its upstanding banks. The surrounding fields all contain possible buried archaeology (PRNs 3970 and 12618) and should not be subject to any ground breaking activities, such as ploughing.

It is understood that the farmer wishes to reinstate the hedgerows in and around this hillfort, any such work should be restricted to existing hedgerow banks. As part of any hedgerow works, there

should be no permanent fencing erected either within or around 15m from the surviving hillfort earthworks.

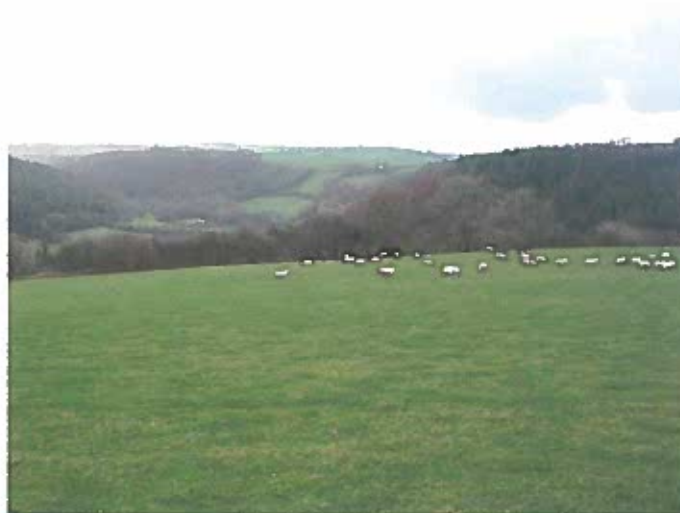
This is a cropmark (a feature that has been identified through patterns of vegetation growth or different coloured soils) shown on aerial photographs and appearing as a series of two/three? interlocking sub-circular enclosures below and to the south of hillfort PRN 3969. Another cropmark line extends northwards from the eastern edge of the enclosures up the slope towards the hillfort.

Plate 2 – Looking south over the area of Cropmark PRN 3970

As with the nearby hillfort PRN 3969, no groundbreaking activities should take place within the area of the cropmark in order to protect any buried archaeological remains.

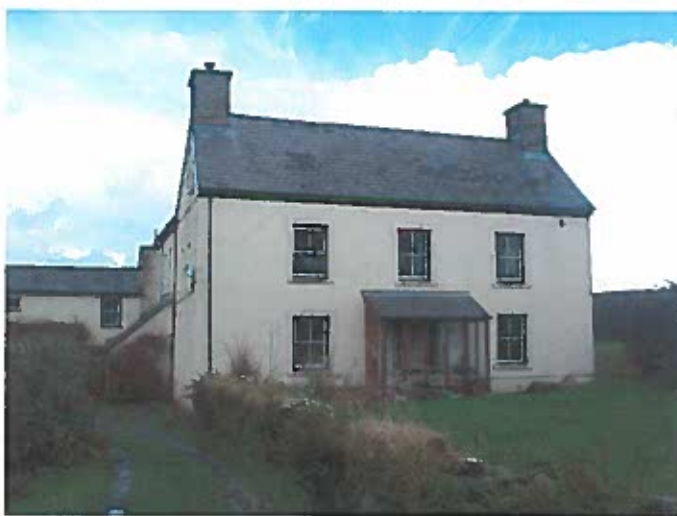
This is a fine 18th century Grade II listed gentry house. It is of an L-plan rubble stone construction, with a three window rendered west facing front and big stone end stacks.

Plate 3 – Cilsant farmhouse (PRN 47113)

This house is currently in use as a dwelling and is not part of the Tir Gofal agreement.

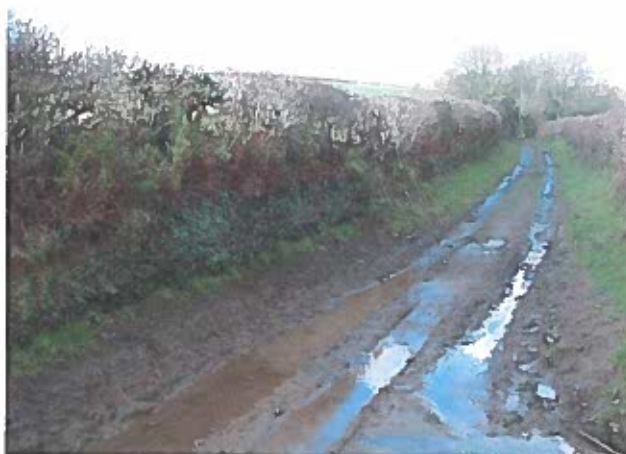
Wide stone walled trackway around 1 metre high running from past the cottage site (PRN 47124) to the north of the farmstead, through the farmyard and past the stables building (PRN 47121) and towards the valley to the south. The stones that form the banks either side of the trackway are laid in a herringbone pattern and survive well in the section of track to the north of the farmstead. It is shown on the 1848 tithe map for Llanwinio parish.

Plate 4 – View along trackway (PRN 47114) from Cilsant farm

Maintain as a historic landscape feature. The stone walls should be kept in good condition and any damage repaired.

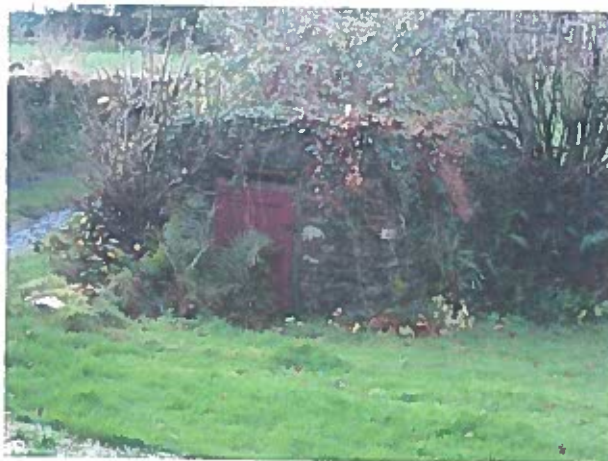
Stone built shed covering the well at Cilsant. Internally it is vaulted and it measures 1.5 metres high and around 2.5 metres wide and deep. It is first shown on the first edition Ordnance Survey map of 1891.

Plate 5 – Well (PRN 47116)

Maintain as a historic landscape feature. Any repairs to this structure should use traditional materials and methods.

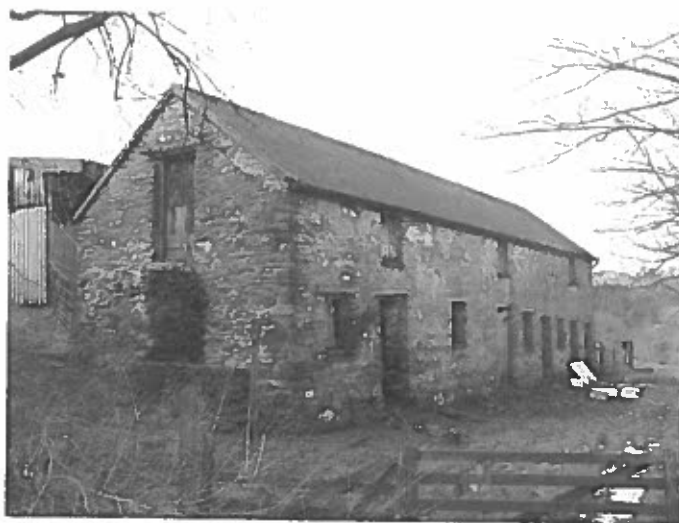
This is a combination farm building comprising stables / cow shed (?) at the south end and three slate divided pig pens at the north. An external stone stair at the south end provides access to the granary above, which is covered by a corrugated sheet roof. Openings are formed by timber lintels with stone cills and rough jams. The granary has nine pane horizontally pivoting windows. A building on this site is shown on the 1848 tithe map for Llanwinio parish.

Plate 6 – East face of farm building (PRN 47118)

Although the granary is currently used for storage, the rest of this building is not presently in use and is beginning to show general signs of neglect. Ideally doors and windows should be replaced / repaired, the stonework repointed where necessary, and the steps at the south end rebuilt in order to secure the medium term future of this buildings. Any repairs or work on this structure should use traditional materials and methods.

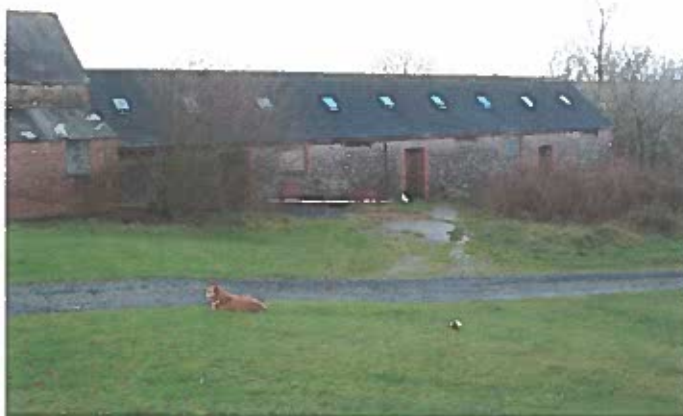
This is an east-west gabled cow shed range that is one of the later farm buildings at Cilsant, although a building on this site is shown on the 1848 tithe map for Llanwinio parish. It is constructed in stone with red brick dressings to the openings.

Plate 7 – South face of farm building (PRN 47119)

This building is in sound condition and should continue to be used as a farm building. Any repairs to this structure should use traditional materials and methods.

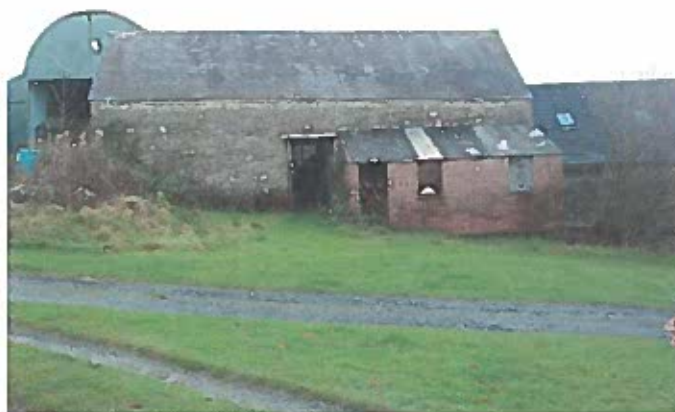
Stone constructed barn built onto the west end of the cow shed range (PRN 47119) and dating to the late 19th Century.

Plate 8 – South face of farm building (PRN 47120)

This building is in sound condition and should continue to be used as a farm building. Any repairs to this structure should use traditional materials and methods.

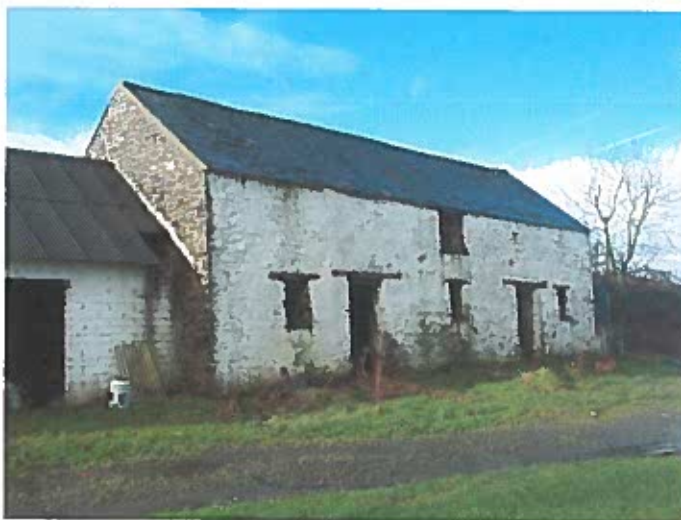
This is a Grade II listed building. It is described as a long lofted stable range with (to the south) an attached longer single storey range, possibly originally cartsheds then cow houses, and dating to the late 18th to early 19th Century.

Plate 9 – East face of stables section (PRN 47121)

It is understood that the farmer wishes to repair the slate roof cover of the stables and where necessary repair the timber framework underneath. If these works are to be undertaken then it is essential to remove the slates with care to enable as many as possible to be reused. Any replacements should be a good match for the existing slates. A brief inspection showed that the roof timbers were in reasonable condition, although any defective areas should be repaired where necessary. The wall tops and areas of stonework around the two pitching holes (?) and doorway should be repaired and where necessary rebuilt using lime mortar and replacement stonework to match. Ideally the shutters to each pitching hole should also be replaced using timber and made to a suitable design.

On a longer term basis consideration should be given to repointing the external faces in lime mortar, repair/replacement of internal joists and floorboards, and rebuilding and repair of the external stairs at the north end. If these tasks are considered now then it will ensure the long term viability of the building as a usable structure.

As well as care of the fabric, active thought should be given to the future of the cow house section of the building. The farmer indicated that it was no longer practical to use it as a farm building and it has certain problems which would make it difficult to convert for other purposes. Again, pre-emptive thought about the future conservation of this building should ensure its long term

viability.

If any works are to be undertaken it is essential that the owner contacts the Conservation Officer at his Local Authority in order to find out if Listed Building Consent is required for the intended works. They then should be able to advise how the farmer should proceed.

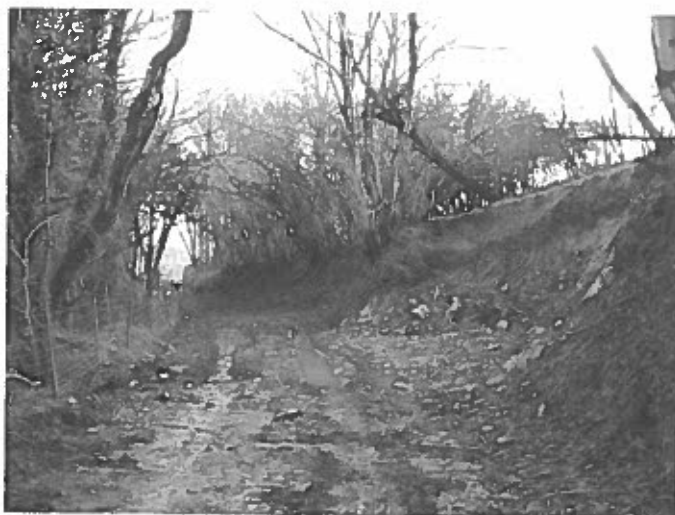
Quarry cut into the side of trackway (PRN 47114), measuring around 14 metres in length.

Plate 10 – Quarry cut into side of trackway (PRN 47123)

Although this quarry should be maintained as a historic landscape feature, it is recognised that further erosion of the field above needs to be prevented and that a continuous hedgerow should be provided along the area of quarrying.

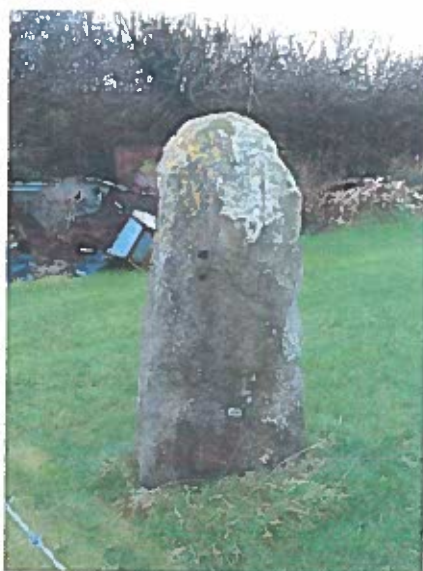
Former stone gatepost in garden of a new building along the side of the track from the main road to Cilsant farm.

Plate 11 – Gatepost (PRN 47125)

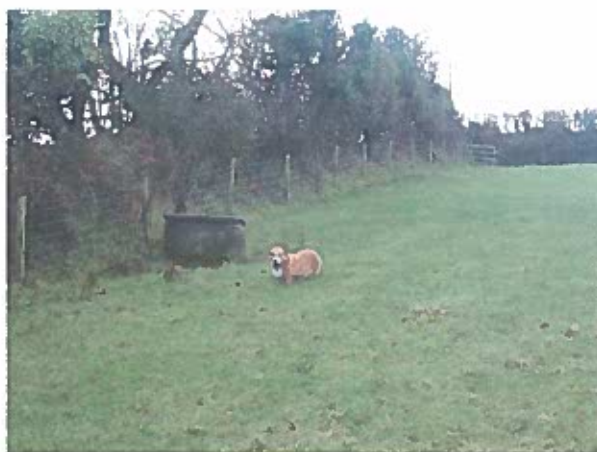
Modern concrete well or cistern located to the west of Cilsant farm near to the main road. It presumably belongs to the mid or late 20th Century, and it is believed that it is no longer used.

Plate 12 – Well (PRN 47126)

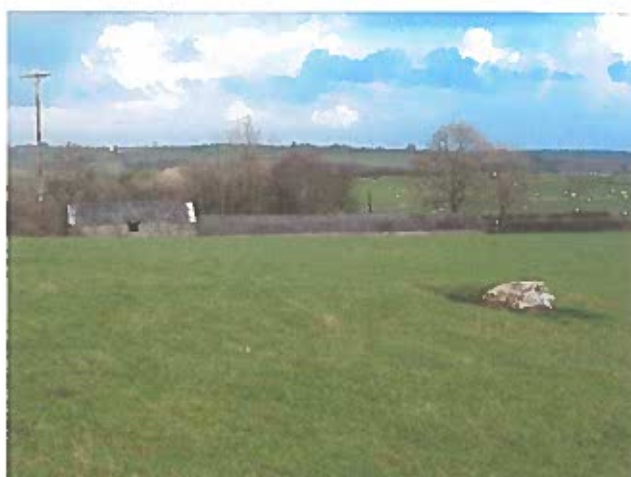
This is a quartz stone in the middle of the field directly to the west of Cilsant farm. It measures approximately 1 metre by 0.5 metre and around 0.5 metre high. It is roughly orientated northwest – southeast. It is likely to be a standing stone.

Plate 13 – Quartz standing stone (PRN 47164), looking east towards Listed Building PRN 47121

Maintain as a historic landscape feature. This stone or the area around it within a radius of at least 15 metres should not be disturbed.
