# Llwynpur W/12/2839

## Tir Gofal Farm Visit Historic Environment Report

Report No. 2003/18

REPORT NO. 2003/18  
PROJECT RECORD NO. 45633

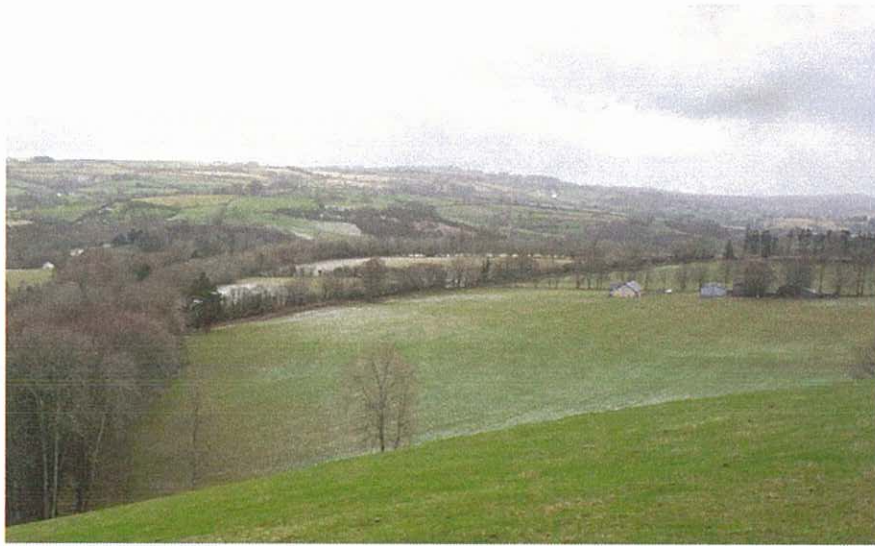
Plate 1- The parkland at Maesycrugiau looking north (PRN 25580)

The parkland fields are presently improved pasture and no traces of the tree rings or specimen parkland trees survive. A shelter belt to the north of the manor survives, although the woodland "Allt Maesycrugiau" to the south has been removed. A shelter belt in the southwest also survives. The three land parcels are defined by a low, steep sided, stone revetted bank which can still be traced around much of the extent, although it is in various phases of being grown out.

Existing parkland features should be retained. Surviving shelter belts and driveway avenues should be retained. The parkland boundary bank should be maintained and preserved. Tree planting should be avoided on the parkland boundary banks. Any tree planting should be in keeping with existing landscape character and the historic parkland layout shown on the early Ordnance Survey maps.

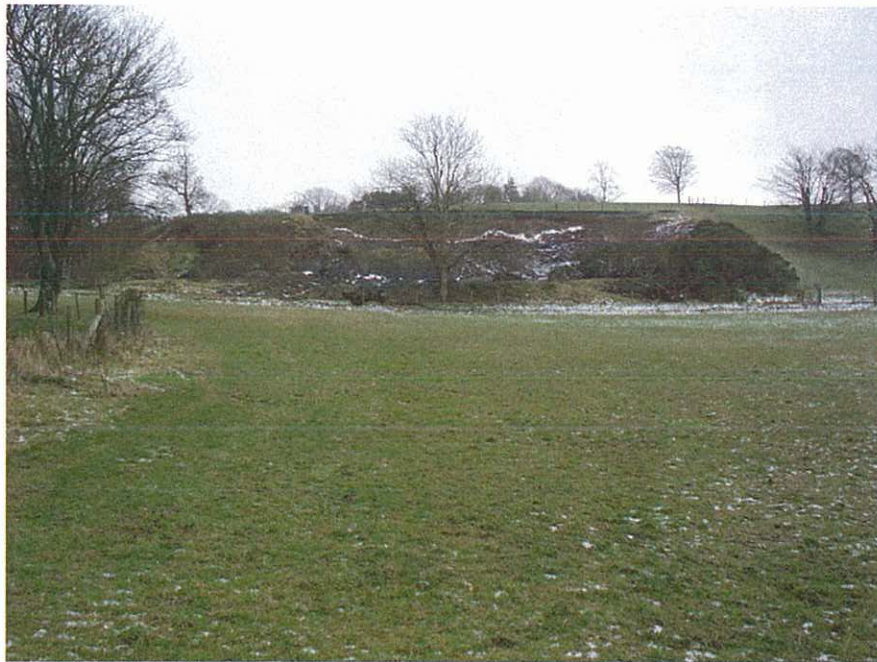
Plate 3- the quarry (PRN 47365) to the south of Maesycrugiau Hall

The quarry first appears on the 1906 Ordnance Survey map and is still visible today. It is accessed by a trackway running NE/SW alongside the lower field boundary of "Allt Maesycrugiau". It appears to have been used recently.

The quarry should not be infilled. Spoil tips should not be removed.

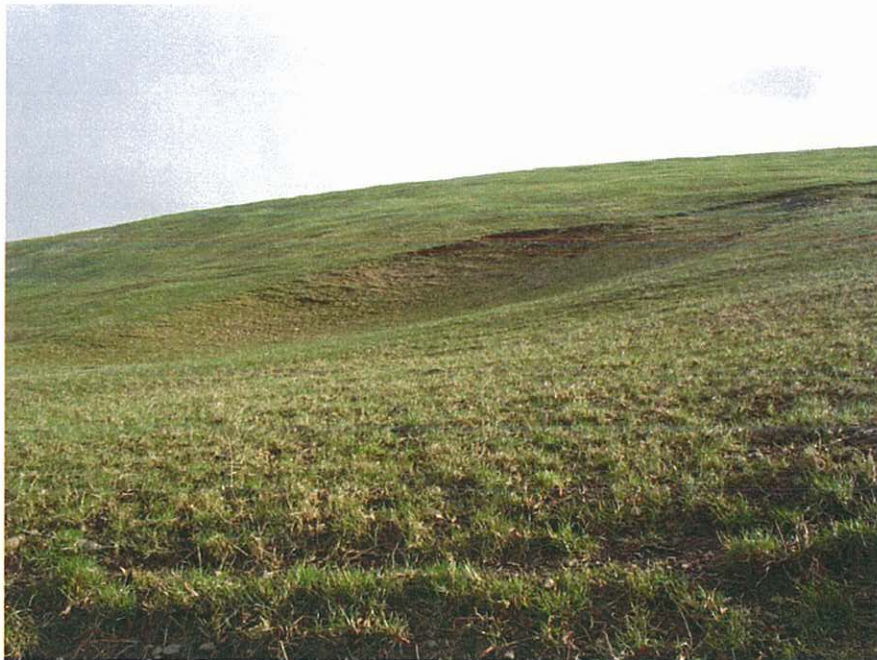
Plate 4- the gravel pit to the southeast of Llwynpur Farmstead (PRN 18179)

The gravel pit, first shown on the 1906 Ordnance Survey map is still visible today as a scar in the hillside.

The gravel pit should be maintained as a visible historic landscape feature. It should not be infilled. Spoil tips should not be removed.

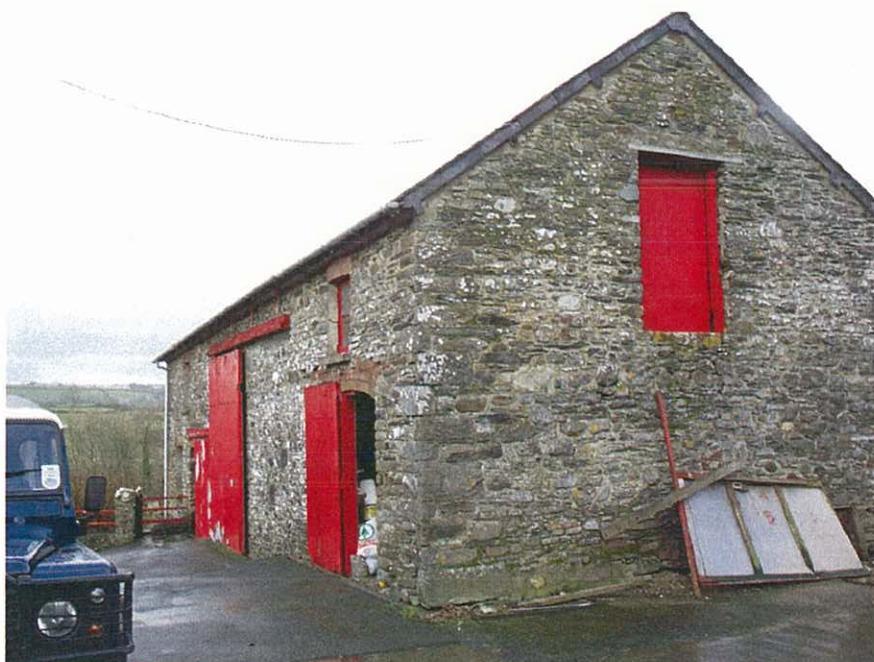
Plate 5- the carthouse; granary (PRN 47368) to the northeast of the farmhouse

This two-storey carthouse, granary building is situated immediately to the northeast of the farm house and is aligned northeast to southwest along its long axis. It is constructed of uncoursed stone with a pitched slate roof. The southwest elevation has a northwest entrance with a brick arch, a southeast entrance with a shallow arched brick voussoir, and a central entrance with a modern sliding door. The ground floor has a window with a brick arch to the northwest, whilst the upper floor has windows with brick arches at either end. An upper storey loading door is visible in the south east gable wall.

A modern cowshed has been built against the rear of the building and detailed examination of the northeast elevation was not possible. The building, which is likely to be of a nineteenth century date, is currently in good condition.

The building should continue to be maintained in a stable condition using traditional materials.

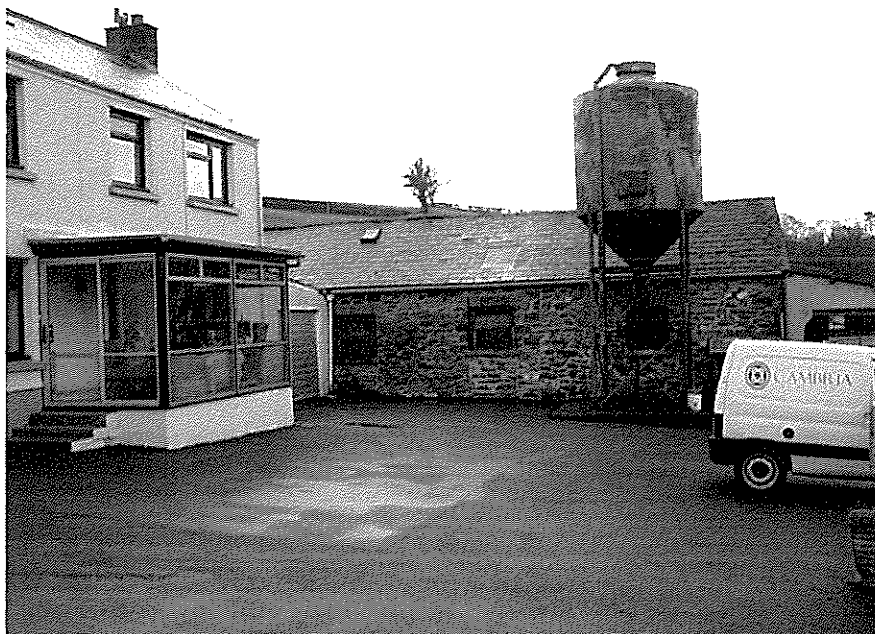
Plate 6- the northeastern elevation of the cowshed (PRN 47369)

This single storey building is aligned northeast to southwest along its long axis. It is constructed of uncoursed rubble with a pitched slate roof. A garage has been built against the southeast end of the northeast elevation. Three evenly spaced windows with brick arches are visible in the northwest end of this elevation and appear to have been created by blocking up the lower half of the original doorways. A large building of breeze block and corrugated sheet box section construction has been built against the southwest lateral wall and further assessment of the character of this building was not possible. The building, which is likely to be of a nineteenth century date, is currently in good condition.

The building should continue to be maintained in a stable condition using traditional materials.

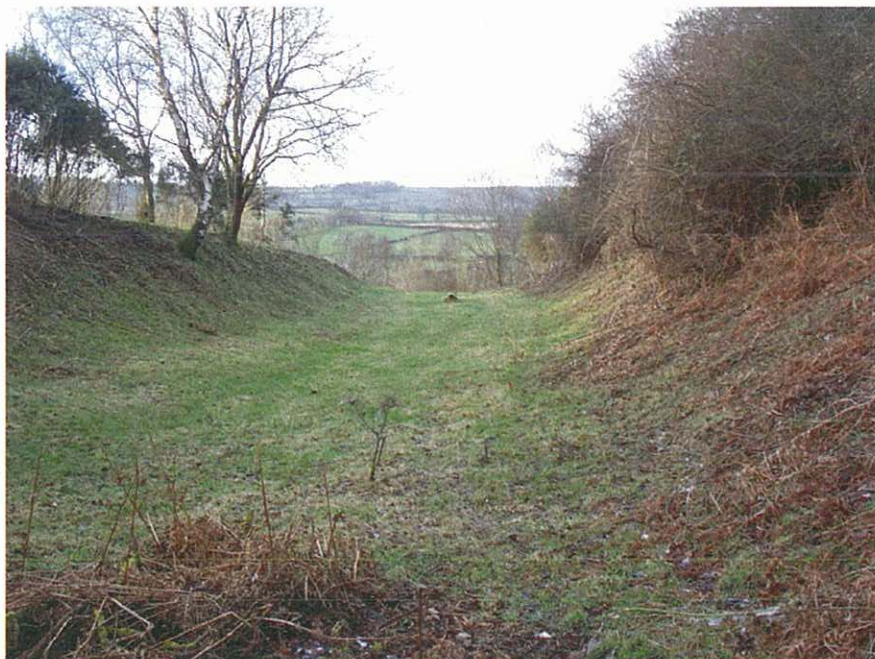
Plate 7- the interior ditch of Castell Pyr looking north showing heavy scrub growth on the western elevation of the outer defensive bank.

i) The western elevation is severely overgrown. The scrub should be cleared, stumps poisoned and the area re-seeded if necessary. The large trees should be left. Towards the northern end some oak and birch have become established. These should be thinned.

The work as Castell Pyr should be undertaken when conditions are dry – to prevent damage to the ground surface. Scrub should be cut at ground level leaving roots in-situ. There should be no breaking of the ground surface. All debris should be removed from the site. Subsequent

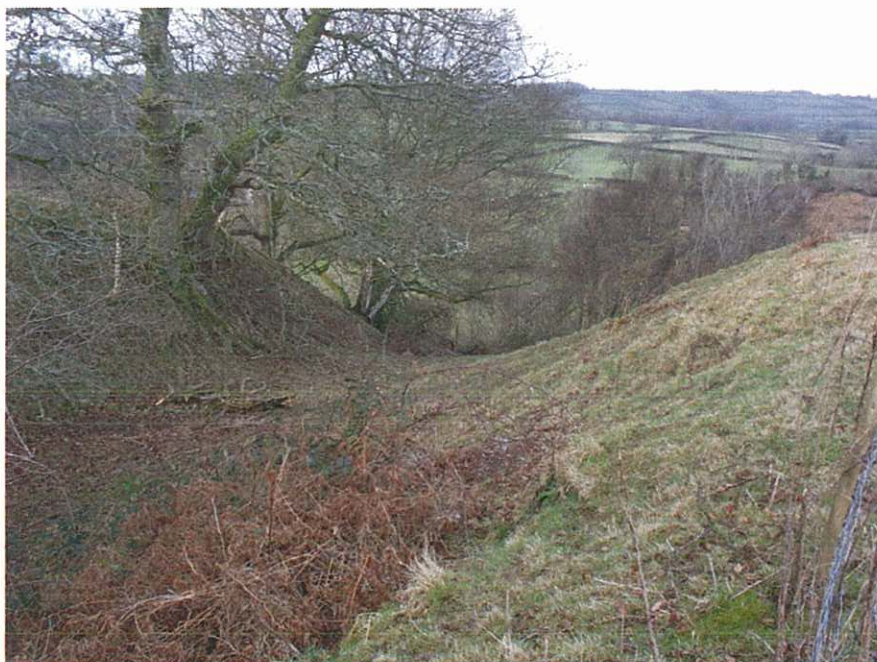
Plate 8- The external ditch of Castell Pyr looking north, showing mature trees on the eastern elevation of the outer defensive bank.

ii) Several mature oaks are growing at the northern end and they appear to be in a stable condition, with a healthy grass cover under. At the southern end there is more scrub with some bare earth exposed. The scrub should be removed leaving the oaks and larger hawthorns. Re-seed if necessary.

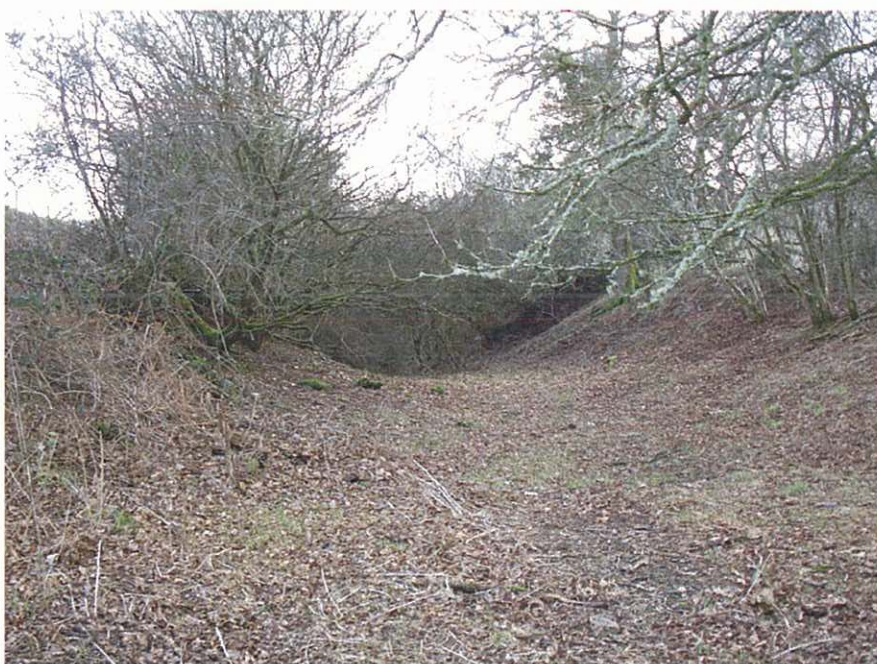
Plate 9- south facing view of the external ditch, showing scrub growth on the outer slope and eastern elevation of the outer defensive bank.

5) External Ditch. The most serious area of erosion on the site has occurred under the scrub growing on the outer slope of the ditch, at the southern end. The scrub should be removed and the area re-seeded. The remainder of the ditch is in a good condition with good grass cover.

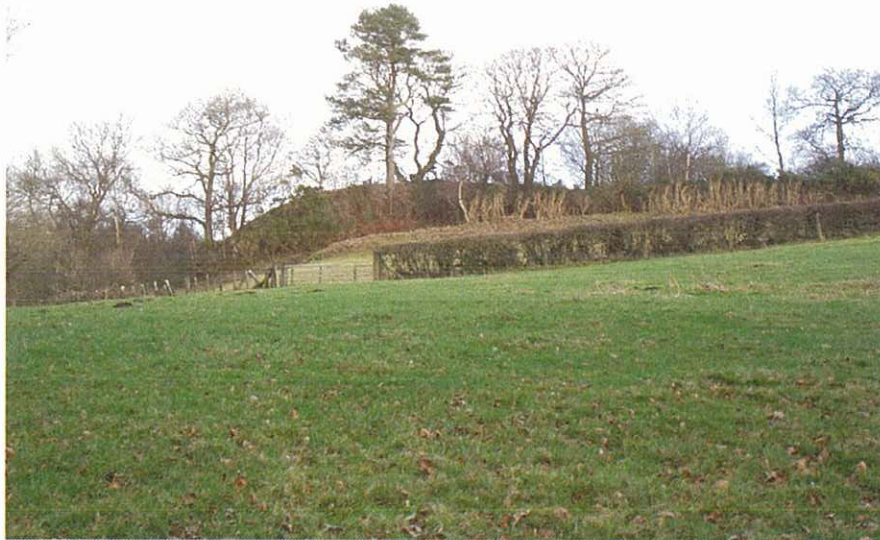
Plate 10- Castell Pyr from the west looking towards the inner and outer defensive bank

To the east of the road, the remains are much more substantial. An inner bank, about 2 metres, follows the line of the scarp and may indicate an original enclosure. Running parallel to it to the east is a much larger outer bank, 3-4 metres high, which appears to have been built predominantly from material excavated from a substantial outer ditch. The effect of this ditch is increased as the outer edge is built into the slope of the hill. Both banks stop short of the scarp at the northern end. There are traces of a north-facing scarp running eastwards away from the site. It is suggested that an entrance trackway lay at this point. The southern half of the eastern defences is heavily overgrown with tress and scrub and belongs to Castell Pyr cottage. It lies outside of the application area.
