## **Pantycoubal W/12/2855**

### **Tir Gofal Call-Out Visit Report**

Report No. 2003/78

Pantycoubal  
Tir Gofal Call-Out Visit Report

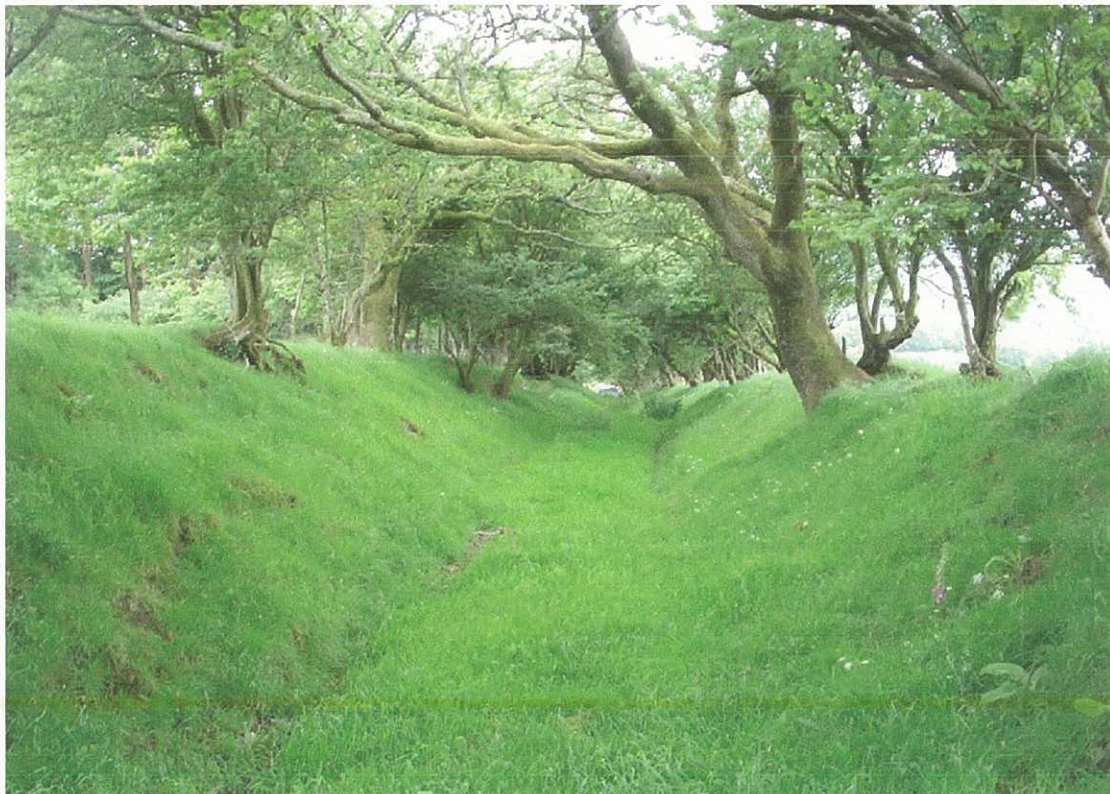
A well preserved section of the substantial trackway at Pantycoubal.

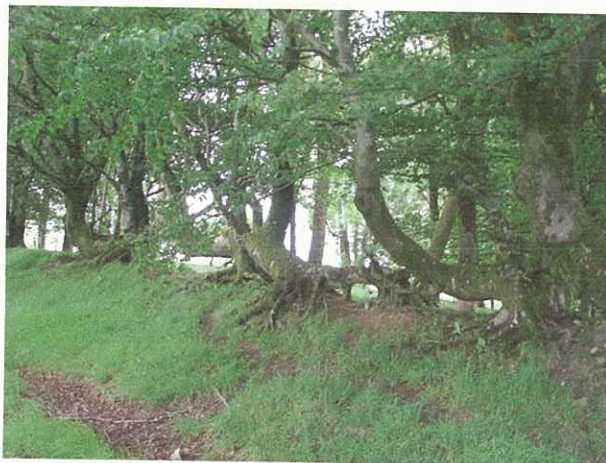
**Plate 1.** *View along a short section of track nearest to the farmstead of Esgair Fynwent. Note how, in this area, the trees show clear signs of having been laid as a hedge. In the long term, the ideal restoration would be to reinstate this hedge.*

The planting along most of the length of the track seems to consist of single trees lining the banks. These would never have been stock-proof, and re-planting in these areas should not be aiming for a solid boundary but should be filling in gaps where mature trees have fallen. However, along the section of the track nearest to Esgair Fynwent, the character of the planting changes. Instead of having banks topped with a line of trees, the bank is topped with what appears to be a grown-out hedge. Ideally this hedge should be re-instated, and managed to reproduce a stock-proof boundary. In the long term, this would eliminate the need for modern fencing in this section.

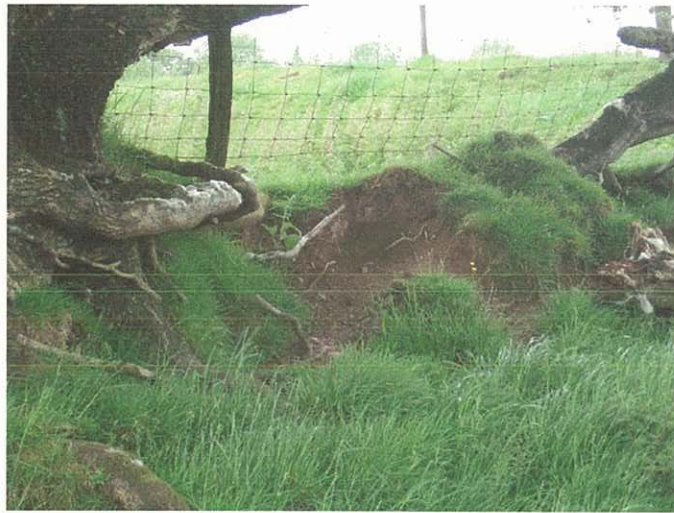
**Plate 2 (above).** *A small section of the bank showing an active sheep scrape which is removing earth from the banks. It also forms a hollow under the fence, preventing this fence from being stockproof.*

Grazing of this trackway and movement through it by livestock has caused a problem with erosion in parts of this feature, as already discussed. Fencing the track out of grazing will have the additional benefit of allowing the vegetation cover to re-establish itself on erosion scars. On the most severe of the sheep scrapes, where tree roots are exposed and may be destabilised, it may be necessary to infill the scrapes with earth and re-seed them. If this is carried out it should be ensured that the profile of the bank is re-created as carefully as possible.

It is important that the trackway is not only restored, but maintained in a stable condition. The proposed re-planting of trees in the larger gaps is to be welcomed, but existing trees must also be managed to prevent them from falling and bringing up large amounts of the banks. Infilling sheep scrapes which are exposing their roots will help to prevent this. Several patches of weeds and scrub will need removing before the path is opened, and will also need to be kept in check in the future, in order to ensure that the path remains in a useable condition. Vegetation should be cut at ground level and removed, not dug or dragged out.

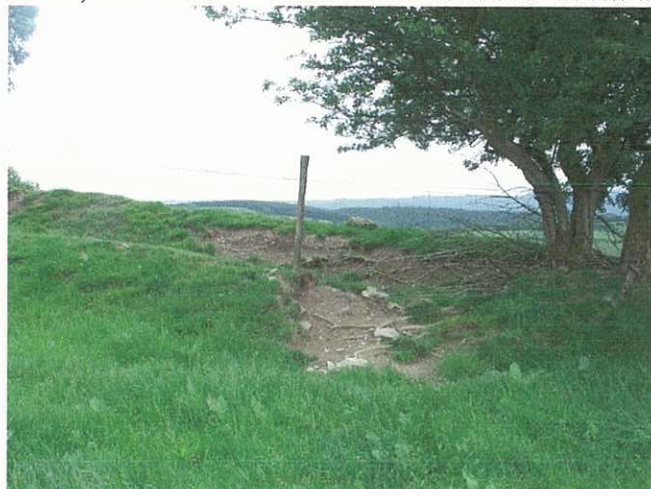
**Plate 3 (below).** *View across the middle section of the track. There is a large gap in the line of trees here, and planting to re-instate trees would improve the appearance of the track. A sheep path also crosses both banks, and has caused a clear erosion scar which will need to recover.*

Ideally, future management of the site would consist of occasional light grazing in dry weather. This would control the vegetation whilst doing minimal damage to the banks. Severe erosion scars and sheep paths may need to be covered with chicken wire whilst grazing is taking place, to discourage livestock from walking across those areas. The wire can be lifted as soon as the vegetation has recovered (Rees,S:1994:p.35).
