Cwm March Farm W/11/3455

Tir Gofal Farm Visit Historic Environment Report

REPORT NO. 2003/53
PROJECT RECORD NO. 45661

Cwm March
Tir Gofal Farm Visit Historic Environment Report

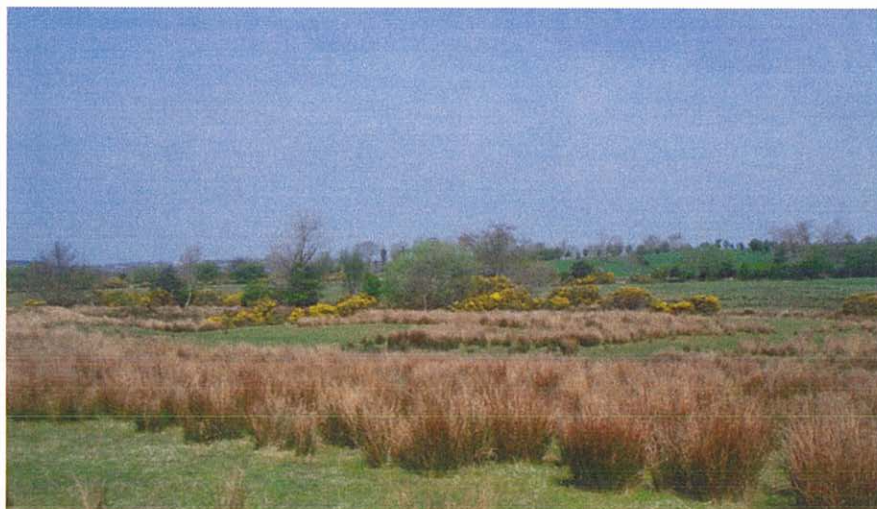
Today the earthwork is much as described above. The shallow ditch is still traceable around the west and southeast sides. The creation of a pond has since destroyed any traces of the ditch on the east side. The low perimeter bank described is increasingly denuded, although it is still visible as a low earth bank up to 0.5 metres high on the east side of the earthwork. It is less visible to the west as a low spread earthwork up to about 0.3 metres high.

Two ponds have since been dug to its north and east. The pond to the east has destroyed part of the boundary ditch, whereas the pond to the north has truncated part of the northern extent of the earthwork platform. Spoil deposits and machinery activity during pond creation may also have reduced the visibility of earthwork remains.

The earthwork lies within low lying marshy ground, which is grazed periodically. No specific threats were identified from the current management regime.

Place 1- looking north to the probable defended enclosure at Tir Bach (PRN 8108)

The site should continue to be grazed periodically in order to keep vegetation growth around the monument under control. There is potential for archaeological deposits surviving below ground level here. No ground breaking activities should be undertaken within 15 metres of this area in order to protect any buried archaeological remains. The area should not be used as a location for feeding livestock.

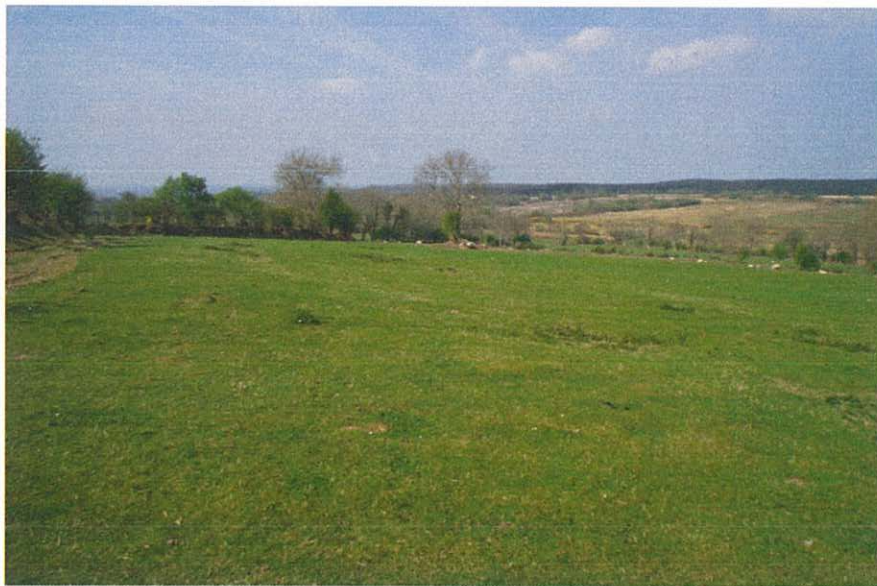
This sand pit is marked as an *Old Sand Pit* on the 1891 Ordnance Survey map. It is visible today as a shallow rectangular scar cut into a gentle hillslope measuring approximately 22 metres by nine metres. It currently lies under pasture, which is grazed periodically.

Plate 2- the sand pit (PRN 47897) looking northwest

The sand pit should be maintained as a visible historic landscape feature. It should not be infilled.

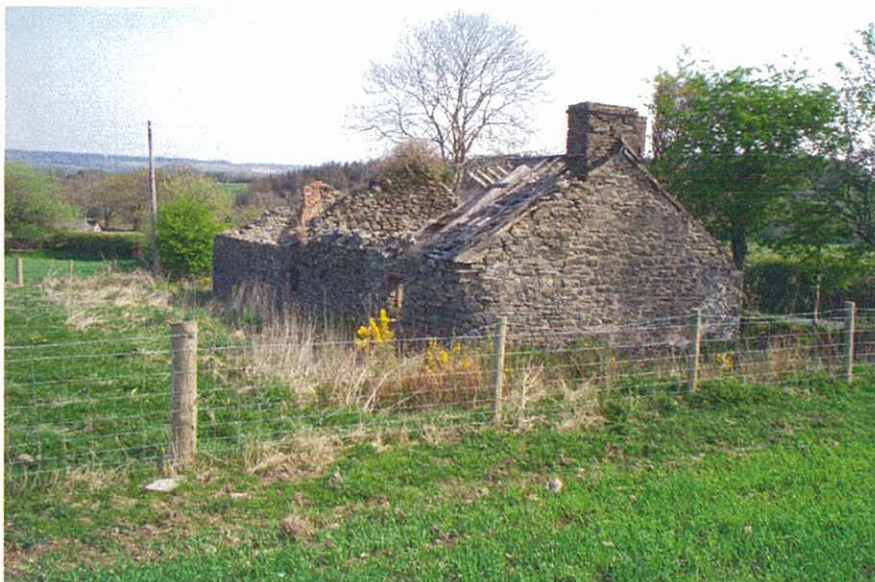
The condition of the building is worsening and water ingress continues to wash out masonry bonds. Vegetation growing out of the south gable end is also weakening masonry bonds making the structure increasingly unstable.

This is the southernmost of two roadside cottages approximately 200 metres to the south of the Afon Bran. It measures approximately nine by six metres and follows a north-south alignment. It is currently ruinous and only the shell of the building survives. All walls survive to full height, although part of the east lateral wall has collapsed at the north end. It is accessed by a central doorway in between two windows in the east lateral wall. A small window was also identified in the south end of the west lateral wall. The roof is almost entirely collapsed and only one of the A-frames survive. Some slates remain at the south gable end. The cottage, which is first shown on the 1843 Cilcennin Parish tithe map is likely to be of an early to mid nineteenth century date. It is no longer in a weatherproof condition and water ingress is washing out lime mortar bonds and weakening the structure.

Plate 3- Pont-Bran cottages (PRNs 47898, 47899)

These buildings are currently in a poor condition. Reconsolidation works are necessary if they are to be brought back into a stable condition necessary for their long term survival. Ideally, masonry should be consolidated and the wall tops capped with a traditional lime mortar mix in order to prevent further collapse.

This cottage is currently in a poor condition. Reconsolidation works are necessary if it is to be brought back into a stable condition necessary for its long term survival. Ideally, masonry should be consolidated and the wall tops capped with a traditional lime mortar mix in order to prevent further collapse.

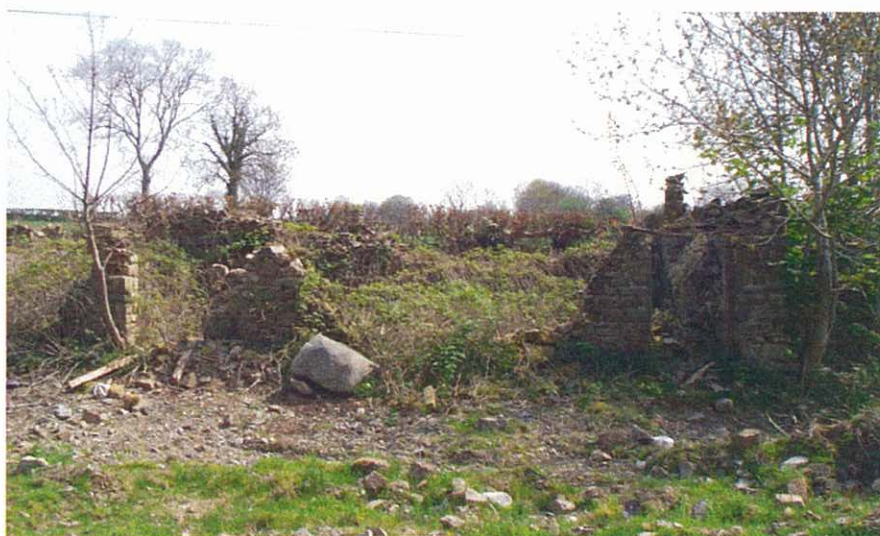
This long, low cow shed defines the eastern extent of the farmyard at Tir bach. It follows a northsouth alignment and measures approximately eighteen by six metres. It is of lime mortar construction, and would originally have had a pitched slate roof. Four bays could be identified. The internal layout of the southern three bays follows a typical cowshed design. Each bay is accessed by a central doorway and the layout of the cobbled floor identifies a central drainage channel, with stalls on either side, although none of the additional building fixtures and fittings survive. The smaller northern bay, measuring approximately six by four metres may also have housed cattle. The building is first shown on the 1843 Cilcennin Parish tithe map when Tir Bach was known as Tiddin y Castel and is likely to be of an early to mid nineteenth century date. The building is currently roofless, ruinous and overgrown with brambles. Part of the east lateral wall survives to eaves height, although the walls are in varying stages of collapse. The interior and surroundings are overgrown with brambles. Young trees are also becoming established in places and some are threatening to displace the wall footings and promote building instability.

Plate 4- part of the eastern elevation of cow shed (PRN 47900)

This cow shed is currently in a ruinous condition. Reconsolidation works are necessary if it is to be brought back into a stable condition necessary for its long term survival. Ideally, masonry should be consolidated and the wall tops capped with a traditional lime mortar mix in order to prevent further collapse. The trees growing out of the wall footings should be cut off at the roots and then treated to prevent regrowth.

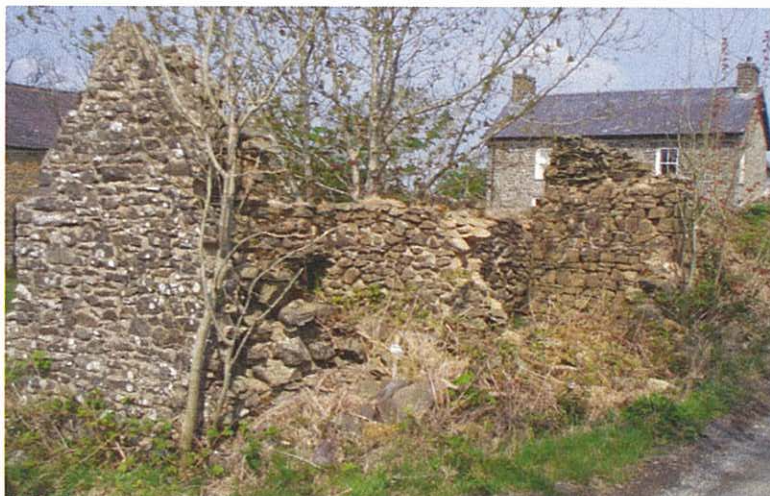
This small building abutting cow shed (PRN 49000) follows a north south alignment and measures approximately seven by three metres. It is of lime mortar bonded stone rubble construction with a pitched roof. A central partition wall divides the building into two bays, which are accessed by doorways on either side of this partition in the western lateral wall. This building is not shown on the first and second edition Ordnance Survey maps (1891, 1906) and is likely to be of an early 20th century date. It is currently roofless and in a ruinous condition, the walls being in varying stages of collapse. Some young trees have become established in the wall footings and their growth threatens to make the building increasingly unstable.

Plate 5- the pigsty at Tir Bach (PRN 47901), the farmhouse can be seen in the background.

This ruinous building is currently in an unstable condition. Water ingress continues to wash out masonry bonds, weakening the structure, whilst young trees growing out of the wall footings threaten to increasingly destabilise an already weakened structure. Ideally the trees should be cut off at the roots and spot treated to prevent regrowth. This should be followed up by a programme of masonry consolidation and repointing in order to bring the ruin back into a stable condition.

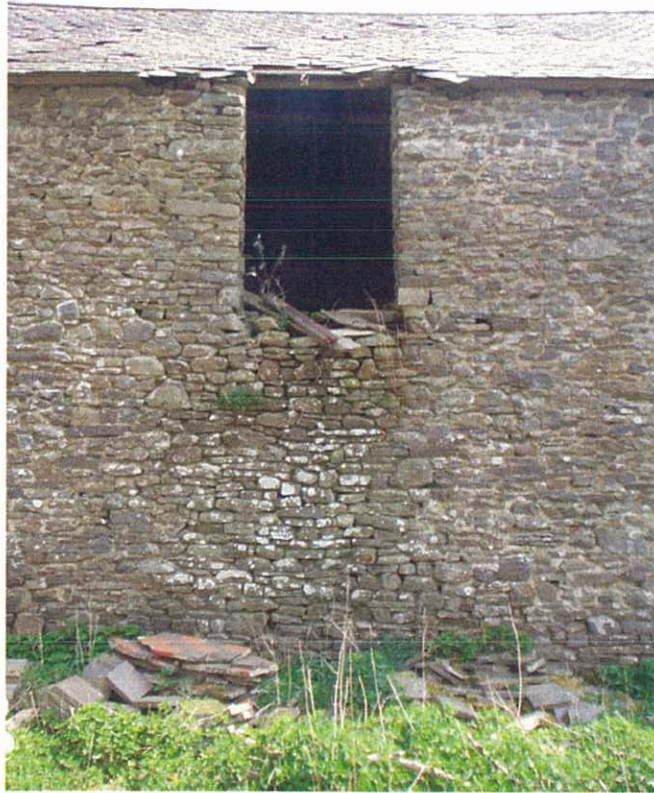
The building, which is of a typical mid to late nineteenth century design is currently falling into a ruinous condition. The eastern pitch of the roof remains in a weatherproof condition, although a few tiles may need replacing. Holes are appearing in the western pitch of the roof, however. Tiles are missing above the loading door of the central hay loft and water is running down the walls and washing out masonry bonds, promoting building instability. Water ingress is also damaging the masonry structure below a large hole to the south end of the west lateral wall. Missing tiles above the stable have promoted rot in the floor joists, which are currently collapsing. This is of particular concern as the building may lose the stabilising influence of these floor joists, which help to bind the walls together.

Plate 6- water damage to masonry bonds in the building range at Tir Bach (PRN 47902)

The building is currently falling into a ruinous condition and reconsolidation and repair works are necessary if it is to be brought back into a weatherproof condition necessary for its long-term survival. Rotten roof batons should be refitted where necessary and missing roof tiles replaced. The rotten floor joists in the stable will also need to be replaced in order to preserve the structural integrity of the building. This should be followed up by a programme of masonry consolidation and re-pointing. This building is a particularly fine example of its type. It would be a great loss if it were allowed to fall into a ruinous condition.

The building is currently falling into a ruinous condition and reconsolidation and repair works are necessary if it is to be brought back into a weatherproof condition necessary for its long-term survival. Rotten roof batons should be refitted where necessary and missing roof tiles replaced. The rotten floor joists in the stable will also need to be replaced in order to preserve the structural integrity of the building. This should be followed up by a programme of masonry consolidation and re-pointing. It would be a great loss if it were allowed to fall into a ruinous condition.

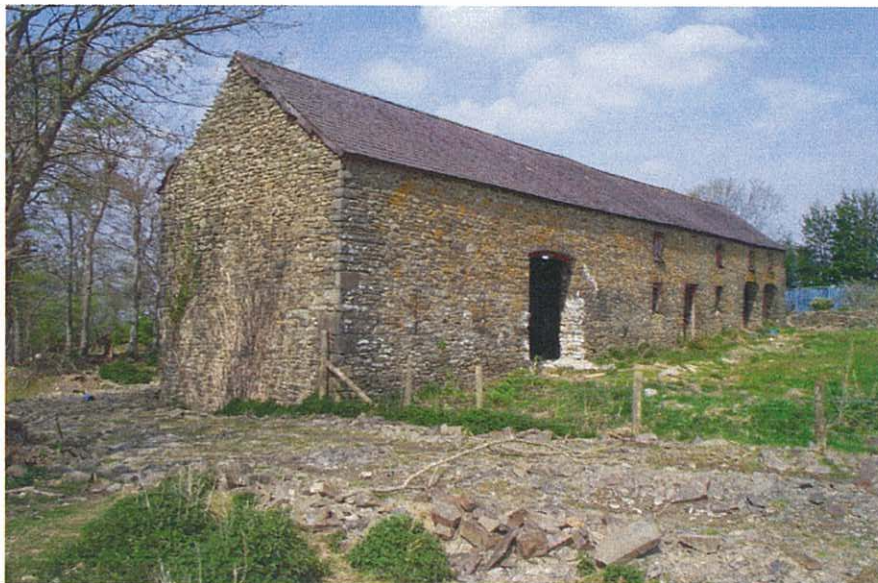
This long building range is a particularly fine example of its type. It is built of uncoursed stone rubble construction with a pitched slate roof and defines the western extent of the farmyard at Tir Bach. It follows a northsouth alignment and measures approximately 30 metres by six metres. It is divided into three units; a southern barn of traditional form, a central stable/ hay loft and a northern cart shed.

The southern barn follows a typical layout of a central threshing floor, accessed by large cart entrances in each wall. Sheaves and straw would have been stored in the bays on either side. A small loft in the south bay would have been used for additional storage. The large central stable block is accessed by a single doorway in the centre of the east lateral wall. Windows are equally spaced to either side. The stable retains many of the original internal arrangements, the cobbled floor and surviving wooden stalls define the historic internal layout, where stalls faced onto the east and west lateral walls. The floor of the upper storey hay loft is currently in a dangerous and unstable condition. The joists are rotten and those in the centre are collapsing. Two pitching holes are visible above the stable windows in the east lateral wall, whilst a central loading door is the only opening in the western wall. The two bayed cart shed to the north retains two cart entrances with stone *voussoirs*. The pitching holes of an upper storey loft are centred above these arches. The loft is accessed by a central doorway in the north gable end up an external set of stone steps.

Plate 7- the building range to the west of the farmyard at Tir Bach (PRN 47902)

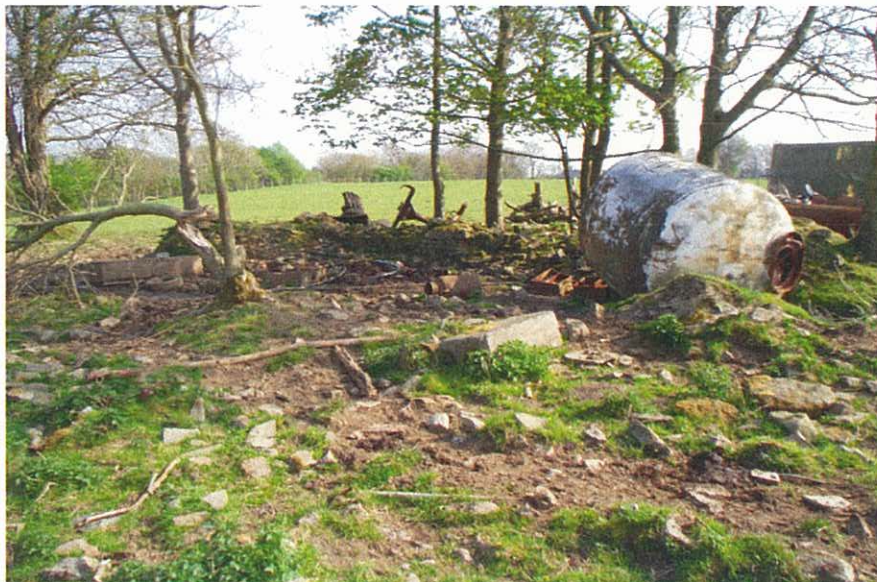
Plate 8- looking south towards the cottage site at Cwm-march-uchaf (PRN 47905)

This cottage is first shown on the 1843 Cilcennin Parish tithe map as belonging to Cwm March. It remains visible on the 1891 and 1906 Ordnance Survey maps, where it becomes known as Cwm March Uchaf. Only the denuded walls of the south lateral wall and part of the east gable end survive. The location of a water trough within the walls of the former cottage, is creating a focus for livestock and the area is heavily poached. This may be damaging buried archaeological remains. Some trees are growing out of the walls and the site is used as a tip for farm rubbish.

Poaching by livestock is the most damaging activity at these sites. In order to prevent livestock from congregating, the area within fifteen metres of the edge of each site should not be subjected to any ground intrusive activities or used as an area for feeding or watering livestock. Farm rubbish should be removed from this area.

Poaching by livestock is the most damaging activity at this site. In order to prevent livestock from congregating, the area within fifteen metres of the edge of this site should not be subjected to any ground intrusive activities or used as an area for feeding or watering livestock. Farm rubbish should be removed from this area.

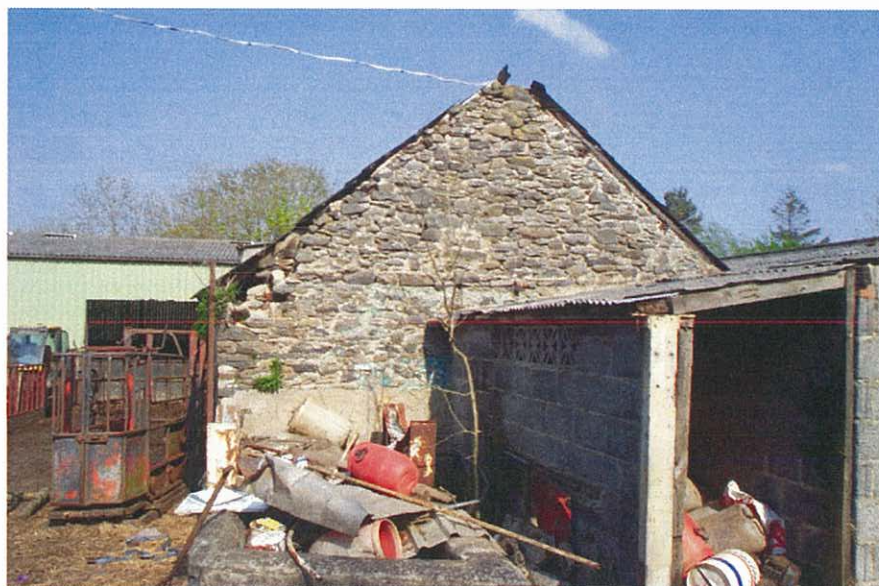
Plate 9- the west gable end of cow shed (PRN 47908)

This cow shed is located to the north of the farmhouse at Cwm March. It follows an east-west alignment and measures approximately fifteen metres by six metres. It is of uncoursed stone rubble construction with a pitched slate roof, and is masked on all but the north side by later farm buildings. The cow shed first appears on the 1843 Ordnance Survey map and is likely to be of an early to mid nineteenth century date. Little of the historic integrity of this building remains, the west gable end being the only wall to survive intact. The remnant south lateral wall is now revetted by a modern wall of breeze block construction, and the north lateral wall has been rebuilt entirely out of breeze blocks. The east gable end has been demolished entirely and this building now forms part of an "open plan" livestock shed adjoining a large modern shed of breeze block and box section construction.

The building is currently in a reasonable condition, although water ingress is washing out masonry bonds in the northern pitch of the west gable end where some roof tiles have been lost.

The building should be maintained in a stable condition using similar building materials to those currently being used. Missing roof tiles should be replaced and areas of instability should be reconsolidated using traditional building materials and techniques.

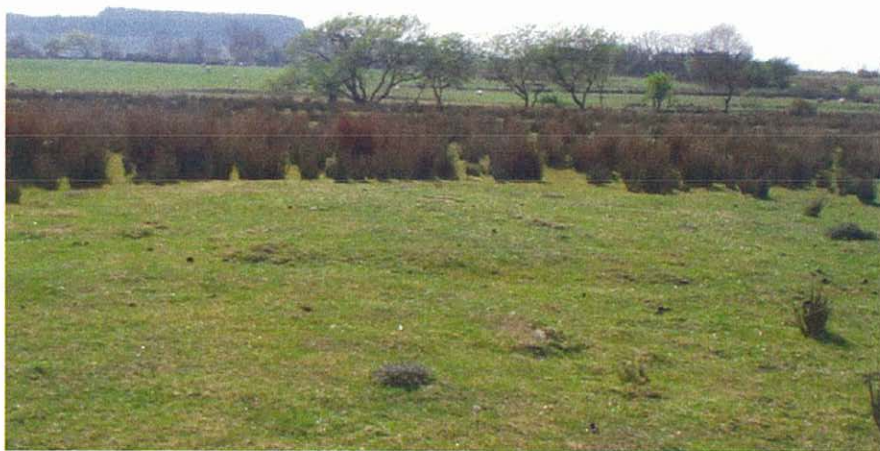
A small building is shown at this location on the 1843 Cilcennin Parish Ordnance Survey map, and identified as Pant y Rhos on the 1891 and 1908 Ordnance Survey map. Few traces of a cottage site remain visible at this location. A raised area of drier land, with scattered stone approximately 0.5 metres above the surrounding area may indicate the site of a former building.

Plate 10- the possible former cottage site of Pant y Rhos (PRN 47910)

Although few visible remains of a cottage site can be identified, there may be archaeological deposits surviving below ground level. No ground breaking activities should be undertaken within 15 metres of this area in order to protect any buried archaeological remains.
