# **Penlan-Uchaf W/13/3282**

## **Tir Gofal Farm Visit Historic Environment Report**

Report No. 2003/27

REPORT NO. 2003/27  
PROJECT RECORD NO. 45666

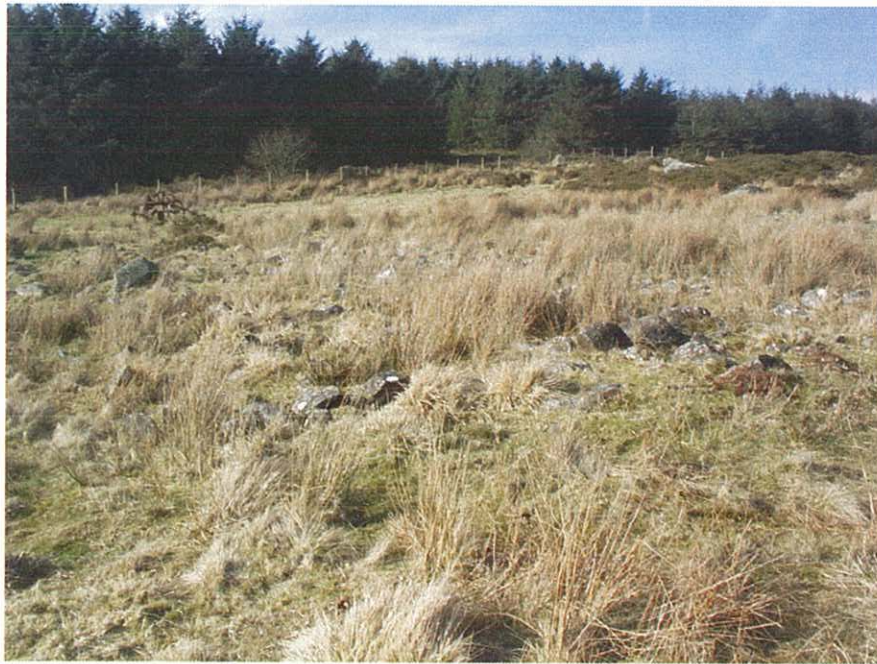
Gochel Sythi settlement is first shown on the Newport and Llanychlwydog Parish tithe maps (1845, 1844) as two buildings, accompanied by small paddocks. Only the field boundaries and cottage enclosure are shown to survive by the time of the 1891 Ordnance Survey map. Gochel Sythi is likely to originally have been a squatter settlement or *tai-unnos* of an 18<sup>th</sup> or early 19<sup>th</sup> century date, when marginal land was becoming increasingly populated during a time of rising population. These settlements were often short lived and like many others, Gochel Sythi was abandoned during the mid to late 19<sup>th</sup> century.

The western half of the settlement (PRN 41475) lies outside of the holding area within Penlan Wood. The eastern extent of Gochel-Sythi (PRN 6463) lies within Penlan-Uchaf and is well preserved under rough pasture. The stony earth banks and associated ditches shown on the early maps are still visible as well defined earthworks. The main boundary bank, which bisects the settlement on an east-west orientation, survives at a height of up to one and a half metres and its parallel ditches continue to carry water. Boundary banks, which demarcate small plots of land and a cottage enclosure are identifiable, although they are less pronounced up to a height of around one metre. The rectangular building platform comprises an even spread of sandstone rubble, aligned east-west and measuring around eight metres by eighteen metres indicates the extent of the building shown on the tithe map. Further interpretation of the building plan and structure was not possible from the surviving material. A discarded plough to the west of the building platform suggests that some of these plots would once have been cultivated, although the area would have continued to be dominated by a pastoral economy. The site is currently under unimproved pasture and tussock grass, which is grazed periodically.

Plate 1- the housing platform at Gochel Sythi (PRN 6463)

There are no immediate threats apparent from the current management regime, although concentrations of gorse are increasingly becoming established over the site and are masking some of the earthworks. An even grass sward, necessary for long term survival of earthwork remains, should be established over the site and any scrub growth should be controlled by targeted burning. No ground disturbing activities should take place within the settlement area, which may preserve buried archaeological remains.

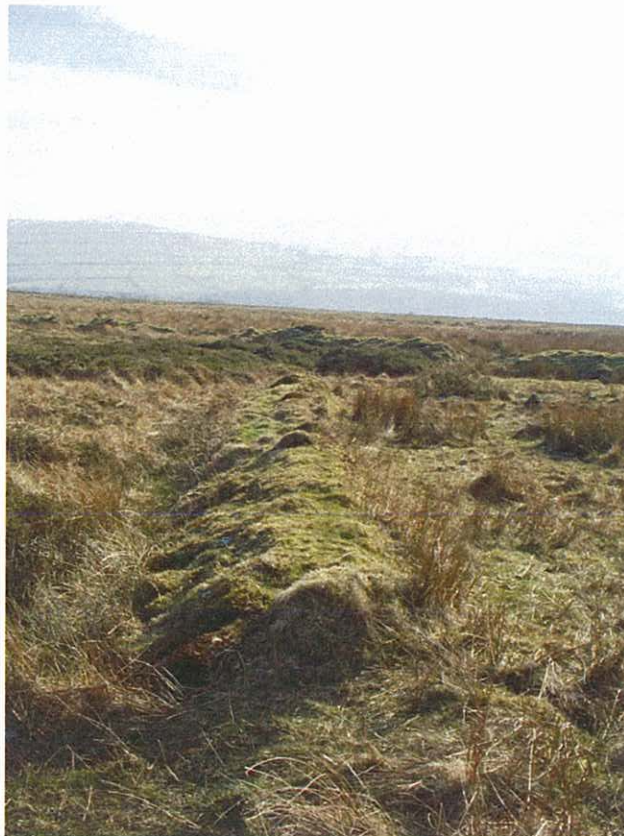
Plate 2- field boundary banks at Gochel Sythi looking east

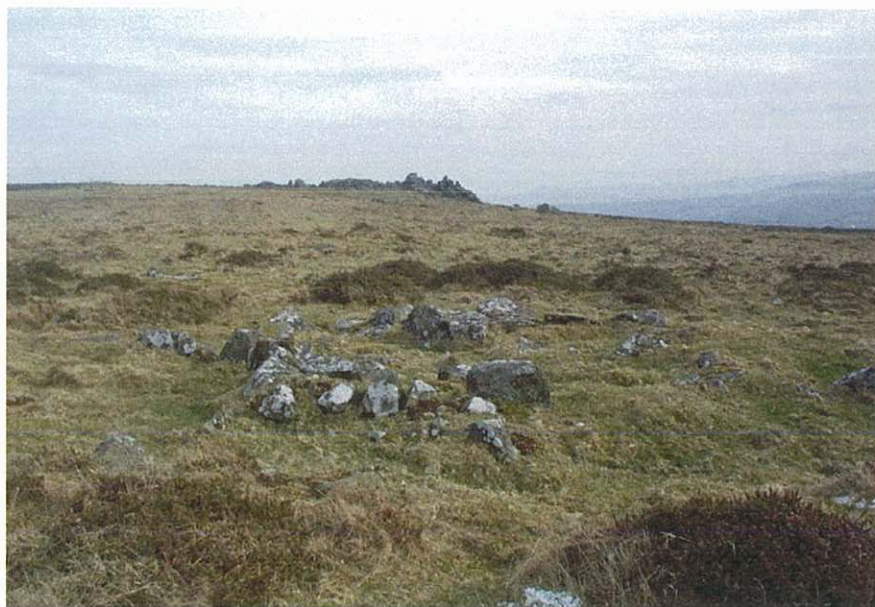
This sub-rectangular feature is aligned north-south along its long axis and measures approximately 5.5 metres by 4.1 metres. Remnant walls of limestone rubble are visible on eroded earthwork banks upto 0.9 metres wide and 0.5 metres high. Some scattered building debris are also visible on the interior of the structure. Interpreting the original function and date of this structure, which survives in a poor condition and is not identified on any of the early map sources is problematical, although it may be an old shepherding cottage. No associated enclosure or field boundaries could be identified.

Plate 3- cottage site (PRN 47387) with Carn Edward in the Background

No apparent threats could be identified from the current management regime. The site should continue to be sensitively grazed in order to maintain a stable grass sward necessary for its long term survival. Scrub should not be allowed to become established over the site.

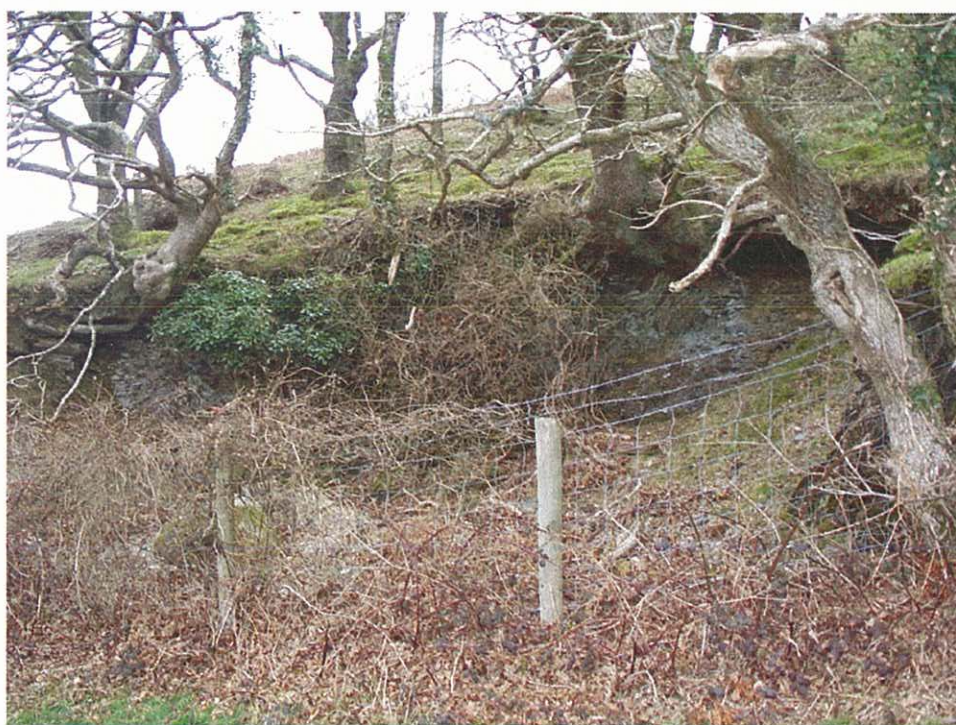
This small quarry is first shown on the 1891 Ordnance Survey map in a natural south facing slope. The landowner believes that the quarry was still in use around seventy years ago when his father was farming.

Plate 4- the quarry (PRN 47532)

The quarry should continue to be maintained as a visible historic landscape feature and should not be infilled.

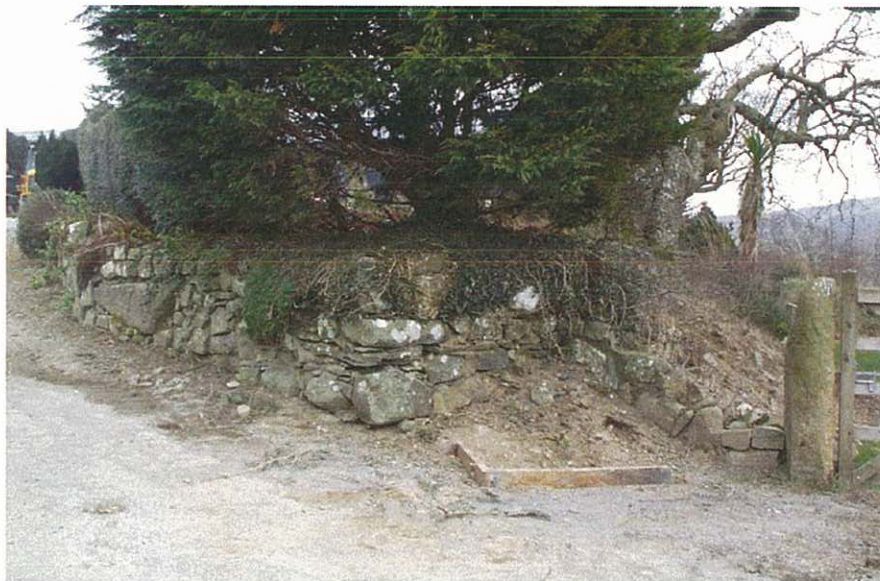
This building, which is first shown clearly on the 1889 Ordnance Survey Original Surveyors Drawings, remains visible on Ordnance Survey maps up until 1964. It follows a northeast southwest alignment and defines the southeastern extent of the farmyard at Penlan-Uchaf. The building no longer survives intact and the remnant walls, up to around one and a half metres high have been incorporated into a modern garden feature.

Plate 5- the remnant walls of the building in the yard at Penlan Uchaf

The remnant walls of the outbuilding should be maintained in a stable condition using traditional building materials and techniques.

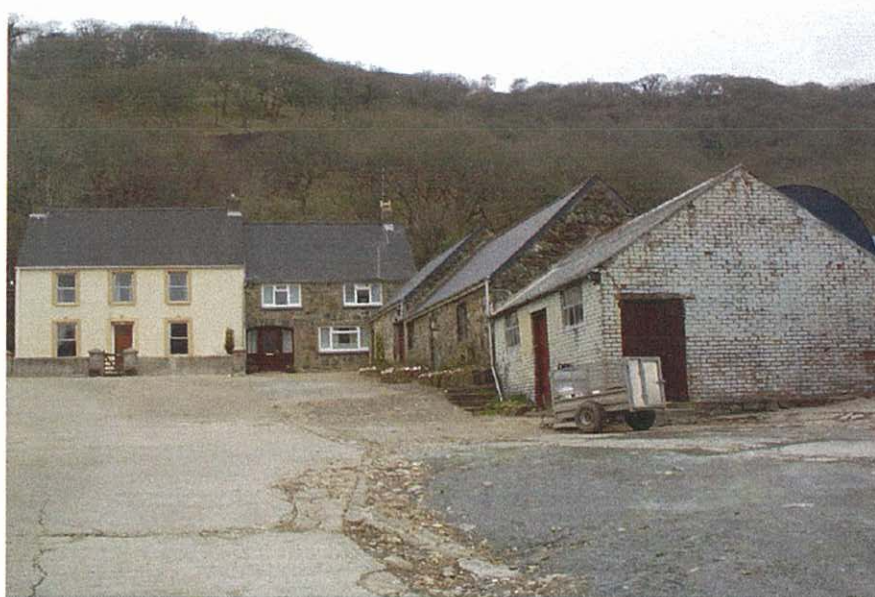
The historical integrity of Llanerch farmstead (PRN 47540) in the valley bottom to the east of the holding is better preserved and the L-shaped arrangement shown on the early Ordnance Survey maps persists today. A long, low building range aligned northwest to southeast defines the eastern extent of the farmyard, which is overlooked by the modest vernacular farmhouse to the north. Modern farm buildings at Llanerch form a discrete unit to the east and consist of large sheds of corrugated iron and sheet box construction.

Plate 6- Llanerch Farmstead (PRN 47540)

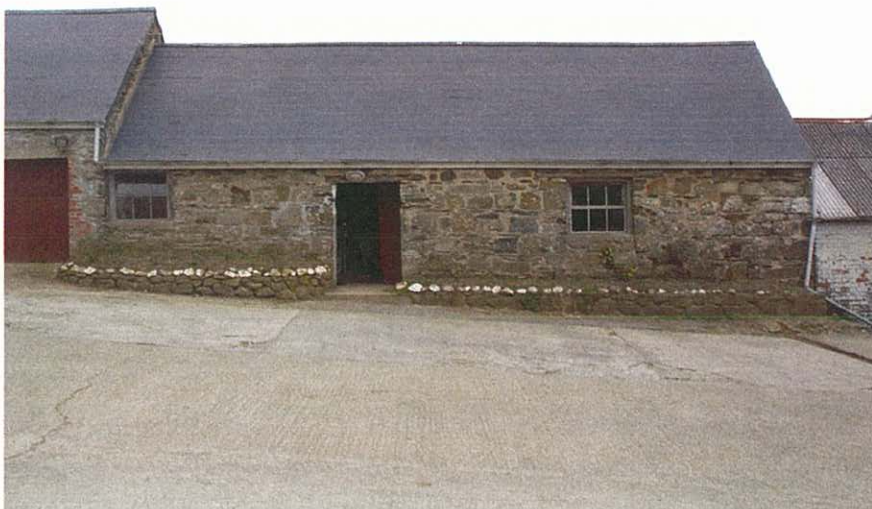
This one and a half storey building forms the central unit of the long, low building range, which defines the eastern extent of the farmyard at Llanerch. It is constructed local stone built to rough courses, with a pitched slate roof. The building is accessed from the farmyard by a central sliding doorway with a wooden lintel. The original square wooden framed windows survive on either side of this central doorway. Infilled slit windows are visible at either end of the rear wall.

The interior of the building is divided into two bays separated by a breeze block wall. Two concrete stalls with halter bars face onto a concrete trough and lateral feed passage in the north bay of the building. The south bay, which is currently empty, is believed by the landowner to have been a dairy when his grandfather was farming. Metal pipes in the south gable wall may survive as remnants of the original dairy apparatus. The building is likely to be of a mid nineteenth century date.

Plate 7- the dairy (PRN 47536)

The building is on the whole in good condition and the western pitch of the roof has recently been repaired. Several tiles have worked loose on the eastern pitch and need replacing if the building is to be maintained in a weatherproof condition necessary for its long term survival. Lime mortar bonds are becoming eroded in parts of the northeast lateral wall and may require repointing using a traditional lime mortar mix.
