Trewarren Farm

W/13/3817

Tir Gofal Farm Visit Historic Environment Report

Trewarren Farm
Tir Gofal Farm Visit Historic Environment Report

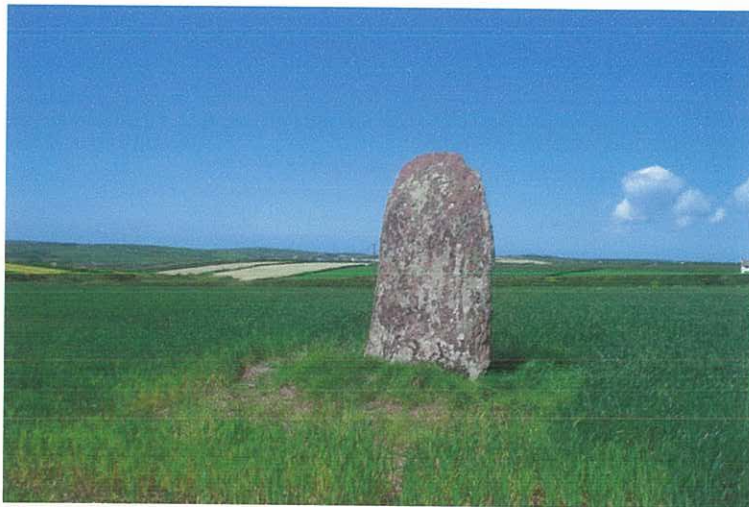
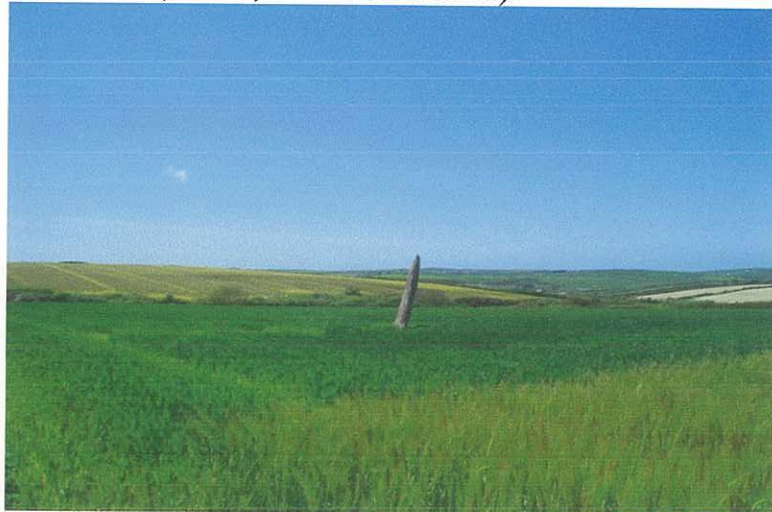
A large standing stone, designated as a Scheduled Ancient Monument. It is a large red sandstone slab which leans at an angle of around 25 degrees. The slab is very narrow, and the appearance of the stone differs according to the direction it is viewed from. There is some damage to the stone on the southeast side, which was probably caused by ploughing. It is clear that ploughing operations have come within 0.5 m on the south and east sides, but the margin is now significantly greater. To the northeast the plough margin is probably still less than a meter.

This monument is a very impressive and highly visible feature of the landscape. Continued close ploughing will eventually de-stabilise the stone's footings, and could eventually cause it to fall.

Plate 8 (above): Standing stone (PRN 2998). The narrow plough margin around the stone can be seen as a paler green. In the forefront of the picture, a larger margin has been left this year.

Plate 9 (below): The appearance of the stone depends on the angle from which it is viewed (above, viewed from the south, below, from the northeast).

A grass margin should be left for 5m around the stone in all directions. The margin should be routinely cut back or grazed to prevent the incursion of scrub.

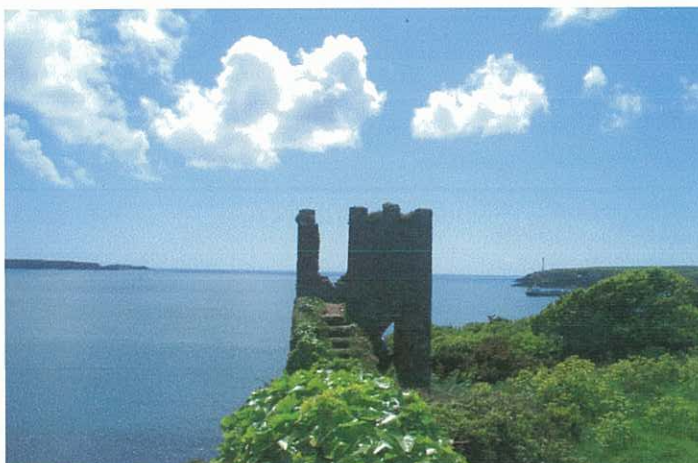
A two storey crenellated folly in a cliff-top position. The tower gives views out to sea and across the bay at Loose Haven. The folly is now largely ruined: it is roofless and the upper storey has gone. The east and west walls have gothic style arched windows, and a similar shaped door is in the north wall. The south wall has almost completely collapsed. A set of dog leg steps outside gave access to the upper storey. The name of the folly – the Malakov Tower – suggests that it was probably constructed around 1855 since a tower of that name was taken in September 1855 in the Crimean War.

Plate 7: The Malakov Tower – a mid 19th century cliff-top folly (PRN 34464). The dog leg steps which gave access to the upper storey can be seen in front of the tower. These are now becoming very overgrown and are in danger of being lost. The folly is a recognisable feature on the skyline.

In the long term, serious consideration needs to be given to the future of this unusual and elegant building. It is an integral part of the Trewarren pleasure grounds, and a local landmark. It is also Grade II listed and therefore protected under the Planning (Listed Buildings and Conservation Areas) Act, 1990.

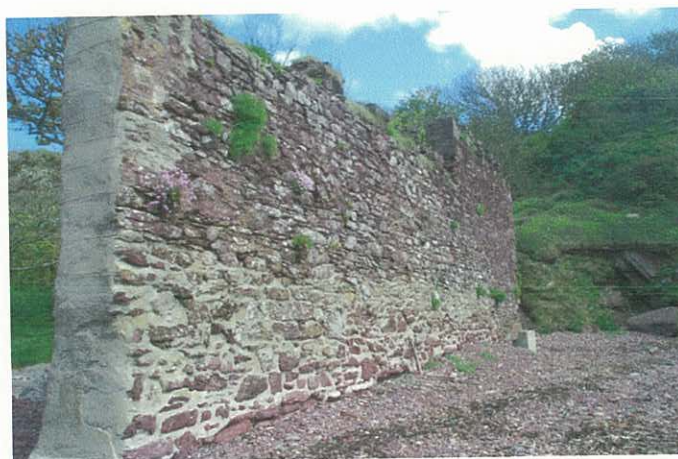
The central parts of the wall stand to around 4.5m with the outer ends reaching 6m. Generally, it is in good condition although some of the crenellations on the western portion of the wall have now gone, and parts of the far western end are becoming overgrown. The central gap was apparently repaired by a Manpower Services team (Cadw and ICOMOS UK:2002:p.320) who have partially re-pointed it with cement, and have also skimmed the exposed width of the wall with cement. Originally, this wall spanned the whole width of the foot of the valley. However, the easternmost part of the wall does not now join up with the valley edge, which implies that a part of the wall has been lost.

Plate 6: The west section of the sea wall (PRN 34759). The cement render on the surface at the forefront of the picture was applied by a Manpower Services team, when they repaired the central gap in the wall.

The sea-wall is generally in good condition, though slightly overgrown at the west end. The top of the wall has some grasses and moss growing, and these should be removed. Ideally the wall should be capped, in order to prevent water penetrating the stonework. Where it is becoming overgrown, vegetation should be cut back and, if necessary, treated to prevent re-growth. Any future capping or re-pointing should use materials which match the original construction.

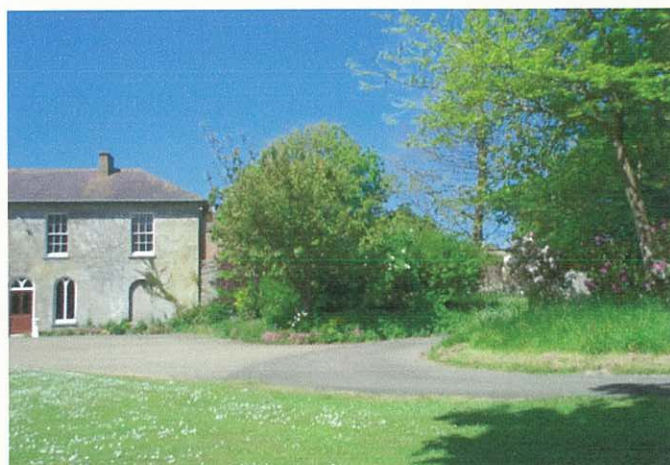
Plate 1: The garden (right, PRN 47818) is cut by a sweeping driveway (front of picture) which manufactures a dramatic view of the house.

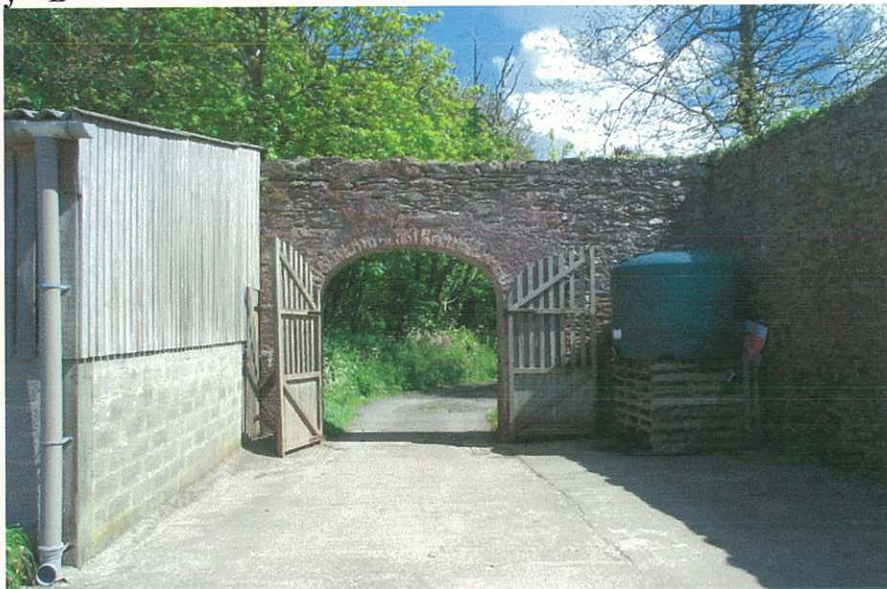
Generally the walls are in good to fair condition, though moss is beginning to colonise the tops of the east and west walls. The owners have already capped parts of the walls to prevent water penetrating the core of the stonework.

Plate 2: The arched gateway in the east side of the service court (PRN 47819)

Vegetation and moss should be cleared from the tops of these walls, and uncapped walls should be capped using appropriate matching materials. A key feature of this farm is its uniformity of building materials, with almost all walling being constructed of red sandstone rubble. It is essential that this uniformity is maintained in future repair work, and great care should be taken that materials are selected which match the original construction as closely as possible.

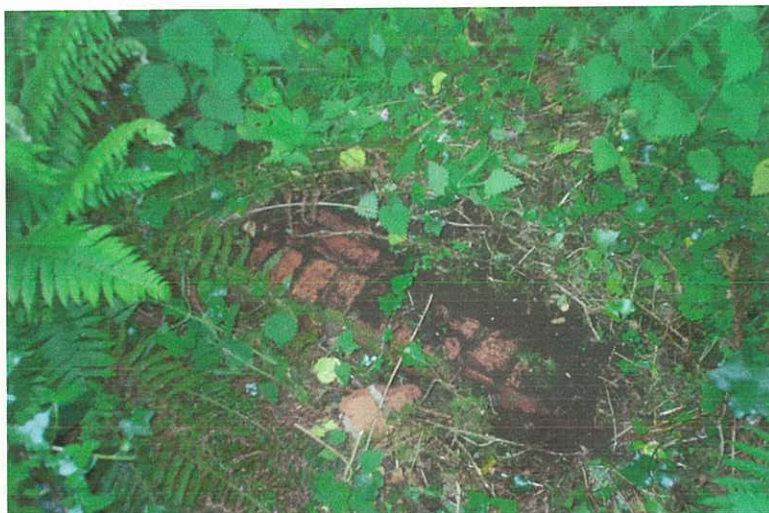
Plate 4: The remains of brick-built raised paths, like this one, are visible under the vegetation in the walled kitchen garden (PRN 47824)

Generally, this garden is in a stable condition. The walls, whilst overgrown, still stand to their full height and many of the paths probably also survive. However the whole garden is choked with vegetation, and the south part of it is inaccessible. Much of the vegetation ideally should be cleared, but several mature trees and shrub clumps may represent remnants of the original planting and should be left in place. To protect the walls and remaining paths, clearance should be carried out by hand – at least initially – in order to establish the pattern of surviving paths and features.

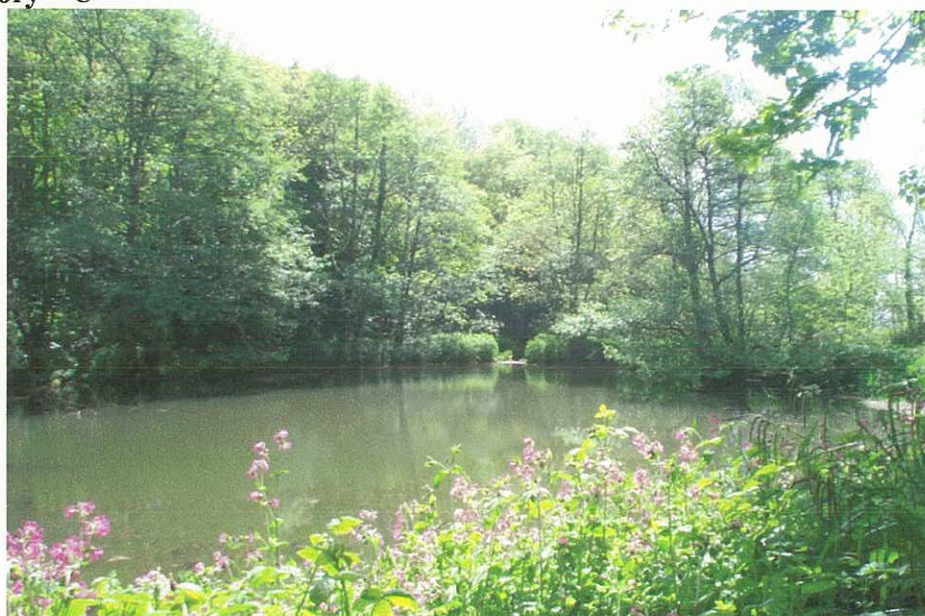
Plate 5: This modern irrigation pond (PRN 47826) blends in very well with the naturalistic style of the original 19th century gardens.

Although this pond is a modern addition to the gardens, in style and appearance it blends in very well. It should be maintained as a visible feature, and prevented from becoming completely overgrown or obscured.

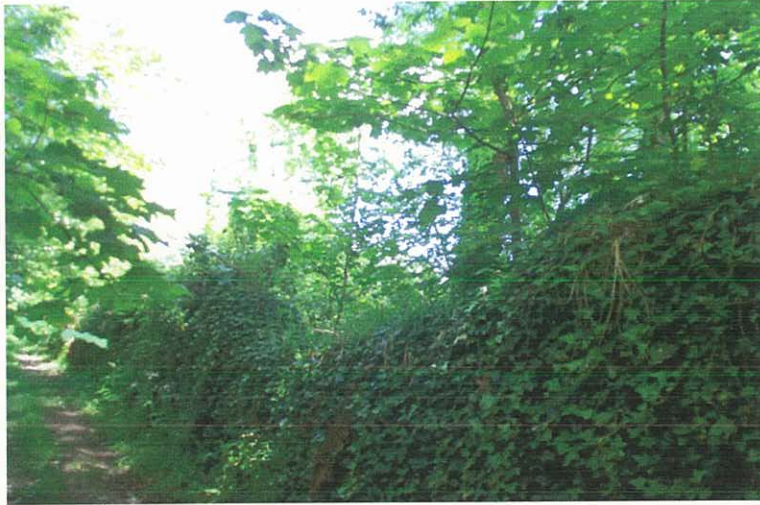
On the west side, an earth and stone bank runs along most of the length of the walkway. The condition of the wall varies along the length of the track. In places it stands to its full height – around 1.7m – but there are areas where it has almost completely collapsed. A large proportion of the wall is ivy covered and overgrown.

Plate 3: The walled trackway (PRN 47831) which leads down the west side of the pleasure garden. Underneath the heavy ivy growth, the wall is of the same red sandstone rubble construction as the other garden features and buildings.

It is unknown whether this track is ever used for vehicular access. Its use in wet weather should be avoided, in order to prevent damaging what remains of the original surface through erosion.

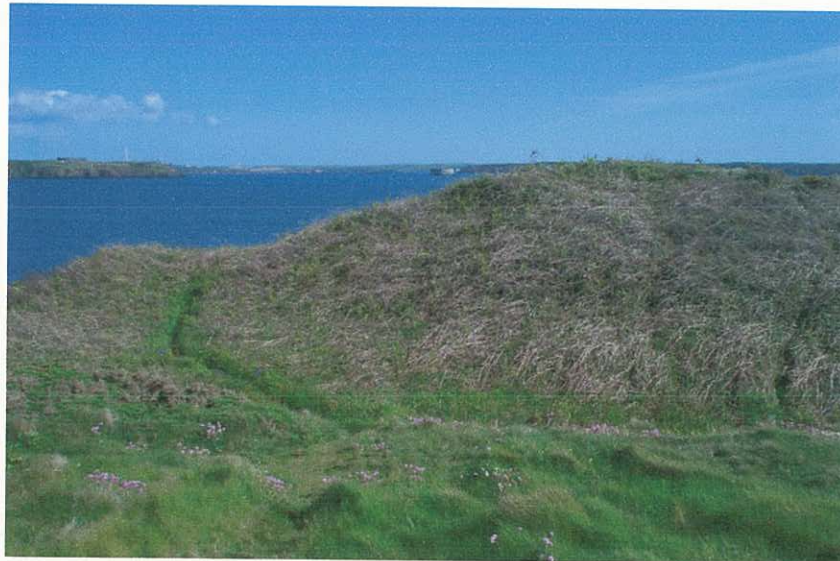
The site lies in an area of unmanaged and ungrazed grassland, at the edge of what is presently an arable field. The Pembrokeshire Coast Path runs past the site, and some footpath erosion has been caused at the east end of the bank by walkers crossing the defences into the hillfort.

Plate 10: The bank of the hillfort at Little Castle Head (PRN 3024), viewed from the landward side. The footpath runs through the ditch, and then crosses the bank at the east side (visible on the left in this picture) where it is causing some erosion to the earthworks.

The site would benefit from being lightly grazed, to control the incursion of scrub, and to maintain a low coastal vegetation cover. Some gorse is growing within the site, and this should be cut at ground level and removed – do not burn on site. Work should only be carried out when the ground is dry, to prevent damage to buried archaeological remains.

The footpath erosion also needs to be addressed before it becomes more severe. Ideally, the monument should be temporarily fenced off and the areas re-seeded. Once the vegetation cover is established, a light grazing regime would keep it stable. If the path continues to erode, either through use by animals or people, it may become necessary to infill scars using inert shale and soil. Please contact Cambria Archaeology if the erosion continues to be a problem.
