Panteg W/13/3832

Tir Gofal Farm Visit Historic Environment Report

Report No. 2003/63

CAMBRIA ARCHAEOLOGY

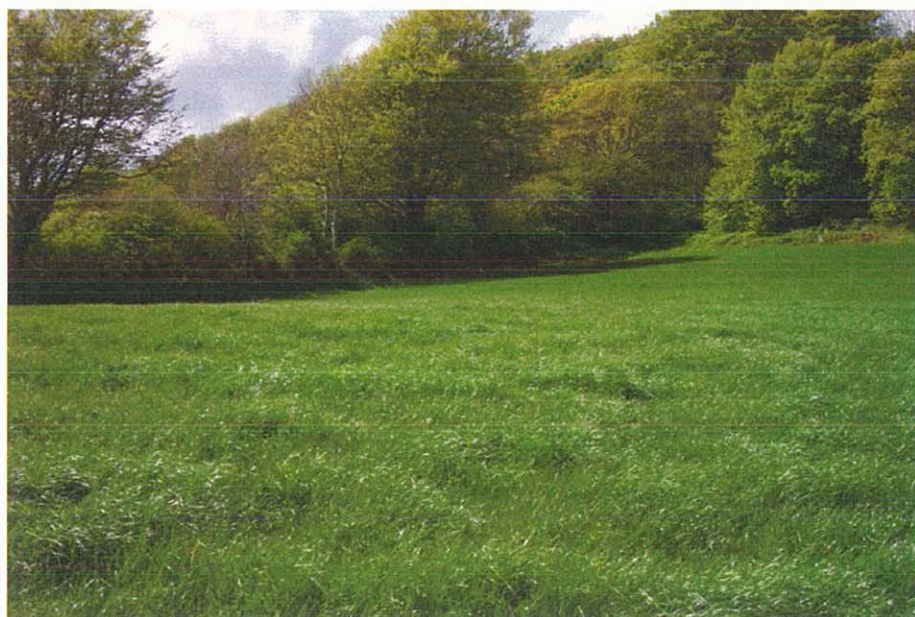
Plate 1- looking west towards the site of rectilinear enclosure (PRN 11776)

A sub-rectangular cropmark measuring approximately 50 by 30 metres with an east-west long axis identified on aerial photographs. This dark cropmark in pasture, indicating ditches is broken on the west side suggesting an entrance. The line of the ditch on the north side is unclear and confused by the northward continuation of the west ditch and the western continuation of the north ditch in the northwest corner (James 1984: 15). This site shows similarities to a class of sub-rectangular enclosures, which are typically assigned to the Romano-British period. A possible association with crop mark (PRN 47947), which is situated approximately 50 metres to the southeast can be made.

The site lies on a naturally terraced area on a moderate to steep south facing slope and commands excellent views to the south, east and west. It was under pasture at the time of the archaeological farm visit and no earthwork remains were observed.

The cropmark indicates a high potential for buried archaeological remains. Ideally the area within 30 metres of the edge of the cropmark site should not be ploughed, subjected to any ground intrusive activity or used as a location for feeding livestock. If ploughing is to continue, any future cultivation should not increase in depth.

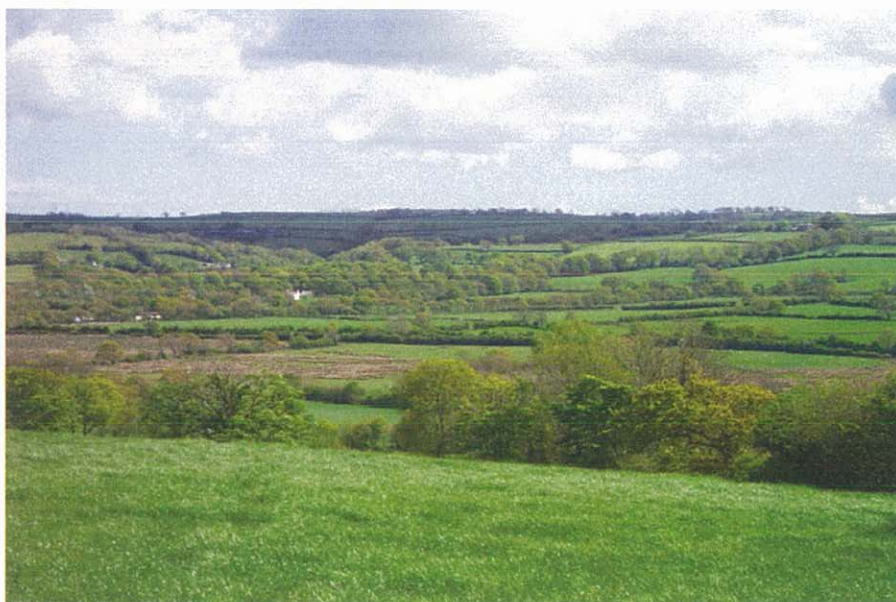
Plate 2- the site of enclosure (PRN 47974) looking south

A dark sub-circular cropmark with an east-west entrance passage, possibly 10 metres wide and approximately 30 metres long leading into a circular enclosure with an estimated diameter of 40 metres. Several smaller cropmark features were identified within the enclosure, although there was considerable background noise making this area difficult to interpret. A sub-rectangular cropmark (PRN 11776) is located approximately 50 metres to the northwest of the main enclosure.

The cropmark shows similarities to the concentric antenna enclosure type. These enclosures are typically concentric, consisting of a small circular inner enclosure within a large circular outer enclosure; with the inner enclosure typically entered via a funnel like passage through the outer enclosure (James 1990, 295-8; T. James 1992, 69). An increasing number of examples are being identified in southwest Wales, in which ecclesiastical features such as cemeteries and churches overly these enclosures, in some cases suggesting the early medieval re-use of Iron Age sites. An example is Llangan, Carmarthenshire, where a "high probability early cemetery site is located within the outer enclosure of an apparent concentric antenna enclosure" (Ludlow *forthcoming*). The outer enclosure is notably absent in this case, and the site can therefore be classified as the antenna or banjo enclosure type, which are also typically assigned to the Iron Age. Despite the absence of the weaker outer enclosure in this case, an argument for the early medieval ecclesiastical re-use of this feature is tempting, in light of the above analogies. This may be further strengthened by the field name Parc yr Eglwys on the 1840 tithe apportionment.

The enclosure is situated on a moderate slope within a well drained pasture field, which has been ploughed in the past. No earthwork remains or features of archaeological interest were identified above ground. The dark cropmarks, indicating ditches are a measure of the high archaeological potential of the site. Aside from the substantial ditches, the interior of the enclosure may hold evidence of hut platforms, storage pits and other features of Iron Age occupation. A speculative church site, may be identified by a dark rectangular cropmark, which measures approximately ten by five metres at the north end of the enclosure near to the entrance.

The cropmarks indicate the high potential for buried archaeological remains here. Ideally the area within 30 metres of the edge of the site should not be ploughed, subjected to any ground intrusive activity or used as a location for feeding livestock. If ploughing is to continue, any future cultivation should not increase in depth. No root crops should be grown.

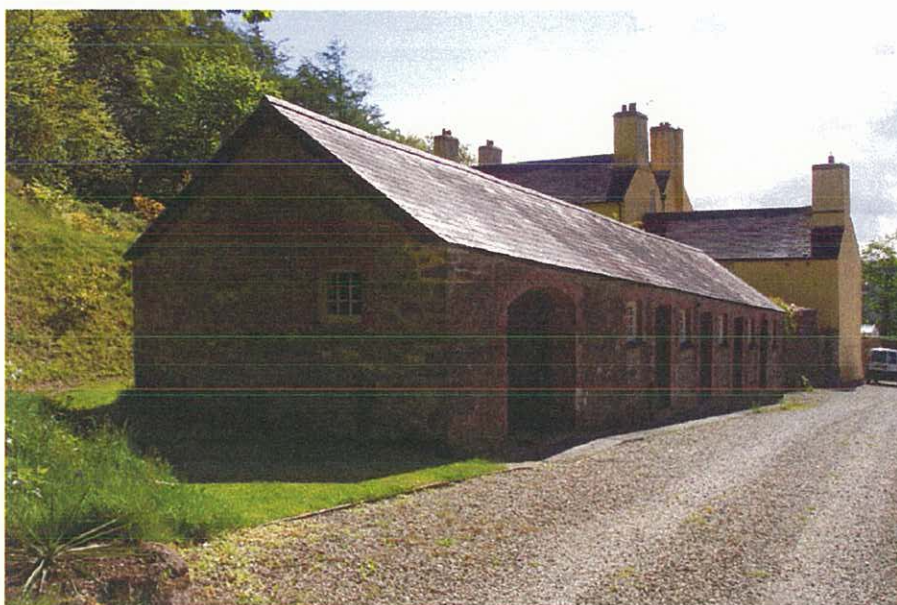
Plate 3- combination farm building (PRN 47948)

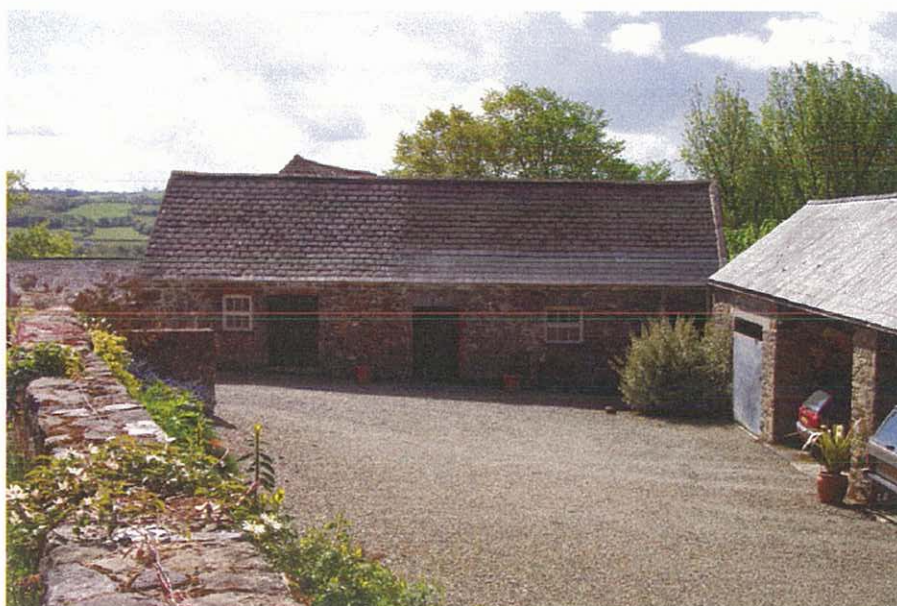
Plate 4- northern elevation of cow shed (PRN 47708)

This cow shed follows an east-northeast-west-southwest alignment and measures approximately 15 metres by seven metres and defines the southern extent of the small yard to the southwest of the mansion at Panteg. It is of uncoursed lime rubble construction, with roughly squared quoins and a pitched slate roof. It is accessed by three doorways in the north lateral wall- a wide doorway with red brick *voussoirs* to the east, a central doorway with stone *voussoirs* and a more recent doorway with a concrete lintel near to the west gable end. Square windows are located at either side of this wall, one with a red brick lintel and the other with stone *voussoirs*. These doors and windows all appear to be later additions to the building, or at least modifications to existing openings. Original stone *voussoired* openings in the east end of the north lateral wall and in the centre of the south lateral wall have since been bricked up. A lateral feeding passage and several concrete stalls indicate that the building was used as a cowshed in the past. The building, which is likely to be of an early to mid nineteenth century date is well maintained and in good condition.

The building should be maintained in its current condition using building materials and techniques faithful to those of its original construction.

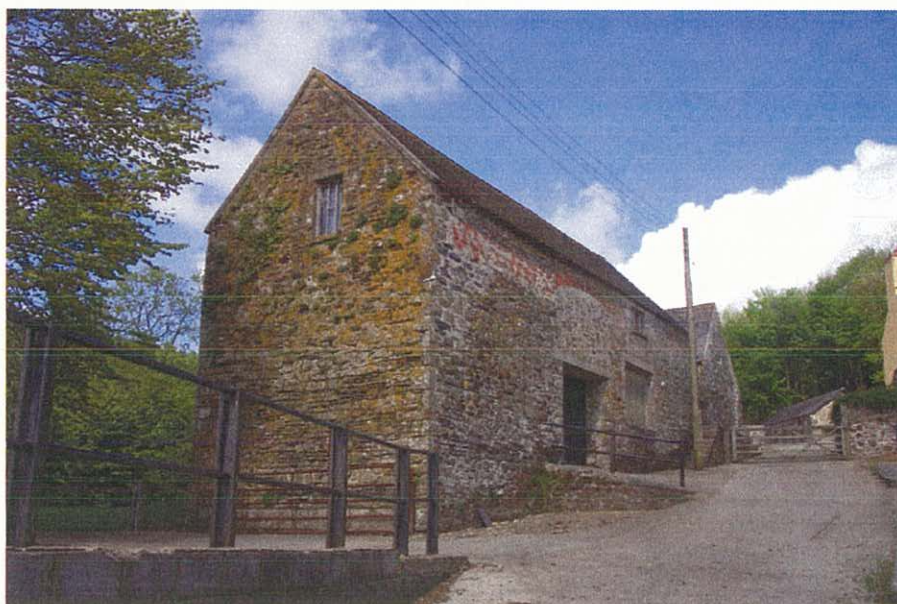
Plate 3- threshing barn, granary building (PRN 47709)

This large threshing barn and granary building defines the western extent of the lower yard at Panteg. It follows a northnorthwest-southsoutheast alignment and measures approximately 16 by six metres. It is of lime mortar bonded roughly dressed stone construction, built to rough courses, with a pitched slate roof. The building has been much modified from its original appearance. The impressive opposing red brick arched cart entrances in the east and west lateral walls have been partially blocked up. Access is gained today through a doorway with a concrete lintel which incorporates the lower half of the original arch in the east wall, and through a wide doorway in the bricked up west arch. Original doorways, with stone *voussoirs* to the north of each arch have also been bricked up. A window opening has been retained, however in the top half of the doorway in the eastern lateral wall. An additional small rectangular window has been added above. Original slit ventilators have been retained either side of the two doorways in each lateral wall. The upper storey granary is a later addition to the barn. Access is gained by a central doorway in the north gable end up a set of stone steps. An inscription "I H 1744" on a central collar beam may date the building, and the roughly hewn beams and peg joints would seem to support this date. The building is currently well maintained and in good condition. Several slates are missing from the eastern pitch of the roof, whilst other are unstable on the western pitch.

The building should be maintained in its current condition using traditional building materials and techniques. Any missing or unstable roof slates should be replaced in order to maintain the building in a stable condition necessary for its long-term survival.

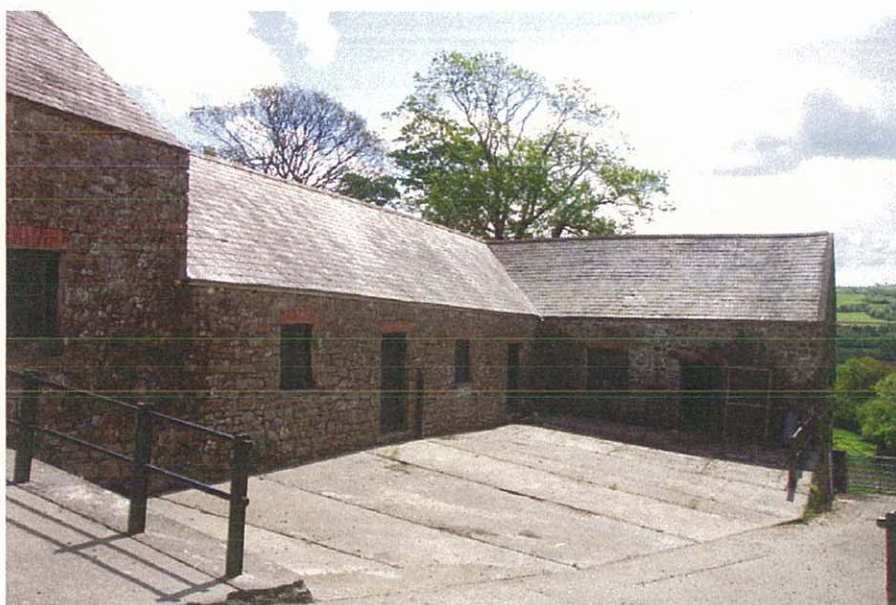
This cow shed forms the southern part of a long L-shaped range, which defines the east and south extent of the lower yard at Panteg. It follows a northnorthwest-southsoutheast alignment and measures approximately 14 by seven metres. It is of uncoursed stone construction, with lime mortar bonding and a pitched slate roof. Access is by two doorways in the east lateral wall. Each has a single square window to the north. All have red brick lintels. The interior of the building preserves a lateral drainage channel and access passageway along the eastern lateral wall with concrete stall platforms and remnant wooden partitions, suggesting that this building may originally have served as a cow shed.

This cow shed forms part of the L-shaped range, which defines the south and west extent of the lower yard at Panteg. It follows an eastnortheast westsouthwest alignment and measures approximately eight metres by six metres. It is of lime mortar bonded stone rubble construction with a pitched slate roof. It is accessed in the north lateral wall by a single doorway with a red brick lintel. A wide rectangular window, with a red brick lintel is situated to its left. The interior of the building retains the rear lateral feeding passage, a concrete manger and four concrete stalls with halter bars, indicating the former function of this building as a cow shed. A door at the east of the feeding passage accesses the adjoining cow shed (PRN 47953). The cow shed, which is likely to be of an early- mid nineteenth century date is well maintained and in a good condition. Some slates on the north pitch of the roof are missing, whilst others have worked loose.

Plate 4- looking sotheast towards cow sheds (PRN 47711, 47712)

The building should be maintained using traditional building techniques and materials. Missing roof slates should be replaced and loose slates stabilised in order to maintain the building in a stable condition necessary for its long term survival.

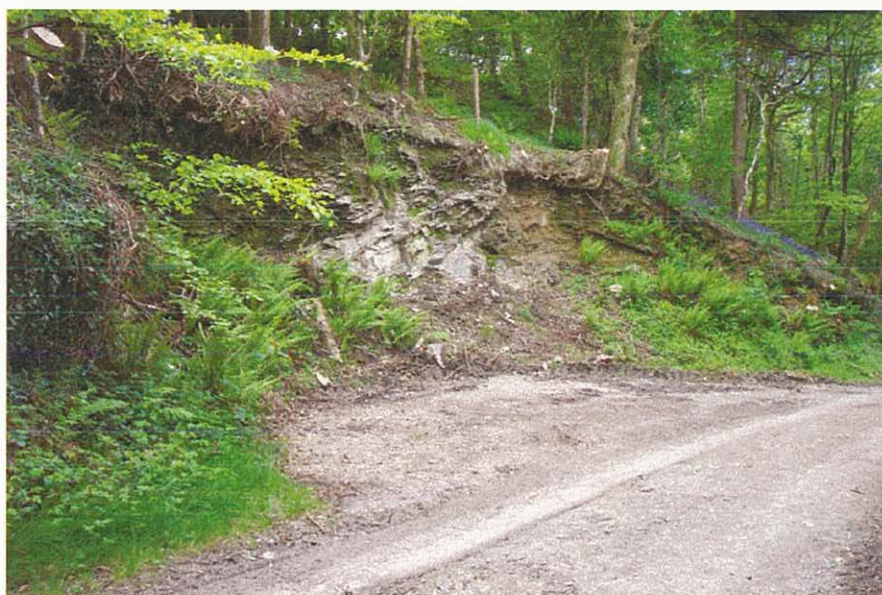
This quarry is situated approximately half way along the main driveway to Panteg. It is roughly semicircular in shape, cut into a steep bank and measures approximately 12 metres diameter. Although partially overgrown, it remains visible today. It is absent from map sources and its date is not known.

Plate 4 – looking southeast towards quarry (PRN 47725)

Retain as a historic landscape feature. Do not infill.

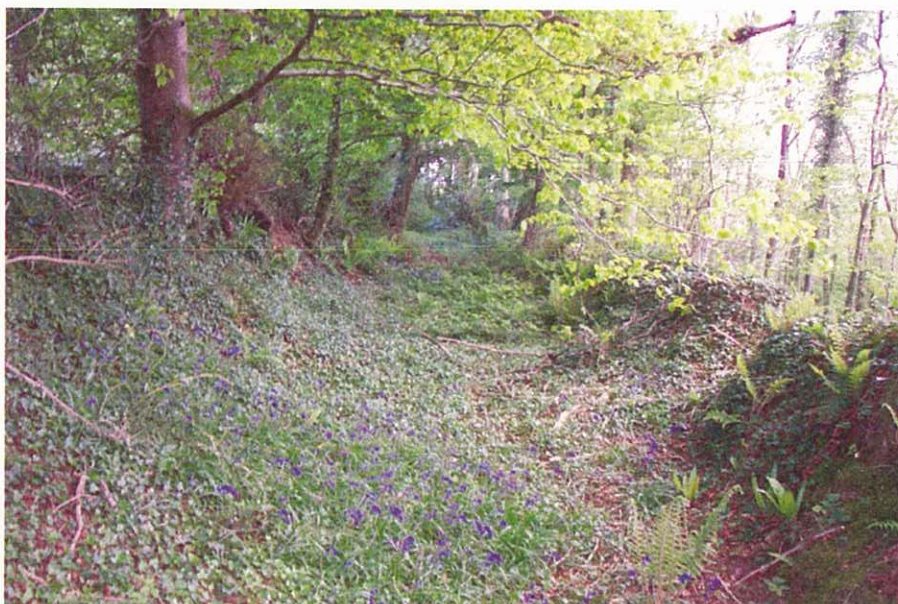
Plate 5 – looking east along the holloway (PRN 47733) to Let Wen
