TIR GOFAL MANAGEMENT PLAN: HERITAGE MANAGEMENT INFORMATION (HE2)

Prepared for:
FENTON HOME FARM
Crundale, Haverfordwest, SA62 4PY

Farm Visited on the
6th May 2004

Tir Gofal Reference No. W/13/3836, 3836a.
Project Record No. 45857
Report No. 2004/62

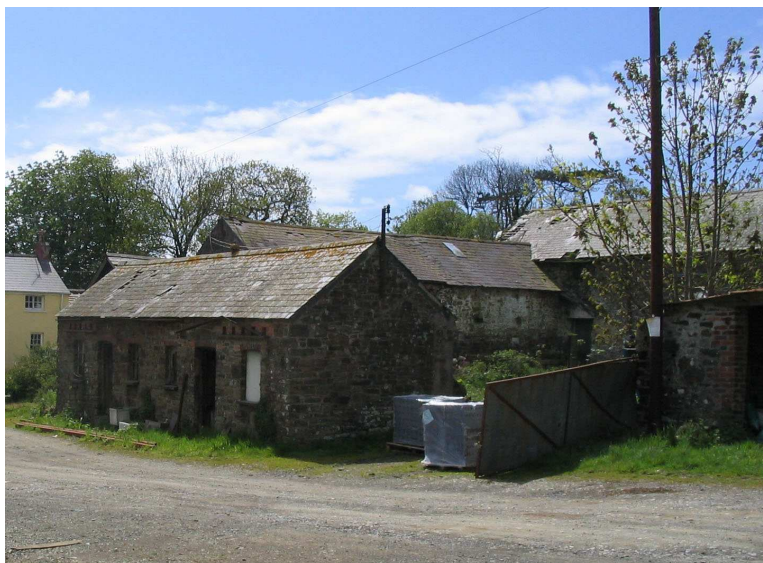
A model farmstead built around a rectangular yard, with the axis of the farm buildings parallel to the mansion (Prn 17762), which lies to the south. The residence is still occupied today but the farm buildings are now derelict.

All of the outbuildings shown on the 1891 Ordnance Survey map are traceable. They are stone rubble built with slate roofs and probably relate to at least three phases of development. An impressive L-shaped threshing barn and cart house range with red segmental brick arched openings faces onto the courtyard, which is completed on all other sides by abutting outbuildings. A long L-range cow shed is situated behind the courtyard to the north. These are differentiated by blue bullnose brick window and door dressings. Later buildings emulate this theme, featuring bluebrick door heads, but lacking other dressings.

Agricultural buildings around the rectangular yard at Fenton Home farm

The mansion is still occupied and a planning application on the farm buildings for conversion to residential use has been granted. As such, neither fall within the Tir Gofal scheme.

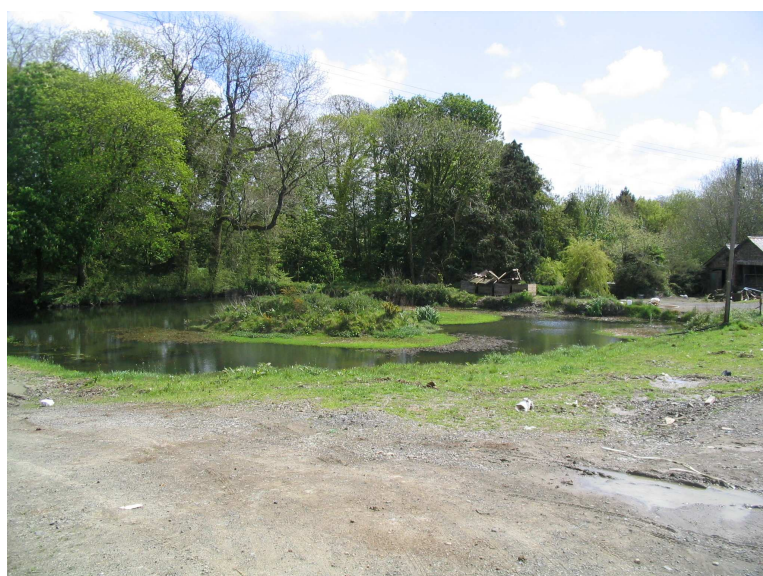
A pond in the east of the farmstead at Fenton Home Farm (Prn 50814). It first appears on the Ordnance Survey map of 1891. It has been enlarged to the west, altering its original, roughly triangular plan (c.40m N-S to maximum 30m E-W). Only the original stone revetted banks on the east and south dam wall are intact today.

The pond at Fenton Home Farm

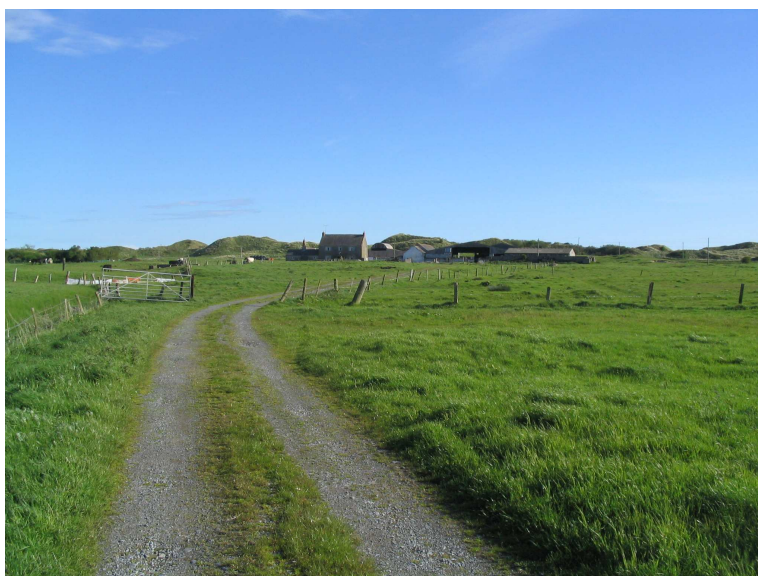
The farm lies on the southern edge of the reclaimed land of East Marsh, close to the dunes of Laugharne Burrows, due S of Laugharne. The farm buildings (Prns 51048, 51049, 51050) are ranged round 3 sides of a courtyard, with the house placed centrally in the N range. The farmstead is listed as a farm group which is an exceptionally well-preserved example of a model farmstead with a precise historical context in ambitious agricultural improvement at the beginning of the C19. It clearly demonstrates a mixed agricultural economy in a series of purpose-designed buildings unified by coherent planning in an enclosed yard, and by strong regional character in design and construction.

Facing south along the approach to East House Farm

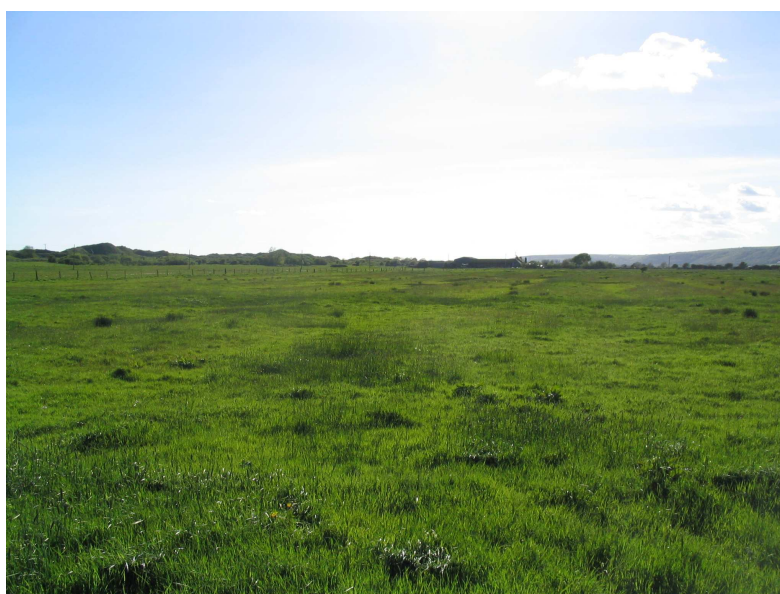
An extensive system of ridge and furrow, in an area of reclaimed marsh, on land belonging to East House Farm.

The earthworks have been under permanent pasture for some time now. No management threats identified.

Ridge and furrow at East House Farm. Looking west.

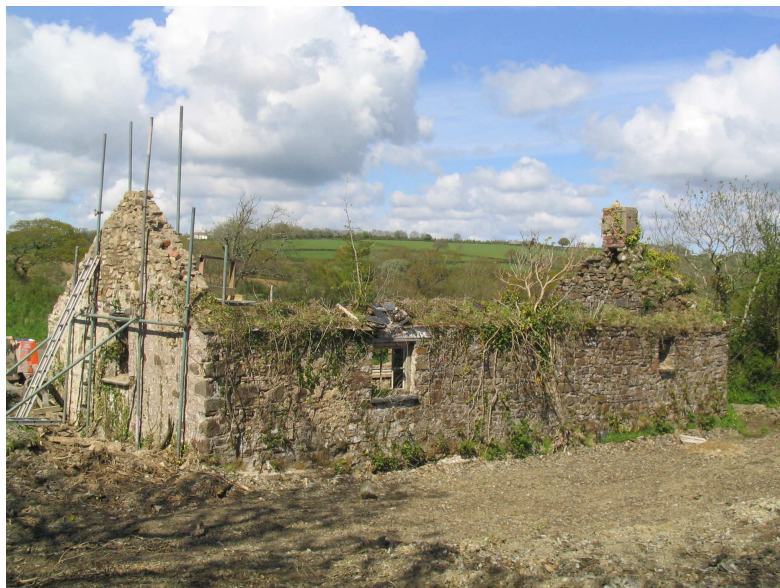
This one-and-a-half storey cottage is all that remains of Little Fenton farmstead (Prn 50819). A building appears in this position on historic maps from the Ordnance Survey Original Surveyors drawings (1810) onwards and the cottage probably dates to at least the early nineteenth century. It is a long, low building (12m E-W by 6m N-S) of rubble stone, originally with a slate roof.

The front wall faces north, where the farmyard would have been. It has recently been rebuilt but apparently retains the original door and window positions. It features a door to the left (east), flanked by evenly spaced windows and another window and door to the right (west). The rear (south) wall is pierced by two window openings with slate sills. Both feature small panel casements with between four and six lights. A small fireplace, about a metre wide is set into the east gable end, and the west end features a central window opening. No internal partitions survive, but an internal step suggests that the building was originally divided into at least two units. The cottage is currently in the process of being restored for agricultural use.

The cottage at Little Fenton is now in the process of being restored.

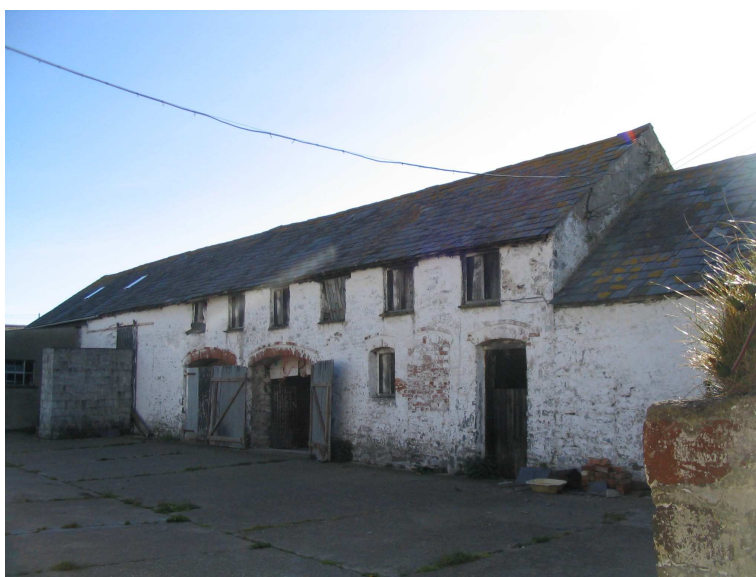
The W range comprises a large and a small barn separated by a lofted cartshed and stable. Construction is limewashed rubble with some brick dressings, and slate roofs. The larger barn (at the SW) has wide high arched doors in both elevations (both now blocked or partially blocked); a C20 extension obscures part of the yard-ward elevation. Under the same roof line are 2 cartshed bays with a small stable alongside: paired cart entries with shallow brick arches, similar arched heads to window and door of stable to right (an additional doorway has been blocked); 6 regularly spaced windows beneath the eaves above. To the N of this, a smaller (and perhaps earlier) barn has narrow opposed doorways and flanking vents.

The combination farm building range on the west side of the farmyard at East House Farm.
