# **Newhouse Farm W/13/3840**

## **Tir Gofal Farm Visit Historic Environment Report**

Report No. 2003/91

Newhouse Farm  
Tir Gofal Farm Visit Historic Environment Report

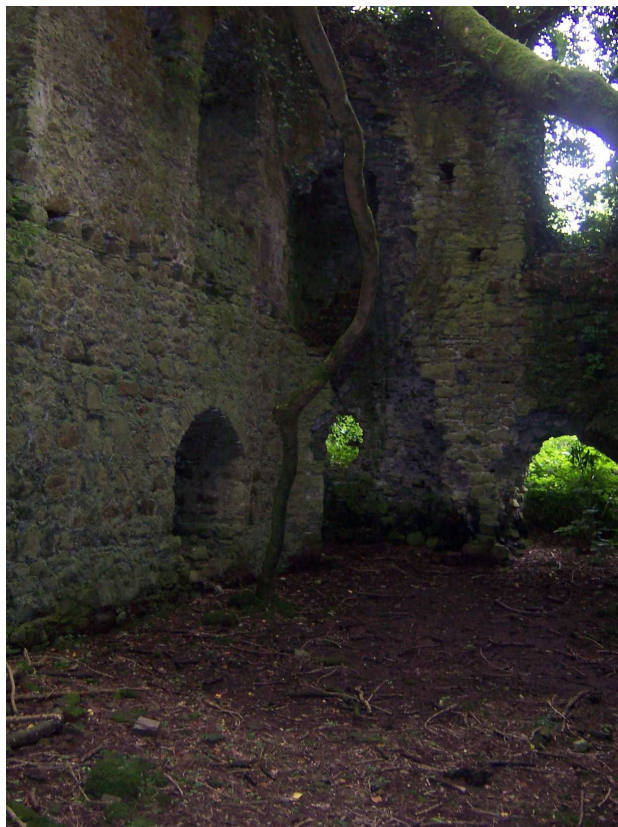
Plate 1- interior of Castell Coch hall house (PRN 3616) looking west.

The surrounding moat and earthwork banks are heavily overgrown, and may be masking additional features. During a visit to the site in 2000, Louise Mees of Cadw noted that a pit measuring 8m by 2m by 1.5m deep had been dug on the southern side of the site.

The following management recommendations were made in consultation with Louise Mees of Cadw, who last visited the site in July 2000.

“The principal aims should be to remove excessive growth of vegetation and stabilise the buildings. The work required is highly specialised. The trees, saplings, ivy and other vegetation growth on and within the buildings should be removed by cutting the growth at ground level (or where plants grow from the masonry), the stumps should be treated with herbicide. This work would have to be undertaken when conditions are dry. All debris would have to be removed from the scheduled area. Great care would have to be taken to avoid damage to the structures during the felling and removal of debris. Following the removal of vegetation from the walls the masonry would be susceptible to weathering and rapid deterioration. Therefore, the clearance of vegetation would have to be followed up by a phase of masonry repair and consolidation. These works would require Scheduled Monument Consent (applications to be made to Cadw).”

It is recommended that some of the vegetation, which is currently masking the site should be removed in order to enhance its appearance. These works should be undertaken in agreement with Cadw.

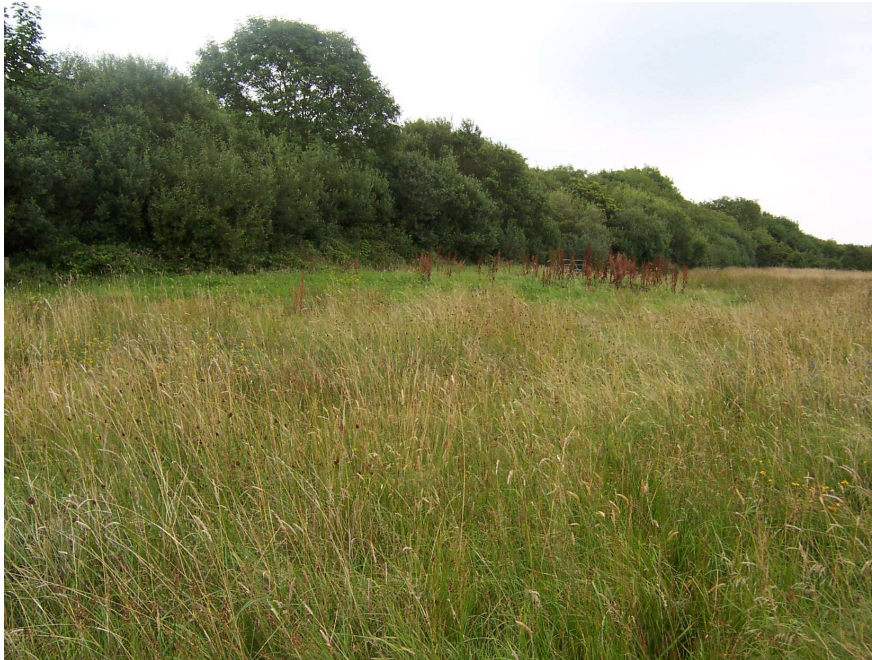
Plate 2- Looking east towards possible round barrow, mining feature PRN 3639

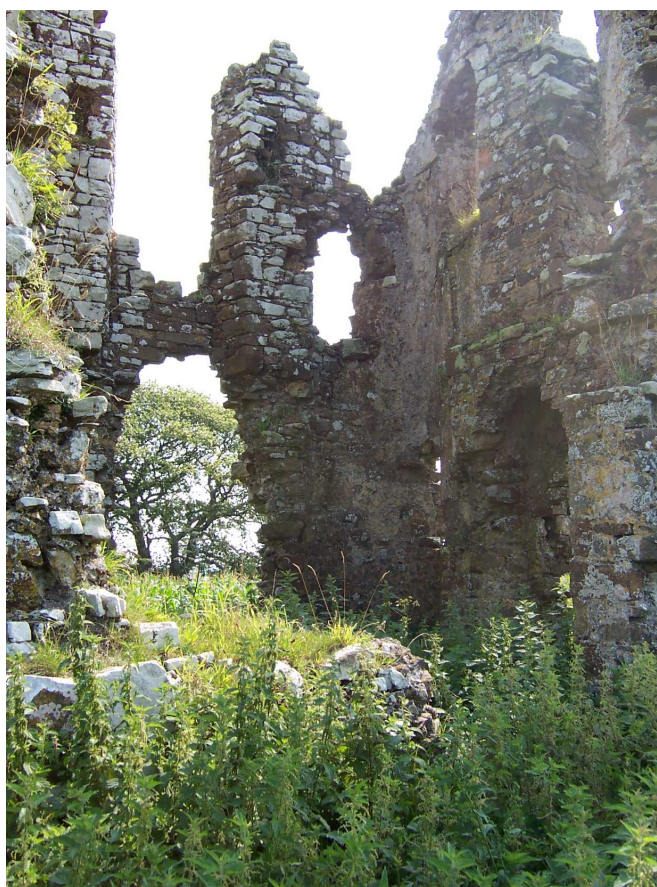
The folly is now in a ruinous condition, and showing signs of recent deterioration. Much of the stone facing has fallen away from the wall exterior, leaving the rubble core exposed and vulnerable to weathering. This is particularly acute on the south and west elevations, and whole sections of walling have also collapsed around the upper windows. Displaced stone remains, where it has fallen around the base of the building. Young trees, have become established in the north and east walls, and are threatening to displace masonry.

Plate 2- interior of the Temple of Four Winds (PRN 14307) looking southeast.

The folly remains an impressive feature within the landscape, and is an important remnant of the late seventeenth to early nineteenth century parkland landscape of the Slebech estate. It would be a great loss if it were allowed to deteriorate further.

In order to limit damage to an already fragile structure, the area within 10 metres of the edge of the folly should not be ploughed, subjected to any ground intrusive activities or used as a location for feeding livestock.

Due to its vulnerable nature, it is recommended that a detailed building survey should be undertaken. The Royal Commission on the Ancient and Historic Monuments of Wales (RCAHMW) may be able to carry this out.

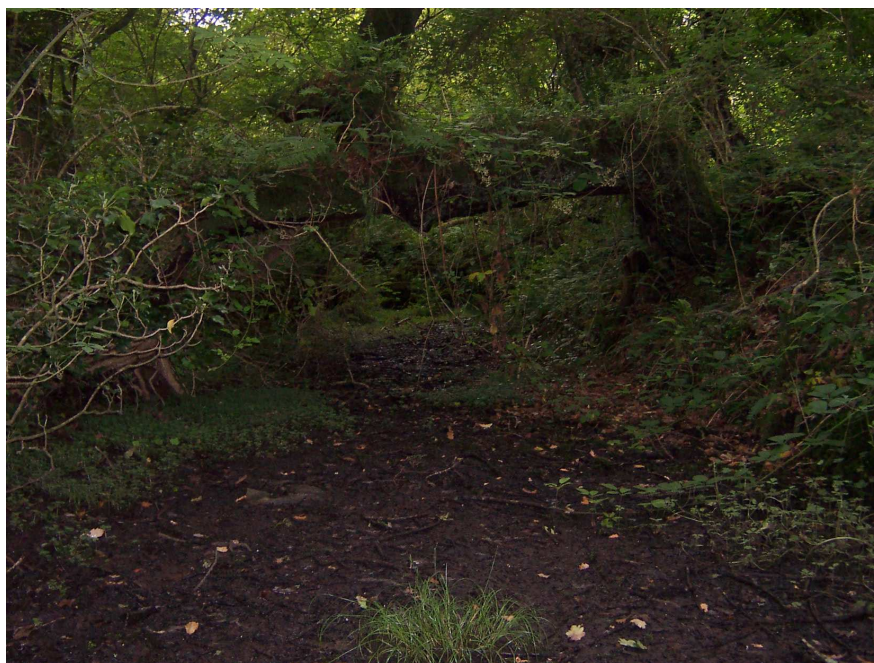
Plate 3- the fishpond (PRN 16763) at Castell Coch is now heavily overgrown and partially silted.

It is recommended that some of the vegetation, which is currently masking the site should be removed in order to enhance its appearance as a historic landscape feature. These works should be undertaken in agreement with Cadw.

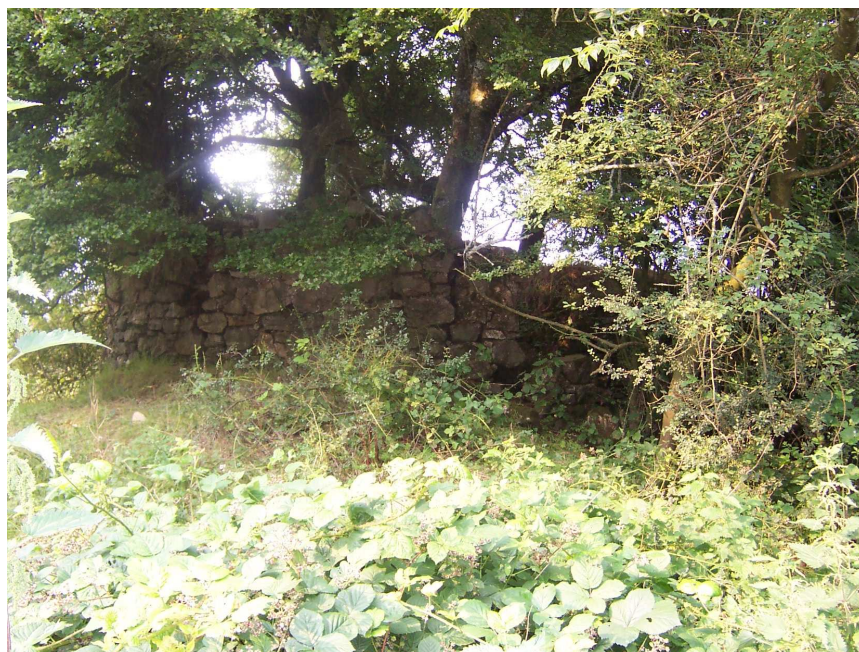
It is now ruinous and in a poor condition. The southern drawing arch has collapsed and the walls on either side are unstable. The north drawing arch remains intact, and features such as the poking hole and kiln eye remain visible. A mature hawthorn bush has become established immediately in front of it to the north. Lime mortar bonds have eroded from the exterior of the western parapet wall and there is a risk of masonry becoming detached here. Several hawthorn trees have become established on the wall surface, and are risking destabilisation of this part of the structure. The “bowl shaped” form of the crucible is well preserved, although the walls are partially collapsed, and a mature ash tree is growing out of its centre. The kiln lies within a pasture field, which is grazed regularly. No specific threats were identified from the current management regime. It is

Plate 4- looking east towards limekiln (PRN 17070).

The kiln is currently in an unstable condition and requires active management if it is to be preserved in the long term. The trees on the western parapet wall should be cut off at the roots and spot treated to prevent re-growth. The stone structure of the kiln would also benefit from a programme of masonry consolidation and re-pointing.

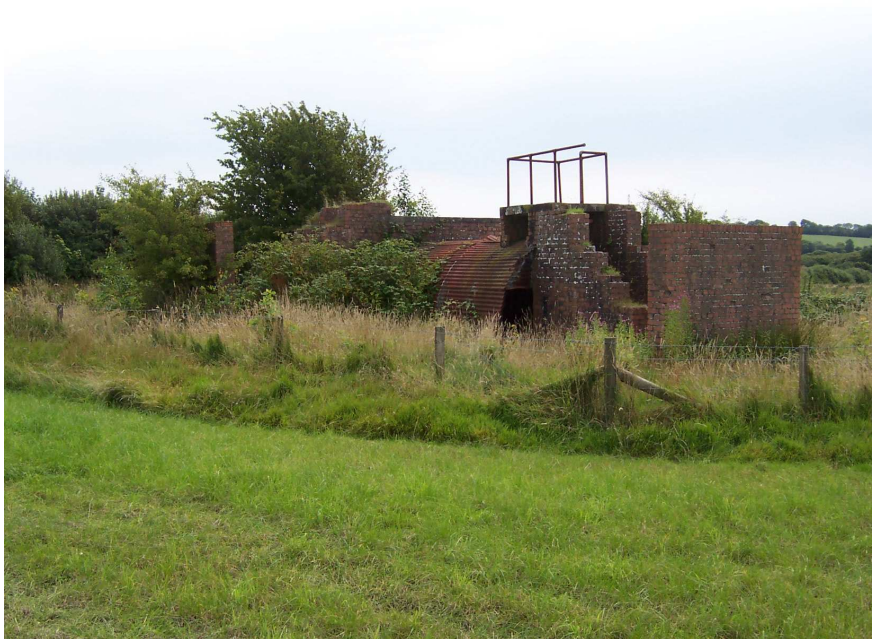
It is now derelict, although remains in a reasonable condition. It is fenced off from a neighbouring pasture field and lies at the eastern end of a newly established plantation, and currently remains visible. Vegetation growth poses the largest single threat to the building, and heavy bramble growth is masking the entire southern wall and part of the northern wall. A hawthorn tree growing against the northern blast wall, threatens to destabilise brickwork. The young trees, which have been planted on all sides of the bombing decoy, will eventually conceal it if they are allowed to grow.

Plate 6- looking west towards the bombing decoy (PRN 28496)

The bombing decoy is a fine example of its type and one of only ten surviving examples within Pembrokeshire. As such it should be protected. Vegetation growing on or near to the structure should be removed and spot treated to prevent re-growth. Ideally no trees should be grown within 10 metres of the edge of the building in order that it can be retained as a visible feature within the landscape. It is recommended that the fence should be re-routed at least ten metres behind the bombing decoy. This will reincorporate the site into a pasture field, which is grazed periodically, eliminating the risk of the site becoming overgrown, and ensuring that it is not neglected in the long-term.

The site also presents an excellent opportunity for public access. Visitor enjoyment of the site could be enhanced by the provision of an interpretation panel, and this should be considered carefully.

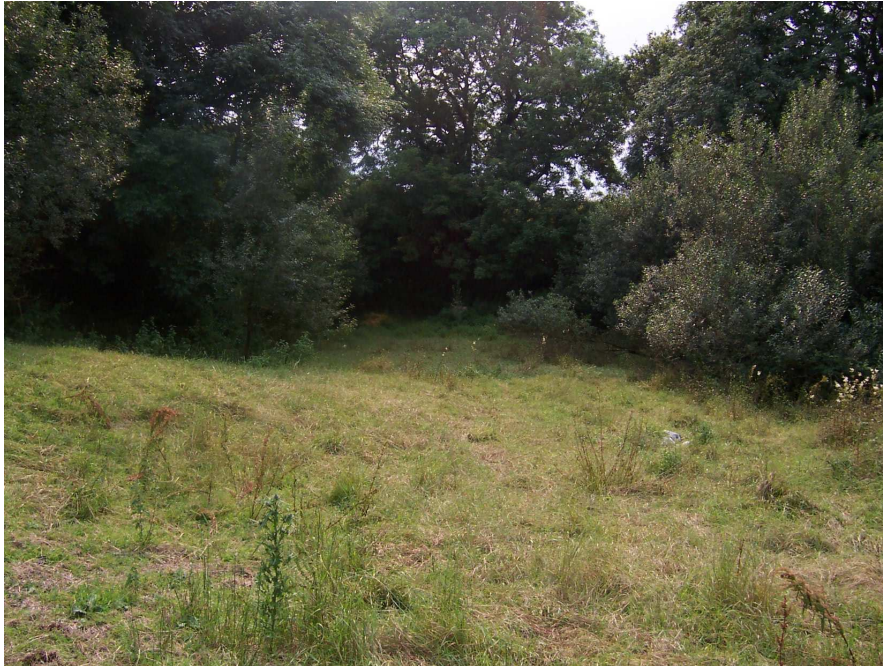
Plate 7- looking southwest towards quarry (PRN 49098).

The quarry should be maintained as a visible historic landscape feature. It should not be infilled. Spoil tips should not be removed.

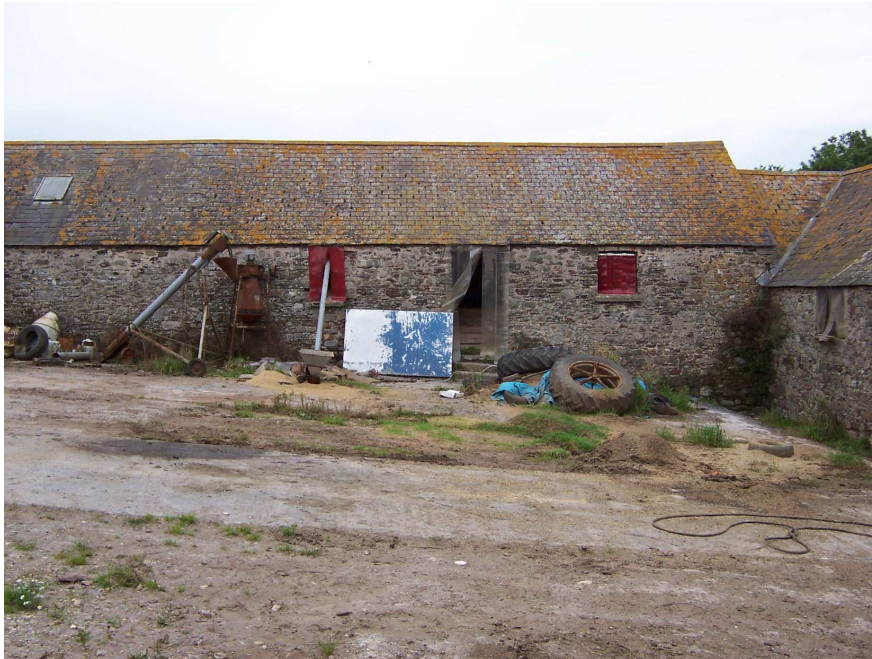
The combination farm building is currently in a reasonable condition, although some of the slates on the eastern pitch of the roof appear to be unstable.

Plate 8- east elevation of combination farm building PRN 49110

The building should continue to be maintained using materials and techniques, which are faithful to those of its original construction. Missing or unstable roof slates should be replaced or stabilised.

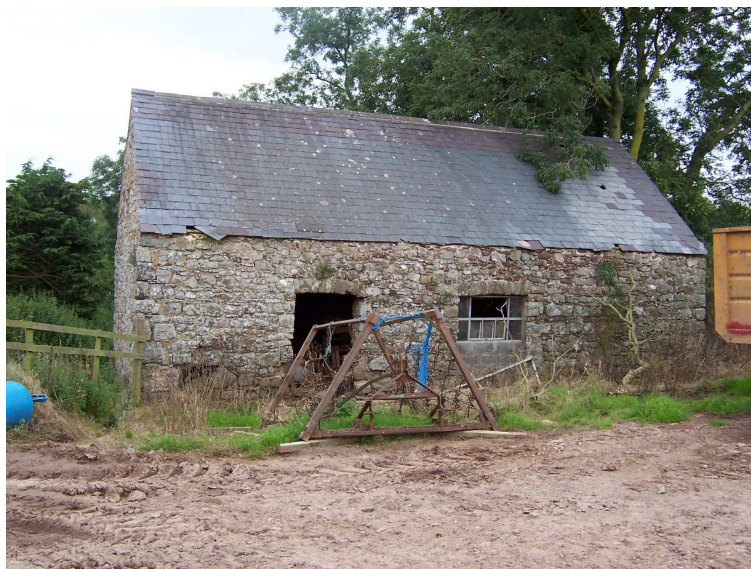
The mill is in need of attention if it is to be maintained in a stable condition necessary for its long term survival. The walls are in a reasonable condition, although lime mortar masonry bonds are becoming washed out and eroded in places. Some masonry was found to be unstable in the north lateral wall. Some of the roof slates are missing, whilst several others are loose. Water ingress is threatening rot in the timbers. Heavy vegetation growth around the north and east elevations are currently obscuring the mill. The interior of the mill is currently used as storage space for redundant farm materials.

Plate 9- south elevation of mill (PRN 49114)

The mill will need to be returned to a weatherproof condition if it is to be retained in the long-term. Missing and loose roof slates should be replaced and repaired. Unstable masonry should be re-pointed. This should be followed up by a more general programme of masonry consolidation. Repairs should be carried out traditional building techniques and materials.

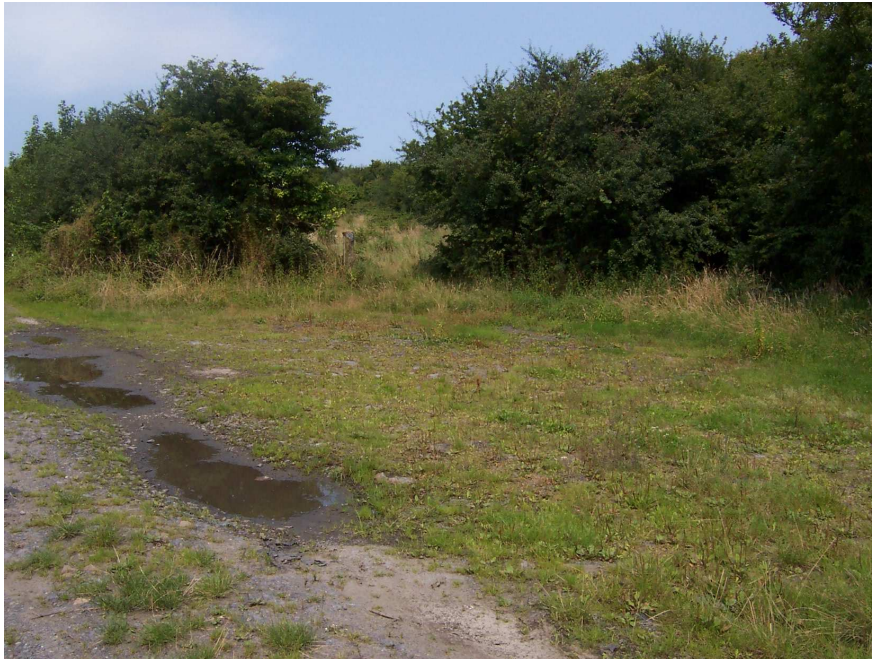
Plate 5- looking east towards the now infilled shaft (PRN 49203)

No specific management recommendations.
