Knowles Farm W/13/3844

Tir Gofal Farm Visit Historic Environment Report

Report No. 2003/97

REPORT NO. 2003/97
PROJECT RECORD NO. 45864

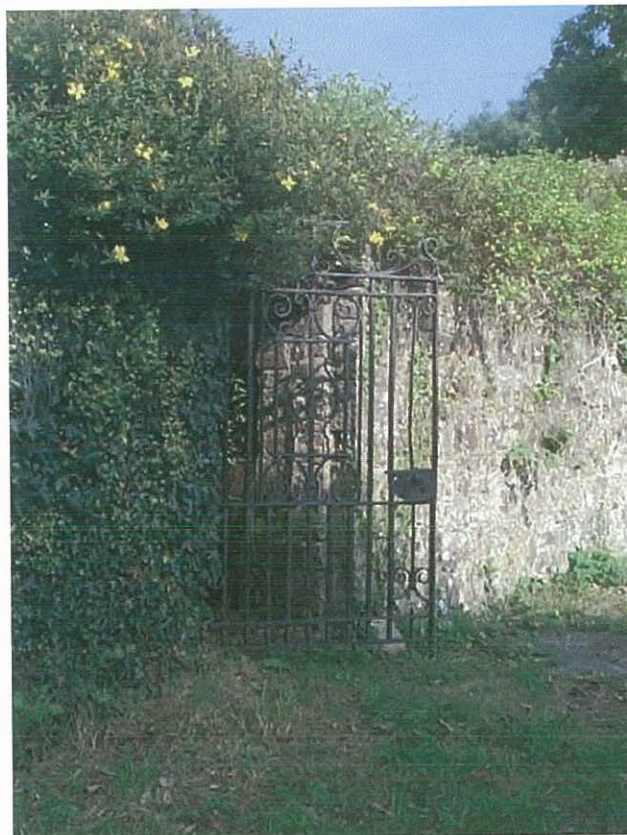
Gateway into the walled garden (PRN 32573).

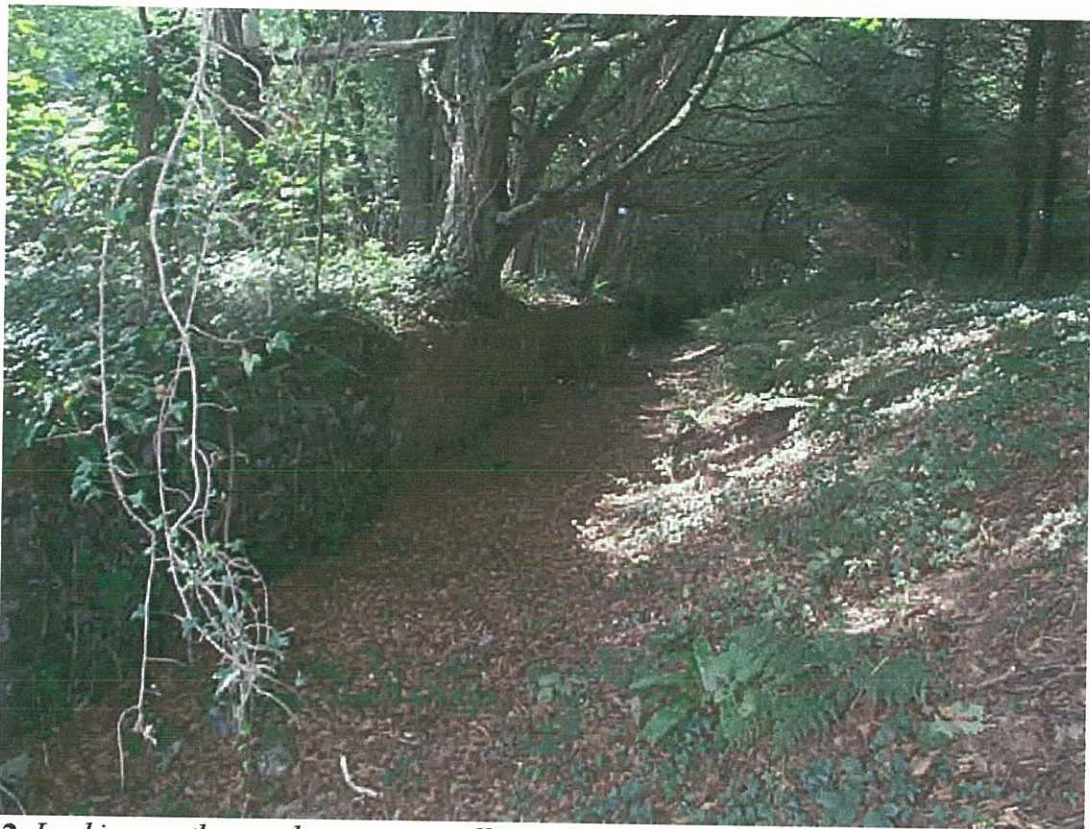
In general, the condition of this part of the boundary is very good. The ditch is still quite clear, and the wall survives to its full height and seems to have been re-pointed in relatively recent years. Further to the south the ditch profile is less clear, and fallen leaves and debris have partially filled it. The wall is also more overgrown with ivy and undergrowth in the southern part. Trees line the parapet of the wall at intervals, although the feature is stable and visible for the whole of its length. At its southernmost end, nearest to the sunken garden (PRN 48637), this boundary is heavily overgrown though the structure seems to be stable. Iron railings run along the top of the wall here, though it is not clear whether these are part of the original structure or are a later addition. The ditch is crossed by a driveway in the southwest (SN01400667) and, close to the southeast terminal, a set of stone steps leads from the terrace (PRN 32576) through the ditch and out into the deer park (PRN 48639).

Plate 2. *Looking southwest along a very well-preserved section of the wall and ditch boundary which separated the garden from the deer park (PRN 48639).*

Ideally, the management of this feature should address two different aspects of it – its structure (the wall and ditch) and its function (to serve as a barrier and to provide uninterrupted views). Structurally, the feature is in a stable condition. Although there are some mature trees growing along the top of the wall the roots do not appear, at present, to be posing a significant threat to the wall. This should be periodically checked, and if tree-roots begin to penetrate the stonework then the trees may have to be felled, and the stumps treated to prevent re-growth. Most of the stonework is in a good condition, but in places the wall has become very overgrown.

Some clearance of the dead leaves and debris from the ditch would also benefit the site, but this should be carried out by hand in order to prevent damage to the bank or the wall.

The conifer plantation at the north end of the boundary should ideally be left to return to pasture after the trees are harvested. It should be ensured that no damage is caused to the wall and ditch during thinning or clearing, and during the harvesting of the plantation.

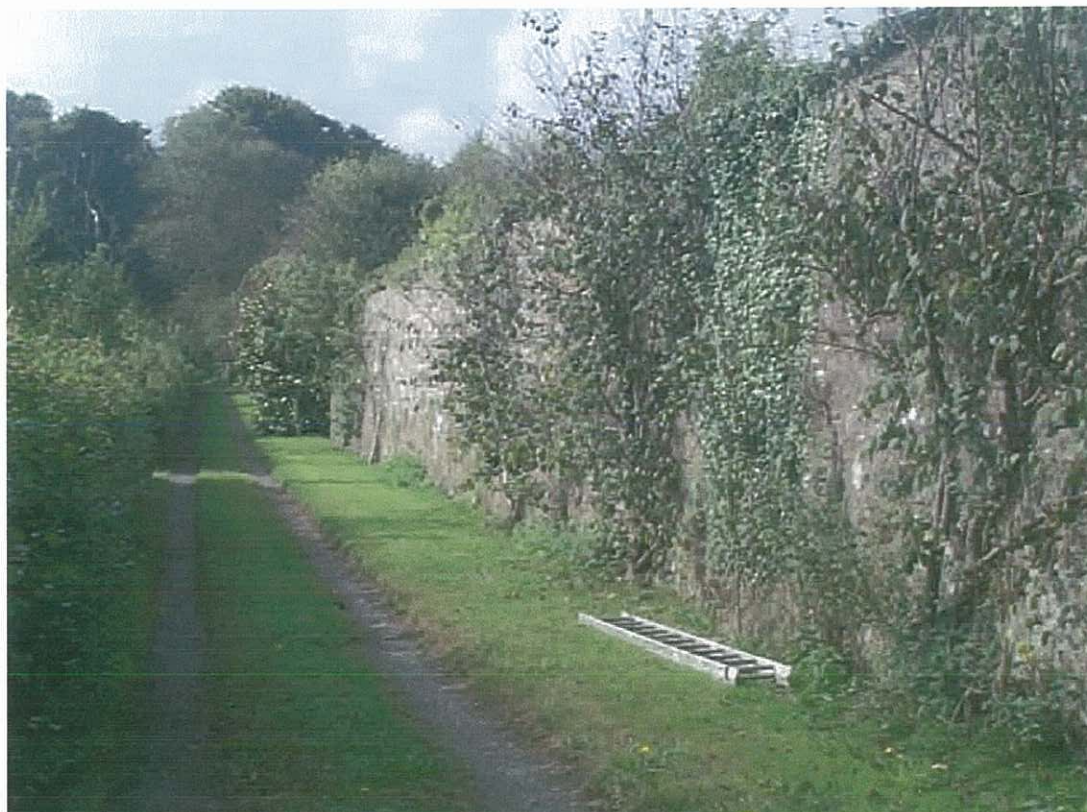
The garden walls vary in condition, but are generally good. The rubble-built north wall stands to around 3m in height, and this was probably the original height of all the walls. However the slate coping on this wall has been lost, and parts of the wall are overgrown. The east wall is substantially overgrown, and is partly fallen in places but the south and west walls are both in good condition, and retain the slate coping which originally would have been present on all four walls. The present-day access to Rosehill Cottage (PRN 34736) is along a track which runs through the walled garden, parallel with the west wall.

Plate 3. *The interior of the west garden wall, looking south, along the track leading away from Rosehill Cottage (PRN 34736). This wall is still used for growing fruit trees. The rest of the garden continues to the left of this picture.*

The garden walls are the most striking and obvious features, and although they are generally in good condition, they would repay some attention. The east wall is partially collapsed in places, and has, in other places, lost the top courses of the walling. These sections of wall should be repaired using, wherever possible, the original stone which is often still present as fallen blocks. Additional stone should be carefully sourced to match the original as closely as possible, and it should be ensured that both the mortar and the construction methods used are also matched to the original construction of the walls.

Most of the slate coping remains on the south and west walls, and this provides a model to copy in order to replace the coping on the other walls and fill in gaps in the existing layer on the south and west walls. Some vegetation control should also be carried out on the overgrown parts of all the walls. Ivy and other climbing plants should be cut off flush with the wall and the roots not dragged

out. Large roots will need to be treated to prevent re-growth, and some re-pointing of the wall may need to be carried out in conjunction with vegetation removal. Care should be taken when working on the west or north walls that existing battens are not accidentally damaged or removed. In general, the interior of the walled garden is quite overgrown. Regular light grazing would help to control scrub incursion and would not damage buried archaeology. The brambles in the northeast of the garden should be cut back to ground level and removed, and new shoots could then be controlled by grazing. Due to the potential for the survival of wall footings and foundations, this area should be monitored for erosion in wet weather.

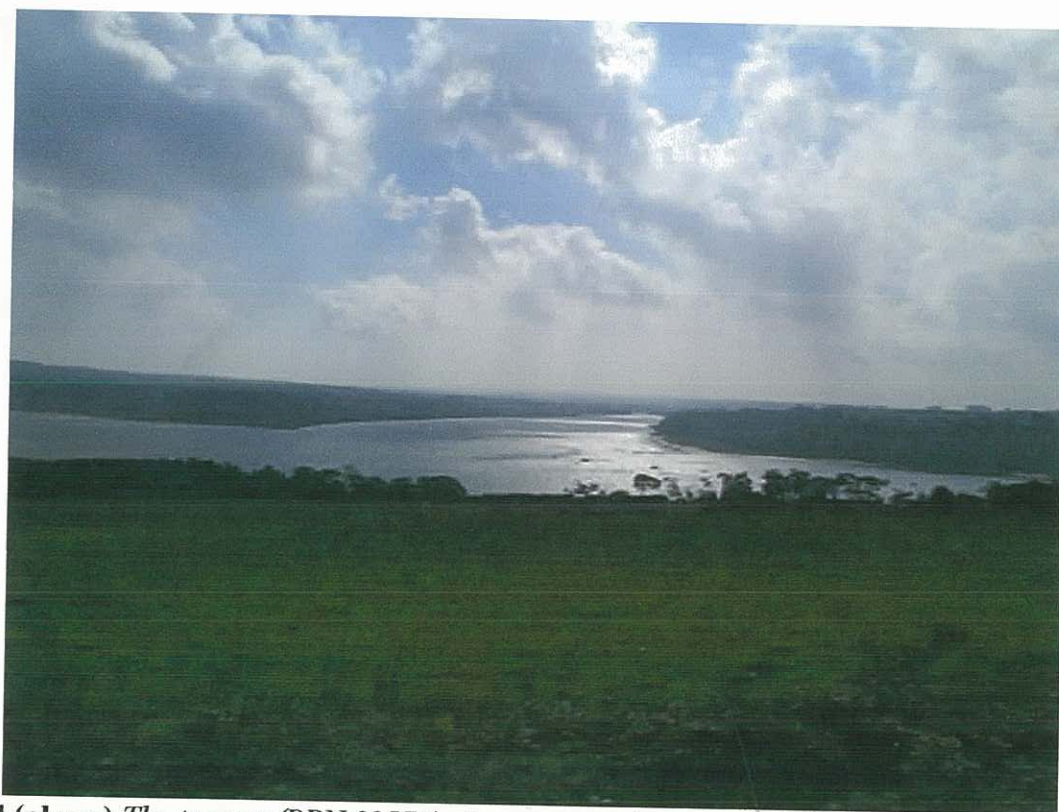
Plate 4 (above) *The terrace (PRN 32576) gives spectacular views across the confluence of the Cresswell and Carew Rivers.*

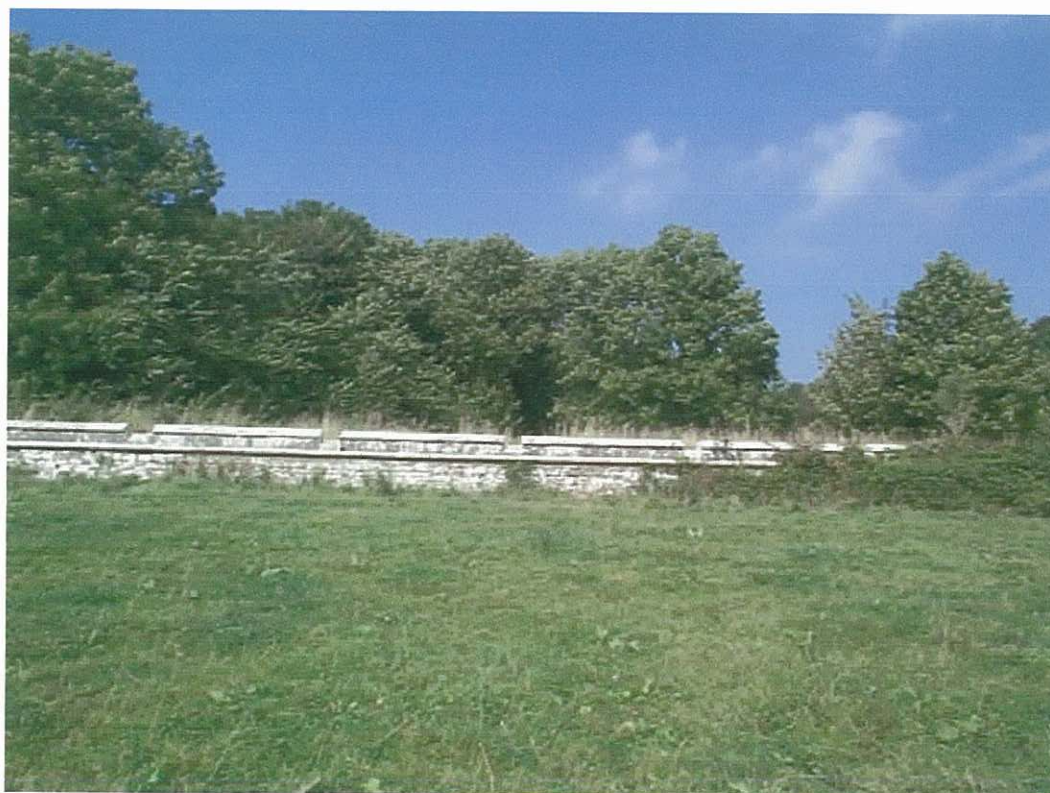
The wall is in very good condition, though overgrown in places, and is still clearly visible from the terrace, as was the original intent.

Plate 5 (below) *The terrace wall as it appears from the meadow beneath the house site.*

The main terrace wall is in good condition and should be maintained using materials appropriate to the original construction. It is overgrown by brambles on the park side in a few places, and these should be cut back to ground level and removed. These fields are currently in use for grazing, and continued grazing will help to control new shoots.

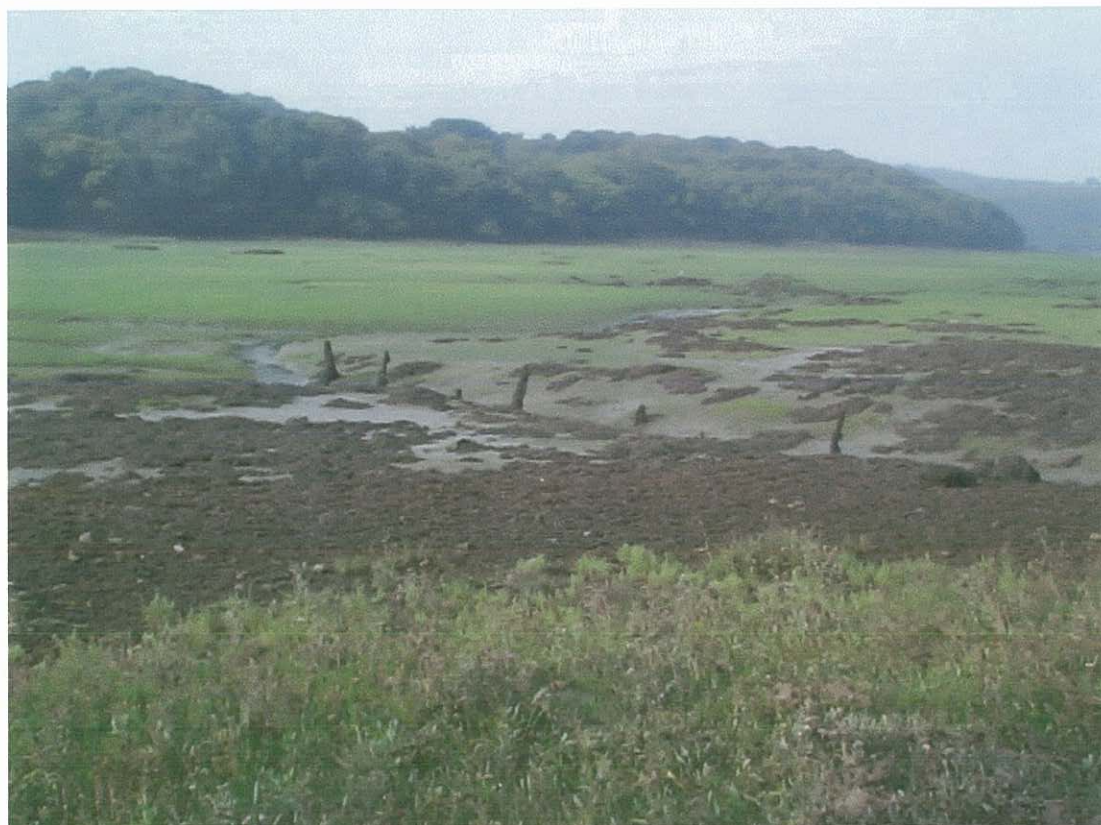
Plate 6. *Entrance to the canalised water channel (PRN 38757) seen at low tide.*

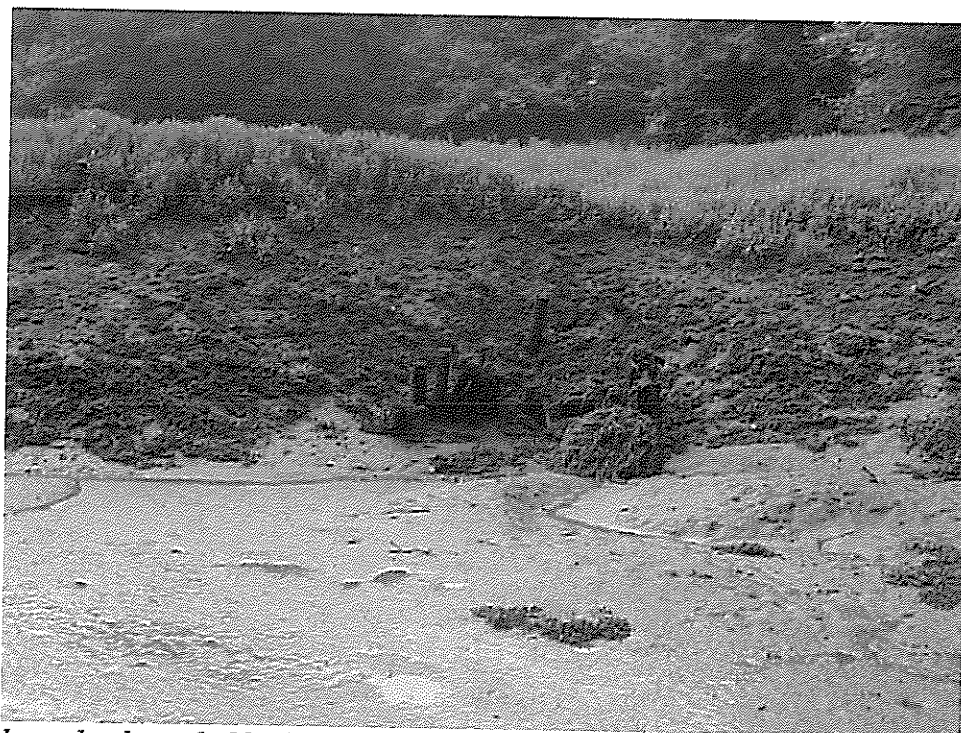
A dock marked on the 1863-4 Ordnance Survey map. This dock is within a limestone quarry (PRN 38760) at the head of an inlet, and is reached by a canalised water channel (PRN 38757). It survives as a flattened platform on the southwest side of the inlet with a slipway leading down to the water. There are frequent small dumps of limestone pieces around the platform. Directly opposite the platform, on the northeast side of the inlet, is a large bank. This is probably the remains of a quay, projecting out of the quarry face. A large pipe in a degraded wooden surround runs through the bank, but it is unknown whether this is part of the original structure or a later addition.

A newer slipway lies just south of the dock, leading up to farmland. Scattered remains of equipment and shells indicate the use of this dock for a later attempt at shellfish farming. The site is generally in a stable condition and is still quite strongly visible.

Plate 7. *A large bank, probably the remains of a quay, part of the dock (PRN 38758). The wooden stakes at the base surround a large water-pipe.*

Although the site is currently stable, it will eventually be lost to the sea, and to silt accumulation. It should be ensured that this process is not accelerated through the disturbance of the site or its surroundings. The site should be maintained in its existing condition.

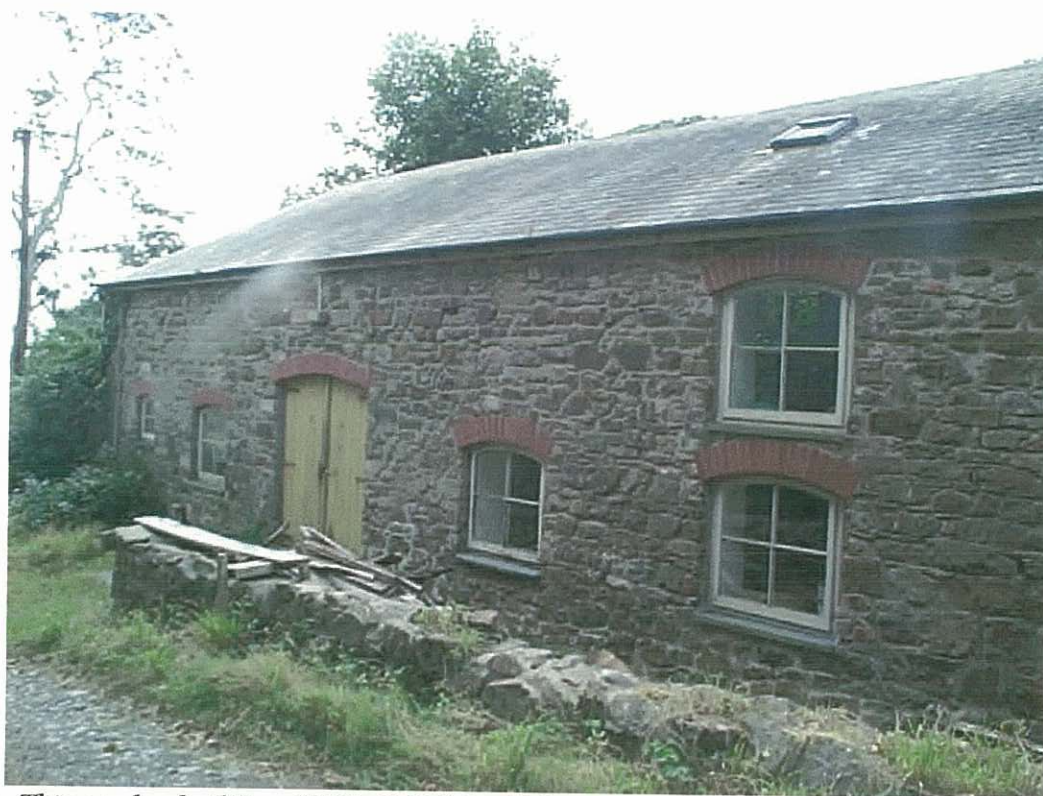
The exterior of the building is in good condition, and the building appears to still be in use. The condition of the interior is unknown.

Plate 8. *This garden building (PRN 48636) is all that survives of a continuous range of buildings seen on the 1863-4 Ordnance Survey maps.*

The building should continue to be maintained in good condition. Future repairs should be carried out using materials which match the original construction.

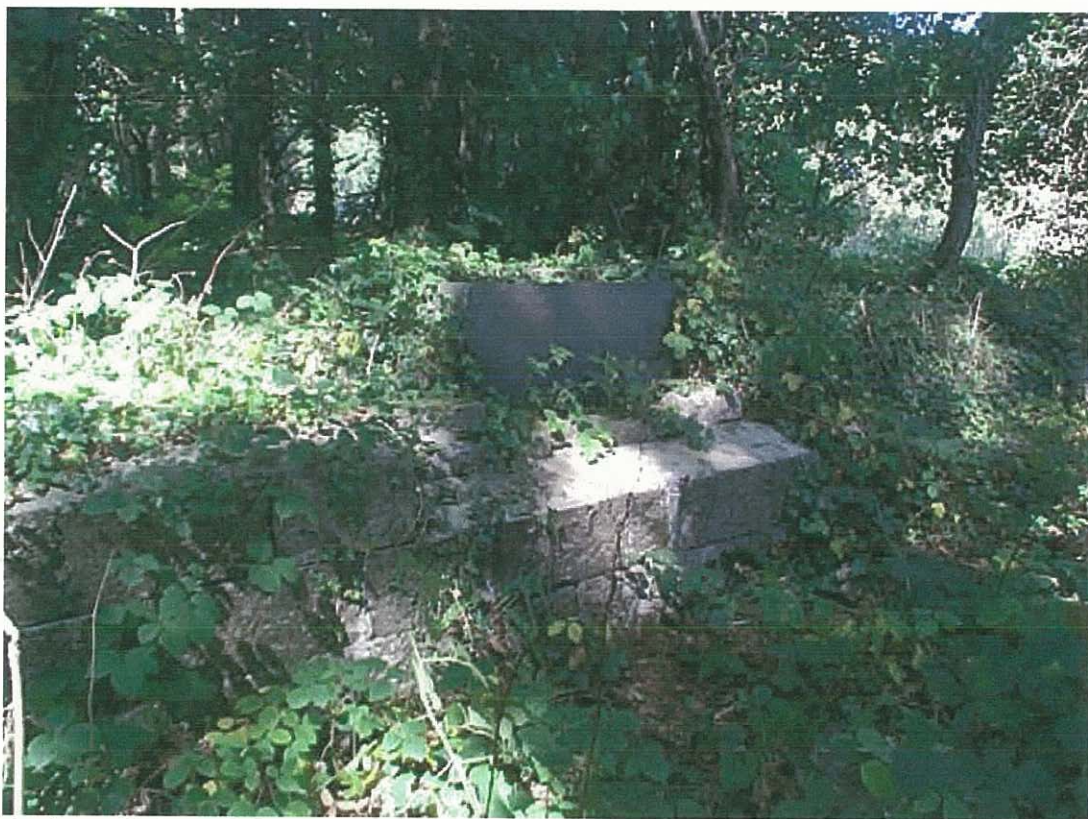
The second interesting feature is a slate-slab water tank, built into the same section of wall. A pipe leads from the tank through the wall itself and emerges lower down, on the garden side of the wall. This cistern apparently linked to a system of pipes which fed the central pond. The tank is in good condition, but is in danger of becoming completely obscured by ivy.

Plate 9. *A small slate-slab water cistern set into the walls of the sunken garden (PRN 48637). The water ran through a system of pipes to feed a central pond.*

It is recommended that, at present, the piles of building rubble and masonry are not removed from the site or disturbed during vegetation clearance. The land-owner has expressed an interest in restoration of this garden in the future and, if this goes ahead, a programme of archaeological investigation will need to be incorporated into the plans. The positioning and type of the building remains may provide important information at that stage, and it may also be possible for materials to be re-used in the restoration process.

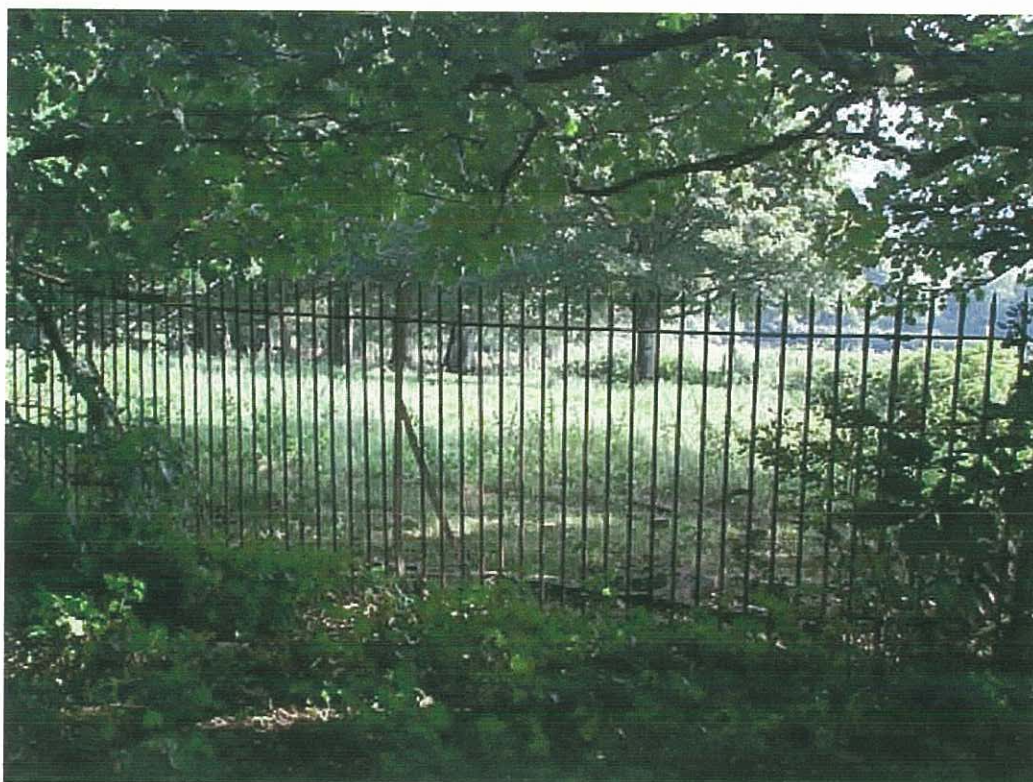
Plate 10. *The iron palings which ran parallel with a driveway (PRN 49132) leading from Lawrenny Castle (PRN 20987) to St Caradoc's Church (PRN 3463).*

The ideal long-term management of the site would be the re-instatement of this driveway and its avenue. Some thinning of the existing woodland would be necessary in order to emphasize the tree-avenue.
