Tir Gofal Farm Visit Historic Environment Report

REPORT NO. 2003/74
PROJECT RECORD NO. 45868

Cwm Maen lies in the community of Cardigan, at grid reference SN15254792. It was visited by Cambria Archaeology on 13th June 2003.

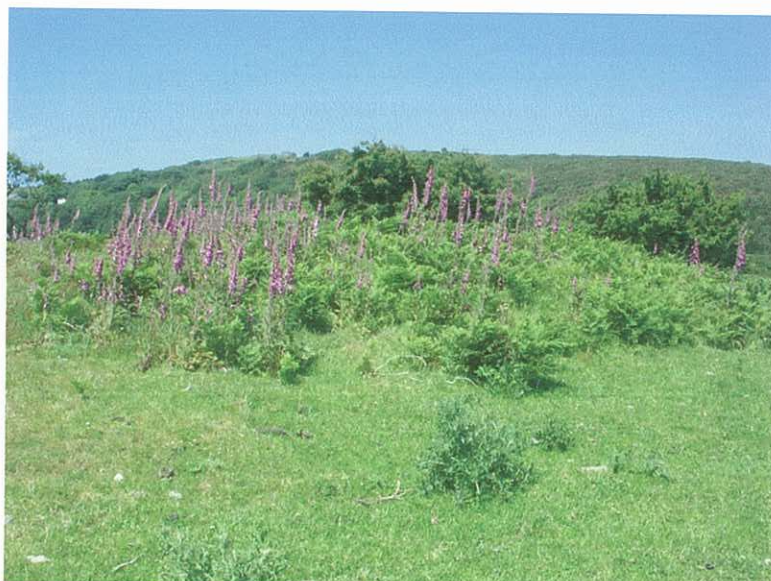
A probable round barrow, marked as 'tumulus' on historic maps. The site survives as a pronounced circular mound around 15m in diameter, on a ridge of high ground. It is possible that the mound is a natural feature, though it does appear to be very regular both in plan and in profile.

The site is generally in a stable condition, and is grazed. There is, however, some erosion in one small area on the top of the mound where the grass cover has been lost and a surface of earth and stone has been revealed.

Plate 3: *A circular mound which may be the site of a Bronze Age round barrow.*

The problem of erosion needs to be addressed as soon as possible. The site should be temporarily excluded from grazing in order to allow the grass to recover. If it does not, then this small patch should be re-seeded and the site left ungrazed until the new grass is established. If the feature is to be temporarily fenced out, then only lightweight electric fencing should be used, and as few posts as possible put in. These should be placed at least 5m away from the edge of the feature.

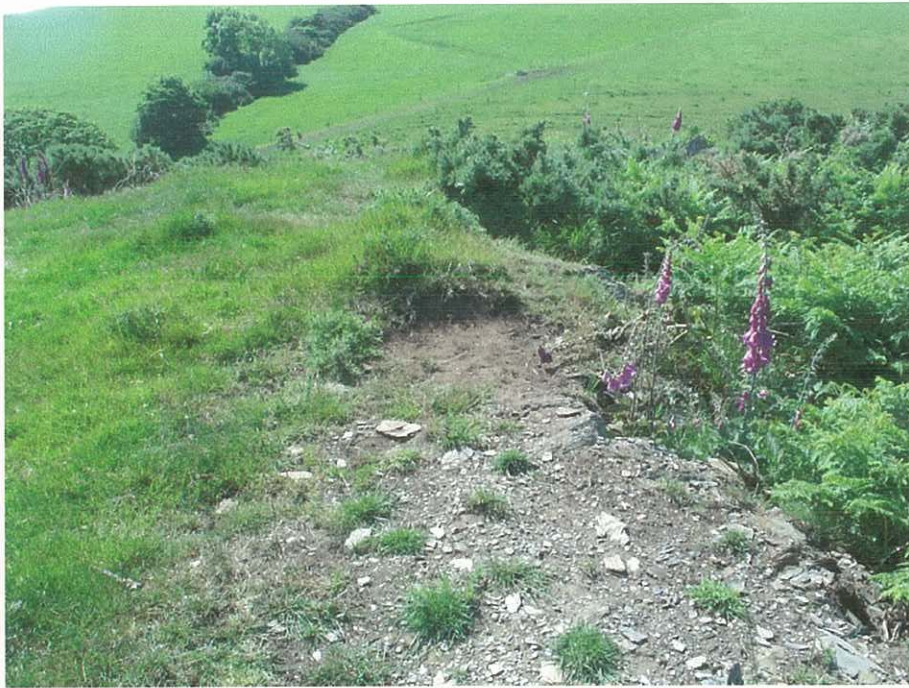
The promontory fort may be represented by a massive rock-cut ditch on the east side, which cuts across the neck of the promontory. A narrower, deeper ditch with a V-shaped profile on the west side probably also pre-dates the motte, and could be part of the Iron Age site. Later modifications were made to the interior of the fort, and to the north and south sides, resulting in the more complex form which the monument has today.

The site generally is in a poor condition, heavily overgrown with gorse and bracken. Erosion is a problem on the east ditch, as a well-established sheep trail enters the site through the ditch. Part of the problem is that the gorse cover is so dense that sheep cannot penetrate the majority of the site, and are consequently re-using the same open paths all the time. The far west of the site, beyond the western ditch, is completely impassable.

Plate 1: *The east side of the east ditch. This may be part of an Iron Age promontory fort which is overlain by a probable motte (PRN 1081). Erosion by sheep is a significant problem on this site – note the sheep scrape in the middle of the picture, and the exposed ground surface in the foreground.*

It is important that a management regime is agreed before significant damage is done to this monument. The landowner has already carried out large-scale gorse clearance across the promontory on which the site lies, and this is now being kept clear through grazing. However, much of the initial clearance was carried out by machine, and this kind of intrusive work cannot be carried out across the monument. Clearance by hand – cutting the gorse to ground level, and removing the waste – would be the ideal solution. However, given the density of the gorse coverage and the size of the area it is unlikely that this will be possible except through a programme of regular clearance of small areas. Once areas are clear, light grazing should ensure that they remain free of gorse.

In the immediate future, it is important that steps are taken to curb the problem of erosion on the site. One solution may be to cut back areas of gorse which will create new paths and open areas. Cut gorse can be placed into the established and eroded paths in order to prevent their use and allow them time to recover. However, this would have to be carried out at regular intervals in

order to prevent the new paths from also causing erosion. Encouraging light grazing within the cut areas should help them to remain clear.

To avoid causing damage to the site, vegetation should not be dug or dragged out, and waste should not be burned on site.

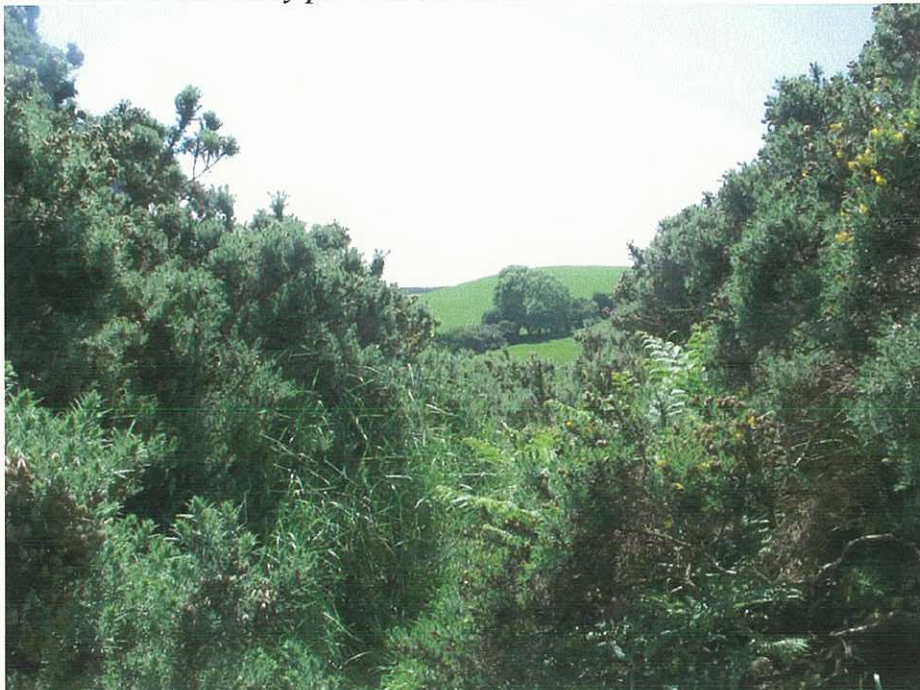
Plate 2: *View of the west ditch from its base. The steepness of the ditch sides, and the V-shaped profile are clues that this ditch may pre-date the motte.*

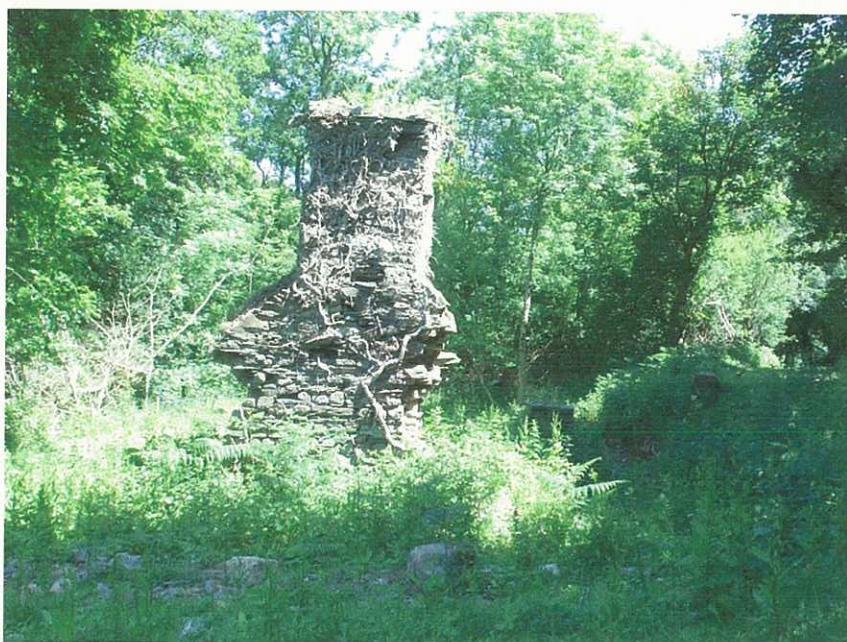
The site of the now-ruined cottage of Cwmdeifo Isaf. Only the chimney at the south end and part of the east wall now survive. The cottage was built from a mixture of stone blocks and slabs, roughly coursed, and held together with lime mortar. Much of the stone has been robbed from this site, and there appears to have been recent ground disturbance.

The chimney stack stands to its full height, but is very unstable. It has been heavily overgrown with ivy in the past, but this seems to have been treated since what remain now are dead ivy roots and tendrils. A small portion of the east wall still stands, around 1m in height and only about 2m long.

Plate 3: *The remains of Cwmdeifo Isaf cottage (PRN 48253). Only this chimney stack remains at the south of the site.*

The dead ivy on the chimney stack should not be removed as it will bring all the mortar out of the joints, and further destabilise the structure. If the ivy begins to re-grow it may need treating again. Further ground disturbance should be avoided in this area in order to protect buried archaeology. Any proposed works which affect this site should be discussed with Cambria Archaeology.

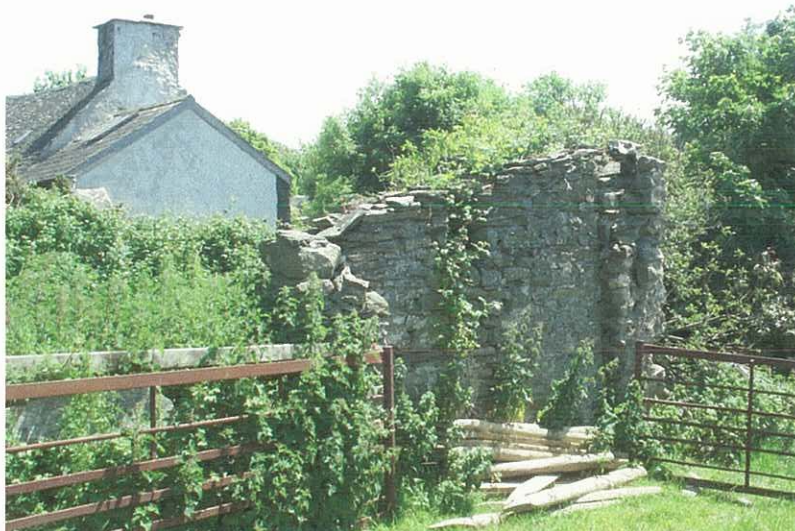
The west end of this building survives as stonework which is included in the north wall of the modern cowshed (PRN 48259). To the east of the cowshed, further evidence of the earlier range can be seen in the form of isolated sections of standing masonry in the gap between the cowshed and Manian Fawr house. Parts of this masonry stand on either side of a gateway, showing how a new access route was knocked through an older building in the 20th century re-organisation of the farm. These walls stand to around ¾ of the height of the cowshed.

The stonework in the cowshed wall is stable, and seems to be in good condition. However, the standing masonry between the two buildings is heavily overgrown, and there has been some dumping of modern farm waste into this area.

Plate 4: Part of the earlier layout of the farmstead of Manian Fawr (PRN 48261). In the background is the present day house of Manian Fawr (PRN 6605). It is lined up with this section of standing masonry and historic maps show one long range in this location (PRN 48528). Further masonry survives in the north wall of the modern cowshed (PRN 48259).

The standing remains of this building should be preserved in as stable a condition as possible.

Vegetation growing on and around the masonry needs to be cut back to ground level, and treated to prevent re-growth, and modern farm waste should be taken away. The walls should be capped to prevent water penetrating into their cores.

Ideally, some re-pointing should take place, using a mortar which matches the original construction of the building. Ground intrusive activities should not be carried out in this area.

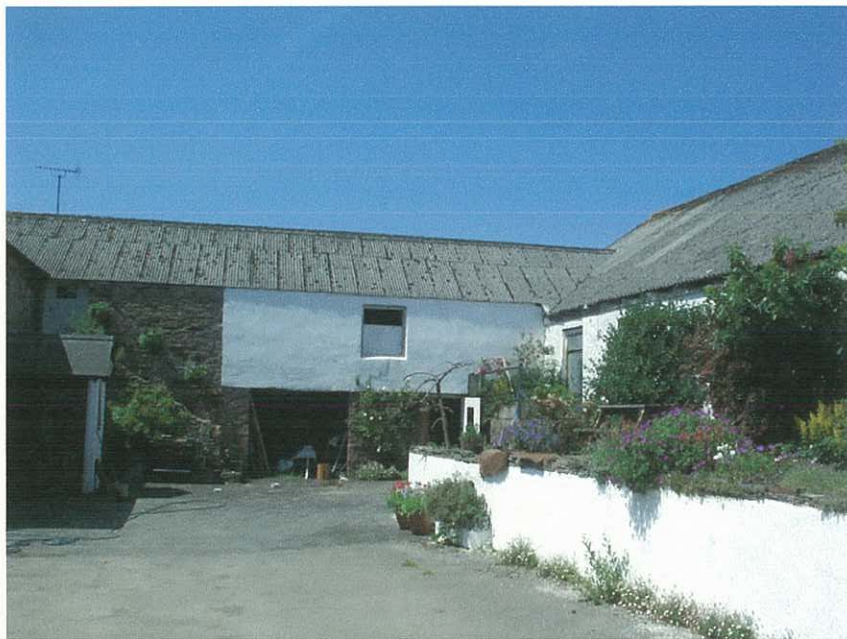
A modern two-bay cartshed, not seen on the 1963 Ordnance Survey map. Brick built pillars support the cartshed bays, and a second storey probably housed a granary which adjoins an earlier granary at the west end of the stables (PRN 48256). The cartshed is situated between the stables (PRN 48256) and the cowshed (PRN 48259), effectively forming a single U-shaped building. It is now roofed with asbestos sheeting, although the landowner plans to re-slate it.

Plate 5: View of Cwm Maen showing the cartshed (PRN 48260) in the centre. To the left is the modern house (PRN 48527) which was converted from Manian Fawr stables (PRN 48256), and to the right is a modern cowshed (PRN 48259).

Re-slatting of this building is to be welcomed. Any future repairs to this building should be carried out using materials which match the original construction of the building.
