Tir Gofal Farm Visit Historic Environment Report

REPORT NO. 2003/69
PROJECT RECORD NO. 45930

9th June 2003

Brynbank
Tir Gofal Farm Visit Historic Environment Report

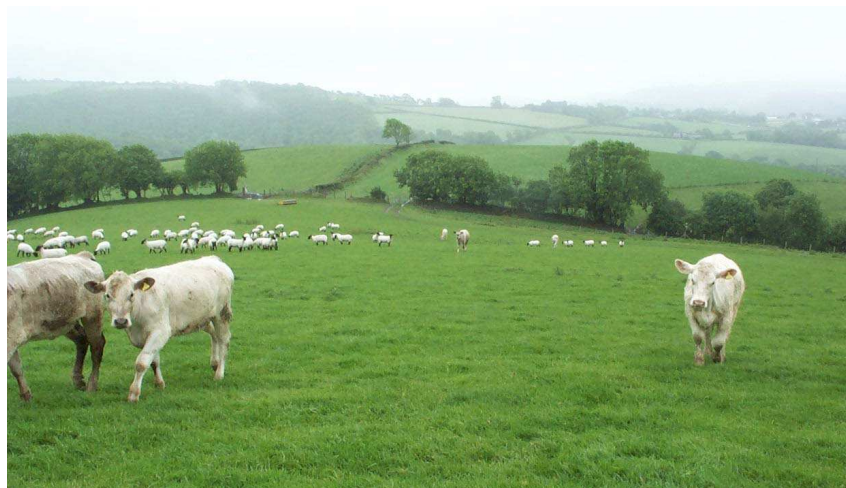
Plate 1- looking east towards the defended enclosure (PRN 11778)

This sub-rectangular cropmark, approximately 100 metres to the east of Brynbanc farmstead was identified in 1984 during aerial reconnaissance by T. James of the Dyfed Archaeological Trust. The dark green cropmark in an otherwise parched field indicate the ditches of a sub-rectangular enclosure measuring approximately 80 metres northeast-southwest by 80 metres northwest-southeast (James, T. 1984). No evidence of any surviving earthworks was identified. Such enclosures are typically given an Iron Age/ Romano-British date. Although only the ditches have shown up from the aerial photos, it is possible that the interior of the enclosure may preserve evidence of round houses, pits, enclosure walls and ditches and stock enclosures.

The site lies on a moderate south facing slope, with excellent views to the south, east and west. It lies within an improved pasture field, which is grazed regularly. A farm trackway runs along the southern boundary of the field a few metres to the south of, and parallel with the line of the southern enclosure ditch. The trackway becomes rutted during wet conditions causing the path of agricultural vehicles to deviate to the north, encroaching on the archaeologically sensitive area of the southern ditch. This is potentially damaging to buried archaeological remains.

The site should continue to be grazed regularly in order to maintain an even grass sward, with no breaks in the ground surface. No ground intrusive activities should be undertaken within 15 metres of the edge of the site.

The landowner has expressed an interest in surfacing the farm trackway with hardcore in order to minimise ground disturbance during wet conditions. This is to be welcomed as it will limit disturbance to sub-surface archaeological remains. The aerial photograph indicates a small margin of perhaps no more than 10 metres between the fenceline and the southern ditch of the enclosure. The trackway should be laid right up against, or as close to the southern fence line as possible, at the minimum width required for agricultural vehicles. If a new fence is to be added, it should be as close to the northern line of the trackway as possible. Any earth removed for the creation of the trackway, should go no deeper than the top soil, with a teram separating layer between the hardcore and earth below.

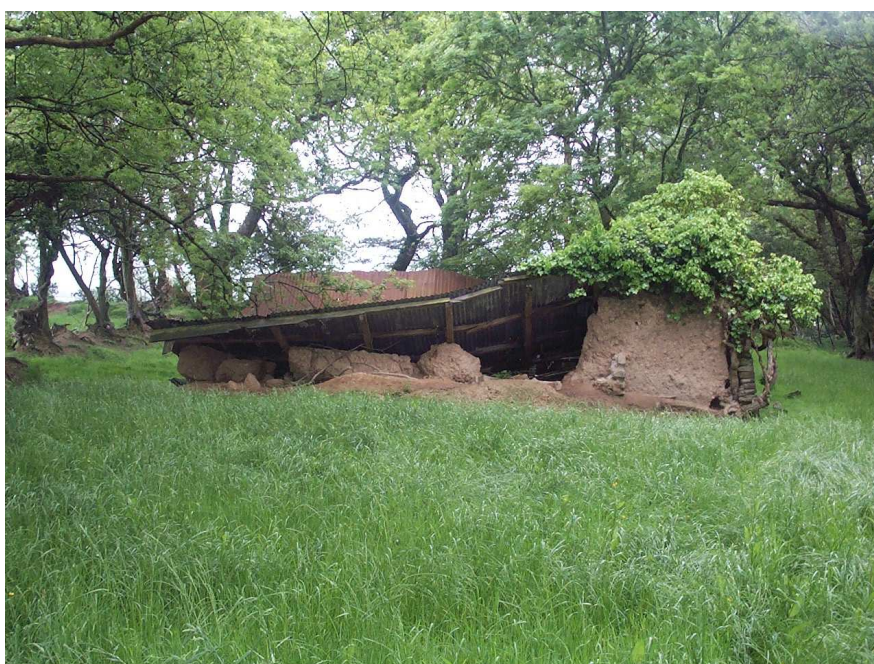
Plate 2- Looking south towards Pen-cil-post cottage (PRN 47743)

This cottage is situated on the side of the old Llanboidy road (PRN 47746). It follows an east-west alignment and measures approximately 10 by 5 metres. It is of part clom, part rubble construction with a pitched corrugated iron roof. The cottage, which is believed by the landowner to have been redundant for over 60 years is now in a ruinous condition. The rubble facing on the north lateral wall has since been lost and the clom wall has been exposed. Only the west end of the wall survives to eaves height, the majority of the wall having collapsed inwards. Only a narrow section between the central doorway and east window opening survives at near eaves height of the south lateral wall, with only the footings surviving elsewhere. The west gable end retains its rubble facing and is perhaps most well preserved. It survives at a height of between 0.5 and 2 metres. Nothing of the east gable end survives. The corrugated iron roof has since collapsed in on itself. Any ivy bush growing up the northwest corner of the building is adding weight to an already weakened structure and weakening masonry bonds. The site currently lies within pasture in the former cottage enclosure, which is grazed regularly.

The ivy growing out of the northwest corner of the building is adding weight to an already weakened structure, threatening the collapse of surviving walls. The roots are also potentially damaging to masonry bonds. The ivy should be cut off at the roots, removed and then spot treated to prevent re-growth. Ideally surviving rubble walls and wall facings should be capped and unstable areas re-pointed using a traditional lime mortar mix in order to maintain them in a stable condition necessary for their long-term survival. The roof, although collapsed continues to provide some protection to the walls and is best retained.

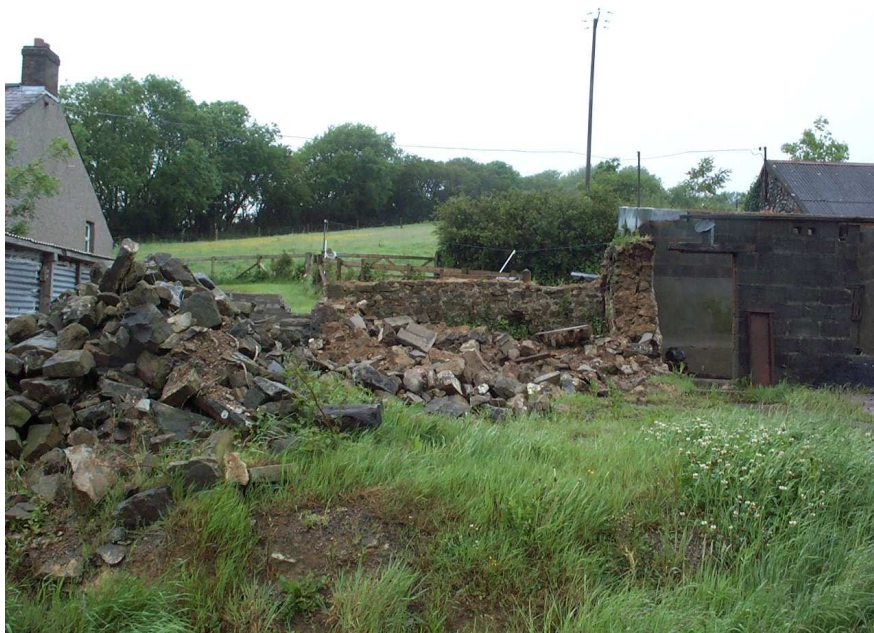
Plate 3- looking north across the site of former cow shed? (PRN 48210)

This building is first shown on the 1891 Ordnance Survey map to the southeast of the farmhouse at Brynbanc. It has since been demolished and only the ruinous north gable end and part of the adjoining east lateral wall survive to a height of around two metres. The surviving concrete floor indicates the former extent of the building, which measured approximately 15 by 6 metres on a north-south alignment. We have no additional information with which to interpret the original function of the building, although it may have served as a cow shed.

The surviving walls of the building should be retained, and capped with a lime mortar mix in order to prevent water ingress from washing out masonry bonds.

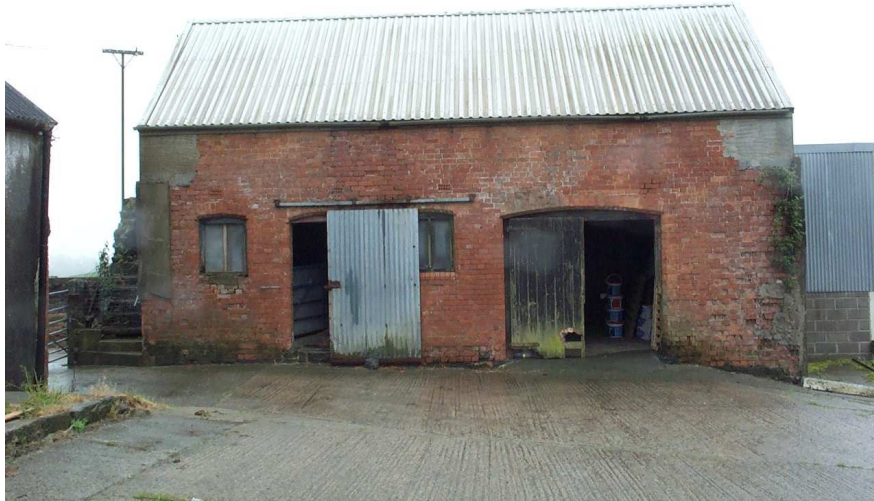
Plate 4- north elevation of combination farm building (PRN 48211)

This two storey cart shed granary building, which is first shown on the 1908 Ordnance Survey map defines the southern extent of the farmyard at Brynbanc. It measures approximately ten metres by six metres and follows an east-west orientation. It is of coursed red brick construction with a pitched sheet tin roof. The lower storey is separated into two bays. The eastern cart shed bay accessed by a wide, low arched cart entrance. The western bay is accessed by a wide doorway, with a low arch. Small square, low arched windows are on either side. The upper storey granary is accessed by a doorway in the west gable end up a set of stone steps. Opposing it in the east gable end is a wide rectangular window opening. The building first appears on the 6 in to a mile second edition Ordnance Survey map and was built sometime between 1891 and 1908. It is well maintained and in a reasonable condition, although some of the bricks are heavily weathered.

The building should continue to be maintained using building materials and techniques faithful to those of its original construction.

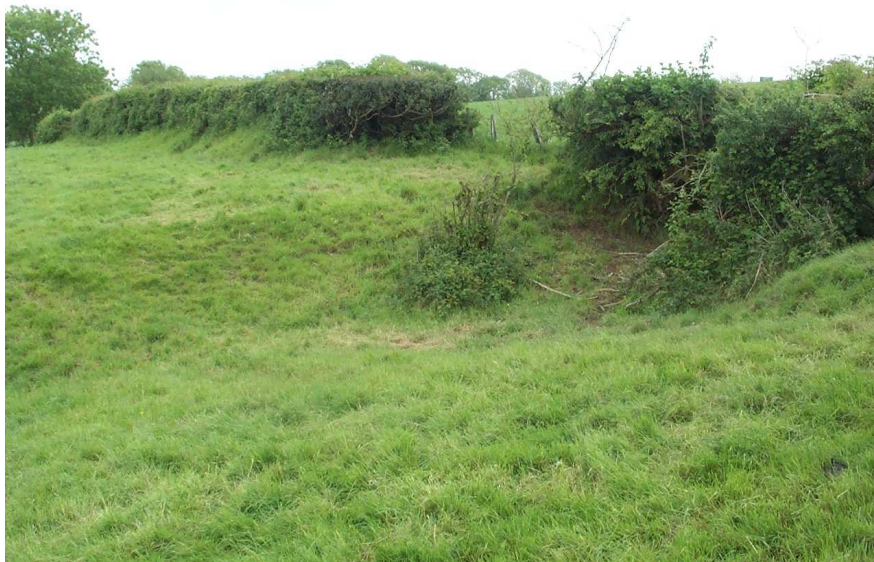
Plate 5- the site of the former well (PRN 48215) at Cilrath-Fawr

A well is identified at this location on the 1891 Ordnance Survey map, although it no longer appears on later map sources. The site of the former well is identified today as a depressed, roughly circular damp area with a diameter of approximately four metres, next to a field boundary in the lee of a shallow slope. This may be all that remains of the site of a homestead first shown on the 1819 Old Series Ordnance Survey map.

The earthworks, which indicate the site of the former well should be retained as a visible historic landscape feature. No ground intrusive activities should be undertaken within 15 metres of the edge of this site.

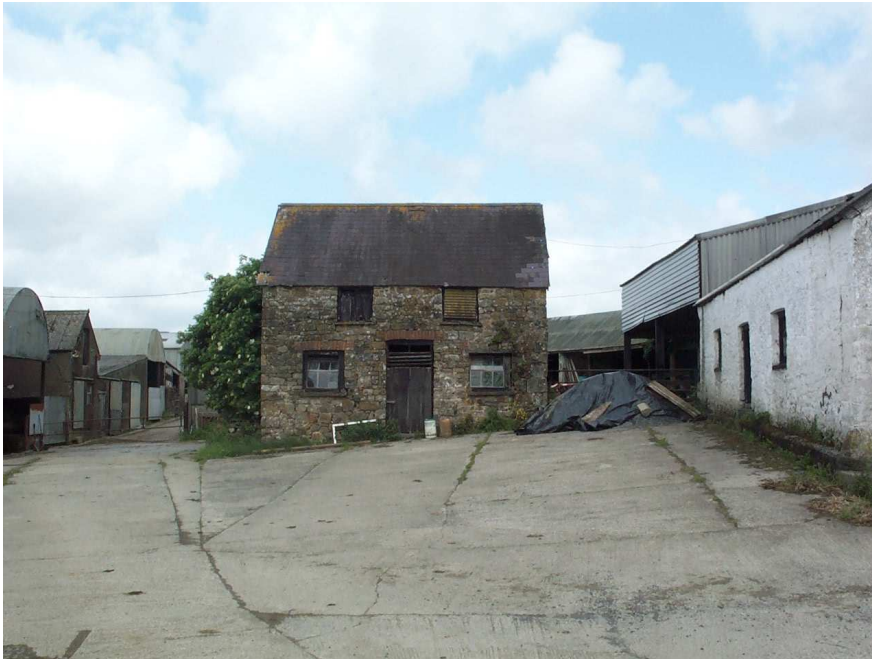
Plate 6- western elevation of combination farm building (PRN 48219)

It is disused and in a poor condition. Some roof slates are missing, whilst several others are unstable. The lime mortar masonry bonds around much of the building are weak and washed out. The west lateral wall is particularly unstable in this respect and is showing signs of “bowing out” away from the gable ends. A young tree is growing out of the steps to the north of the building, which is prising apart masonry and threatening instability in the steps and the north gable end of the building.

The building is currently in a poor condition and requires attention if it is to be maintained in a stable condition necessary for its long term survival. Rotten elements of the roof structure will need to be replaced and the missing roof tiles reinstated in order to bring the building back into a weatherproof condition. Unstable areas of the building should be reconsolidated and re-pointed using a traditional lime mortar mix. The tree growing out of the external steps should be cut off at the roots, spot treated to prevent re-growth, allowed to die and then removed. This should be followed up by a programme of masonry consolidation where necessary.

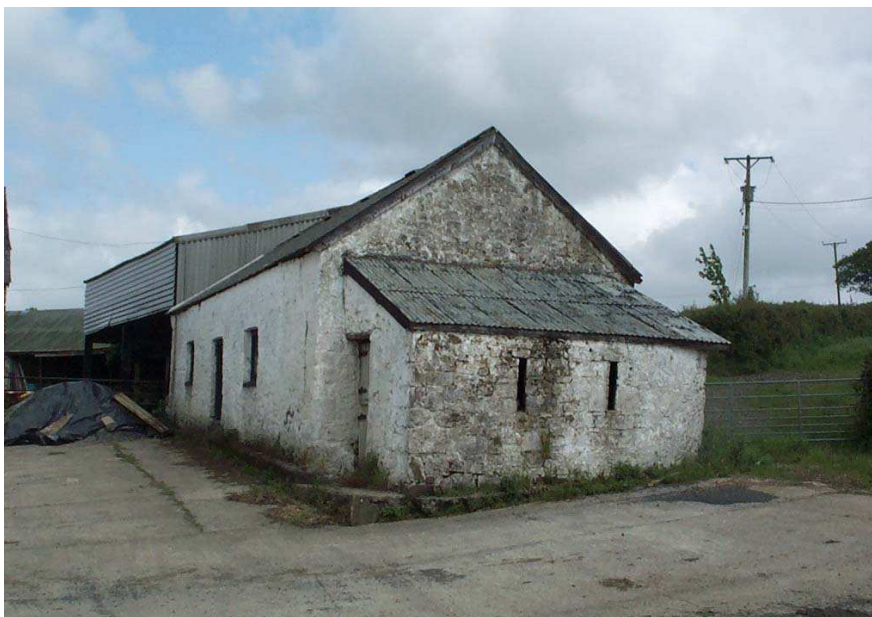
Plate 7- looking east towards shed (PRN 48221) and cow shed (PRN 48220) at Cilrath-Fawr.

This small lean-to, measuring approximately four by four metres abuts the southwest gable end of cow shed (PRN 48220). It is of uncoursed stone rubble construction with a single pitched corrugated iron roof. It is accessed by a wooden heck door in the northwest lateral wall. There are two evenly spaced slit windows in the southwest wall. It is a later addition to the cow shed and is likely to be of a late nineteenth, early twentieth century date. It has been used as a coal store in the past, although is now redundant. It is well maintained and in good condition.

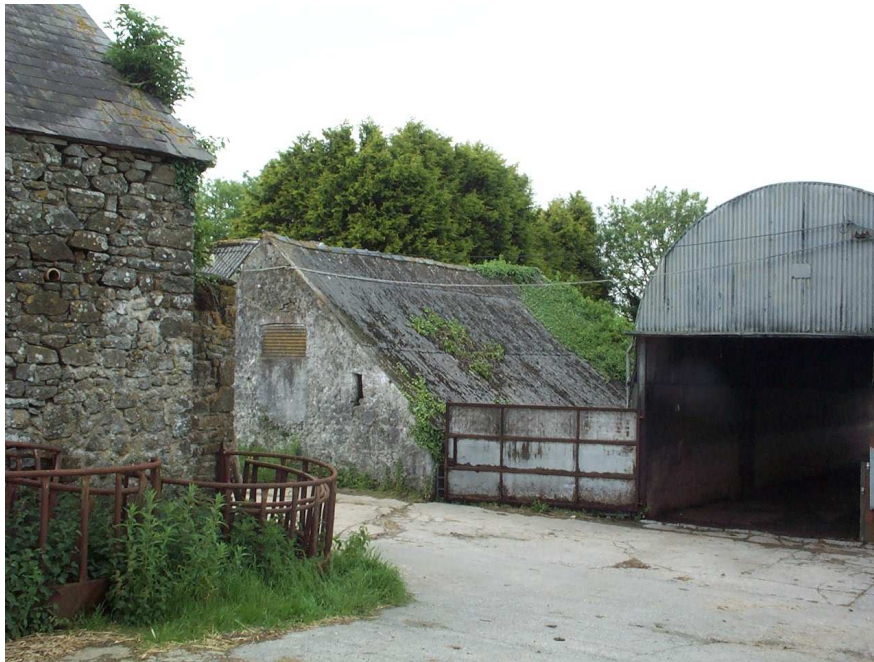
Plate 8- looking northwest towards combination farm building (PRN 48223), showing ivy growth around the north end of the building.

The building is currently in poor condition. Masonry bonds are crumbling and stone is becoming dislodged from the walls in both gable ends. Heavy ivy growth over the north end of the building is penetrating under the eaves and weakening the roof structure. It is also damaging masonry bonds, adding to structural weakness in the walls.

The ivy around the southwest gable end of the building should be cut off at the roots, spot treated to prevent re-growth, allowed to die and then removed. This should be followed up by a programme of masonry consolidation where necessary. Many other area of the building would also benefit from selective re-pointing in order to bring walls back into a stable condition. Any maintenance works should be carried out using traditional building materials and techniques.
