Blaen-maenog W/12/3254

Tir Gofal Farm Visit Historic Environment Report

Report No. 2003/107

Blaen-maenog
Tir Gofal Farm Visit Historic Environment Report

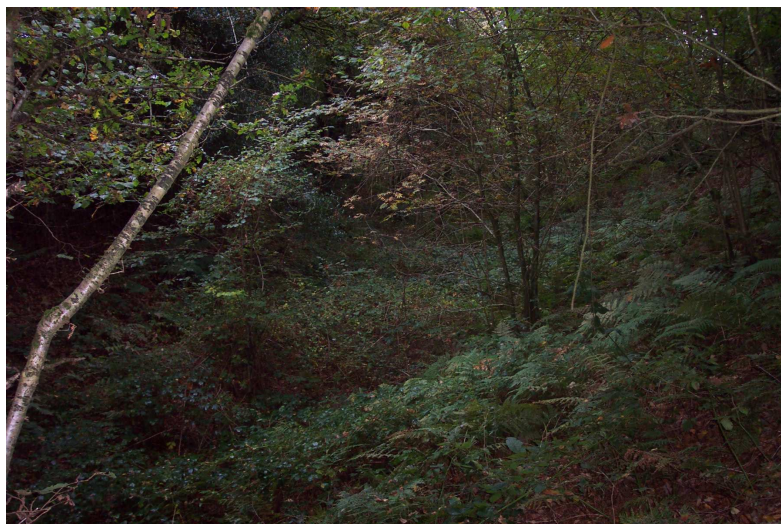
This is in contrast to the massive earth banks and ditches on the southern side of the fort. These earthworks are almost completely obscured by a stand of mature oaks, interspersed with younger trees and scrubby vegetation growth. Vegetation cover is particularly dense on the west side, and bramble growth is all but impenetrable. A fallen tree here indicates the potential for erosion scars on the steep sided banks through root damage. No other unstable trees were identified during the archaeological farm visit.

Grass cover on the monument is generally shaded out by the trees, and leaf litter predominates over the surface. Some grass cover remains in areas of sparser tree covering on the east side of the earthworks and on top of some of the defensive banks. A circular scrape, approximately 4 metres in diameter and 1.5 metres deep has been removed from the outer bank. A concentration of stone rubble visible on the southern side may indicate the remnants of a stone revetment wall on the outer face of the defensive bank. No further breaks in the ground surface, or active erosion was identified on any other part of the monument. It is in a stable condition at present.

Plate 3- the defensive earthworks of Caer Blaen Minog hill fort (PRN 2280) are now heavily overgrown.

The hillfort is currently in a stable condition, and no active threats were identified at the time of the archaeological farm visit. Trees on the earthworks should be monitored for signs of instability, and unstable specimens should be cut off at the roots, or stabilised through selective pruning in order to prevent them from falling naturally. This will prevent erosion scars from altering the appearance of the earthworks.

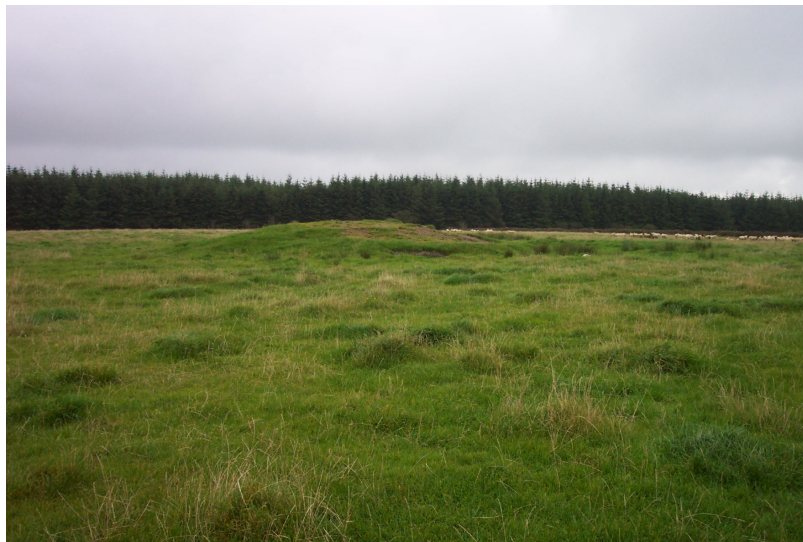
A large and well preserved round barrow standing some 1.7 m high and 20m in diameter. It is sited on top of a high plateau from which a number of other round barrows can be observed.

Plate 1- looking east towards Crug Perfa roundbarrow (PRN 2303)

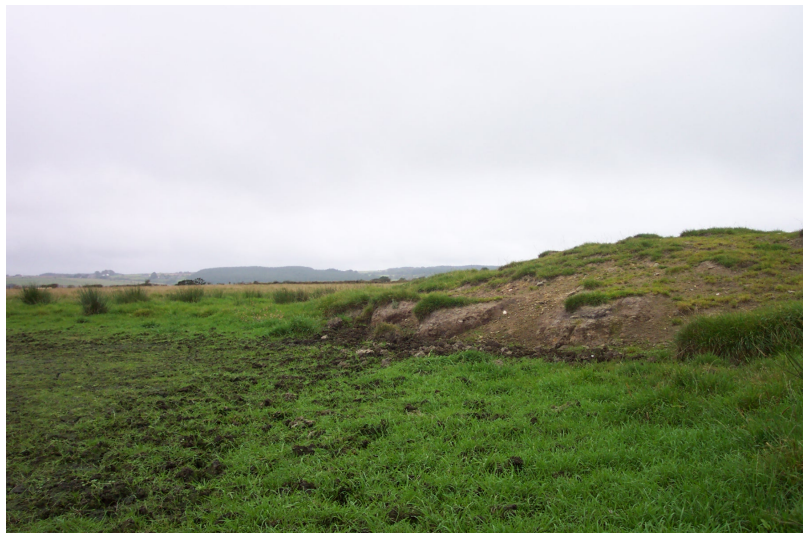
A marshy area to the east of the barrow is a seasonal watering point and livestock tend to congregate here. The round barrow is visibly trampled and scarred, with widespread loss of grass cover. This is particularly acute on the eastern side where active erosion hollows are disfiguring its profile. Similar, though less acute scars are visible from all other aspects. A white quartz boulder is visible on the south side of the barrow and other loose stones are exposed on its surface.

Cadw Scheduled Ancient Monument (SAM) condition reports record erosion through livestock trampling as a long-term problem, and it is clear that the round barrow will not recover naturally. Pasture surrounding the monument was heavily poached and pockmarked at the time of the archaeological farm visit.

Plate 2- active erosion hollow on the eastern side of Crug Perfa round barrow (PRN 2303).

In order to protect the site, it should be temporarily fenced off with electric fencing, and re-seeded. The severe scrapes on the east side of the round barrow should be filled in with inert material from elsewhere and reseeded in order to restore the profile of the monument.

The fencing should be erected 10m from the base of the barrow. This will avoid poking the stakes through any sub-surface archaeological remains and will prevent livestock from congregating on the mound when grass cover has recovered.

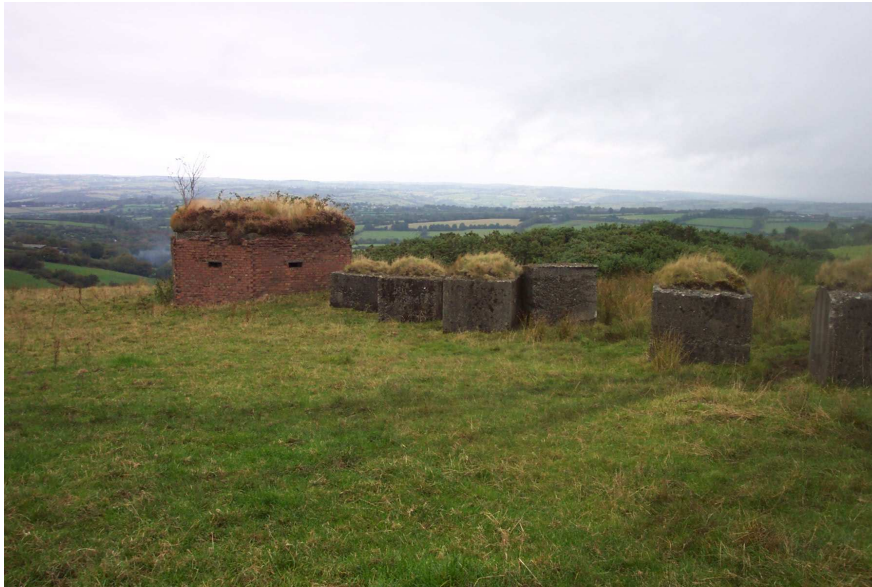
The section of the Rhos Llangeler stop line at Blaenmaenog Farm remains largely intact today. Anti-tank cubes have been displaced in two locations to permit machinery access to farmland to the west.

Plate 4- looking northwest towards the stop line (PRN 33901) and pill box (PRN 49211)

Some of the clay brick shuttering is coming away from the outside of the pill box. This is superficial rather than structural however and the pill box remains in a stable condition. Some scrubby vegetation is becoming established in the turf cover on the roof of the pill box.

The anti tank blocks are a rare surviving remnant of the Wester Command: Carmarthen World War II stop line, which extended from the mouth of the Tywi to the south, to Llangeler to the north. In order to preserve the stop line, the anti tanks blocks should be retained in their current position.

Vegetation should be monitored and kept under control to prevent structural damage being caused to the pill box.

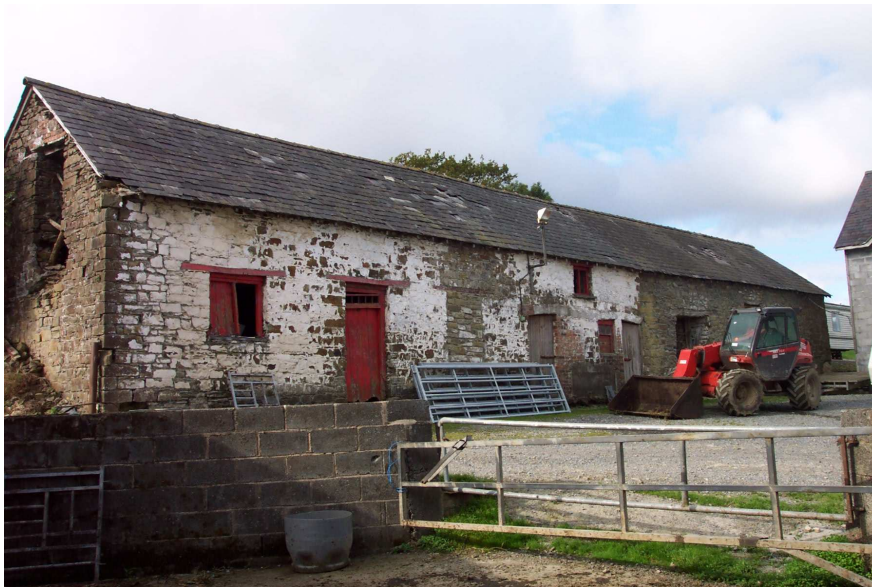
A stylised drawing of the farmstead on the tithe map of 1840 shows a rectangular building in roughly the same location, which may correspond to this building. It can first be positively identified on the 1889 1:2500 Ordnance Survey map and is at least of a late nineteenth century date. It is currently in a poor condition, and some maintenance works are necessary if it is to be brought back into a stable condition. Wall footings have become displaced in the north lateral wall and threaten to undermine this part of the building. Lime mortar bonds are washed out in many areas and there is further risk of masonry becoming unstable. A tree is growing out of the wall footings in the southeast gable end. This is a potential cause of structural instability in this part of the building. The granary steps nearby have since collapsed.

The roof is also a concern. Some slates are missing, whilst many others are loose.

Plate 5- northeast elevation of combination farm building (PRN 49221). Adjoining combination farm building (PRN 49222) visible beyond.

Displaced and unstable masonry should be replaced and reconsolidated where necessary. This should be followed up by a more general programme of masonry consolidation. Missing and unstable roof slates should be replaced in order to bring the building back into a weatherproof

condition. Materials used should be compatible with those of its original construction. The tree growing out of the southeast gable end should be cut off at the roots and spot treated to prevent re-growth.
