# THE DRIL HALL, PEMBROKE, PEMBROKESHIRE

## AN ARCHAEOLOGICAL WATCHING BRIEF

Report No.  
2002/70

REPORT NO. 2002/70  
PROJECT RECORD NO. 46044

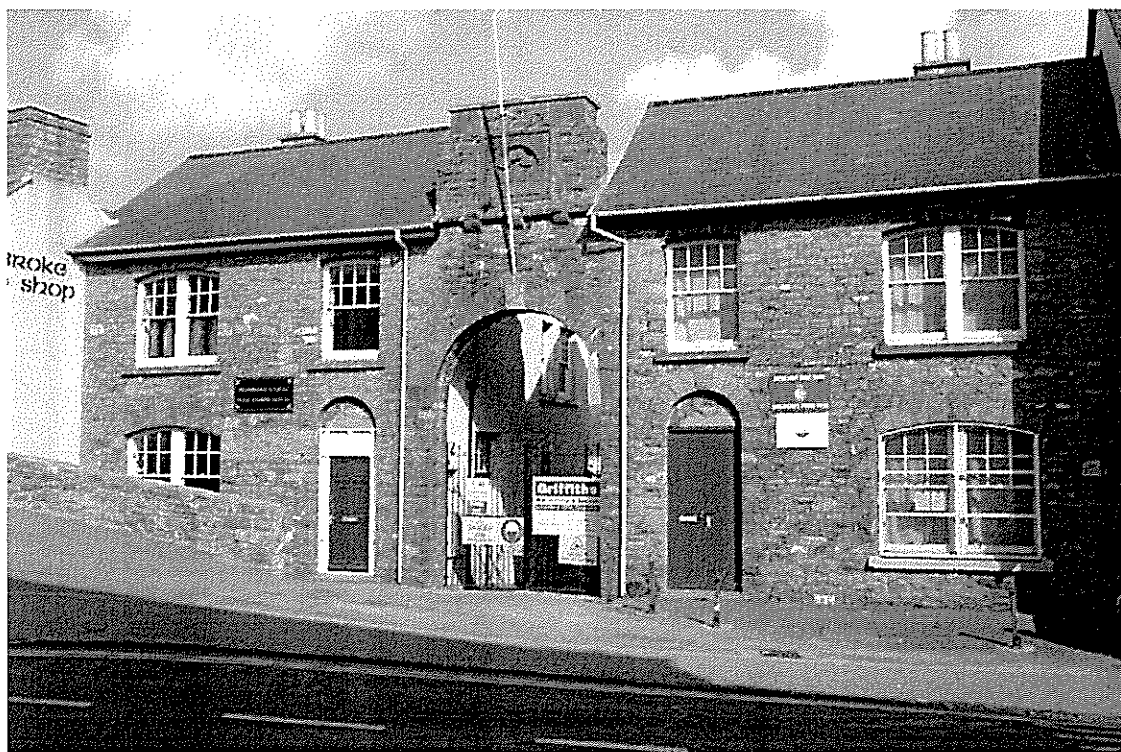
**Photo 1:** The Street Frontage of the Drill Hall Site.

The street frontage associated with the Drill Hall is occupied by an imposing structure built in a similar architectural style to military buildings in Pembroke dock (see Photo 1). It consists of a full centred semi-circular archway flanked on each side by a two storey, two bayed building, each with a doorway with a single-light segmental headed window above. The bays furthest away from the archway feature segmental headed double windows on each floor. The walls are of limestone rubble with dressed stone around the openings. Although the exact date of construction of the Drill Hall frontage is not certain it is thought to date from about 1910.

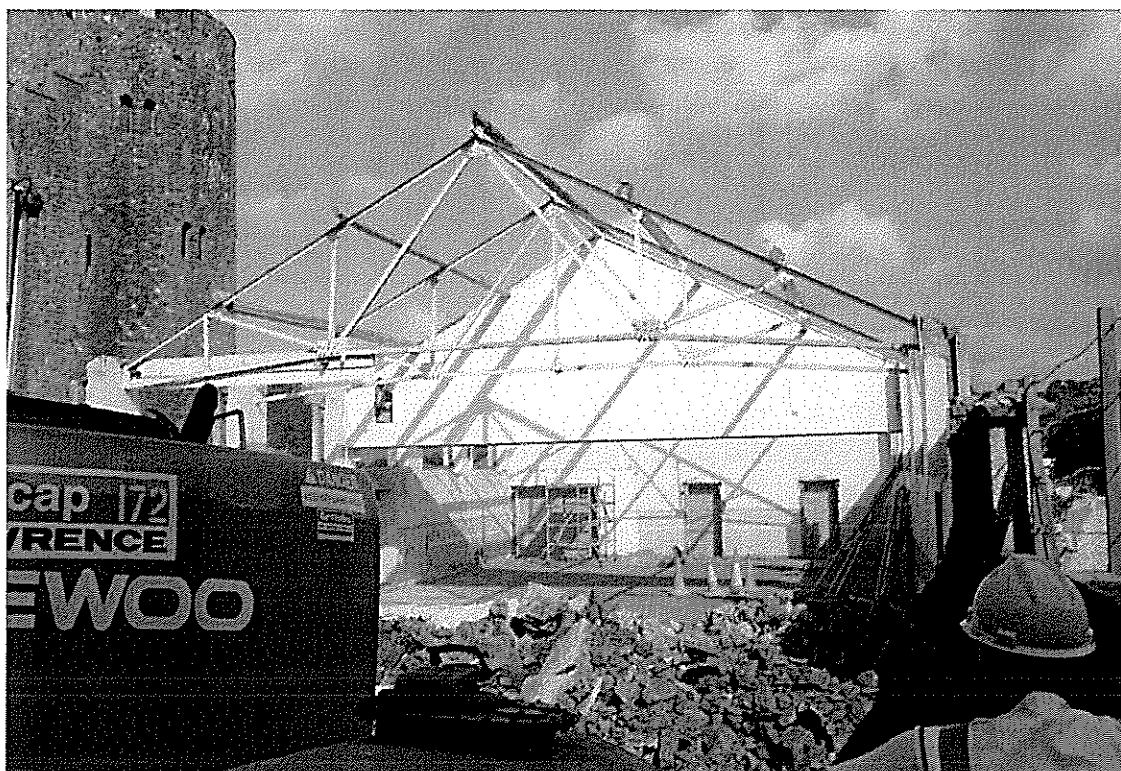
**Photo 2:** The Drill Hall During Demolition.

The Drill Hall itself is a detached steel framed building of brick and stone, with a low pitched slate roof supported by steel trusses. The gable ends contain circular lights. High rectangular windows are ranged down the west and east sides of the building. It is set back from the street front, situated in the open area behind the frontage and accessed through the archway.

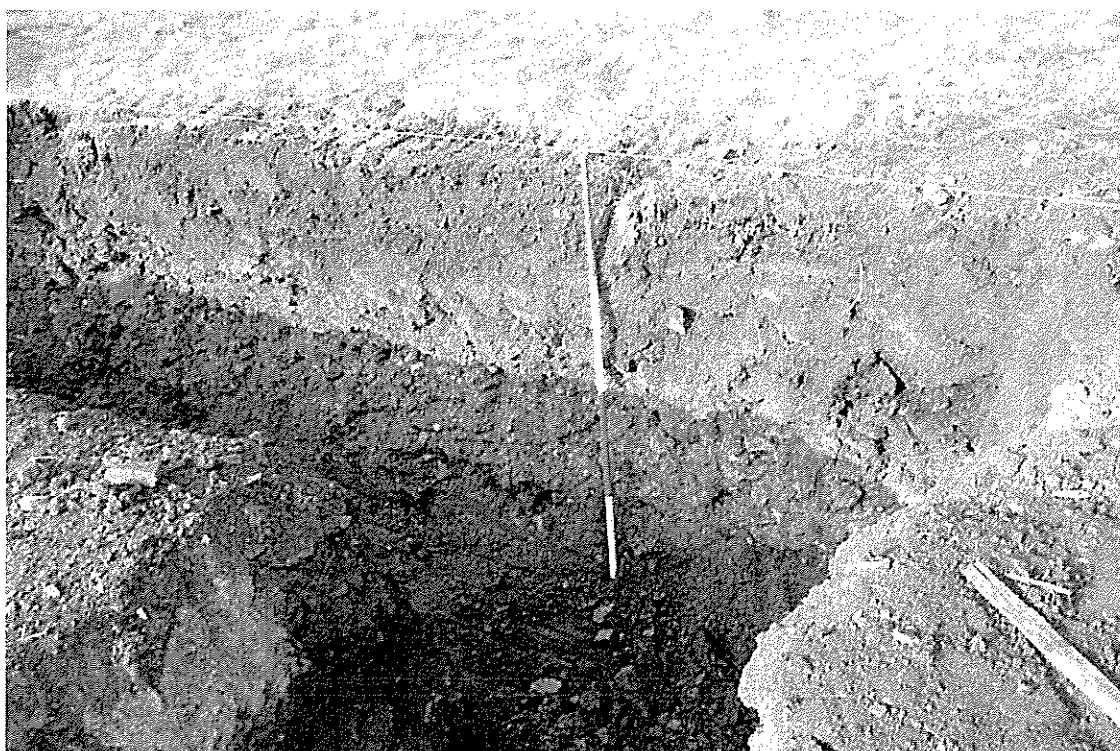
**Photo 4:** Stratigraphy of the Western Foundation Trench (east Facing Section).

To the west of the wall, beneath the topsoil (approximately 0.25m thick) was a layer of loose stone rubble and mortar up to 0.50m thick (see photos 4 and 6). This is presumably derived from the earlier demolition of the property boundary and other features. A mixture of modern, 19<sup>th</sup> century and possibly 18<sup>th</sup> century ceramics were observed within this rubble. This deposit presumably fills in the former passageway (or defensive ditch of the castle) leading to the quay. Below the rubble was a natural layer of coarse stone rubble in a mid red-brown clay-silt matrix, approximately 0.30m thick. This lay directly above solid limestone bedrock. The bed rock slopes downwards towards the north.

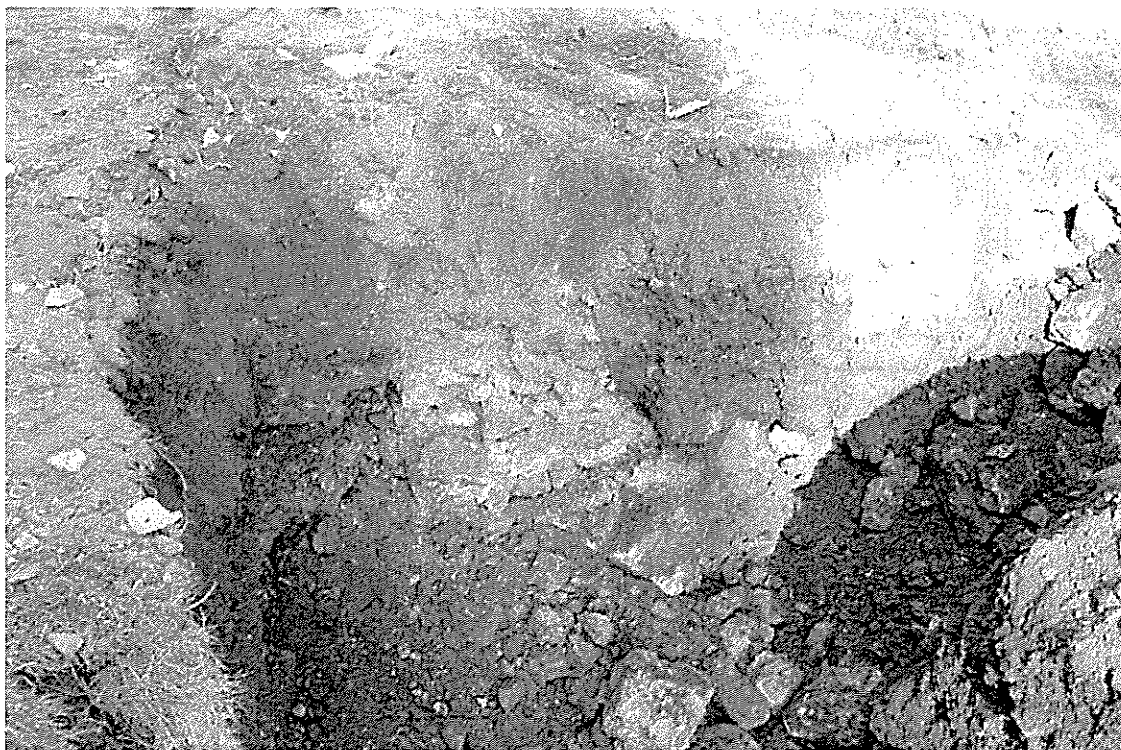
**Photo 7:** stratigraphy in the North Foundation Trench (south Facing Section)

The stratigraphy within this trench was essentially similar to that of the eastern trench except that it contained a cross section through the wall at its west end (see photo 7). Immediately to the east of the wall is a deposit of burnt coke or coal, presumably waste from a fireplace. This deposit appears to be within a linear cut feature, either a foundation cut for the construction of the wall, or the remnants of a cut for an earlier property boundary on a similar alignment. The deposit was not present at the southern end of the foundation trench and does not appear to be of medieval origin.
