**ST. MARY MAGDALENE CHURCH,
ST. CLEARS,
CARMARTHENSHIRE**

ARCHAEOLOGICAL RECORDING

Report No.
2002/69

REPORT NO. 2002/69
PROJECT RECORD NO. 46045

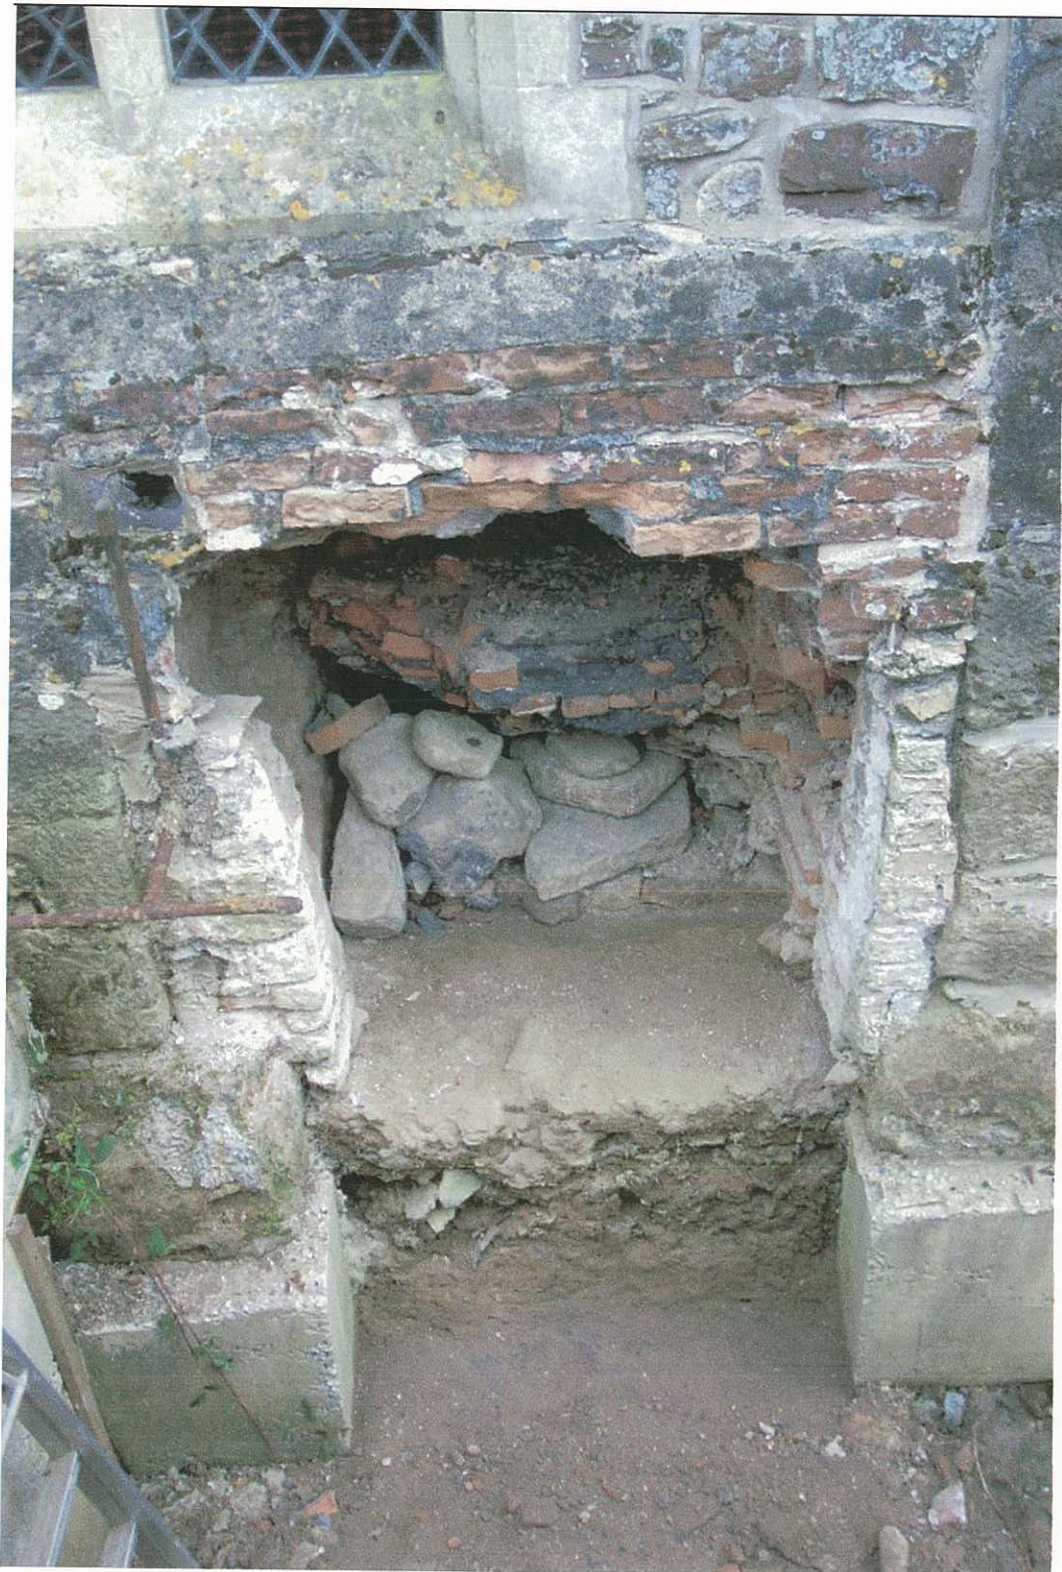
Plate 1: External view of the crypt entrance

When visited in September the north, west and east faces of the trench were concreted as was the base of the trench. On the southern side there was concrete underpinning the exposed foundations of the north wall of the church. This obscured most of the deposits below the wall foundations (which had previously been sketched) except for the portion below the medieval doorway where there were no foundations to underpin (see plate 1).

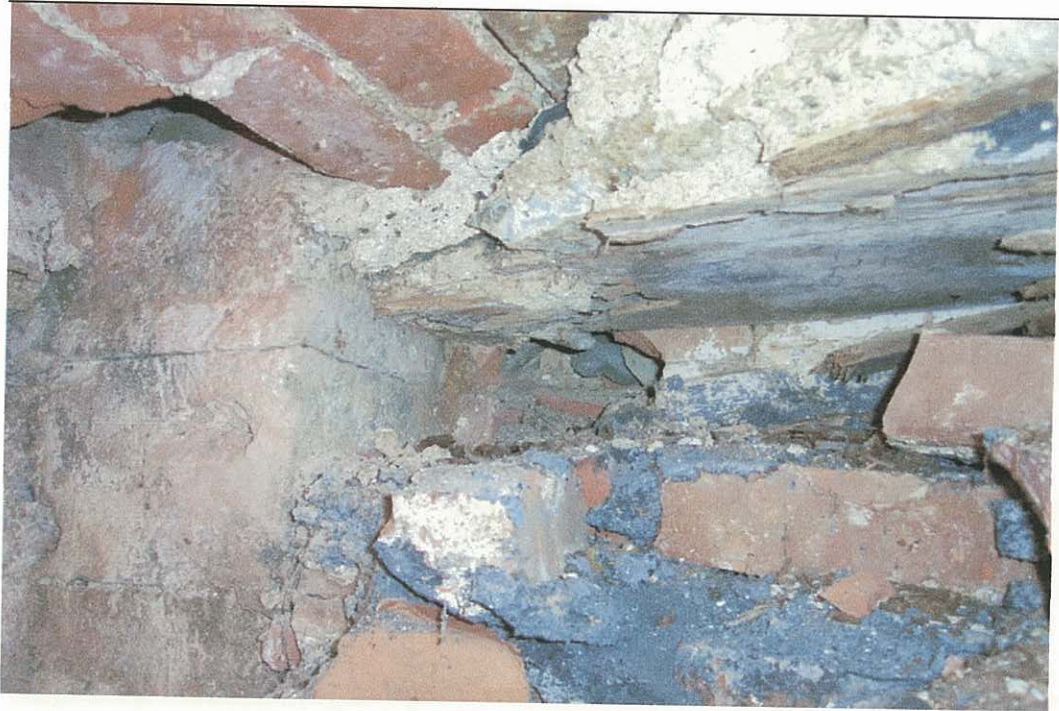
Plate 2: Dressed limestone medieval door Jamb (left), brick vault (above) and brickwork blocking the entrance to the crypt

The thickness of the wall between its external north face and the northern end of the crypt (exposed during this investigation) is not the entire thickness of the north wall of the church (see figure 3). What is thought to be the remains of a dressed limestone door jamb was revealed on the eastern side of the doorway/crypt entrance (Plate 2, and figure 3). This stonework is thought to be the remains of the original doorway which may therefore indicate the original north wall face before the outer 'skin' was added. An area of brick infill inserted beneath this door jamb may indicate the position of the original threshold which would have been removed when the crypt was inserted.

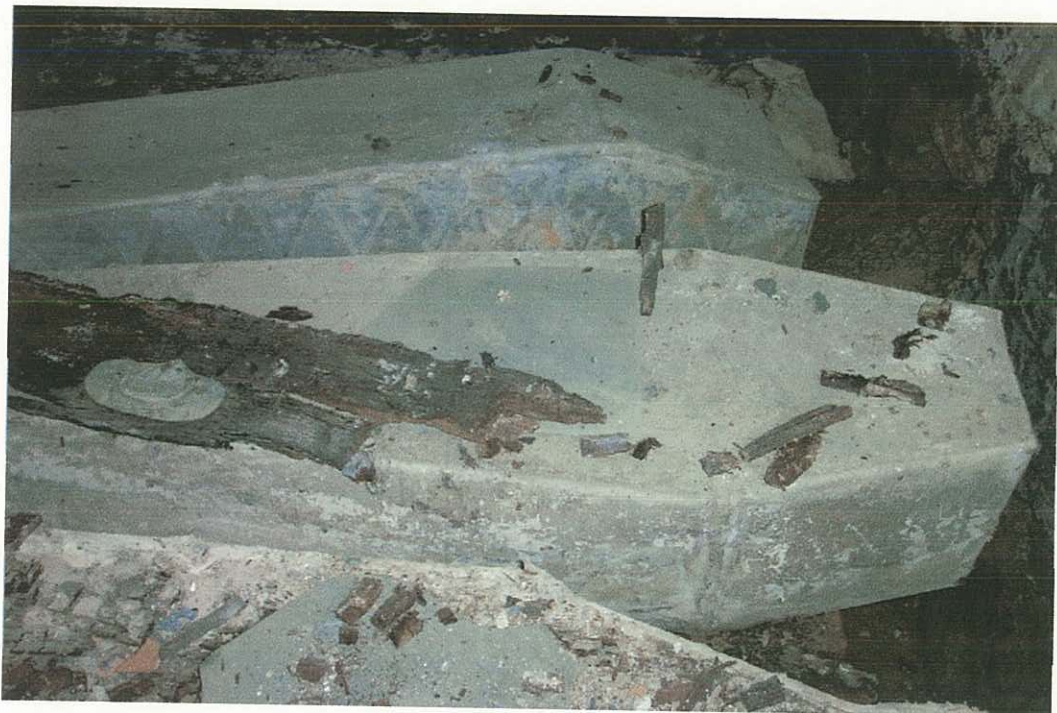
Plate 3: Lead coffins within the crypt

Examination of the interior of the crypt indicated that there were four lead coffins (plate 3). No skeletal material was visible. The Chapman memorial lists five burials, since only two of these were adults it is doubtful that the four full size coffins observed can be equated with those of the Chapmans.

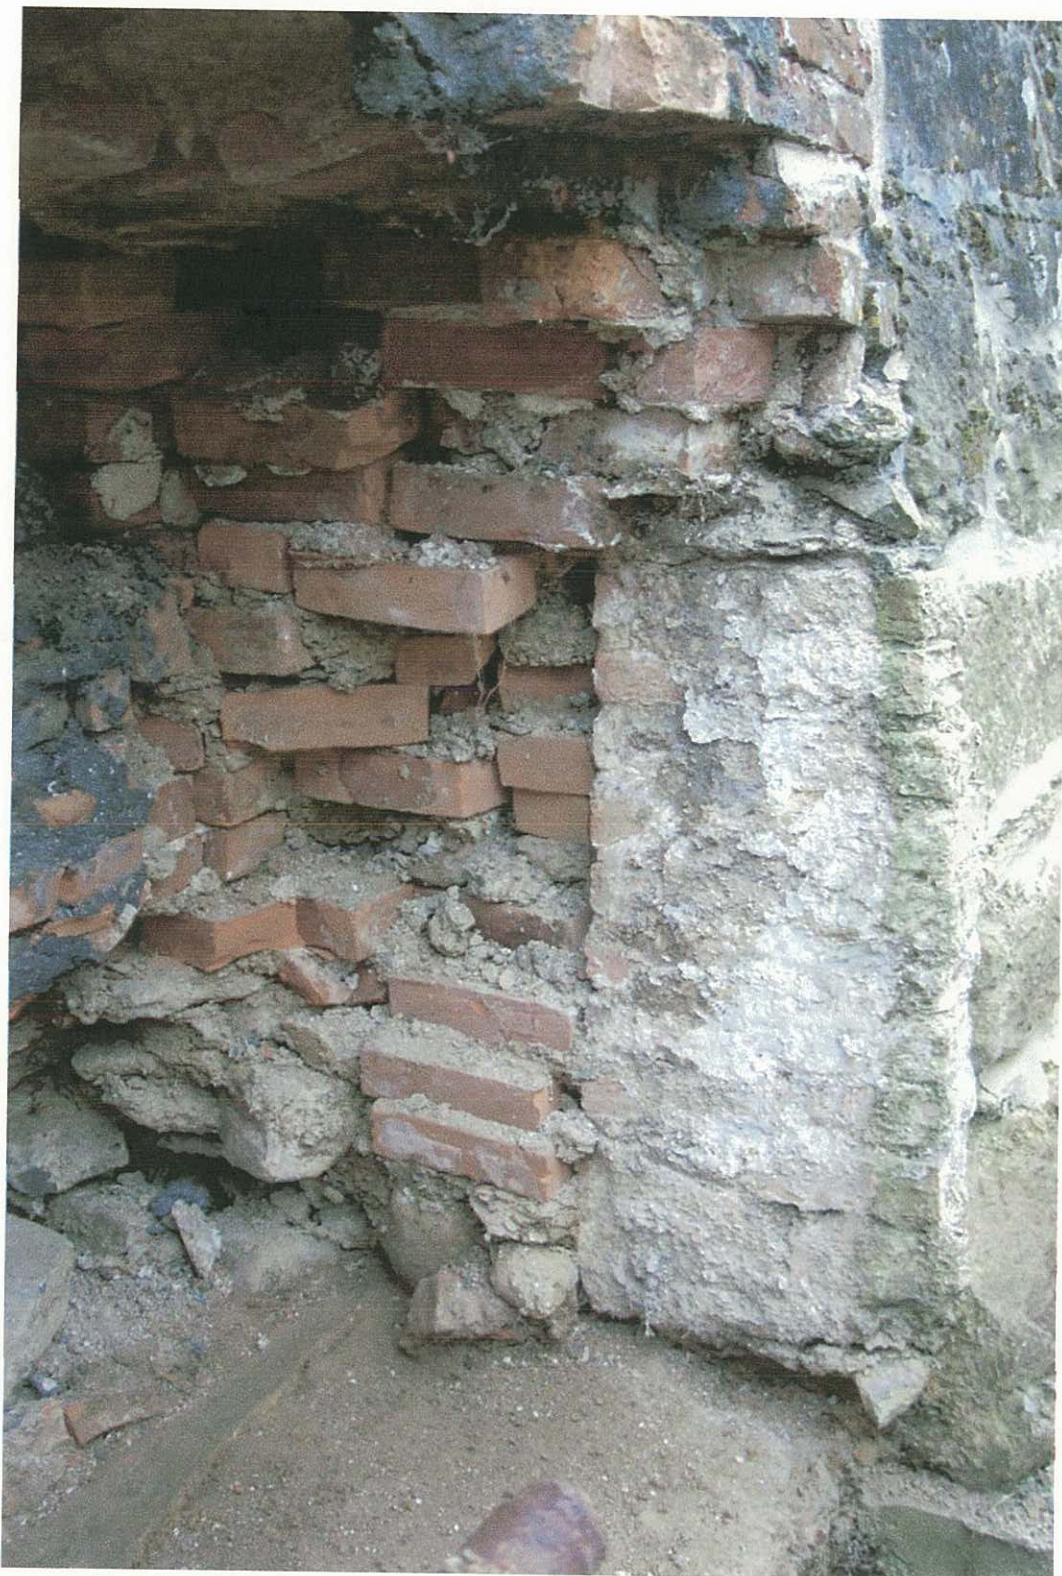
Plate 6: West side of the crypt entrance (right) with brick blocking (left)

Built against the stonework forming the sides of the medieval door opening are two mortared brick piers that form the mouth of the entrance to the crypt (plates 5 and 6). Surviving fragments of stone above these brick piers suggest that they originally supported a slate lintel. At some stage this lintel was destroyed when the crypt was opened. This may have been because the ground level outside the church had risen to such an extent that the original crypt entrance could not be easily accessed.

The pipe for the heating system that was installed in 1898 runs within a duct through the wall on the east side of the 14th century doorway, above the level to which the door was demolished when the nearby window was inserted (see figure 3). The material above the truncated brick vault in the entranceway to the crypt is therefore all likely to be contemporary with the insertion of the later window. It is at present impossible to ascertain how much of the western side of the 14th century doorway survives within the wall (beyond what is visible on the exterior), since it is obscured by later brickwork infilling of the entrance to the crypt (see plate 6). As yet there is no reason to suppose that it is not intact.
