# THE CORONATION HALL, PUMPSAINT

## ARCHAEOLOGICAL WATCHING BRIEF

Report No. 2002/93

Report Prepared for:  
THE CORONATION HALL COMMITTEE

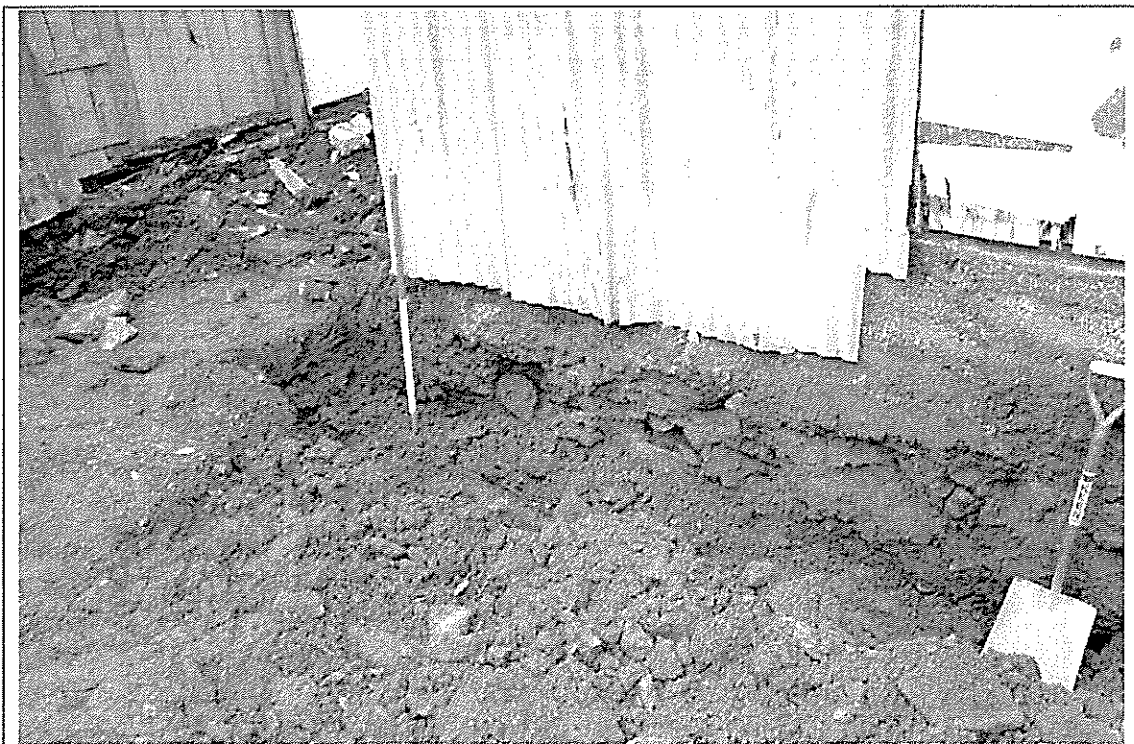
Plate 1: Trench 2 showing the footings for one of the 1950s extension blocks.

*T2* was excavated along the base of the south wall of a 1950s extension to the hall. The rubble stone foundations for the extension were revealed. This area had been disturbed in the past by modern drainage works, which included the insertion of new drains and a soakaway. Cleaning the south section of the trench revealed layer of loose brown clayey loam, which contained some large loose stones, overlying a layer of light brown clay, with some gravel, which contained very occasional charcoal flecks. This in turn overlay a layer of mixed brown/grey/green clay and small to medium-sized stone blocks and shale, which may have been derived from the fort's rampart material.

A modern feature containing loose loam, small stones and plastic pipe fragments cut the section at the east end of this trench. This did not appear to extend into the other trenches and was presumably part of the extension or drainage works.
