Tynywaun W/12/3293

Tir Gofal Farm Visit Historic Environment Report

Report No. 2003/76

Tynywaun
Tir Gofal Farm Visit Historic Environment Report

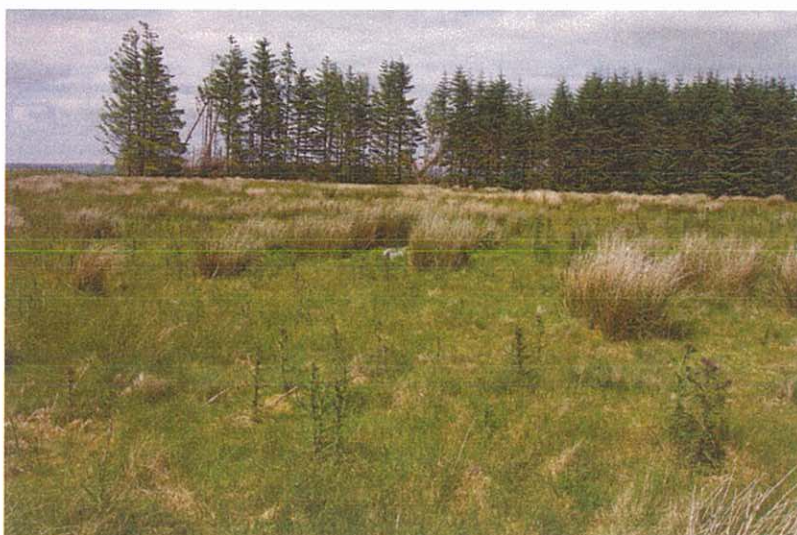
The round barrow remains much as described above, although a dense sward of tussock grass has become established over the northern half of the site. It currently lies within a pasture field, which is grazed periodically. No specific threats were identified from the current management regime.

Plate 1- looking north towards round barrow (PRN 12864)

Ideally, the tussock grass, which has become established over the northern half of the round barrow should be cleared in order to enhance the visibility of the site. No ground intrusive activities should be undertaken within 15 metres of the edge of the site.

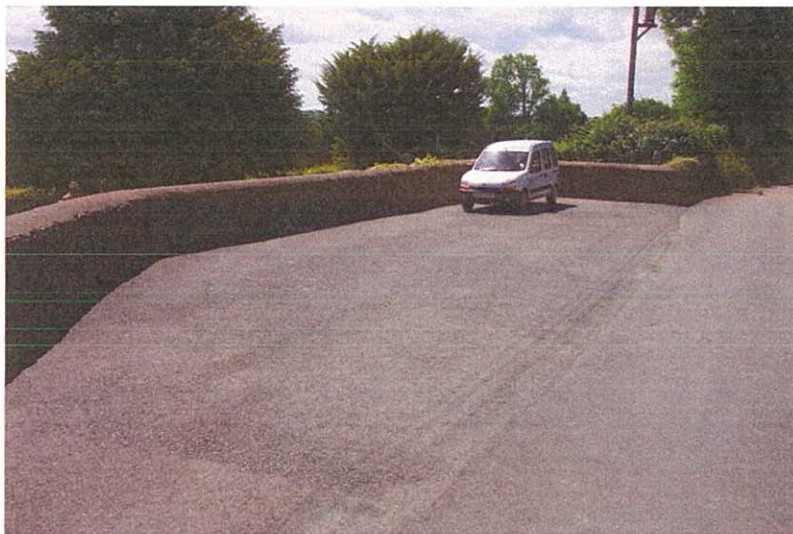
A long building is shown on the roadside in front of the church on the 1840 Cynwyl Gaeo Parish tithe map. It is later identified as the Bell and Yew Inn on the 1891 Ordnance Survey map. The building has since been demolished for the creation of a church car park. The area now lies under tarmac, and no traces of the former building survive.

Plate 2- the former site of the Bell and Yew Inn (PRN 21867), now a church car park.

No specific management recommendations can be made in this instance.

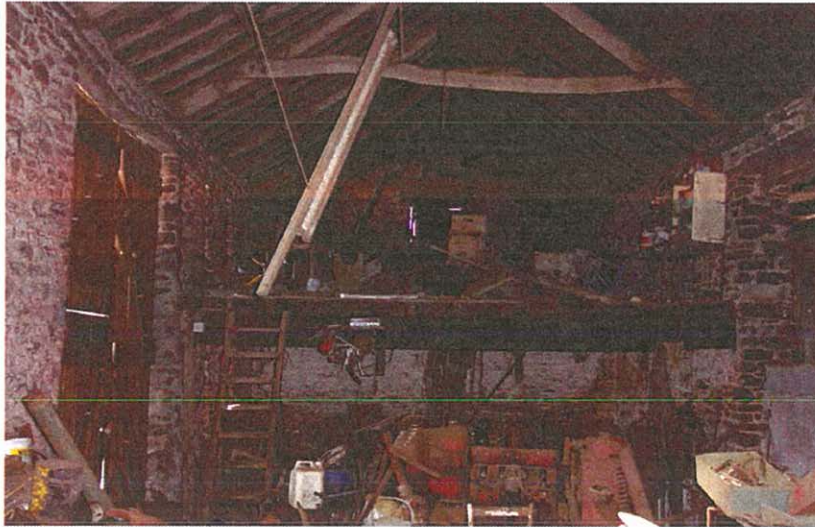
The upper storey of the building formerly served as a granary. The loft remains intact over the western two thirds of the building and is accessed by a wooden ladder from the threshing floor. Two opposing square windows, with wooden lintels are visible at the west end of the building. A loading door is situated in the centre of the west gable end of the building. Joist slots in the east gable end indicate that a smaller loft was once situated to the east of the granary doors.

The building, which may be of an early to mid nineteenth century date, is currently well maintained and in very good condition. It is presently used for storage, although the cart shed bay now houses cattle.

Plate 3- the interior of combination farm building (PRN 48287) looking west.

The building should continue to be maintained using traditional building materials and techniques.

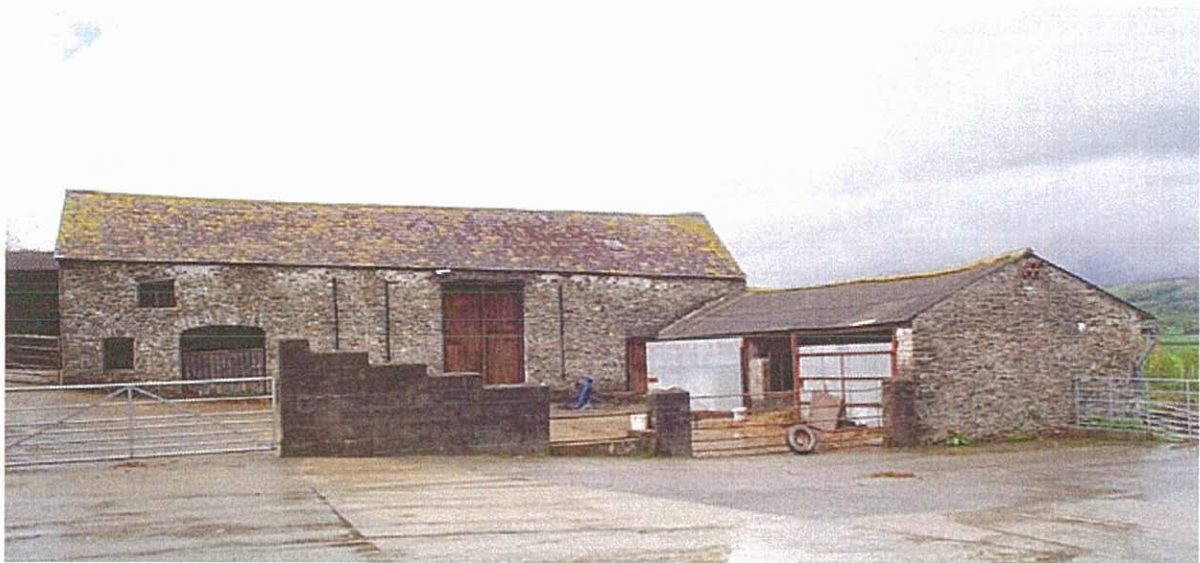
Plate 4- looking north towards combination farm building (PRN 48287) and cow shed (PRN 48288)

This cow shed adjoins combination farm building (PRN 48287). It follows a northsouth alignment and measures approximately 18 by 6 metres. It has been substantially modified from its original construction, and little of the original historic structure remains. The original stone rubble, lime mortar bonded north gable end survives, to a diminished height, completed to eaves height with breeze blocks. The original south gable end is largely intact, and has been re-pointed with concrete in the past. The eastern lateral has been entirely rebuilt out of breeze blocks, whilst the western lateral wall has been lost entirely and is now made up of several metal panel doors. The roof structure has been replaced and both pitches are now roofed with corrugated asbestos. The building is currently used as a cow shed.

It is first identified on the 1891 Ordnance Survey map, although it is likely to be of a much earlier date. It has been significantly modified from its original construction, and although, in this sense its historic integrity is diminished, it continues to contribute to the group value of the farmstead.

The cow shed should be maintained using material compatible with those currently used.

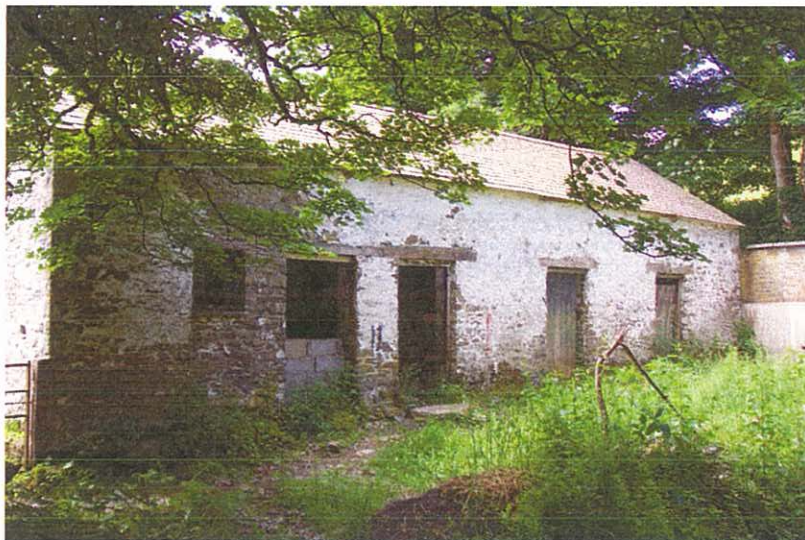
Plate 5- looking west towards northern lateral wall of combination farm building (PRN 48291)

This cow shed building, with a former upper storey loft abuts the north gable end of the farmhouse at Llwynchwrt. It follows a general eastwest alignment and faces onto a farmyard and combination farm building (PRN 48292) beyond it to the north. It is of stone rubble construction with roughly squared quoins and a pitched slate roof and measures approximately 16 by 6 metres. Access is gained by four heavy wooden framed doorways, with wooden lintels in the north lateral wall. The only additional lower storey opening is a square window, with a slate sill and lintel towards the east end of the wall. Opposing upper storey loading doors in both gable ends of the building imply the presence of a former upper storey loft. The western loading door has since been blocked by a 12 pane wooden sash window, which is missing several panes and beginning to rot. The loading door in the east gable end has since been lost, and the wooden frame is rotten in places. The loft has been lost and two joists towards the east end of the building are all that survive. Little of the original historic internal layout of the building survives, although a wooden hay rack has been retained at the east gable end. The building is currently divided into two bays by a low breeze block partition. Several concrete drainage passages and stall platforms across the width of the building indicate that its last agricultural use was as a cow shed. The building is no longer used for agricultural purposes.

This building, which is likely to be of an early-mid nineteenth century date is currently in reasonable condition, although some maintenance works are necessary if it is to be brought back into a stable condition. Water ingress through the loading doorway in the east gable end is washing out masonry bonds, promoting structural instability. Masonry blocks are becoming detached between the two doorways in the eastern end of the north lateral wall. The wooden doorframes are beginning to rot and may need replacing. Two of the doors in the north lateral wall are missing, whilst those remaining are in poor condition, either broken at the hinges or rotten. The loading door in the east gable end is missing. The sash window in the centre of the west gable end is rotten and missing several panes and may need replacing. The roof is well maintained and in good condition.

Unstable masonry should be reconsolidated and re-pointed where necessary. This should be followed up by a more general programme of masonry consolidation. The landowner has expressed an interest in replacing the doors and windows. This is to be welcomed providing that replacement materials are in keeping with those used in the original construction. Replacement doorways should be wooden panelled, and the heavy wooden doorframes replaced where necessary. The loading door in the east gable end should be replaced, in order to prevent water from entering the building and damaging masonry bonds.

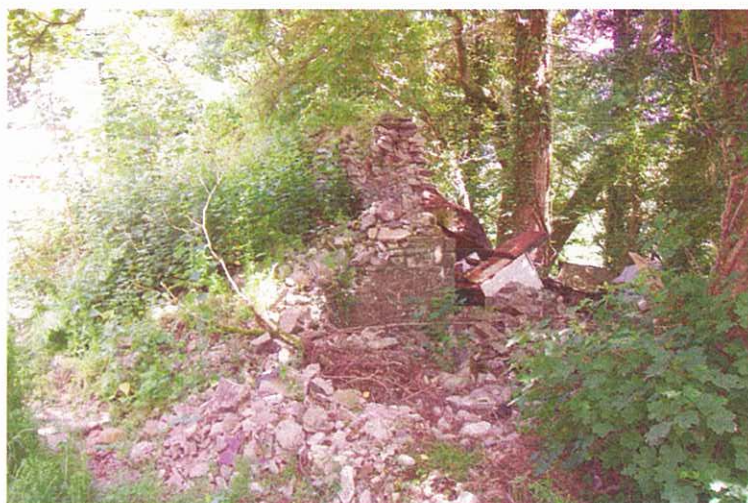
This ruinous building lies to the east of the farmyard at Llwyncwrt. The southwest wall survives to full length, and is approximately eight metres long. The northwest and southeast walls have since been demolished and its former extent is not known. An abutting wall, approximately three metres long to the north-east may have formed part of an annex. Both walls survive to a maximum height of approximately two metres. A small square doorway, approximately one metre, with a stone lintel is situated in the side of the abutting wall, where it meets the southwest wall. It has since been blocked off. No additional evidence survives with which to interpret the building. Building debris has been deposited against the southwest wall, whilst the southeast part of the site has been used as a dump for domestic goods. Further investigation was not possible.

It is absent from map sources before 1906 and may be of an early twentieth century date. The site is currently overgrown and surrounded by both building and domestic debris. The ruinous condition of the building and absence of information from map sources make interpretation problematical, although the small door may indicate that the eastern part of the building may have served as a kennel. Water ingress is washing out masonry bonds in the walls promoting instability.

Plate 6- looking northeast towards the ruined agricultural building (PRN 48293).

Ideally the wall tops should be capped with a traditional lime mortar mix in order to prevent water ingress from further weakening masonry bonds. The domestic rubbish should be removed from around the ruin in order to make it more visible as a historic landscape feature.

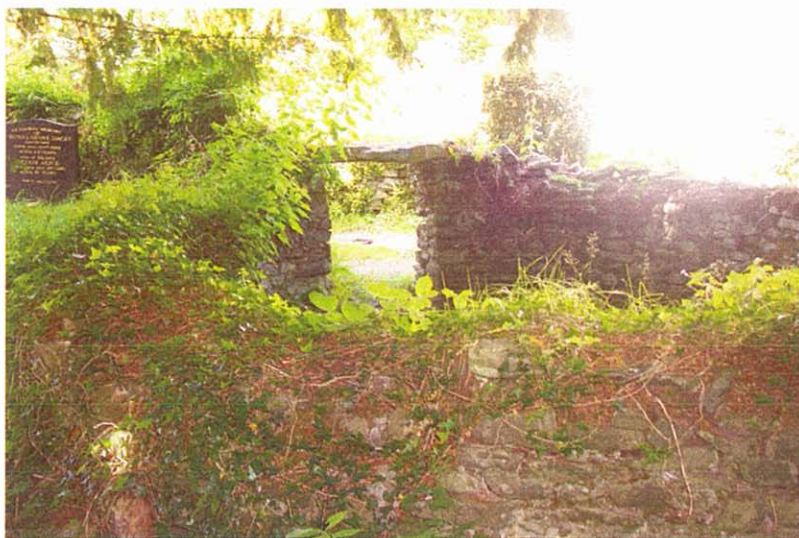
This circular pound is situated on the northwest boundary of St. Davids Churchyard near to the farmhouse at Llwyncwrt. It is approximately five metres in diameter, with lime mortar bonded stone rubble walls approximately 1.4 metres high. It is accessed from the west by a narrow entrance, approximately 1.2 metres wide, with a large stone slab for a lintel.

The pound, which is first shown on the 1891 Ordnance Survey map remains in good condition, and although lime mortar bonds have been washed out of the walls in places, they are substantially intact. Ivy is becoming established over the southern side of the structure, which is potentially damaging to masonry bonds and may cause structural instability.

Plate 7- looking west towards pound (PRN 48294).

Ivy should be cut off at the roots, spot treated to prevent re-growth, allowed to die and then removed. This should be followed up by a programme of masonry reconsolidation and re-pointing where necessary.

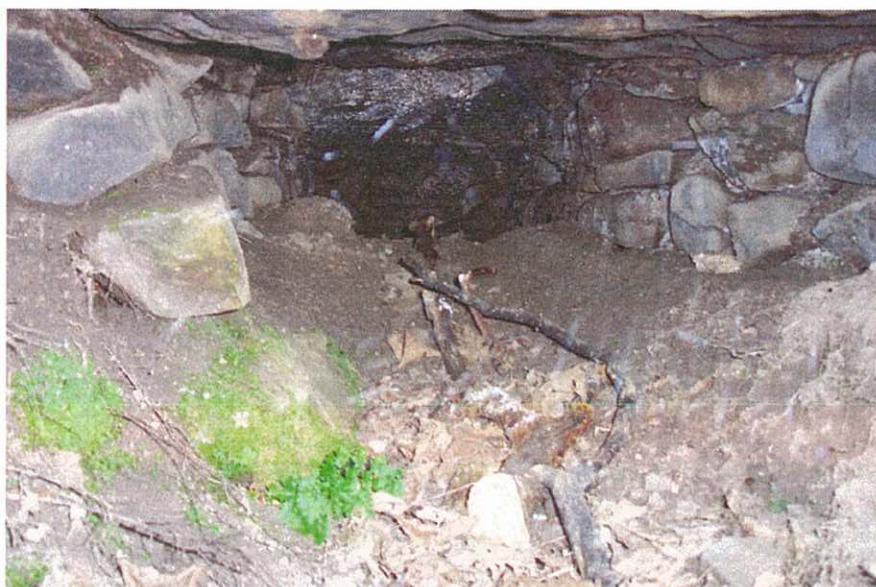
This field kiln is built near to the top of a steep natural bank, approximately 15 metres above the Afon Twrch. The stokehole, approximately 0.8 metres wide and 0.5 metres high, with a wide stone lintel leads into a stone built flue, of similar width, at least 1.5 metres long. The flue appears to drop down into a chamber, although being inaccessible, its interior dimensions, and nature of construction are not presently known. Local inhabitants who have seen the drying chamber believe it to be wide and circular, although no dimensions were specified. The drying chamber has since been infilled and its structural details are not known.

Plate 8- looking down the stone flue towards the drying chamber of corn drying kiln (PRN 48295).

The corn drying kiln is in a stable condition and no active management need apply. It should be retained as an important surviving historic feature. No ground intrusive activity should be undertaken within fifteen metres of the edge of the site.

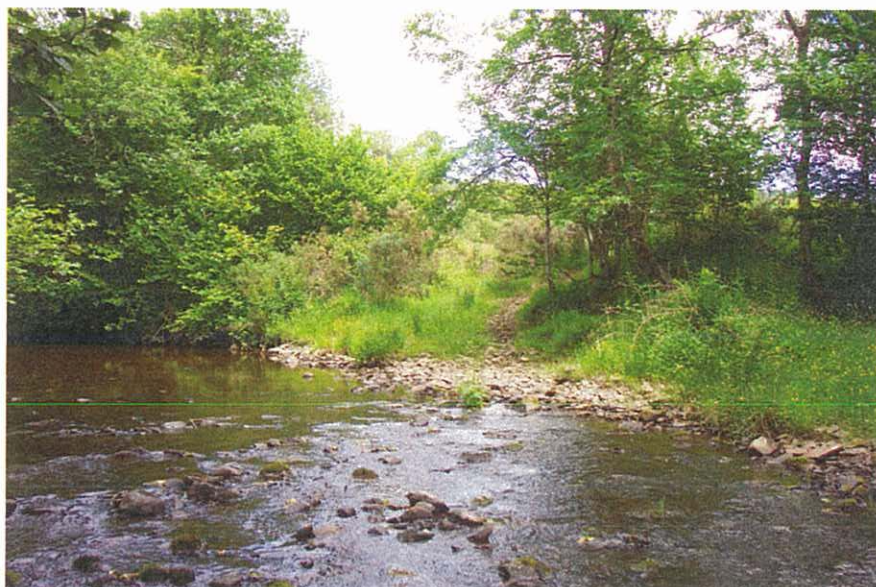
This ford is first shown on the 1891 Ordnance Survey map, approximately 130 metres southeast of St. Davids Church, Llanyrcwys. Although a road bridge now carries the road over the river, the ford can still be seen to the north. It remains visible as a shallow area, where the river widens slightly, which is easily accessed by shallow slopes from the fields on either side. It is now disused. No evidence of any structural features associated with the ford were identified.

Plate 9- looking east from ford (PRN 48296)

Retain as a historic landscape feature. No ground intrusive activities should be undertaken within 15 metres of the edge of the site.

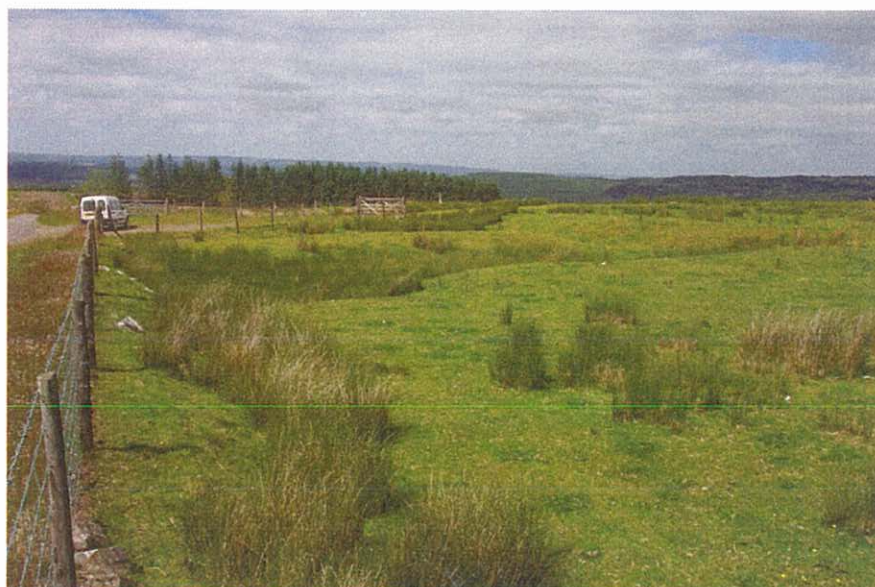
These quarry pits are situated alongside Sarn Helen, the line of which is now perpetuated by the modern road to Llanfair Clydogau. Several sub-circular pits, some overlapping, were observed at the northeast end of the holding. These varied from approximately 5 metres diameter to over 10 metres, flat bottomed, of fairly uniform depth at around one metre deep. A second concentration was observed 200 metres to the south (PRN 48298), near to the intersection of a farm trackway. Similar examples have been observed to the south and the north of the holding. A Roman date is probable for these features, which may have been exploited for the construction of Sarn Helen.

The quarries currently lie in rough pasture fields, which are grazed periodically. No specific threats were identified from the current management regime.

Plate 10- looking north over the Roman? quarries (PRN 48297) to the east of Sarn Helen.

The quarries should be retained as historic landscape features. They should not be infilled.
