Troed y Bryn W/12/3304

Tir Gofal Farm Visit Historic Environment Report

REPORT NO. 2003/65
PROJECT RECORD NO. 47188

Troed y Bryn
Tir Gofal Farm Visit Historic Environment Report

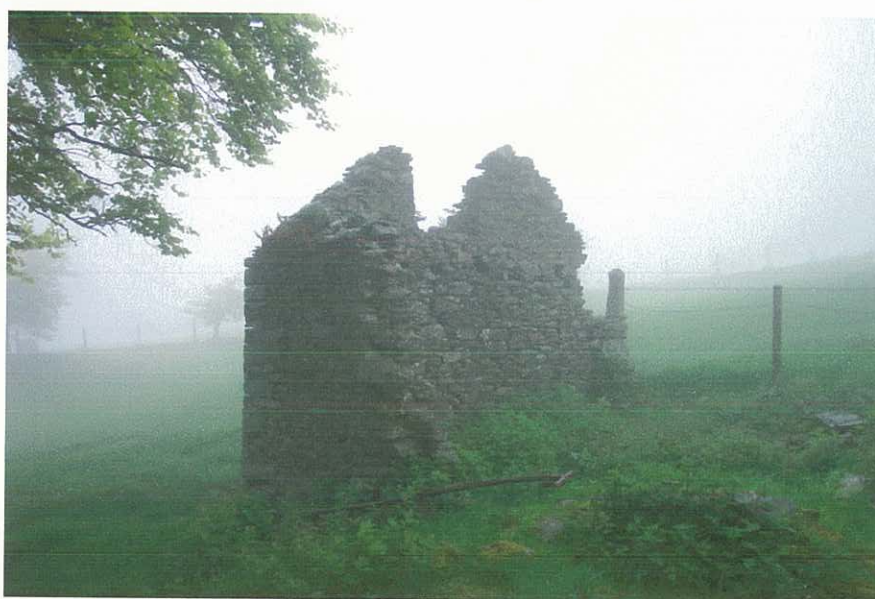
The remains of a small cottage, about 9m x 5.5m. The two gable ends stand to around three-quarter height, but the side walls are completely crumbled. Footings can still be seen for internal walls, and these suggest a simple ground plan, with two rooms divided by a very thick central wall. There is no trace of a chimney in either gable end, which implies that either the fireplace was in the centre of the building – hence the very thick central wall, or that the cottage had a chimney hood at one end rather than an integral chimney. These hoods were normally made of wickerwork and daubed. The cottage is seen on the 1834 Ordnance Survey Old Series map, and the presence of either of these features would imply that it could have been substantially older. Traces of the enclosure which surrounded the cottage can still be seen.

The cottage site is in a good condition. It lies within a pasture field, and is grazed which is ensuring that no scrub is encroaching into the building remains.

Plate 1. *The surviving west gable of the ruined cottage at Pen Lan (PRN 48052)*

The current management regime of light grazing should continue. The presence of clear wall footing suggests that there is excellent potential for buried archaeology to survive. In order to protect this, no further ground intrusive activities should take place within the enclosure.

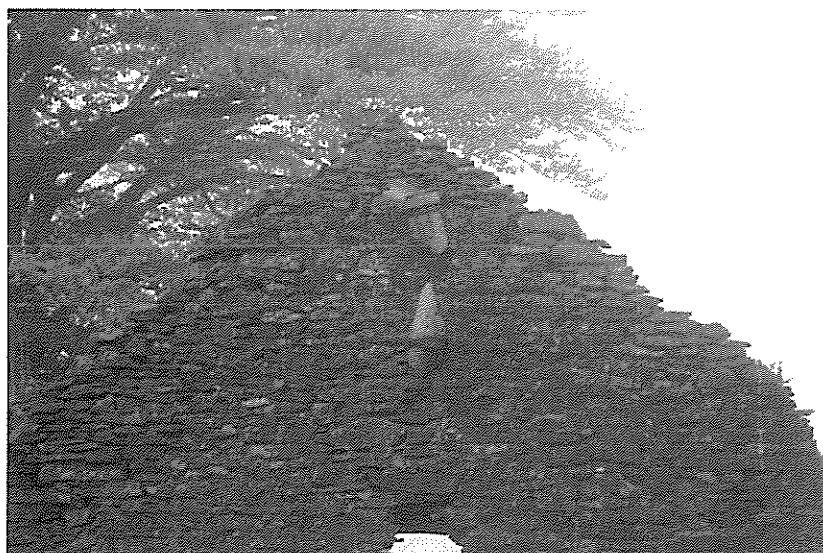
The west gable end of the cottage survives to its full height and suggests that the building was originally two storeyed. The exterior has a clay stove-pipe bracketed to it, with a hole knocked through at the base of the wall, presumably to hold a grate or stove. The east gable is largely crumbled, but the remains of a large fireplace can still be made out. The south elevation of the building does not stand to full height, but does still have a central doorway with a wooden lintel, and window openings on either side. There seem to be no openings in the north elevation. Historic maps date the cottage to at least 1834, and possibly earlier.

The site is in a stable condition, though the interior is becoming overgrown and the tops of the walls are being covered with moss. Several large, mature trees grow near the cottage.

Plate 2: *The west gable of Pant Gwyn cottage site (PRN 48053). The clay pipe bracketed to the wall would have acted as a flue for a grate or stove.*

The site would benefit from being lightly grazed in order to control the undergrowth, and the tops of the walls may need capping to prevent water from penetrating into the core of the stonework. It should be ensured that tree branches do not begin to rub against the stonework, and that any dead branches be removed before they fall into the site.

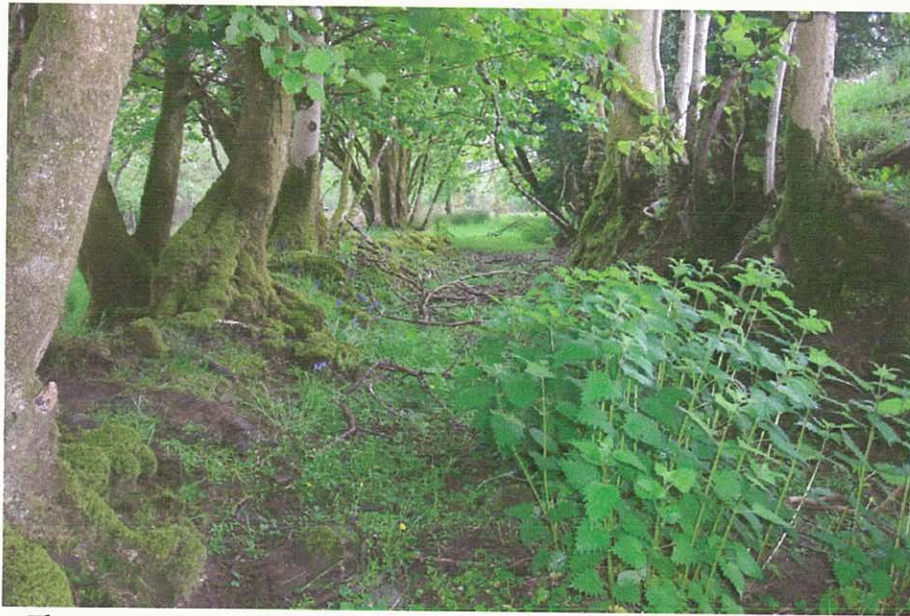
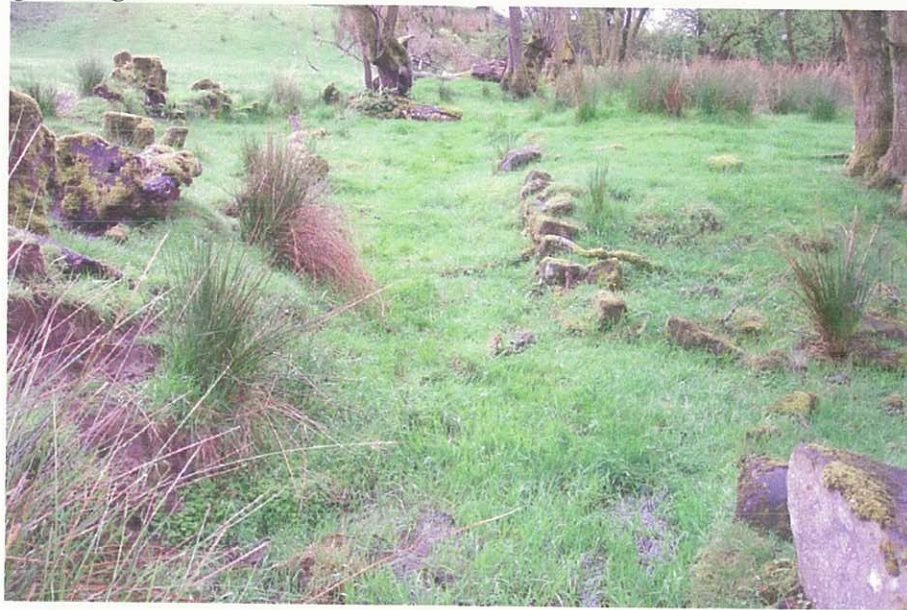
The mill race which served Felin Rhos (PRN 5121). The whole length of the race survives, and for the most part is a clear earthwork with stone walling along parts of the west side. Until recent years the race still carried water, but it is now blocked at both ends.

As the race continues north it becomes more pronounced, and is visible as a clear landscape feature – mostly as a cutting on the east side, and as a stone and earth bank on the west. It is normally between 1m and 2m wide, and in places over 1m deep. The condition varies along the length but it is generally good, with the earthwork being either turf-covered, or with a rocky base. A line of trees run along the east side, and their roots are helping to support the cutting on this side of the race. There are a few points where the ground is wet underfoot, or where the feature has become overgrown.

Plates 3 & 4: *The race survives as a clearly defined earthwork feature, but condition varies along its length. Above (plate 3) the race is marked by tree-lined banks. This is towards its north end. Below (plate 4) the earthwork is more slight and the stone-lining can be seen. This is about halfway along its length.*

As part of the Tir Gofal scheme, the landowner intends to fence out the length of the race, and open it as a permissive footpath. Sections of this feature are already fenced, but at other points new fencing will have to be put in place.

In general, there should be few problems with this scheme, since the anticipated use of the route is light. However, there are a few areas of concern which should be addressed. Firstly, the earthwork should not suffer from erosion caused by walkers. The path will need to be monitored, most notably in the few areas where the ground is wet underfoot. If erosion is a problem, then access to the path may have to be seasonal, in order to prevent damage during wet weather. It should also be ensured that the path runs along the base of the mill race, and that erosion is not caused to the bank on the west side. Some vegetation clearance will need to be undertaken in places too, in order to make sure that the base is always passable and walkers do not need to use the banks. Vegetation should be cut at ground level and removed, never dug or dragged out.

If the mill race is to be completely fenced out from grazing, then a routine of scrub clearance will also become necessary to prevent invasive species like gorse and bramble from getting a foothold. Occasional light grazing may prove the most practical way to achieve this.

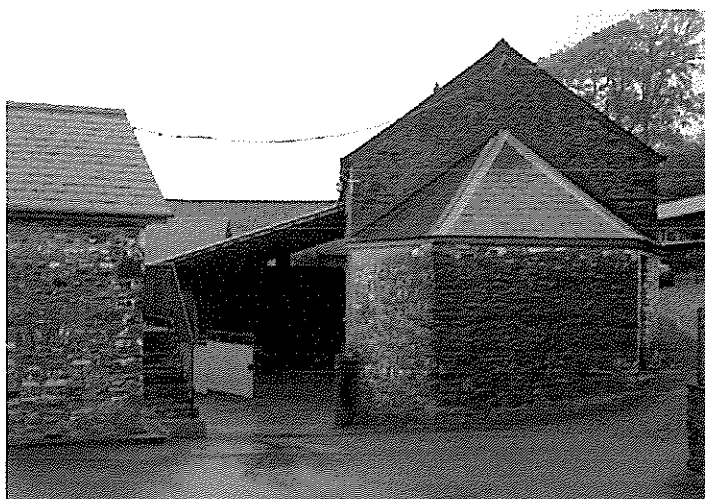
A small, half-hexagonal building appended to the south gable of the barn (PRN 48059). It has a cobbled floor and is slate roofed and stone-built, like the other buildings in the farmstead. The function of this building is unknown, but it is likely that it was deliberately designed to be decorative.

Plate 6: *This small, three-sided building (PRN 48058, right of picture) was probably at least partially designed to be decorative.*

The building is in good condition and has been re-slatted fairly recently. Future maintenance should ensure that materials and techniques are used which match the original construction. The cobbled floor should be preserved.

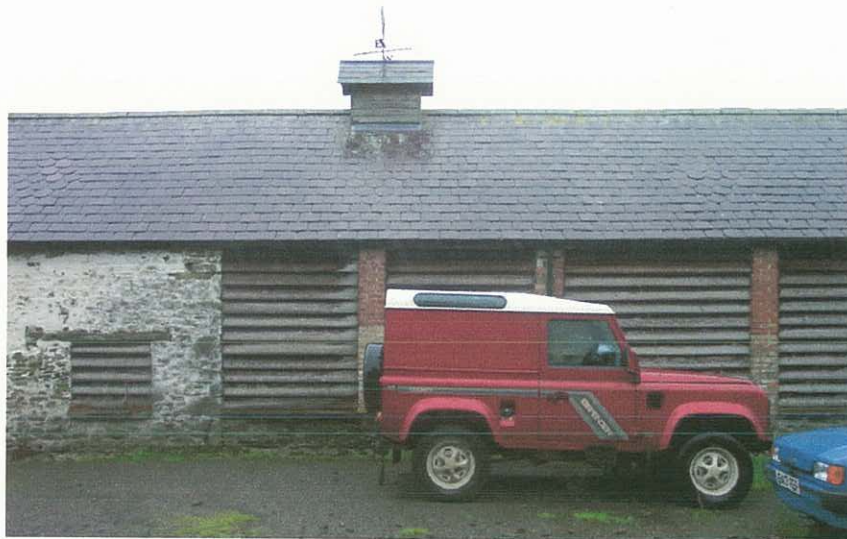
This building is generally in a stable condition. The landowner has already carried out sympathetic restoration of the granary walls, and has re-slatted the whole length of the building. However, not all the floorboards in the upper storey are sound, and a modern lean-to style extension has been added to the west side of the building, creating a kind of covered yard between the barn and the stables (PRN 48060) and cowshed (PRN 48061).

Plate 7: *The east elevation of the combination farm building (PRN 48059). To the right of the picture are the wooden slat sides of the granary. To the left, the stone wall of the threshing barn. These stand above a cartshed (later used as a cowshed) which is terraced into the hillside and accessed from the west side. The small 'turret' and the weathercock are decorative finishing features, typical of this kind of well-designed estate farm.*

This building is an ideal candidate for building restoration works, especially since the landowner has already carried out a substantial amount of work. The floorboards upstairs need replacing, as do the internal doors. On the west side of the building, several of the wooden slats are missing, and these should be replaced. It was unclear whether this was a work which was currently in process, since there was a scaffold tower against the west elevation.

The landowner has expressed an interest in removing the modern extension, and uncovering the central farmyard. This would be very welcome, and would restore the integrity of the original, planned farmyard. However, great care would have to be taken that in removing this extension no original masonry was damaged.

The future maintenance and restoration of this building should use materials and techniques which match the originals as closely as possible.

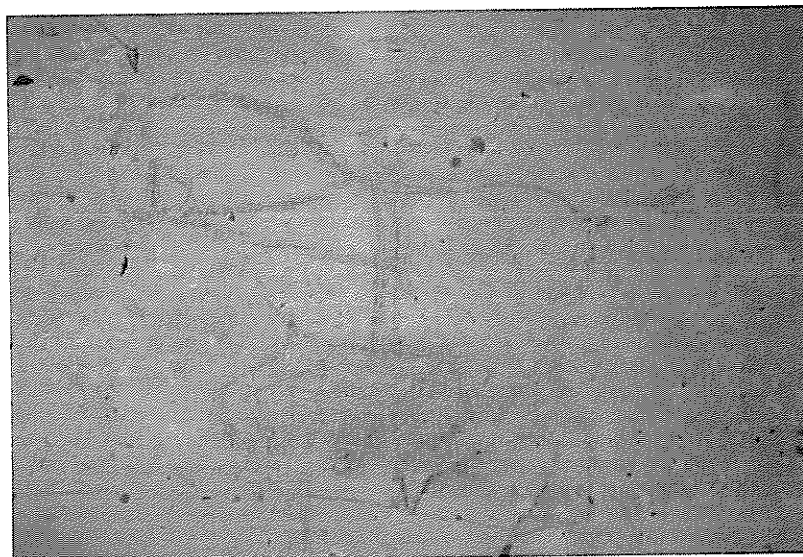
In common with the rest of the farmstead, this building has been recently re-slatted, and is in a fair condition.

Plate 8: *One of the pencil sketches on the internal plaster of the stables (PRN 48060).*

The landowner has expressed an interest in removing the modern extension, and uncovering the central farmyard. This would be very welcome, and would restore the integrity of the original, planned farmyard. However, great care would have to be taken that in removing this extension no original masonry was damaged.

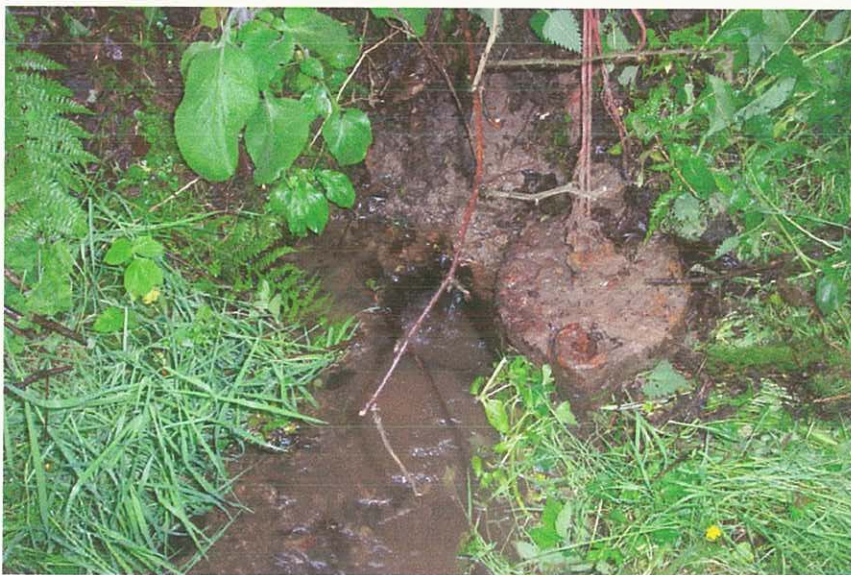
A roughly oval pond, about 25m long, with an iron plug in the west side. The landowner informed Cambria Archaeology that this pond used to provide power for a water wheel which powered a threshing machine, used until around the 1920s. The wheel pit still survives (PRN 48063). The pond apparently had timber-faced sides, but there is no sign of these now. The plug is in a good condition, and can still be used to control the water level in the pond. The water from here drains into a culvert which runs under the whole farmstead, and would probably have been used to flush away farm waste.

The pond is now overgrown, but the banks seem to be in good condition.

Plate 9: *The iron plug which controls the flow of water from the pond (PRN 48062) into a culvert which runs under Troed y Bryn farmstead.*

Some vegetation control should take place around the edges of this pond, in order to maintain access to it. Larger shrubs and saplings on the banks should be cut back and removed so that the pond does not become completely choked with vegetation. It is important that the pond is not allowed to silt up, since this would block the culvert and drainage system. No damage should be done to the banks in the process of any cleaning, maintenance or restoration works, and no ground intrusive activities should be carried out in or immediately around the pond.
