Abersannan W/12/3319

Tir Gofal Call-Out Visit Report

Report No. 2003/82
Report Prepared for:
Countryside Council for Wales

Abersannan
Tir Gofal Farm Call-Out Visit Report

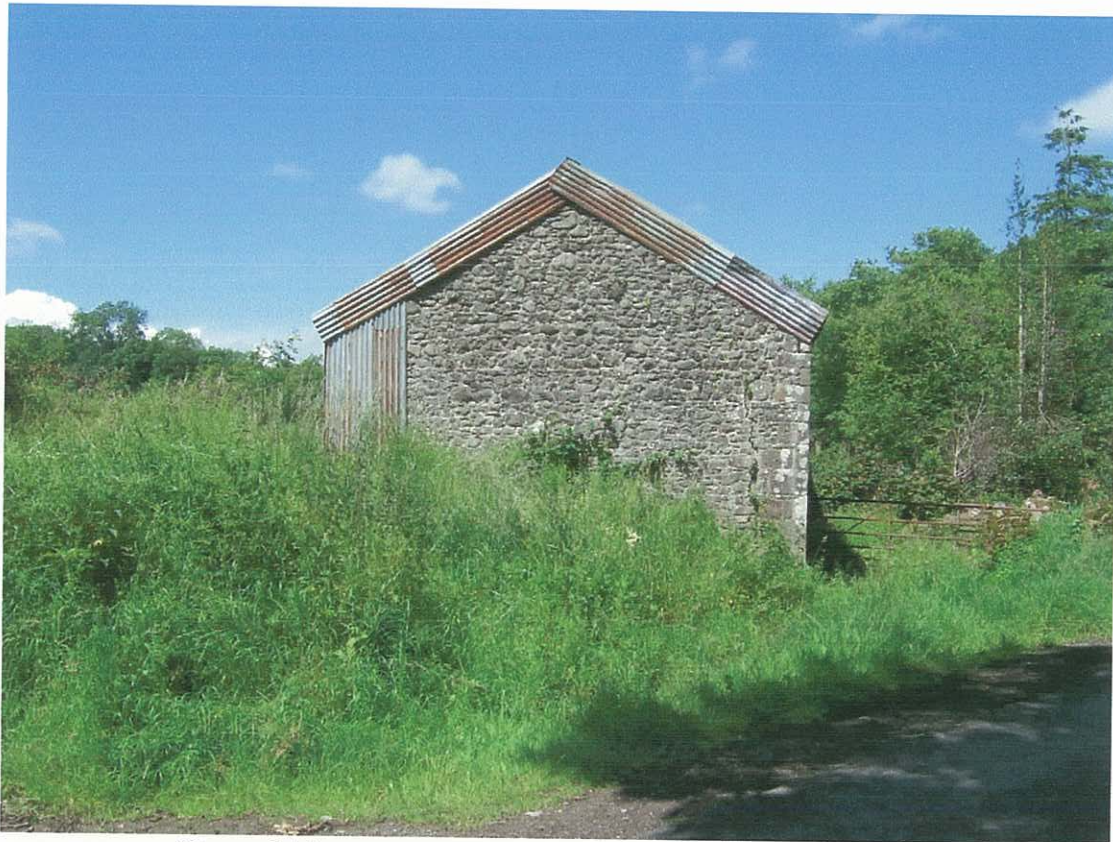
View of Abersannan Woollen Factory, seen from the road.

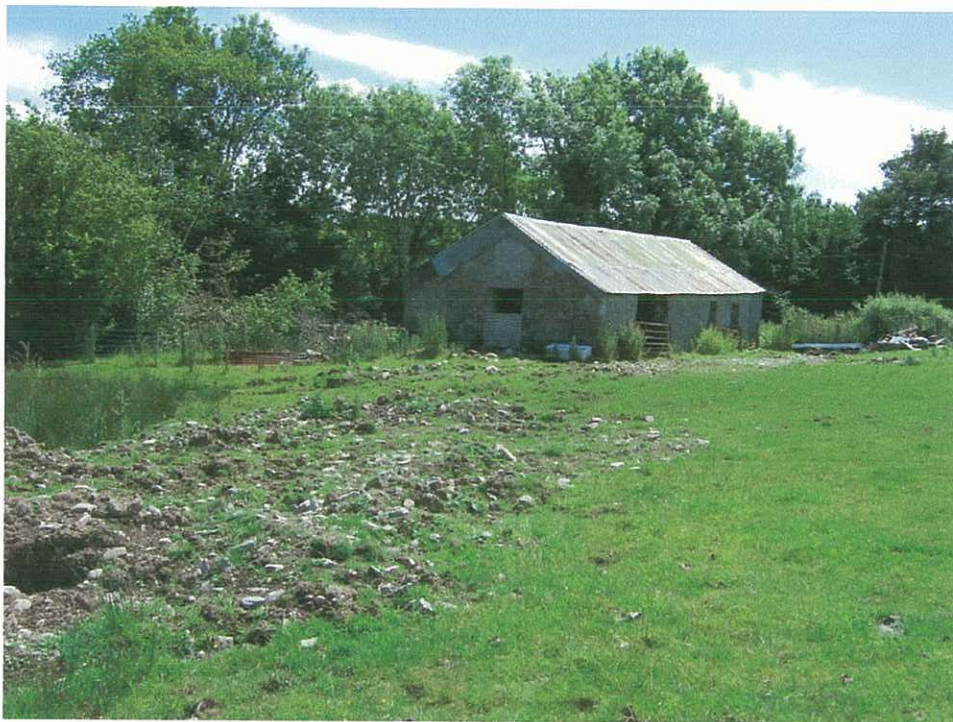
The mill survives as a single-storey rectangular building by the side of Afon Sannan. It is about 17m x 6m, with three doors in the west wall and four windows (one of these is now blocked) in the east wall. A further door is in the north gable. All of these openings have wooden lintels, most of which were put in place by the current landowner using timbers from the original, collapsed, roof structure. The large amounts of doors and windows point to this being a purpose built woollen factory rather than a re-used building since a good light source was essential for cloth manufacturing.

Plate 1. *View of the woollen mill, seen from the north.*

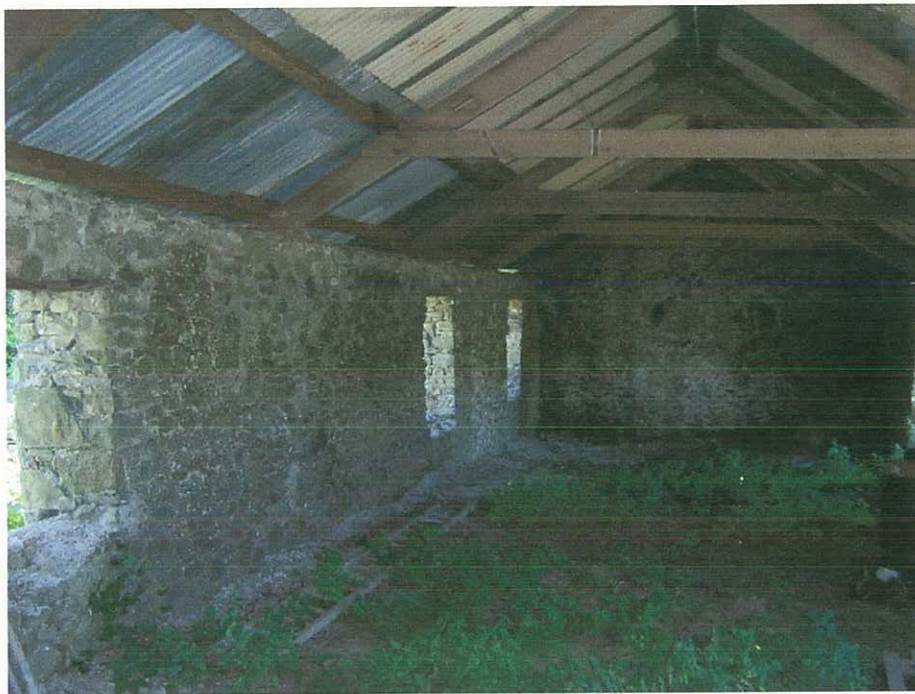
Plate 2. *View of the interior of Abersannan Woollen Mill. There is a fourth window, now blocked, in this east wall. The lintels above the windows and doors have been added by the current landowner, using timbers from the collapsed roof.*

In general, the site is in a good, stable condition. The current landowner has done a large amount of restoration work, re-building the tops of the walls and filling in gaps in the stonework. He has also re-roofed the building with corrugated iron sheeting, and it is now weatherproof. However, there are problems with the building which may need addressing in the future. There are several large, structural cracks in the north gable wall, and the very tops of both gable ends are missing.

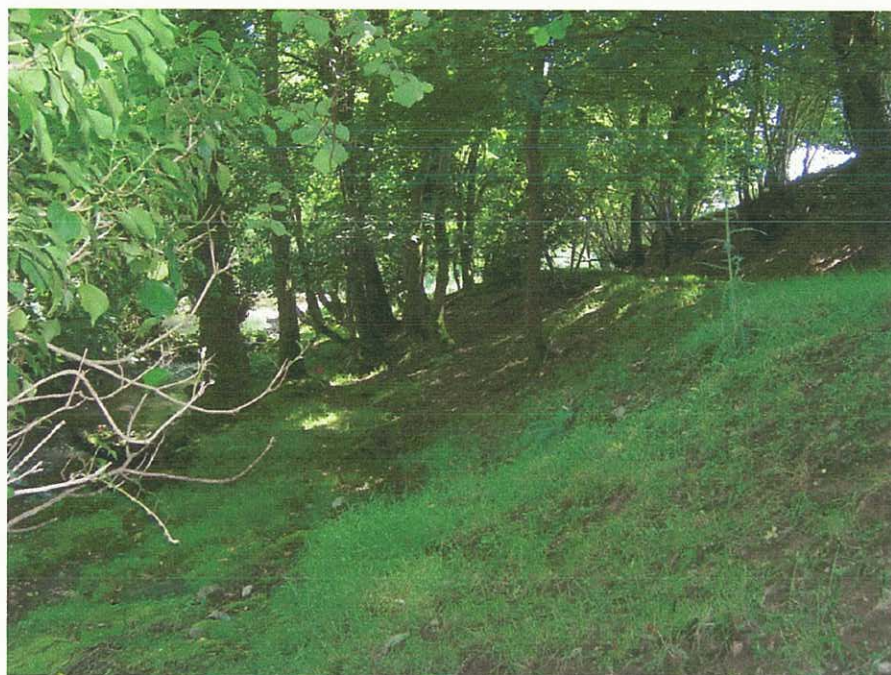
Leading away to the north of the mill is a very slight, linear earthwork which marks the remains of the mill race. The line of the race is discernible as it crosses the field, and then passes into woodland by the side of the river. Here the race is clearly visible as a flattened terrace, running parallel with, but above the river. In some places the terrace is preserved well enough that both a sunken channel and a raised path next to it are visible. Further north the terrace becomes lower and less pronounced, until the race is being carried along the base of the slope next to the river. The point at which the race joins with the river is not clear. A short length of channel cut into rock next to the river may be the only remains of a weir which is marked on the 1st and 2nd edition Ordnance Survey maps.

Plate 3. *The line of the mill race shows as a clear terrace on the hillside which runs parallel to the river but at a higher level. The terrace for the race is on the right of this picture, and the river is at the base of the slope on the left.*

The southern portion of the mill race is under pasture. Light grazing will not damage the site, but grazing may need to be controlled in wet weather to ensure that there is no erosion of the turf covering. The northern portion of the race, in the woodland next to Afon Sannon, seems to be under no immediate threat. However if the woodland is not going to be grazed this may, in time, prove a problem, allowing vegetation to become established across the earthworks. The most practical way of preventing this may be to use temporary electric fencing to occasionally allow light grazing of the earthworks. This would have to be undertaken in discussion with the Tir Gofal project officer.

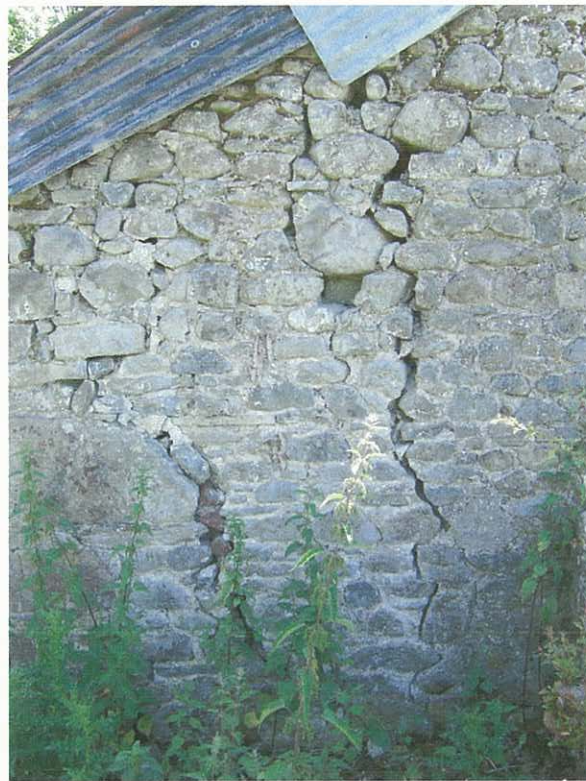
Plate 4. *The north gable of the mill shows serious structural cracks which need to be monitored.*

Although the main mill building is in a stable condition, there are some problems which will need to be addressed. The landowner informed Cambria Archaeology that the large cracks in the north gable have not widened in the past few years, but these should continue to be monitored. If they do begin to move, then it will become necessary to look into the possibility of using a metal tie or other methods to stabilise the building.

Future consolidation and restoration works should use materials which are sympathetic to the original fabric of the building. At present, the landowner is re-using fallen stone to carry out repairs, and this is something which is to be encouraged. If possible, future maintenance should use a lime mortar, matching the one which was used in the original construction, and the tops of the gable ends should ideally be re-built to prevent water from penetrating into the wall core.
