GWARNOETHLE

Tir Gofal Farm Visit Historic Environment Report

REPORT NO. 2003/105
PROJECT RECORD NO. 47200

Gwarnoethle
Tir Gofal Farm Visit Historic Environment Report

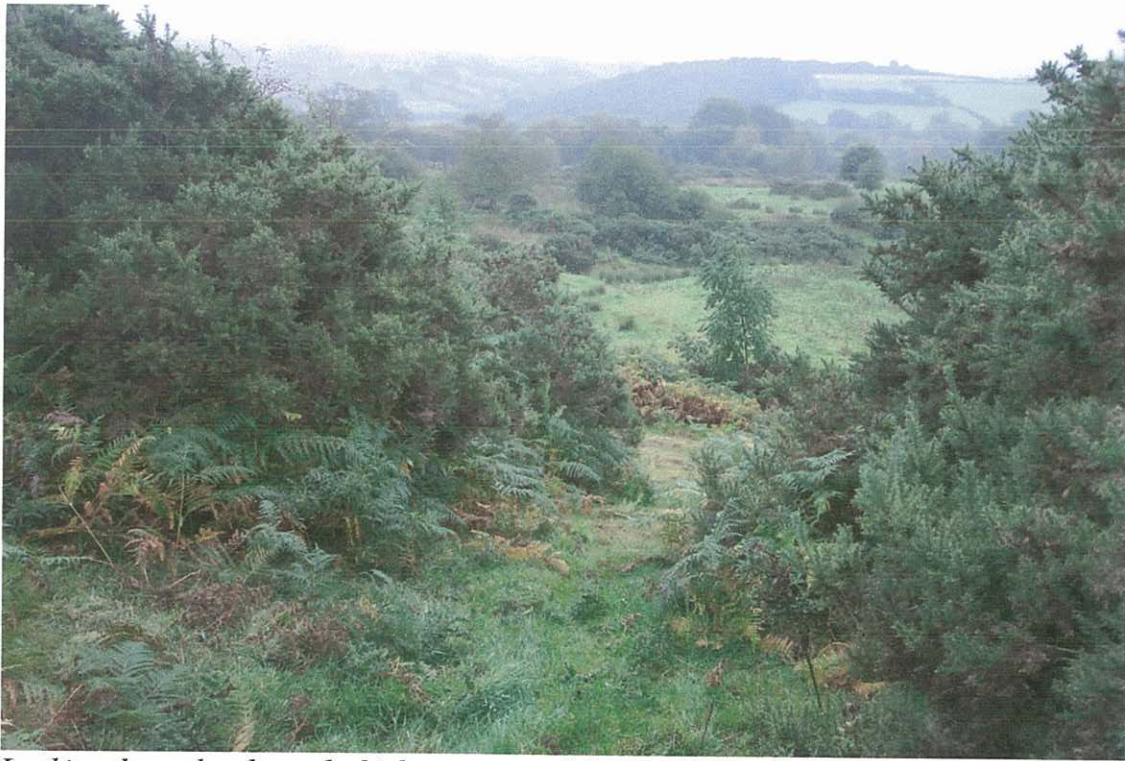
Looking down the channel which runs east of the Roman water tank (PRN 49148).

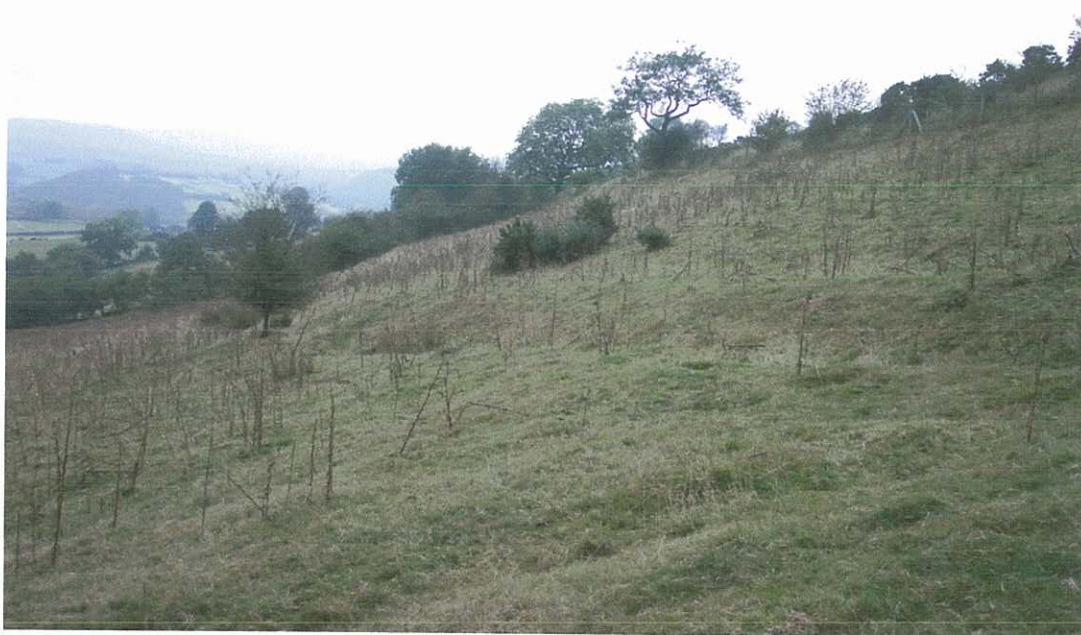
In general this part of the feature is in fair condition, but there are a few specific areas of concern.

Plate 1 (above) *Part of the Scheduled section of the Annell Leat (PRN 8882, SAM Cm210). The leat survives as a clear earthwork running around the contour of the hill.*

The scrub and bracken at the southwest end of the Scheduled area is obscuring the visibility of the site, and the roots will also cause damage to the relatively slight earthworks. This vegetation should be cut at ground level and removed. Great care should be taken not to damage the ground surface – the works should only be carried out when conditions are dry, and roots should not be dug or dragged out.

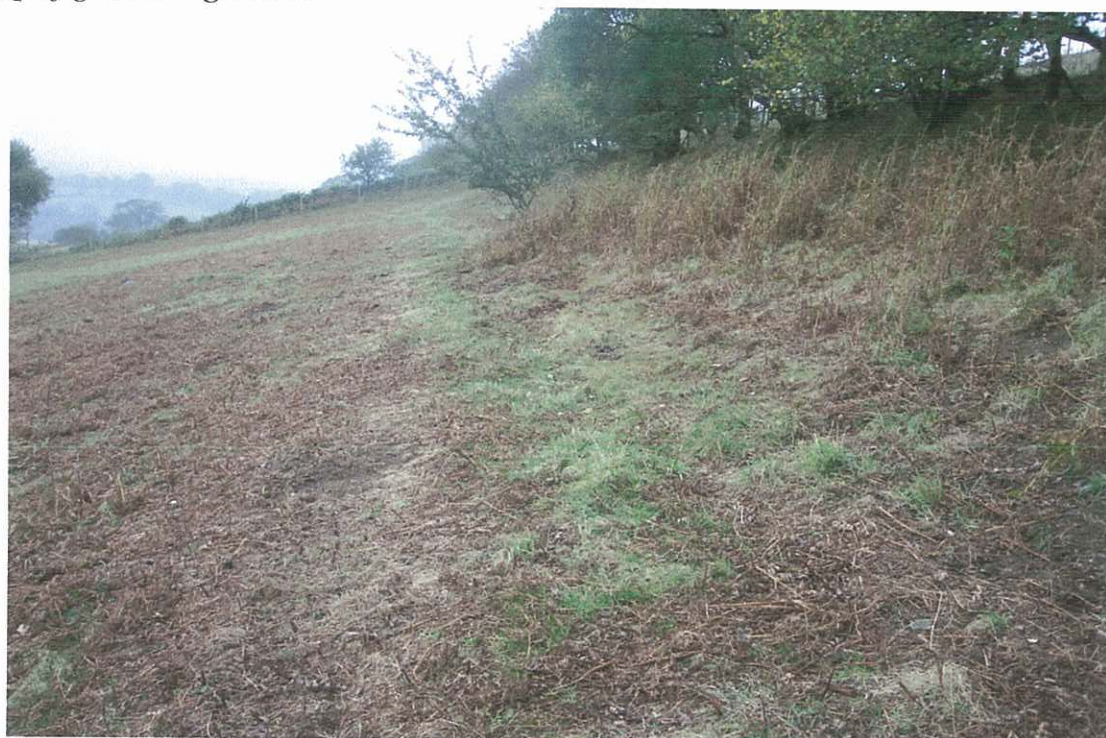
The projected line of the Roman Annell leat, continuing from the Scheduled section to the north. The southern part of this feature is not visible on the ground, partly due to scrub and bracken growth. Recent bracken clearance had revealed clearly the earthwork of the leat further north, two fields south of the Scheduled Area. The earthwork there is in a good, stable condition, and it is likely that further physical remains may survive.

Plate 2 (below) *Another section of the Annell Leat. This area is not Scheduled, and was only revealed by recent bracken cutting. The leat survives as a slight terrace, visible in the picture as a strip of greener vegetation.*

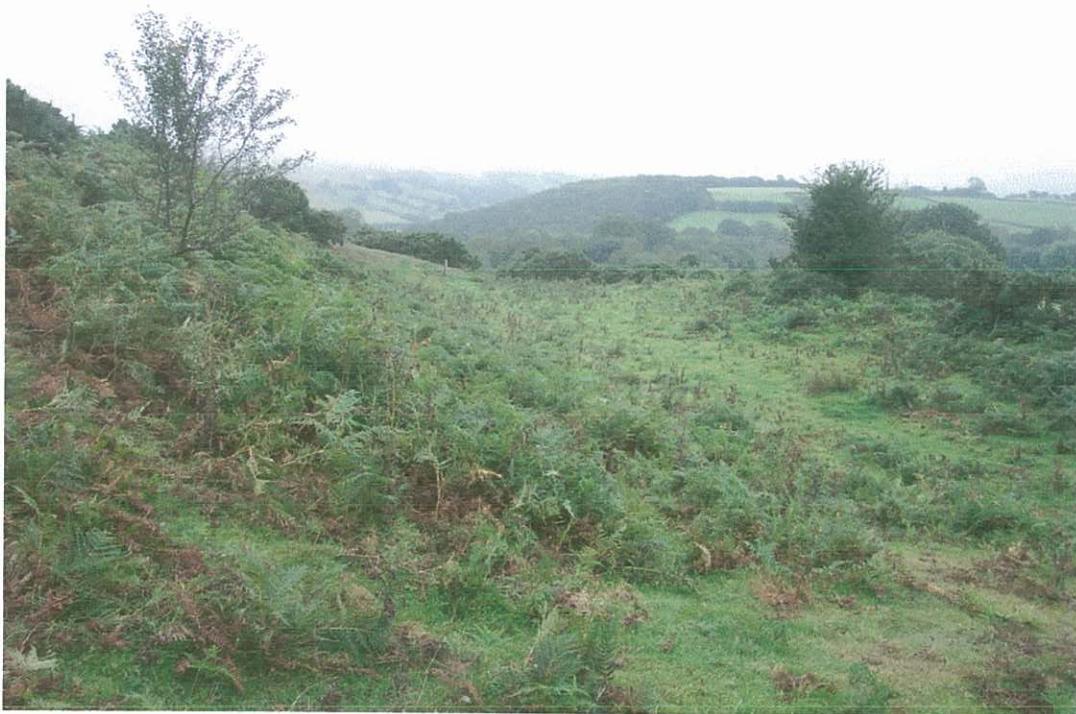
The tank is in a stable condition, but the site is somewhat overgrown. There is substantial gorse and scrub growing on the outer (down-slope) bank and another heavy patch of gorse to the northeast, above the tank. The interior of the tank is quite clear, as is the exit channel to the east. However, where the rock sides are exposed, the channel is vulnerable to erosion, and one corner of the rock is already split and becoming softer and more flaky.

Plate 3 (above) *The large tank (PRN 49148) at the end of the Cothi Leat (PRN 1947). To the left of the picture(upslope) the tank is terraced into the hillside. The flattened area is the silted up interior of the tank whilst the upturned 'lip' at the right of the picture is a massive bank forming a revetment wall.*

However, great care should be taken that the ground surface is not damaged during these works, and they should only be carried out when conditions are dry. This will need to be done as a matter of some urgency, before the scrub becomes so established that its removal inevitably causes erosion of the topsoil.

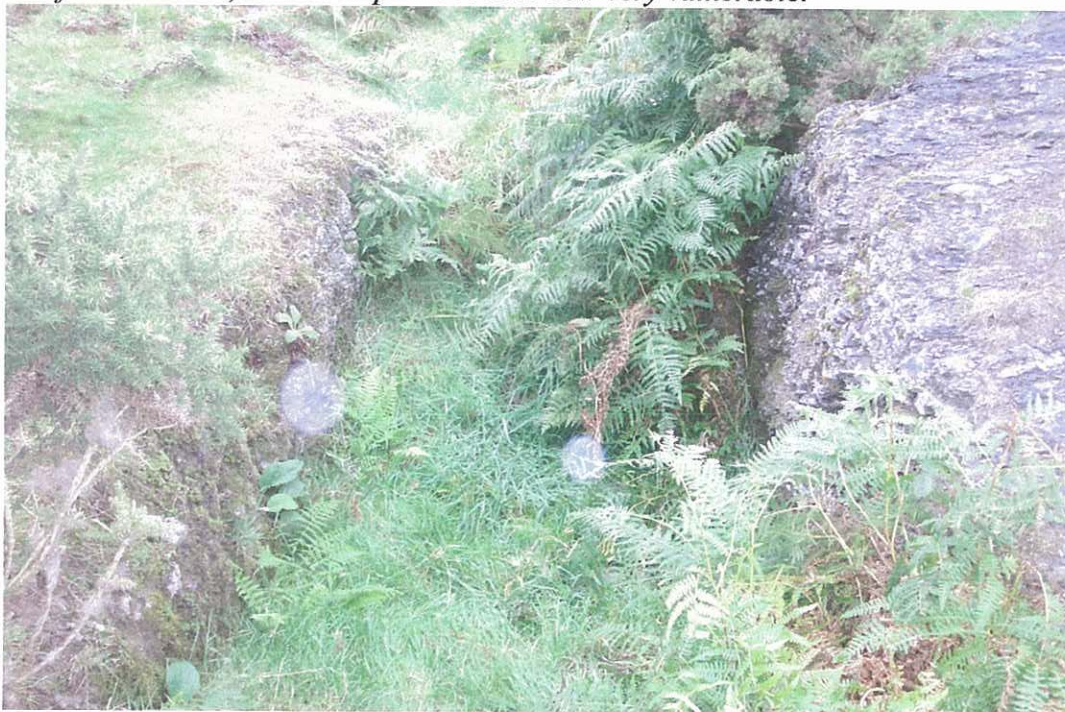
Plate 4 (below) *The exit channel to the east of the tank. Previous excavations revealed the rock-cut sides of this channel, and the exposed rock is now very vulnerable.*

The exposed rock of the channel is potentially vulnerable to damage, and great care should be taken not to knock or damage this area whilst clearance is being carried out. It may be advisable to temporarily mark out the area with high-visibility tape or meshing during works on the tank.

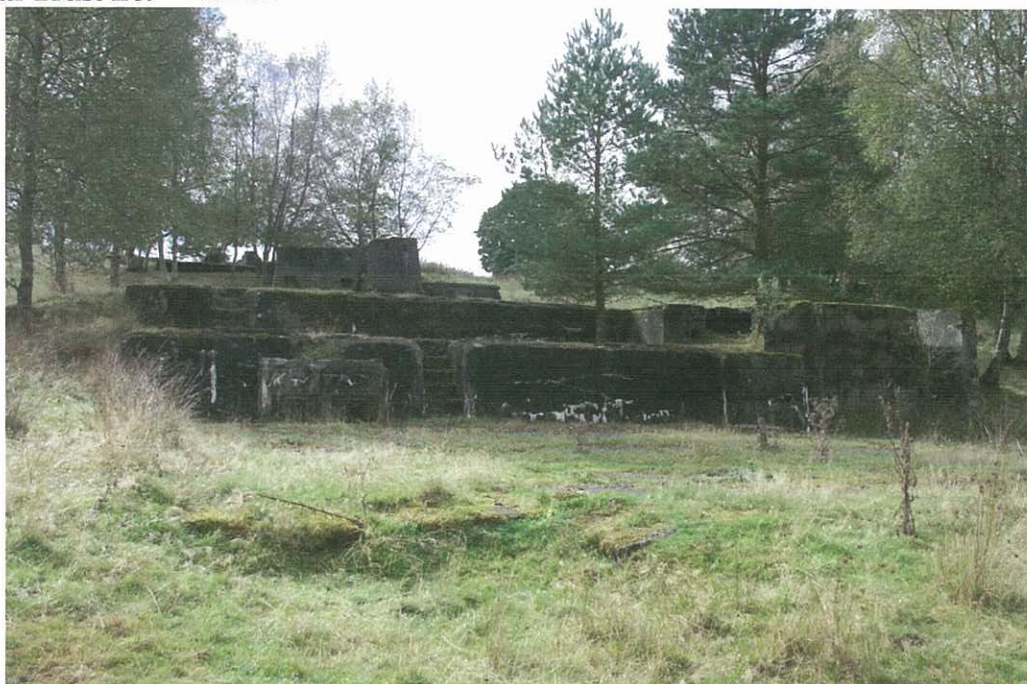
Plate 5 Concrete footings and plinths for machinery – all that remains of the final stage of ore processing at the British Goldfields processing mill (PRN 20429). These are the foundations of the ball mill (PRN 49152)

In general, the site is very stable, and what remains now is that which was left after demolition of the mill and removal of the machinery. A few saplings are growing within the structure itself, and these should be cut down before the roots begin to damage the concrete. Regular light grazing of the site will help to ensure that there is little or no regrowth.

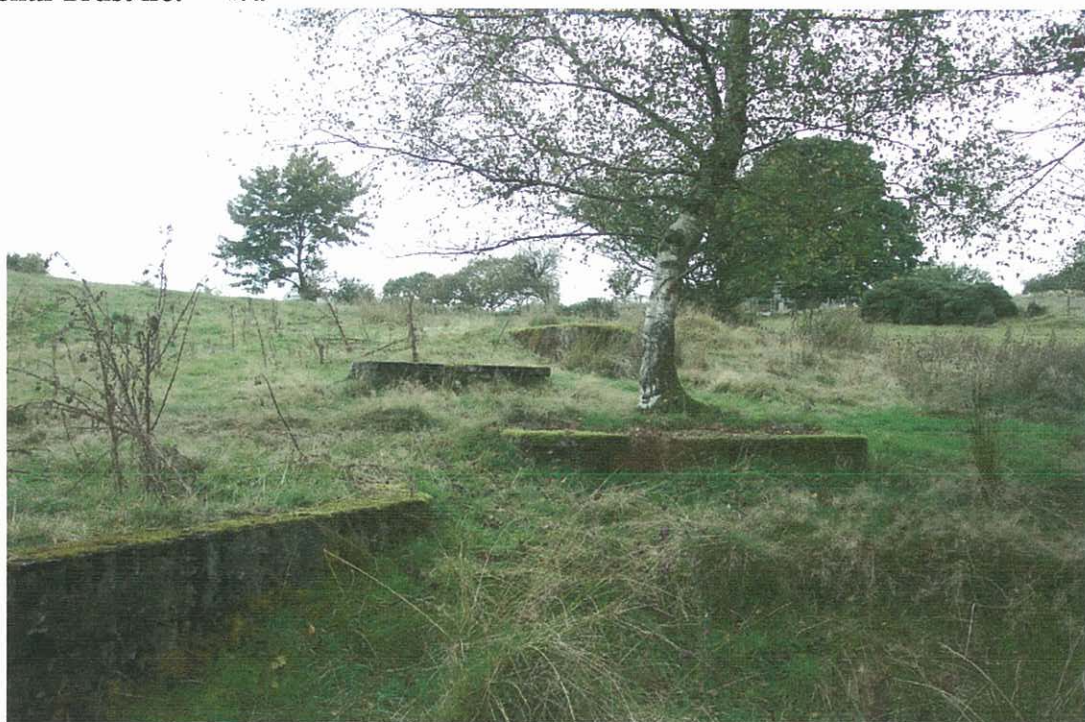
These plinths are some of the most vulnerable of the structural elements on this site. Where the plinths are not capped with cement, water is penetrating into the mortar and weakening the structure. The bricks are also more vulnerable to damage by vegetation and tree-roots than other concrete structures are.

Plate 6 *Part of the route of the conveyor belt (PRN 49153). This picture is looking from the ore bin (PRN 49155) towards the tippler (PRN 49156).*

Vegetation should be kept clear of these sites in order to ensure that they remain visible and are not damaged by roots. Any vegetation growing in or around the plinths should be cut back to ground level. Regular light grazing should help to discourage re-growth. Consideration should be given to capping the exposed plinths with cement, to prevent further water penetration. If this is to be carried out it should be ensured that the cement used is matched to that found on some of the other plinths.

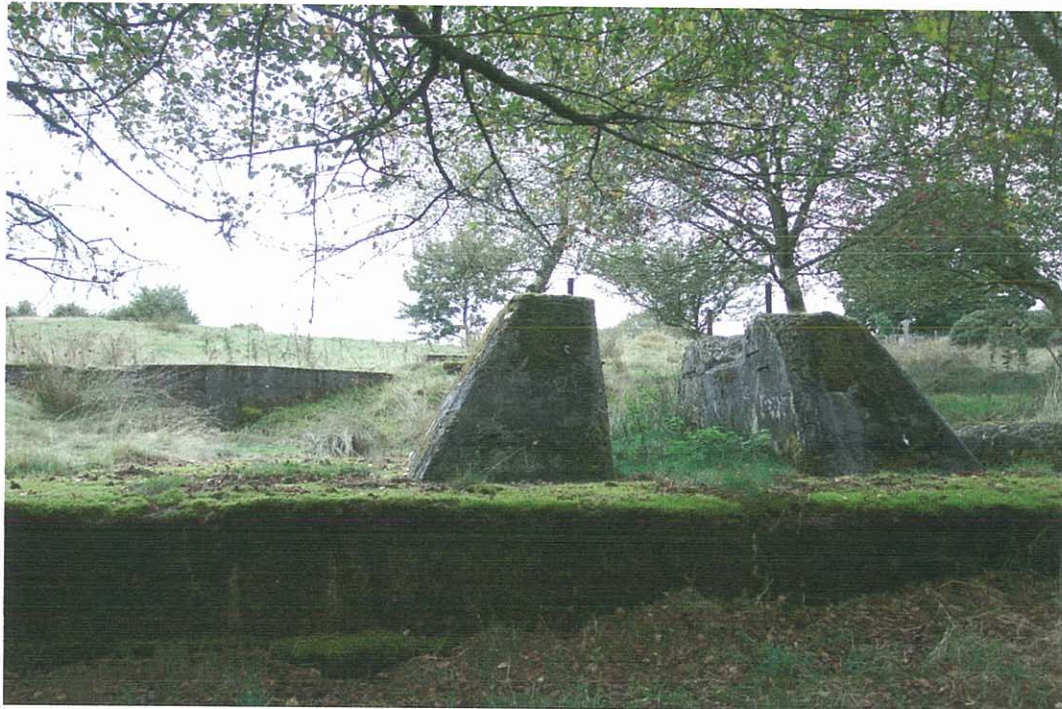
Plate 7 *The concrete supports for the gyratory crusher (PRN 49154).*

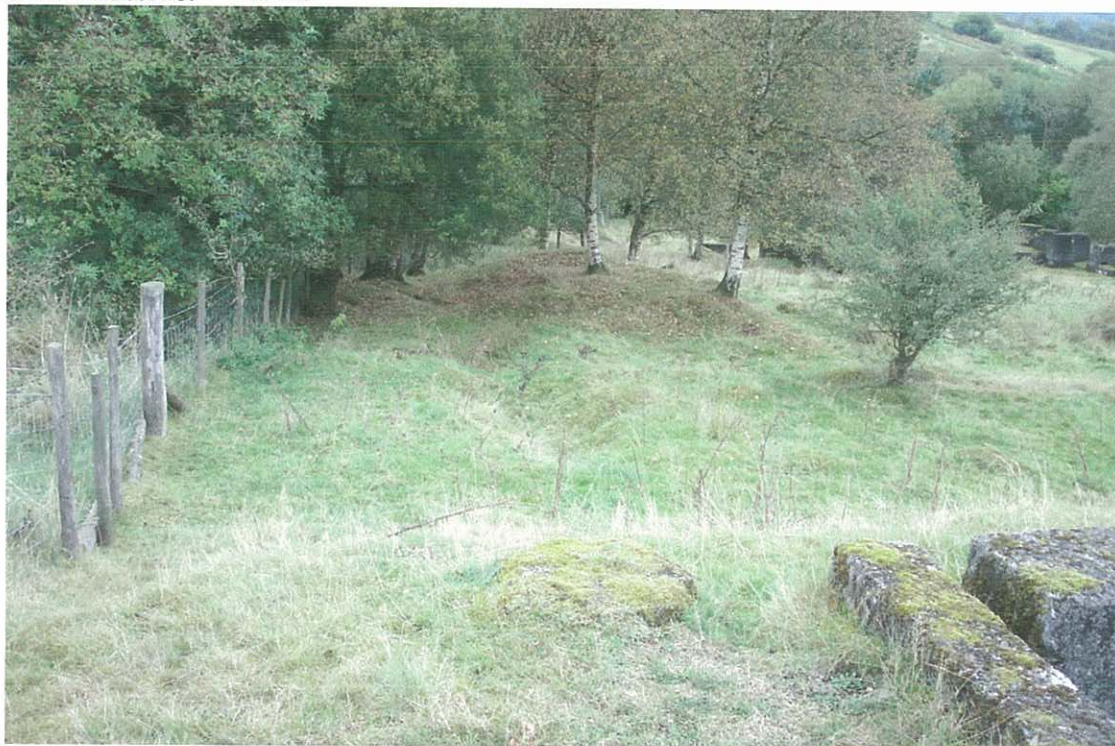
Plate 8 View from the tippler (PRN 49156) down a small gully to the spoil heap (PRN 49157). The whole field containing the 1930s processing site (PRN 20429) is littered with similar small earthworks connecting different parts of the machinery. They are not yet properly recorded or understood.

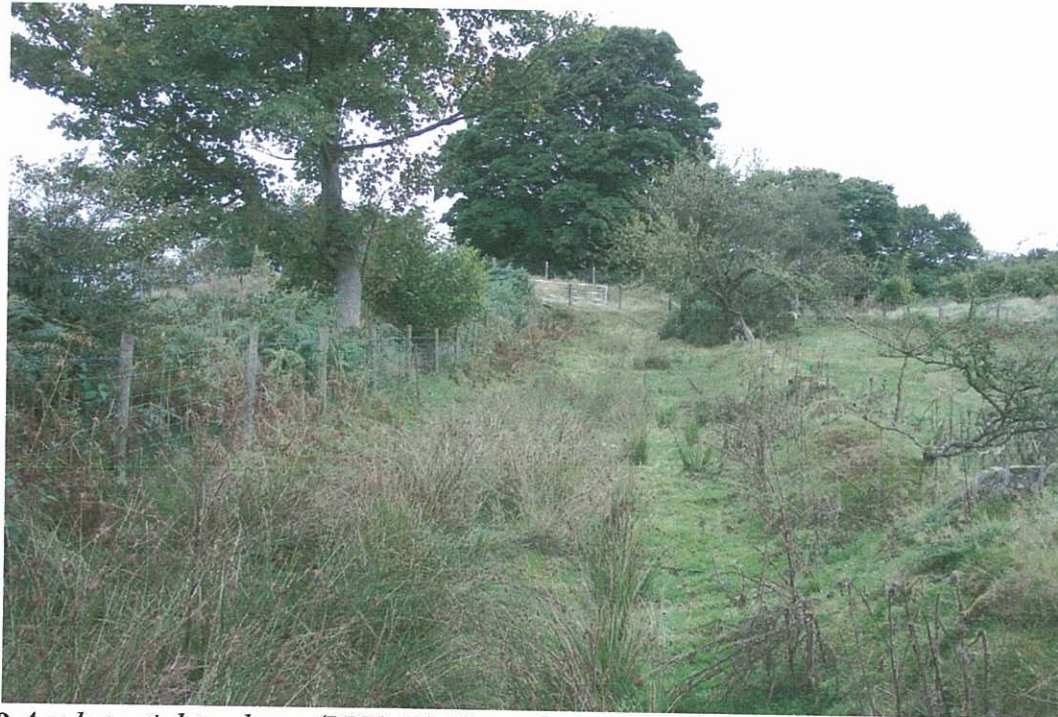
Plate 9 A substantial trackway (PRN 49164) marked on the 1st and 2nd edition Ordnance Survey maps.
