**ARCHAEOLOGICAL WATCHING BRIEF ON THE  
SCRAPING AND RELINING**

**WATERMAINS**

**FROM PONTRHDYGROES TO CWMYSTWYTH,  
CARDIGANSHIRE (CON 9407)**

NOVEMBER 1994

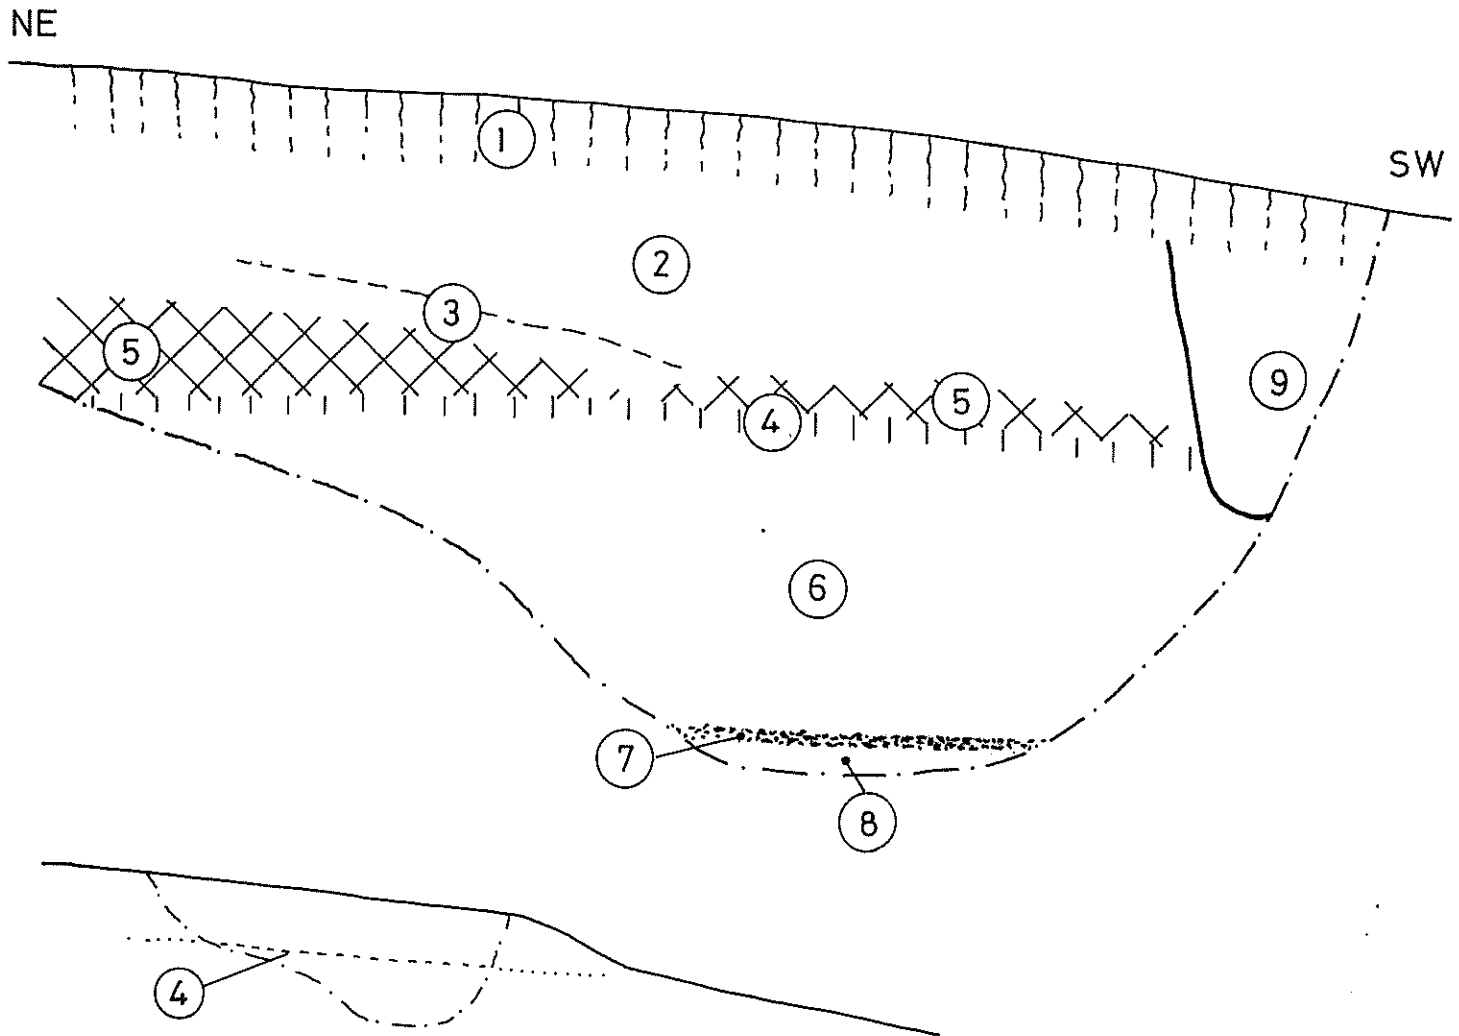
# TRENCH 1 · SE FACING SECTION · 1:20

Trench 1 (Figure 1), located on the edge of a terrace created for a carriage drive, was of greater interest. It comprised a pit 3.5m by 1.2m and 1.8m deep with a SE facing section composed entirely of man-made deposits. These consisted of:

1. Topsoil. A dark brown silty loam about 20cm thick.
2. Layer of shattered shale fragments and gravel in a matrix of dark brown silty-loam. This layer seems to consist of a mixture of subsoil and topsoil - a dump of material to create the terrace for the carriage drive.

3. Layer of fine gravel. This is really a lens within 2, but its angle of rest indicates that it and 2 were deposited from the NE.
4. A 5cm thick layer consisting of a silty-clay loam with a small percentage of small stones and charcoal specks. This seems to be a thin buried soil or turf line.

5. A band, up to 20cm thick, of grey-white crushed mortar with some shattered stone fragments. This has the appearance of being a demolition layer deposited after the removal of larger reusable stones.

6. A thick, 0.8m, layer of banded gravel ranging in size from the very fine (2-3mm) up to shattered shale of 5-6cm and varying in colour from orange to olive brown. This layer has the appearance of a undisturbed fluvio-glacial deposit but the presence of layer 7 below it clearly demonstrates that it was laid down by man in recent times.

7. A thin layer of charcoal. The charcoal seemed to consist of hardwood, not oak, twigs and branches up to 4cm dia-

meter. Also present were what appeared to be small fragments of degraded mortar and a iron object, possibly a nail.

8. Gravel, orange brown in colour, possibly the undisturbed geological subsoil.

9. Trench for a modern drainage pipe.

The exposure in Trench 1 is of interest as there seems to be two phases of construction present over an original ground surface at an unknown depth though perhaps at about the level of layer 7. Phase 1 consists of the charcoal deposit over which the massive dump of gravel, 6, was laid. A thin soil, 4, had formed over this gravel. This soil is at approximately the same level as the ground surface to the SW (see sketch section). Phase 2 comprises a dump of demolition material, layer 5, and a gravel deposit, layers 2 and 3. Clearly the purpose of this dump was to create the terrace for the carriage drive. In Trench 2 it would appear that the geological deposits have been cut into in order to create a terraced area. It is probable that the gravel deposits quarried here were redeposited in the area of Trench 1. The source of the demolition layer 5 in Trench 1 is unknown.

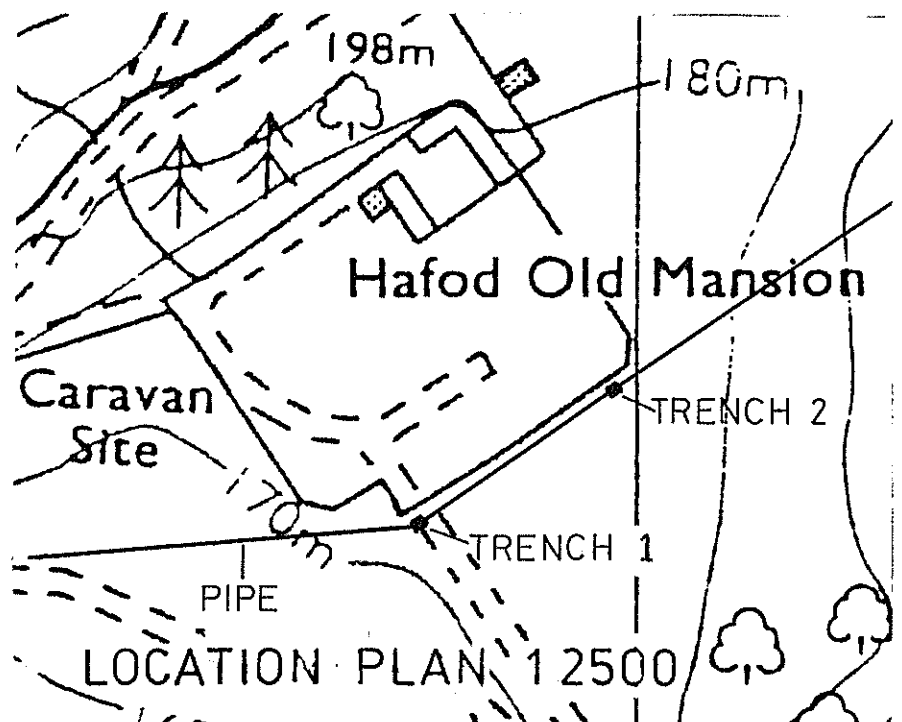
SKETCH SECTION

Figure 1. Location map showing location of trenches near  
Hafod mansion, Section of Trench 1, Sketch section of  
showing position of Trench 1.
