# **Excavations at Carmarthen Greyfriars 1983-1990**

**TOPIC REPORT NUMBER 3**

## **THE STRUCTURE AND DEVELOPMENT OF THE FRIARY BUILDINGS**

**TERRENCE JAMES**

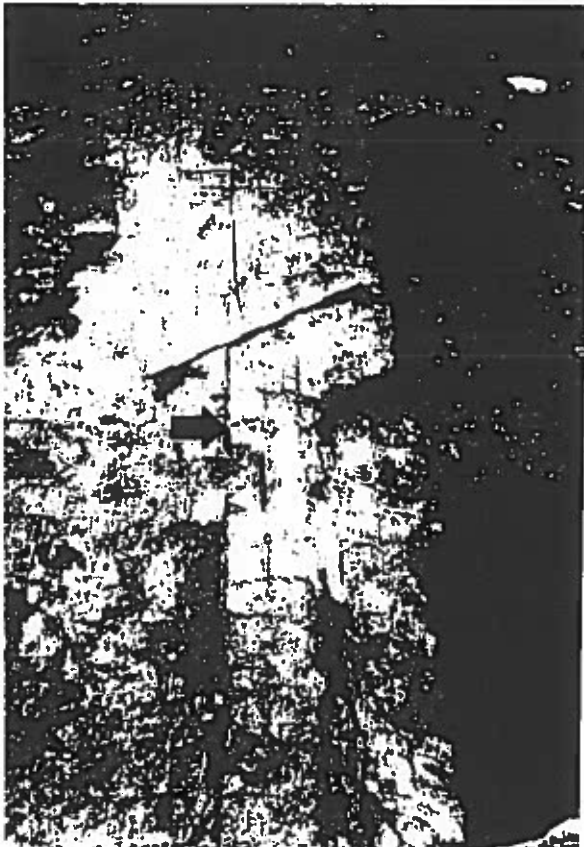
Plate 2.6. The straight line of tile impressions in layer 1861. In one area it is possible that the tiles had been lifted for the excavation of grave 1899 and then relaid, forming a break that can be seen here (arrowed).

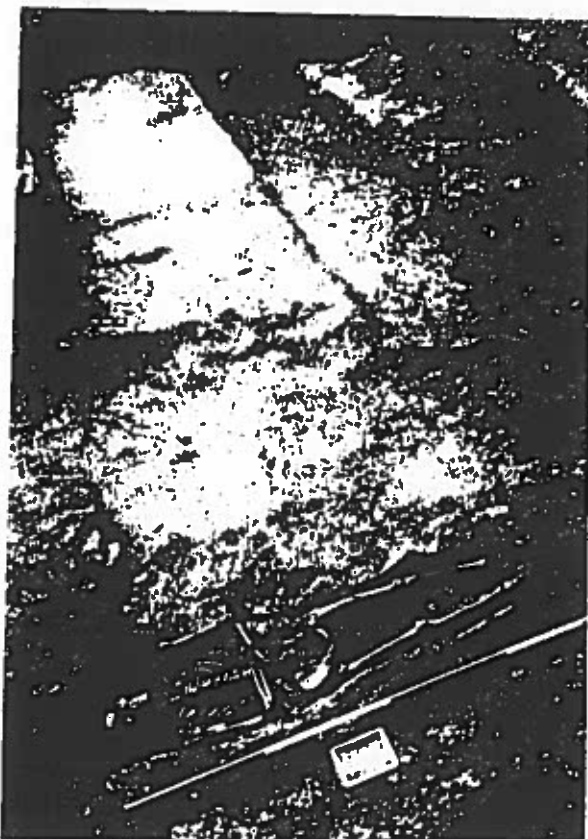
*Plate 4.5. B2, the East Cloister Alley looking NNE. The very base of NS wall lines 722 and 948 just survived the destruction of Civil War ditch 500. So also did a number of graves.*

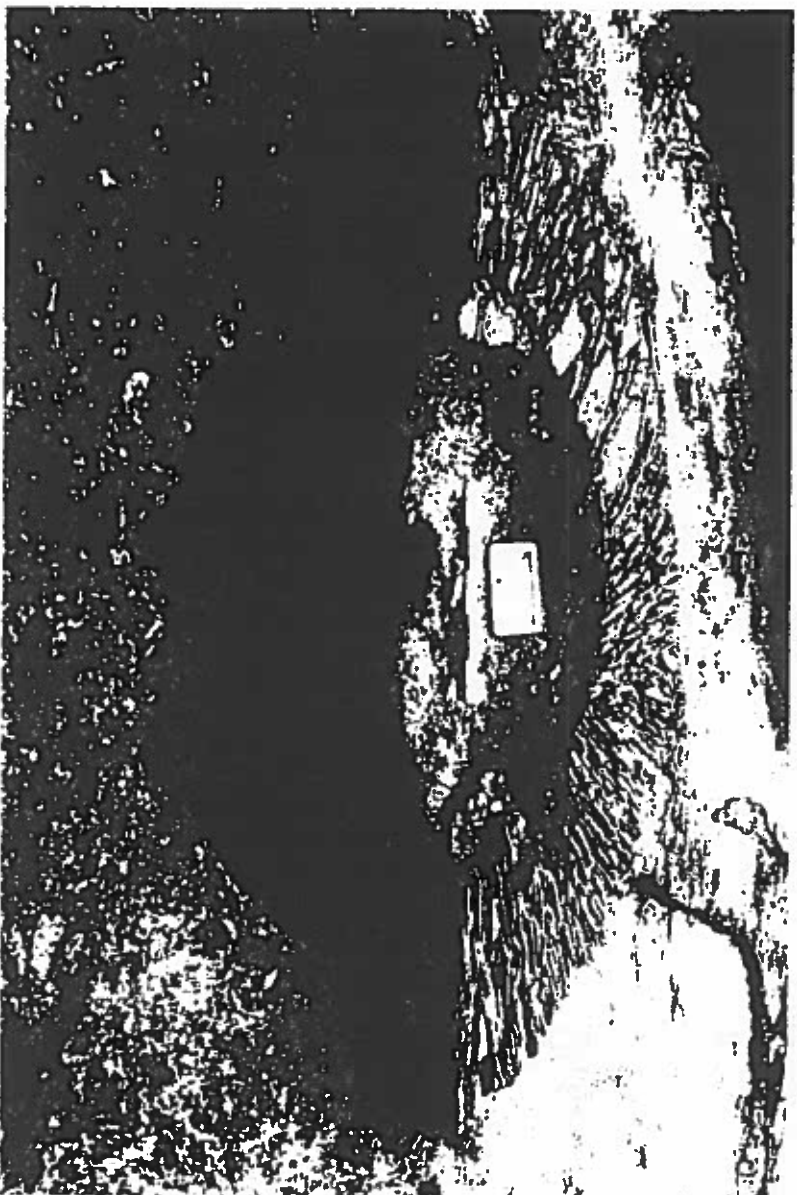
Plate 5.7. Circular feature 279, half-sectioned.

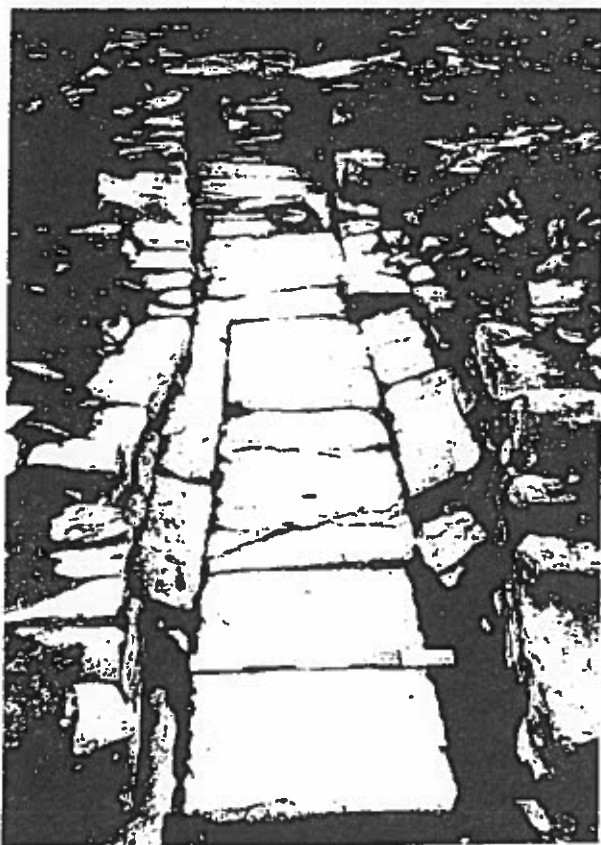
Plate 7.10. Privy drain 58 from SE with location of sluice beyond capping stone (top).

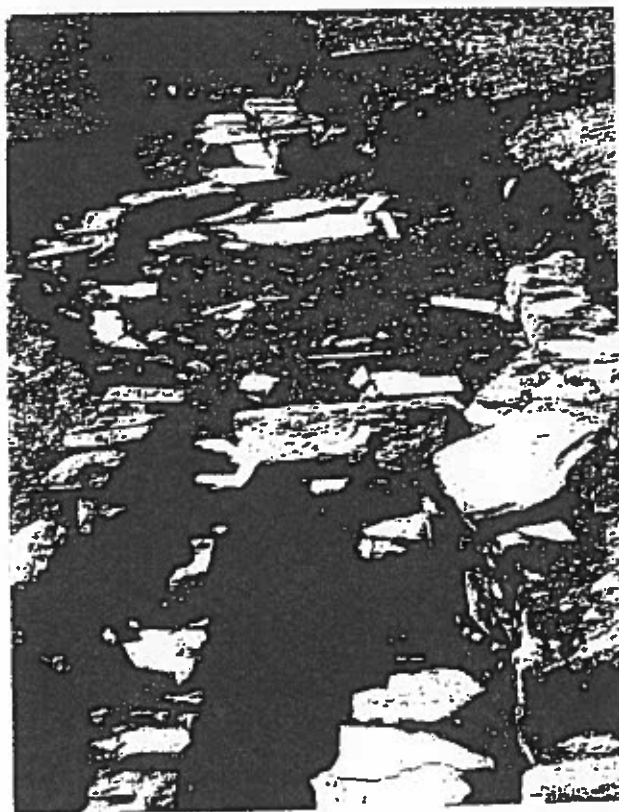
Fig. 7.11. Capstone with sluice (observed) and cistern beyond with drain 58 in foreground
