REPORT ON THE WATCHING BRIEF ON THE PONTARDULAIS

TO

AMMANFORD

GAS PIPELINE, CARMARTHENSHIRE (HPW 66)

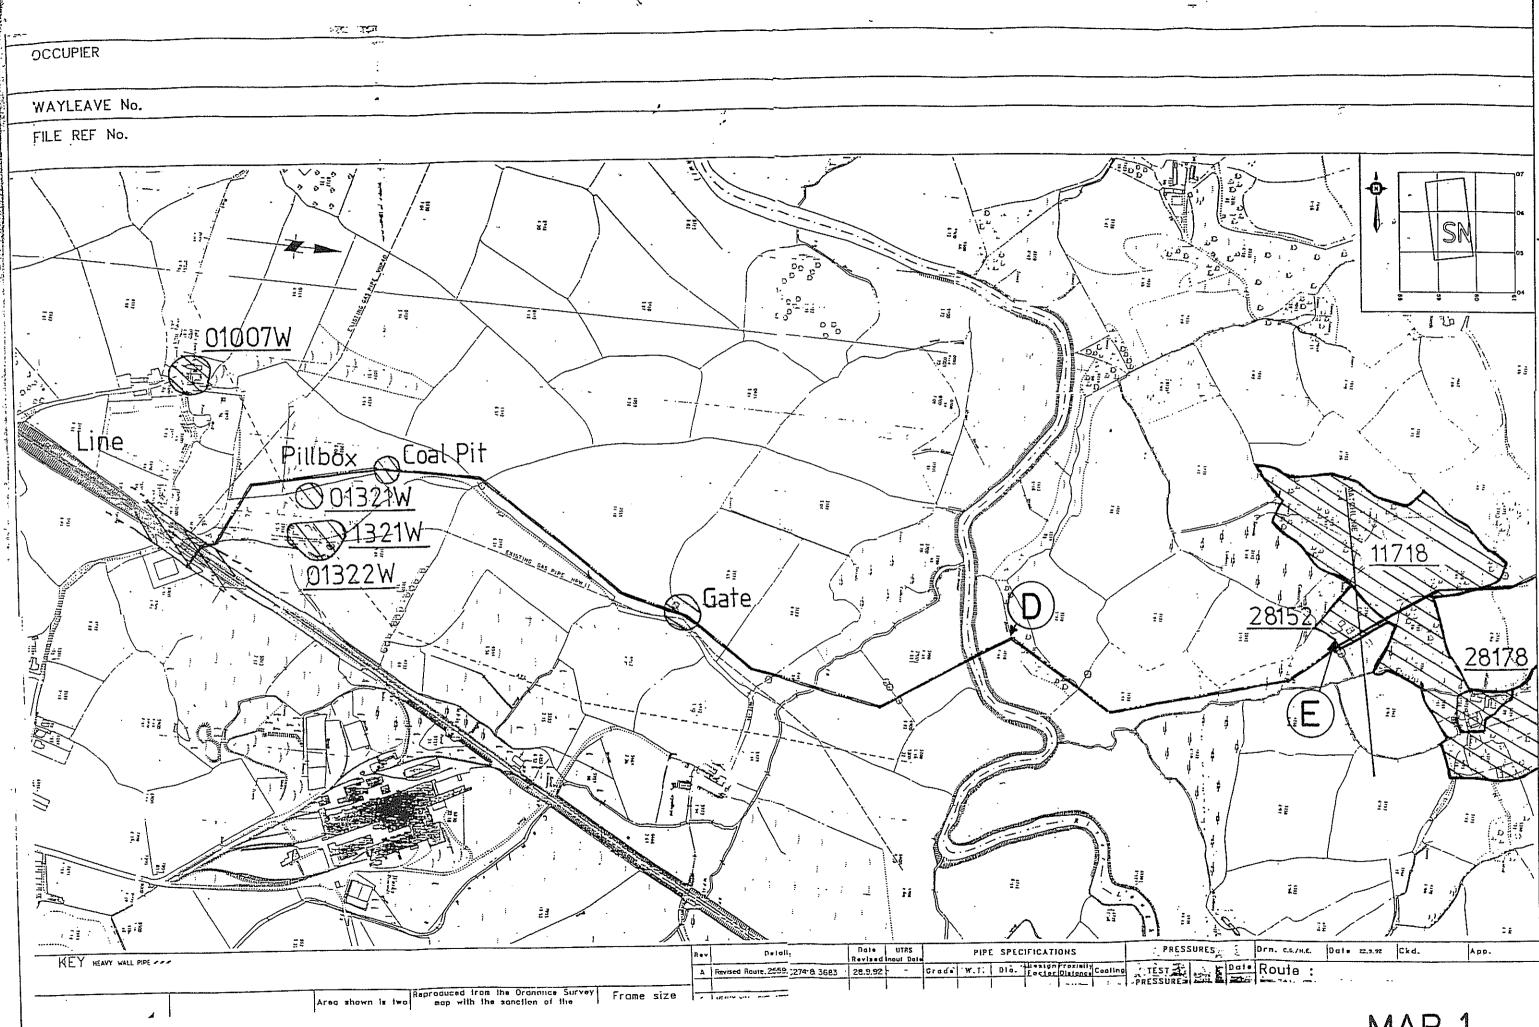
From the River Loughor (Map 1) to the north the pipeline crossed an area of alluvium and then ran along a low terrace composed of coarse gravel. Only one hedgebank (D) now exists from the river to the hedgebank E. This surviving hedgebank was only 30cm high and was composed of upcast topsoil and subsoil. It overlay an orange-brown silty-loam buried soil - this is substantially different from the present-day topsoil.

Hedgebank E, forming the boundary to an area of woodland (11718) and lying close to an old farm (28152), was a substantial structure, over 3m wide and 1m high with a ditch to the south. It was built from large, rounded boulders and soil. A large sherd of 18th century pottery was found in the make-up of the bank.

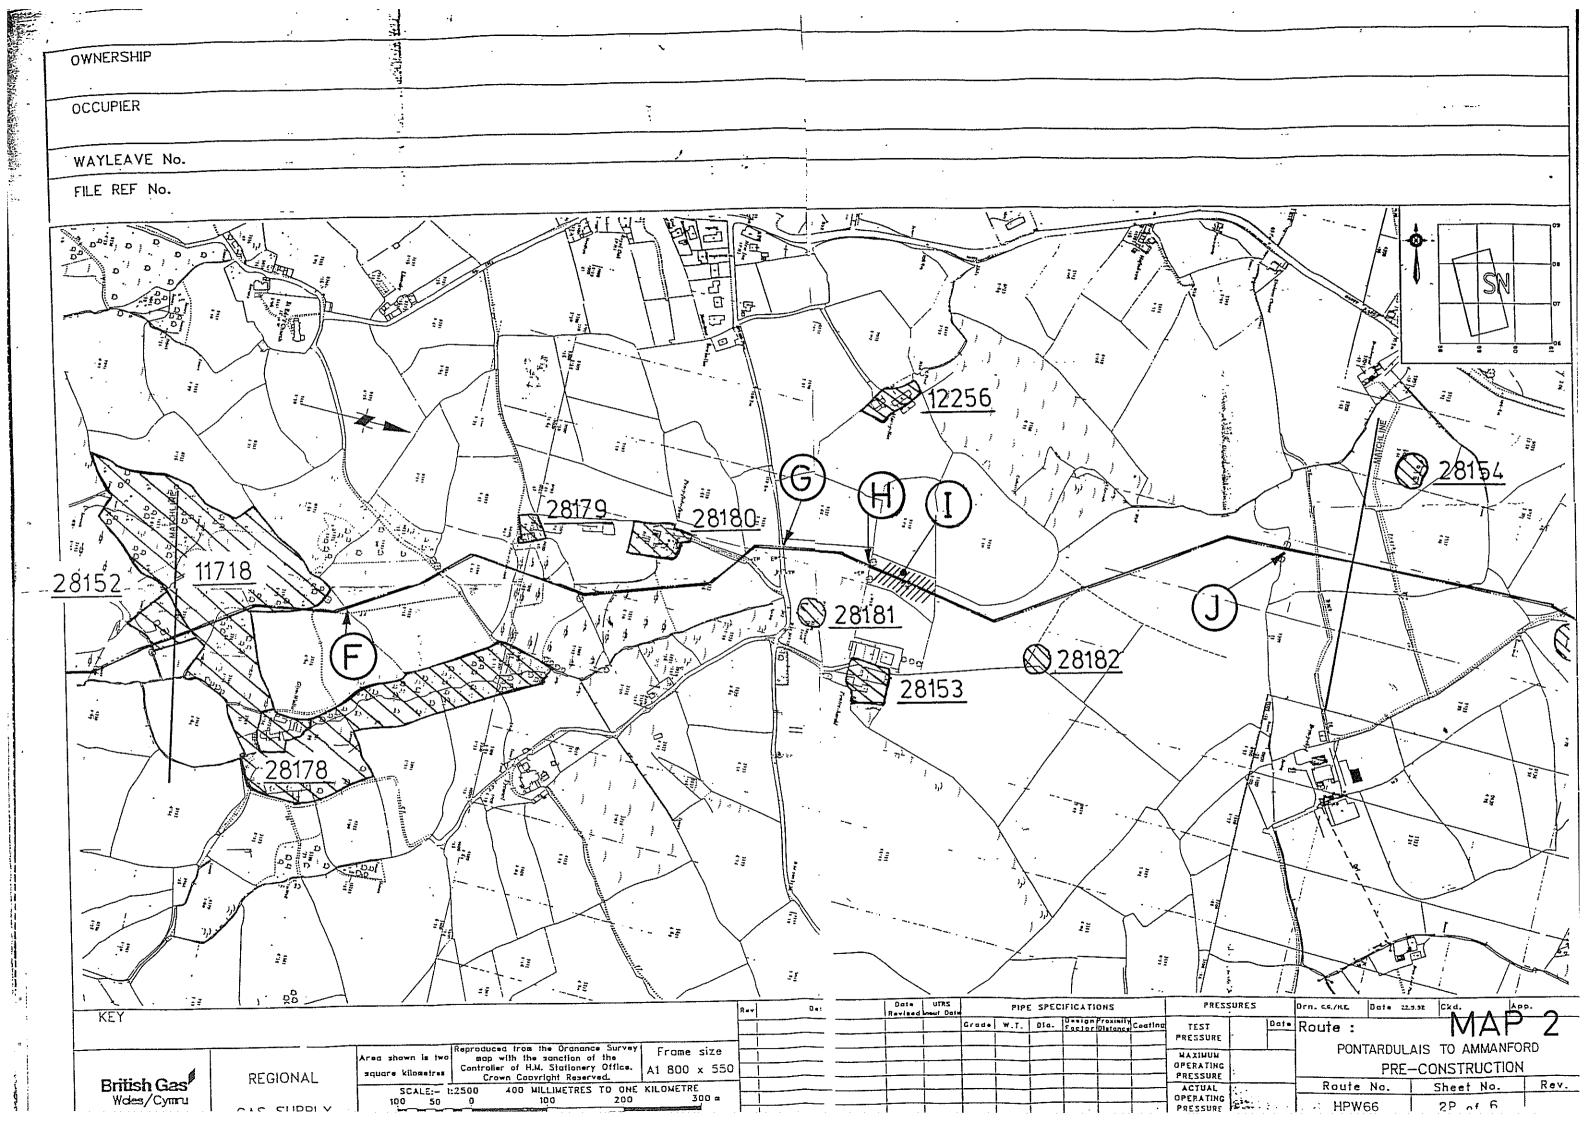
It was not possible to identify any features of interest in the pipeline corridor through the woodland 11718 because of the nature of the topsoil strip. However, on either side of the corridor insubstantial former hedgebanks were noted demonstrating former agricultural use of this area of woodland. To the north of the woodland boundary F was seen to be a substantial lynchet (Map 2).

The two roadside hedgebanks G were quite insubstantial, about 0.6m high and 2m wide, and composed of upcast topsoil over a midbrown silty-loam buried soil. This contrasts with the modern dark brown silty-loamy topsoil recorded between banks F to H. Bank H was earth built with a rubble stone facing - it was not possible to record the buried soil associated with it.
