# STARLING PARK, CARMARTHEN

## ARCHAEOLOGICAL EVALUATION

Report No. 2004/1

Report Prepared for:  
PERSIMMON HOMES (WALES) LTD

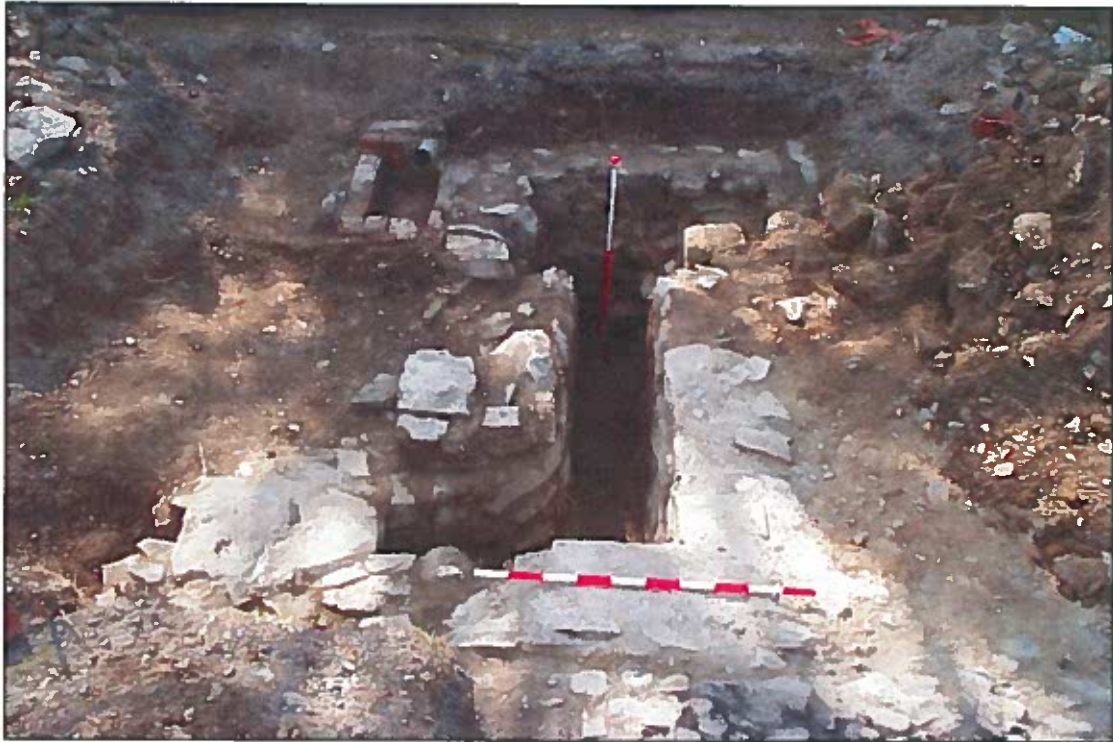
The stone drain (Plate 1) was located at the south end of the southern extension of Trench 2 and was a well-built L-shaped structure consisting of large and medium size mortar-bonded stone blocks. The drain was effectively a channel created by the construction of two 0.40m wide L-shaped walls some 0.40m apart at the top and slightly battered towards each other becoming 0.30m apart at the bottom. The return of the more southeasterly of the walls was curved and its base lay upon a rectangular stone slab, elsewhere the walls were set directly onto the natural gravel. The east to west length of the structure was 2.3m long and the southern return was at least 2.8m long and continued beyond the edge of the excavation trench. The depth of the drainage channel was 0.50m at its east end falling gradually to 0.80m at its most southerly exposed end. Apart from the stone slab at the return, the bottom of the drainage channel was of natural gravel with no other evidence to show that the base was formerly stone lined: it is possible that any basal slabs had been robbed for re-use elsewhere when this drain fell into disuse and was back-filled (214). Two large capstones spanned the structure at its eastern end and, again, it is possible that the whole structure was formerly capped in this way (see description of later wall 215 below).

At the base of 213 there was a dark brown layer of silt (235) to an average depth of 90mm, which contained pottery sherds and occasional fragments of glass. The pottery sherds, plain cream ware and blue transfer-printed ware, are typical of the developed tablewares of the 18<sup>th</sup> and 19<sup>th</sup> centuries respectively.

*Plate 1. View of stone drain 213, looking south*

The results of the evaluation were conclusive enough to enable targeting of the future watching brief phase of the project towards those areas of the site that retain the highest archaeological potential. In particular the area around the stone drain structure requires further investigation and further elucidation of the nature of the structure itself may also be possible. The former farmyard area to the northwest of the house will also require close monitoring during the watching brief given the minimal results gained from the excavation of Trenches 3 and 4 during the evaluation.

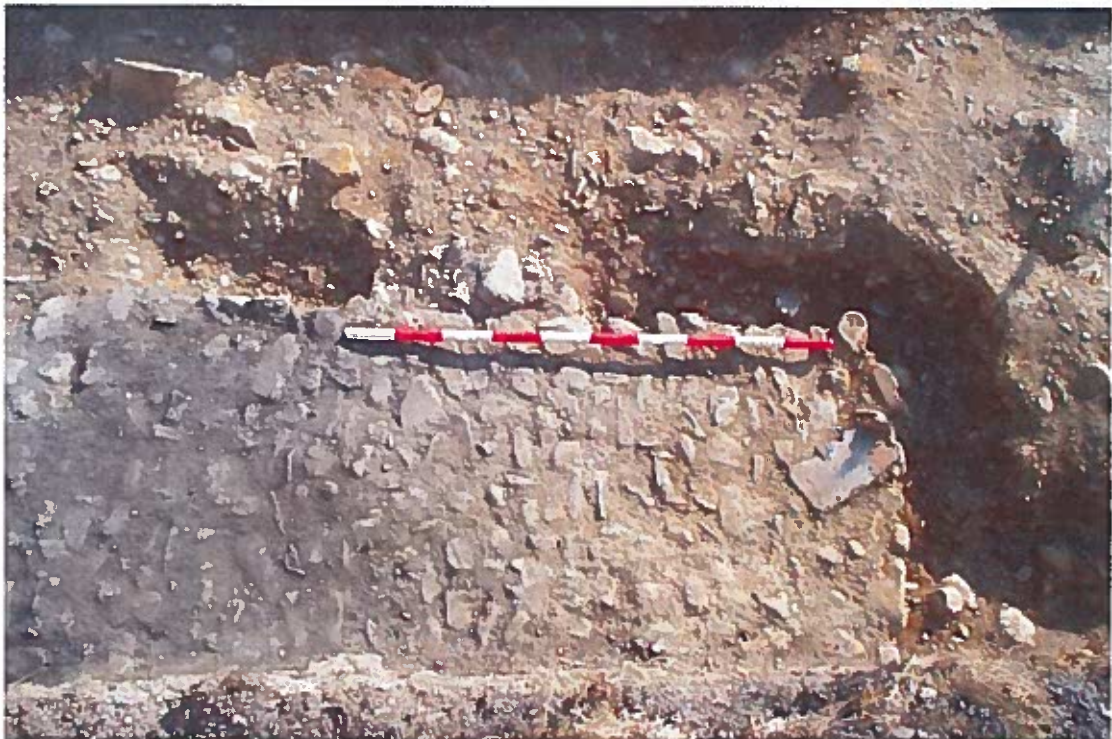
The outer face of the northern wall of 213 appears to have been plastered or rendered with a yellowish grey plaster (216). The plaster surface was abutted by the southernmost edge of a pitched stone cobble surface (209). The pitched cobbles comprised 40% small and medium size rounded pebbles and 60% small and medium size angular and sub-angular stones bedded into a stiff clay, which had been laid directly onto the natural glacial gravel. The surface of the cobbles was covered throughout by a thin layer of coal dust and small coal fragments (208). The cobbles abutted plaster surface 216 for a distance of 0.85m and continued beyond the northwest corner of 213 for a distance of some 0.66m following the line of a possible 0.42m wide robbed wall (212), represented by a distinct, but thin, linear mortar patch overlying the natural glacial gravel. The cobbles then followed a near right-angle return to the north exhibiting a relatively undisturbed straight edge on their western side for a distance of 4.8m where they returned, again at a near right-angle, to the west for a further 2.10m before continuing beyond the northern edge of the excavation trench (Plate 2). The north edge of the cobbles dipped gradually down from east to west (Fig.4) before levelling out and abutting a robbed wall foundation trench (210), which bounded the western edge of the cobbles and appeared to join robbed wall line 212.

*Plate 2. Near vertical view of western return of pitched cobbles 209, looking south*

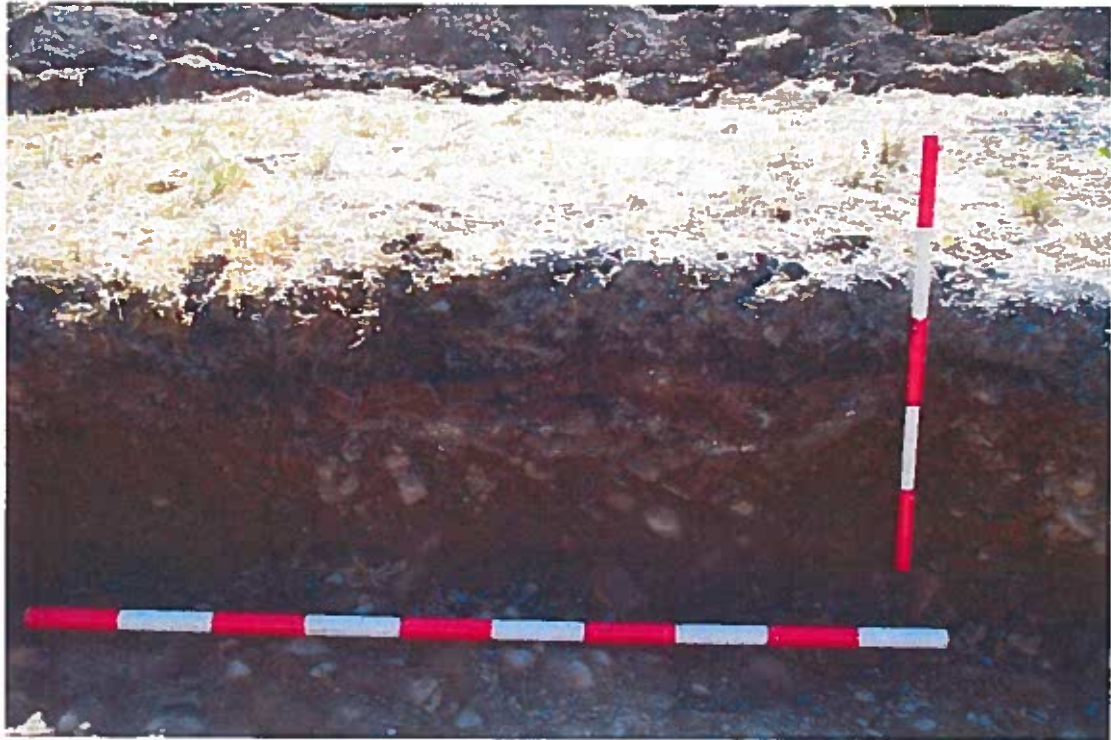
The western wall of the west block was represented by a 0.60m wide robber trench (206) which survived to a depth of 0.20m and was shown also in Trench 1 in the north facing section as context 110 (Plate 3). The western return of the west wing of the building was also represented by a robber trench (112) seen only in the east facing section of Trench 1 (Plate 4).

*Plate 3. View of north facing section in Trench 1 showing robber trench 110*

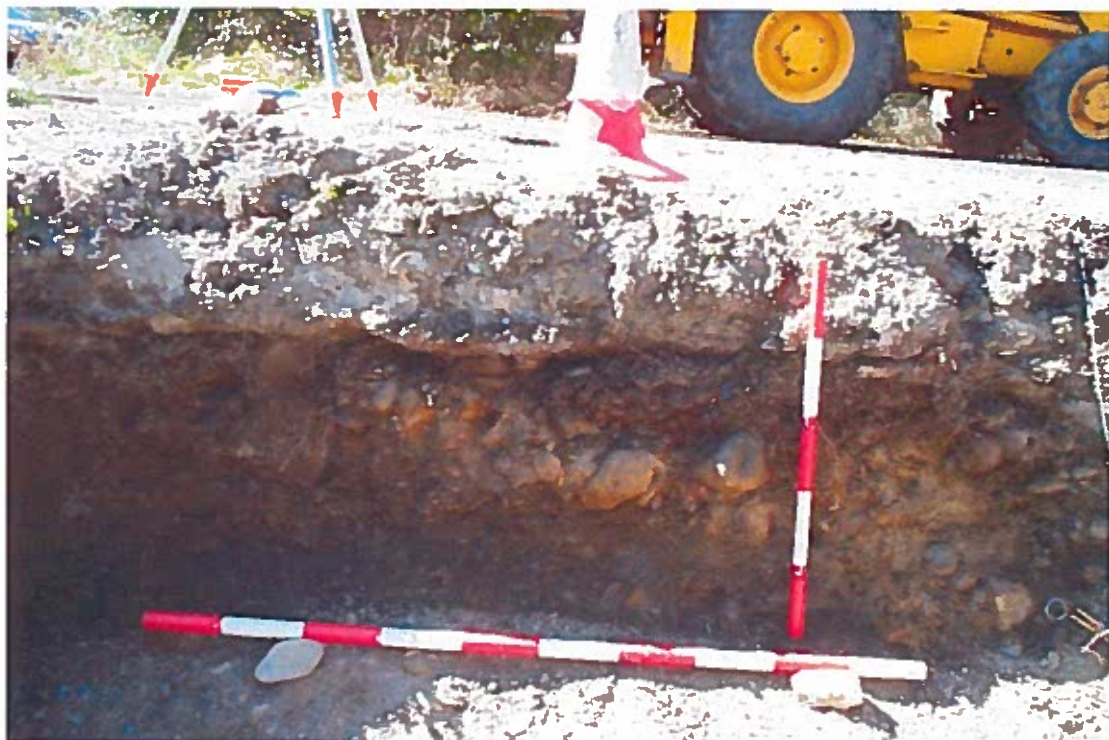
*Plate 4. View of east facing section at the end of Trench 1, showing robber trench 112*

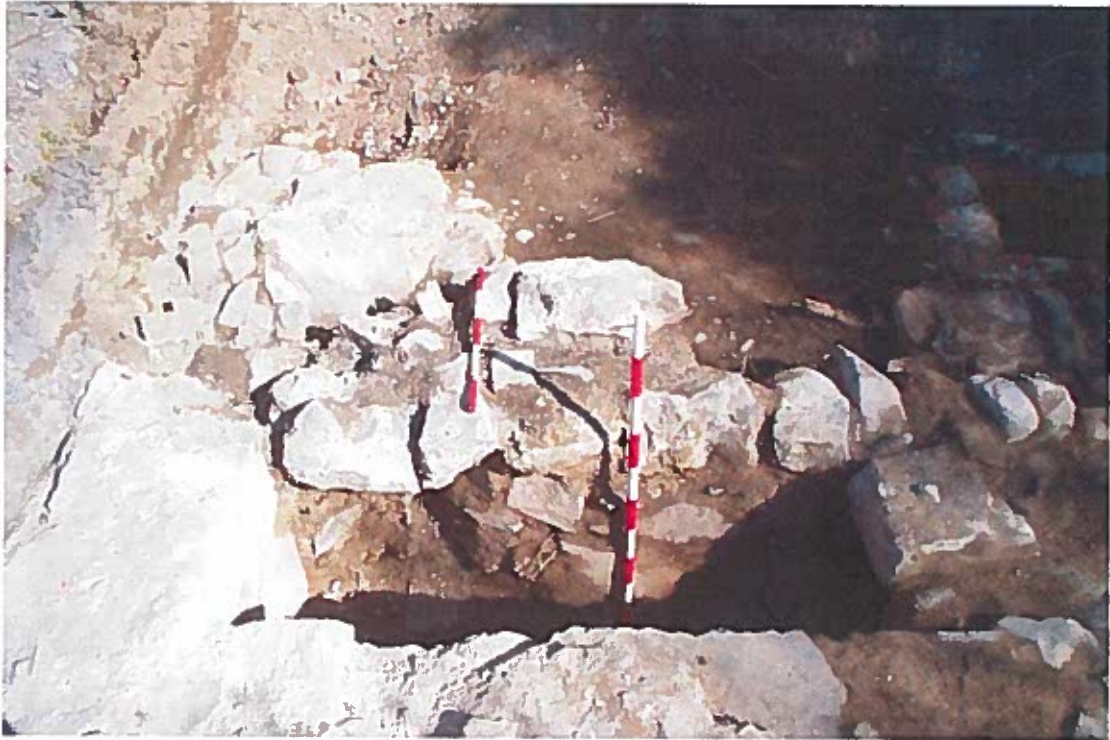
Evidence for the eastern wall of the west block was present in the form of both robber trench (203) and wall footing (215) in Trench 2 with no evidence present in Trench 1. Robbed wall foundation trench 203 was 5.8m long, 0.60m wide where fully exposed, with an average depth of 0.12m and appeared to cut through the entire eastern edge of the pitched cobble surface 209. Wall footing 215 was 0.60m wide and consisted of at least two courses of mortar-bonded stone to a maximum height of 0.25m extending for some 2.6m N-S before returning to the west for at least 1.60m and continuing beyond the edge of the excavation. The footing was overlying drain 213 (Plate 5) and the demolition backfill (214) of its drainage channel, suggesting that 213 had at least partially fallen into disuse by the time the west block building was built. The outer face of 215 where it crossed fill 214 was also the most westerly limit of the capstones (Plate 6) left *in situ* on the stone drain 213: perhaps this indicates the possibility that any other capstones were removed prior to the backfilling of 213 and the construction of wall 215. Also abutting the outer face of 215 on its eastern side were the remnants of a rectangular brick-built drain (217) (Plate 7) measuring 0.80m by 0.48m and comprising at least two courses of single bricks with a flat sandstone base and a plastic outfall pipe exiting beyond the edge of the excavation trench to the south.

*Plate 5. Wall footing 215 crossing stone drain 213 and its backfill 214, looking east*

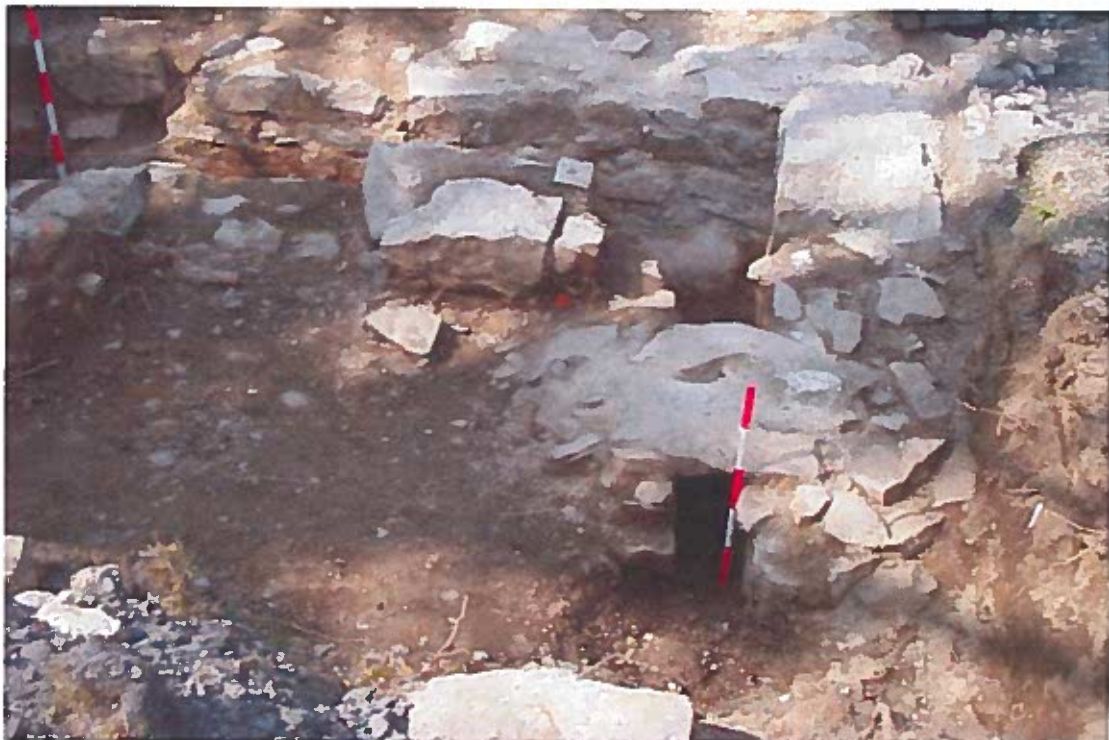
*Plate 6. View west of stone drain 213*

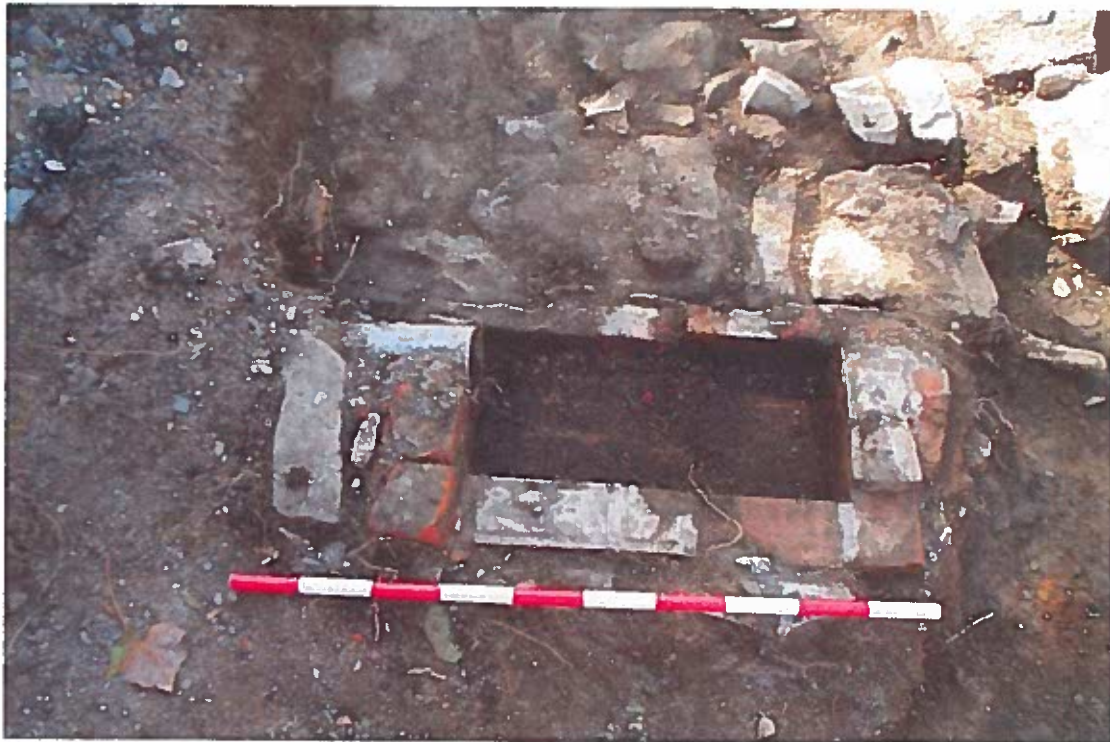
*Plate 7. View of drain 217 looking west*

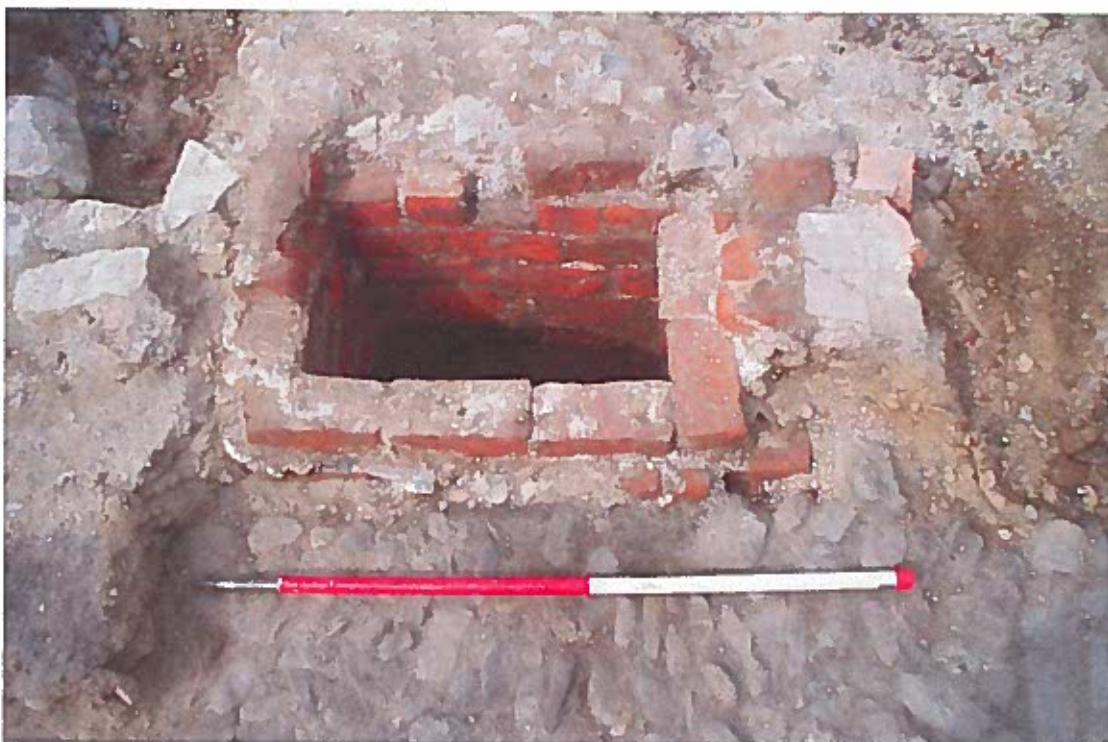
In the most northerly extension of Trench 2, the red brick-built footings (231) of a vertical-drop soakaway drain (Plate 8) were revealed. It was a rectangular structure measuring 0.84m E-W by 0.60m N-S comprising five courses of bricks set into the

natural gravels to a depth of 0.41m but with an additional depth of 0.23m of gravel removed from the bottom to form a soakaway. The footings for this feature cut through the cobble surface 209. The lower, silty, fill of the soakaway contained a high percentage of pottery, which was retained for finds analysis. The potsherd assemblage represented at least two types of pottery; a cream jug with a green transfer-printed battle scene and two pieces of blue transfer-printed tableware depicting Swiss landscape scenery. From markings on its base, the cream jug was identified as being produced by Lowe and Abberley at the Viaduct Works in Longton, Staffordshire: it is known that this firm only occupied that site between 1862 and 1863, which means that the sherds cannot have been deposited into the drain before that time. The blue transfer-printed tableware was popular and widely available throughout the 19<sup>th</sup> century.

*Plate 8. Red brick soakaway drain (231) after removal of its fill, looking north*

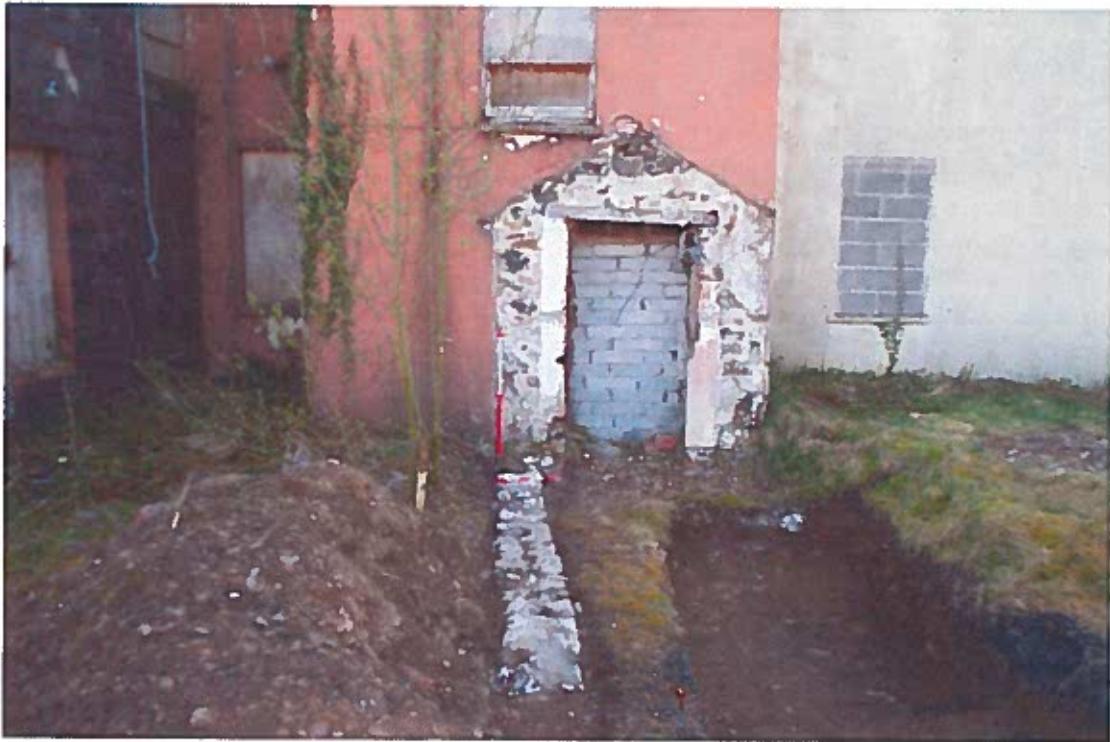
At the east end of Trench 1 and within the additional trench (T 1b), excavated alongside it to the north, the footings for the walls of a connecting corridor between the west block and Starling Park House were revealed. The more northerly of the wall footings (106) extended for some 3.70m, was 0.40m wide, and abutted the wall on the northern side of the possible service stair wing at the rear of the house. It survived to a height of 0.20m and comprised mortar-bonded stonework (Plate 9) resting on natural gravel. The southern wall footing (107) also abutted the house, was 1.0m long and survived to a height of 0.11m: it too comprised mortar-bonded stonework resting on natural gravel, but appears to have suffered more damage than 106 did during the demolition phase. The tops of both wall footings lay, on average, only 50mm below the present ground surface.

*Plate 9. Wall footing (106) of skewed connecting passage, looking east*

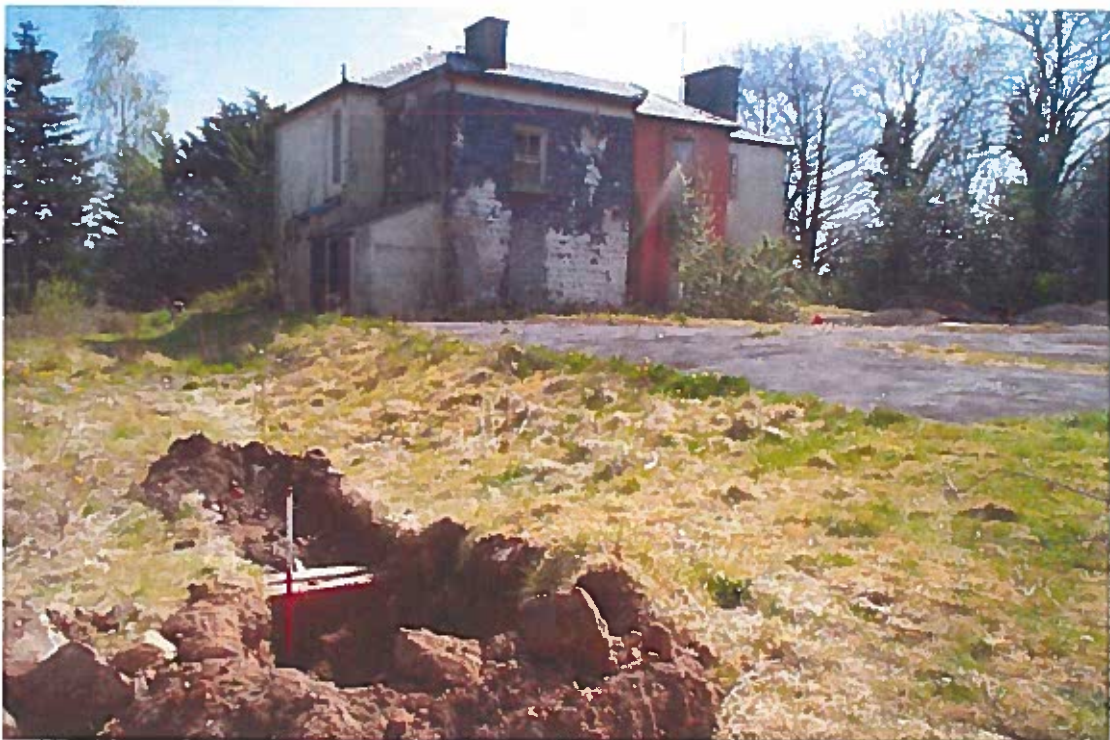
In Trench 4, buried by much re-deposited demolition debris and other dumped material (401), the red brick footings (Plate 10) of what appeared to be a modern building were seen to rest upon a concrete foundation (403). The footing (402) was 0.30m wide, comprised seven courses of bricks to a depth/height of 0.53m, and was aligned north to south continuing beyond both sides of the 1.0m wide excavation trench. Some 0.30m to the east lay a solid concrete feature (404), aligned as 402, measuring 0.30m wide and 0.19m deep. A length of electric cable was protruding from beneath the feature but it was not possible to identify whether this was associated with it. It seems probable that 402 represents the footing for the western end of one of the Health Authority buildings marked on later editions of the Ordnance Survey maps, which formerly stood to the north of Starling Park House.

*Plate 10. View southeast of modern foundations for Health Authority building  
exposed in Trench 4,*
