# ABERSTRINCELL LIMEKILNS

## Archeological Survey

Report No. 2003/45

REPORT NO. 2003/45  
PROJECT RECORD NO. 47782

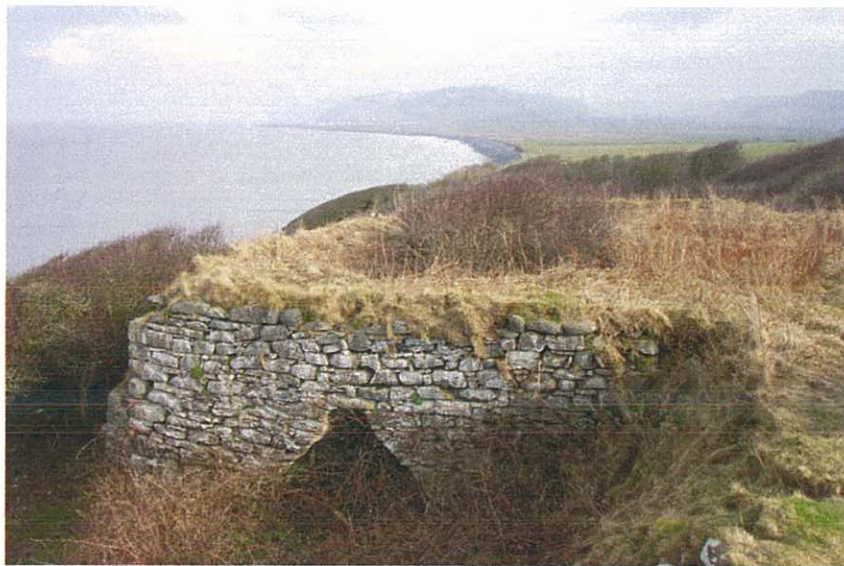
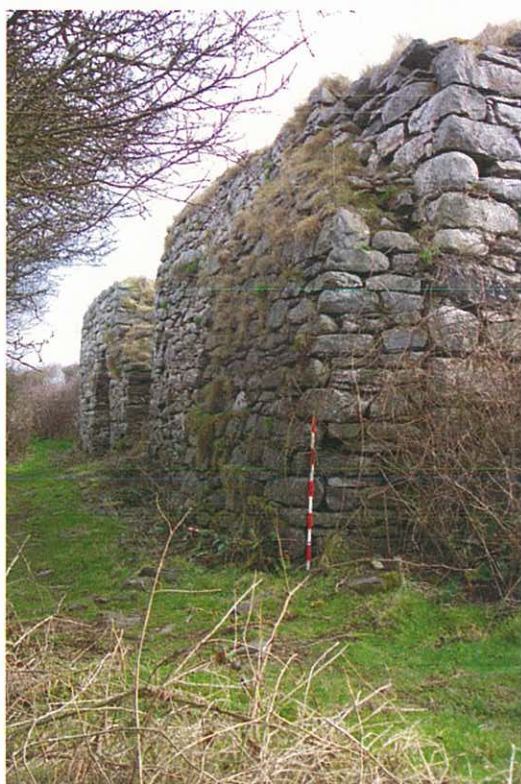
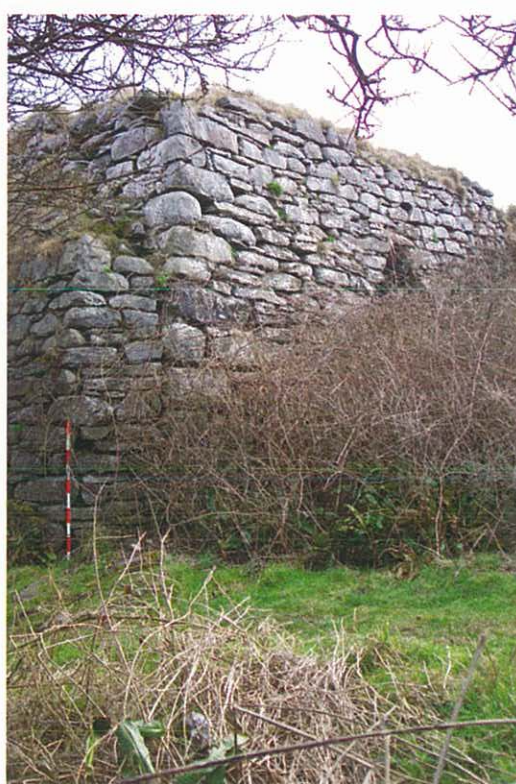
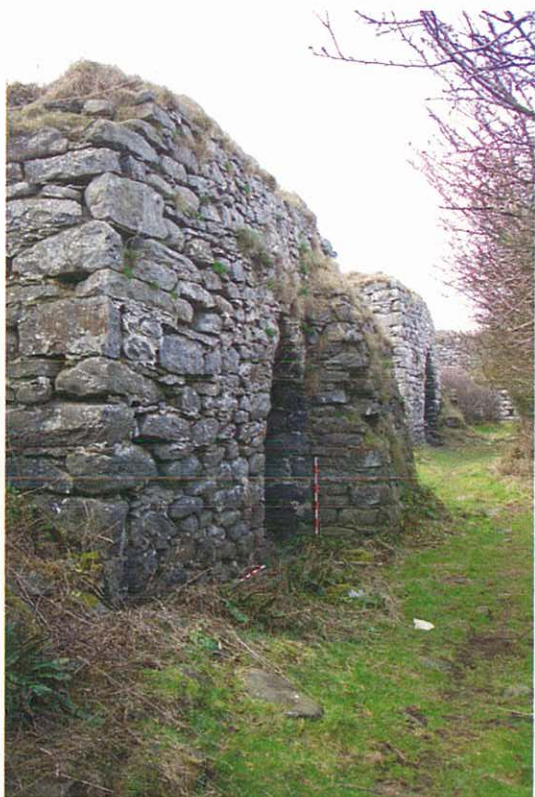
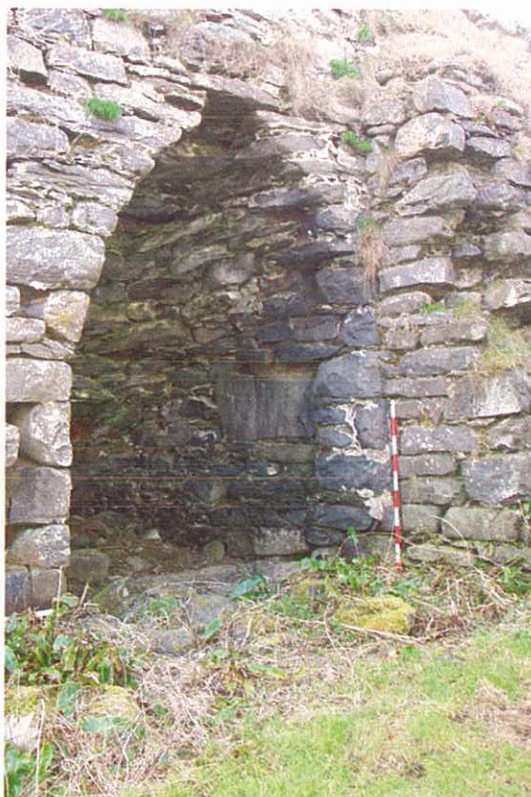
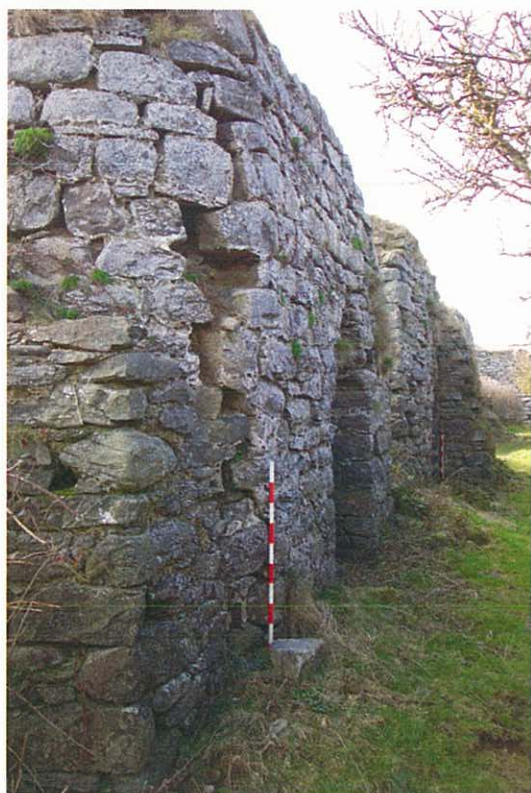
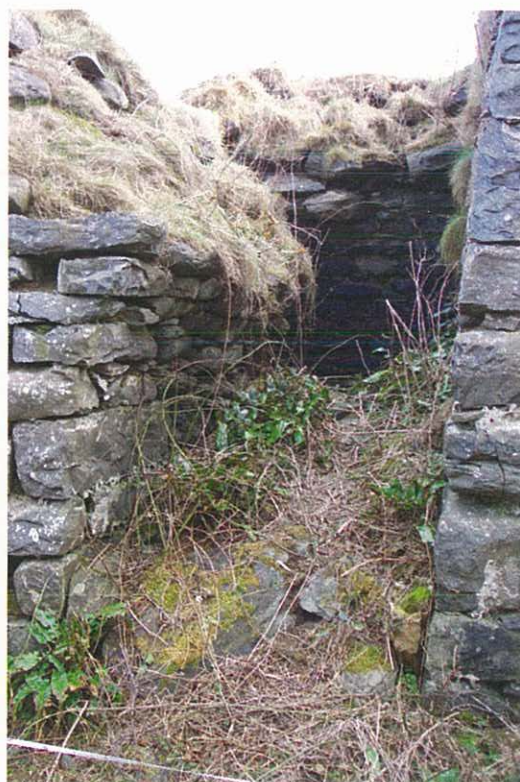
**Aberstrincell Limekilns, Kiln no.s 1 & 2**

Kiln 1: This is perhaps the most modern kiln on the site as it has been added to the west face of kiln 2. It has a later buttress on its rounded north east corner and its chamber is infilled. The drawing arches between kilns one and two form a T-shape with the vaulted arm between the two kilns having partly collapsed.

Kiln 2: This is buttressed on the south west corner, and its chamber is overgrown. The draw hole openings are capped with a course of brickwork supported by a heavy iron band.

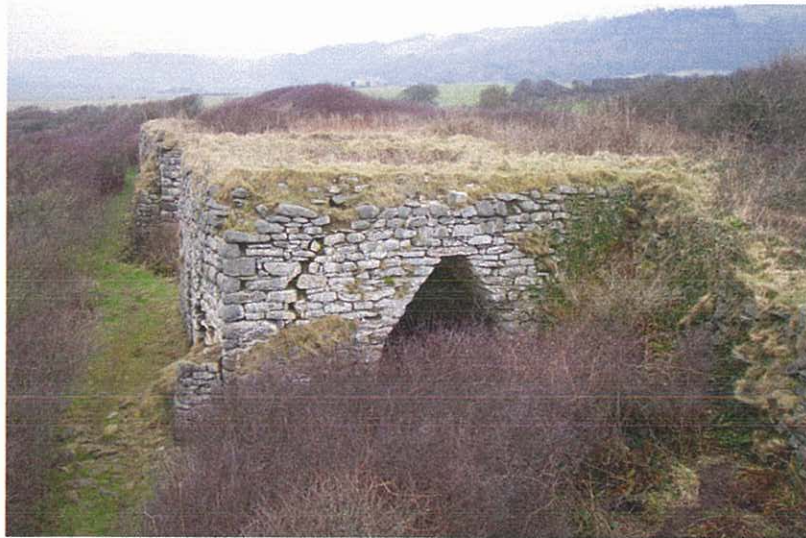
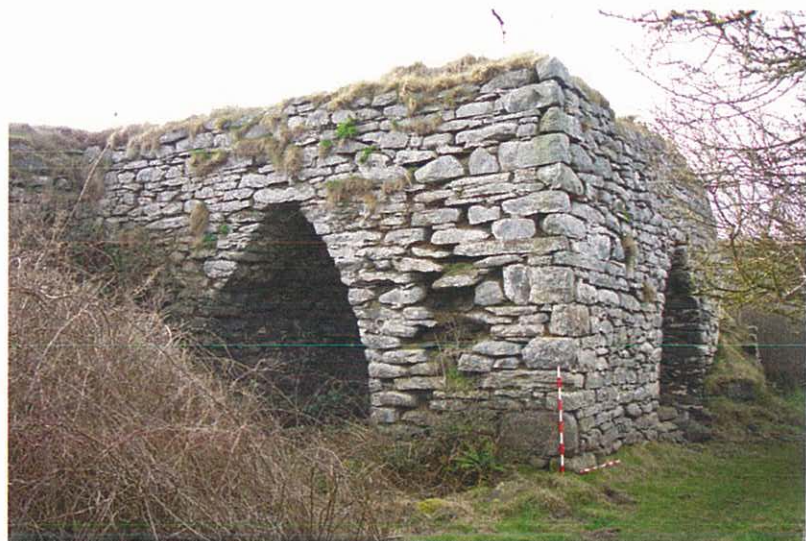
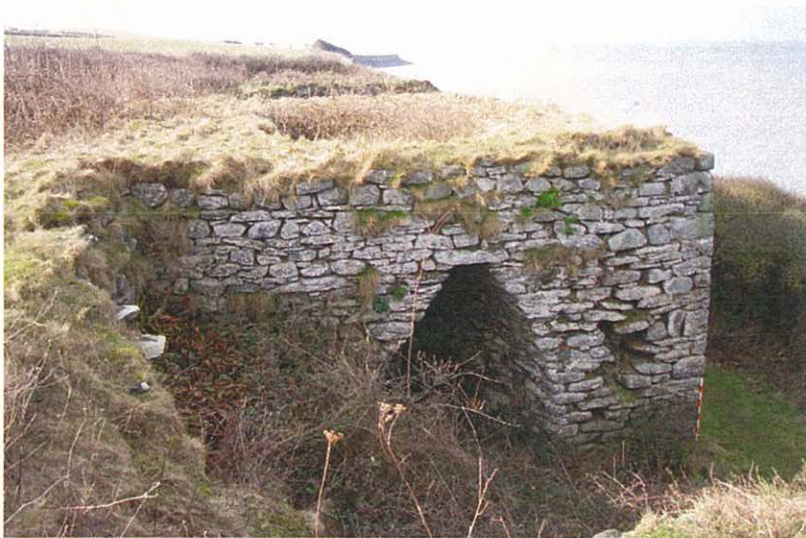
**Aberstrincell Limekilns, Kiln no. 3**

Kiln 3: This has two buttresses on its south west corner and the chamber is infilled. There are iron grating bars and brickwork surviving in the draw hole openings.

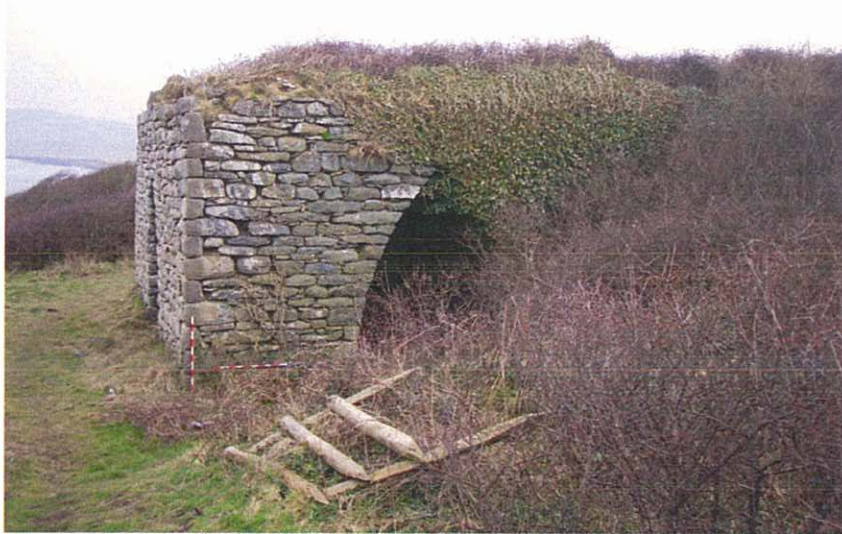
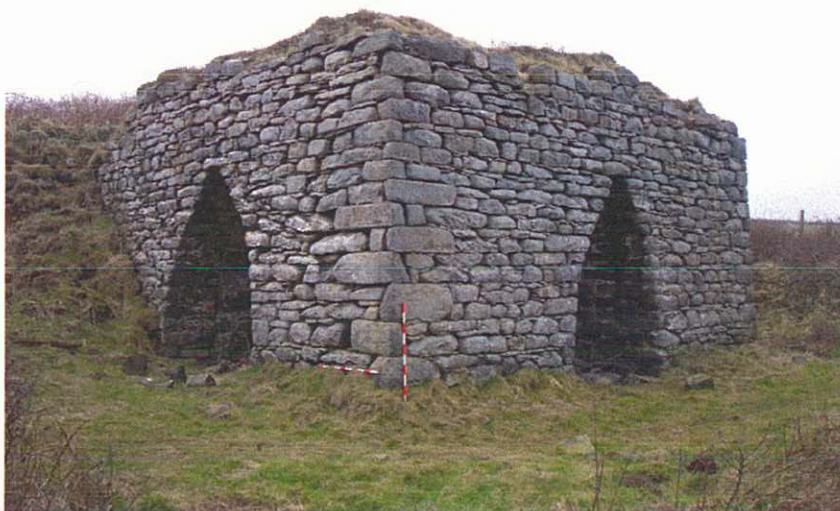
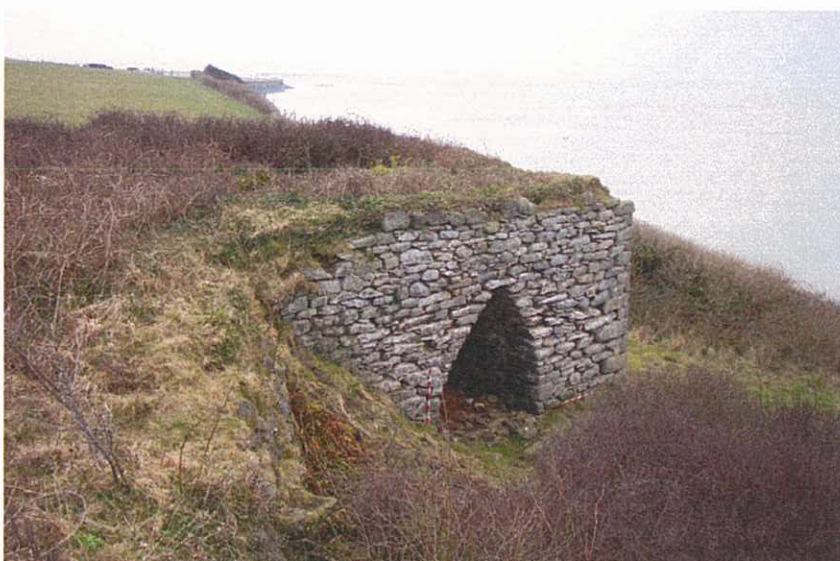
**Aberstrincell Limekilns, Kiln no. 4**

Kiln 4: This is the most ruinous and its chamber has collapsed. This reveals an interior with a vitrified cobble lining and several iron bands to give additional support.
