**TIR GOFAL MANAGEMENT PLAN:
HERITAGE MANAGEMENT INFORMATION
(Call Out)**

**Prepared for:
Plas Cefn Gwyn
Tir Gofal Reference No: W/11/3738**

**Project Record Number: 47843
Report Number: 2008/104**

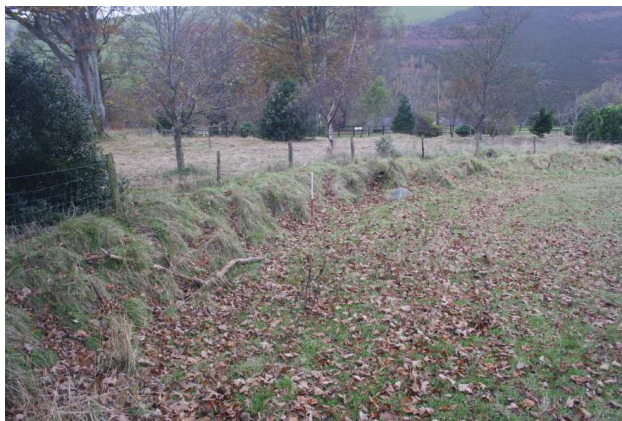
The historic boundary is located within the field to the east of the house, running along the western and northern boundaries. For most of its length it comprises a stone-faced bank, standing to a maximum height of 0.80 metres and approximately 1 metre wide, with an associated ditch, again generally 1 metre wide. The stones on the bank are under a thick coat of coarse grasses and moss and a few large stones have become dislodged and lie away from the feature. Some areas of the bank have been damaged, possibly by livestock movement, which has spread or even flattened it in places. A post and wire fence has been erected along the line of the bank, on its western side.

The ditch varies from a shallow depression in the south to a more distinct, cut channel in the north. Its function is to drain water from the field, which slopes up to the east, down to the stream that borders the northern field boundary. Silting, overgrowth and sporadic damage to the earthwork appear to have prevented effective drainage and the northwestern area of the field is now waterlogged

(Left), looking northwest, bank and ditch at southern end of field. (Right), looking north, bank and ditch at northern end of field

- Reform the earth and stone bank in the areas where it has suffered damage. In some sections the bank has been flattened and spread, requiring reconstruction and re-consolidation, using traditional methods.

- Clear vegetation from the stone-facing and ha-ha revetment. The roots should be left in situ and spot treated to prevent re-growth.
- Restore the stone-facing where necessary, using original stones where possible or replacing like-for-like.

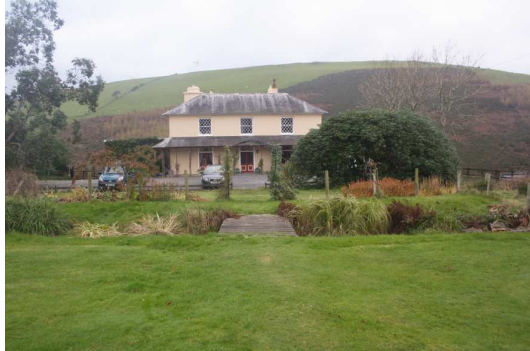
The section of earthwork that crosses in front of the house differs in character to the rest and has many of the attributes of a 'ha-ha' with the east-facing side of the ditch being vertical and stone-faced, with only a slight bank behind it. The drystone revetment stands approximately 0.60 metres high and the ditch is 1.50 metres wide.

OS map shows a cleared gap through the woods to the east, in the direct line of the house. This area is wooded over by the time of the 1905 2nd edition OS map. This section of the earthwork is very waterlogged and the ditch is overgrown with reeds or, in the area immediately in front of the house, been planted with aquatic plants. The stone-facing is also very overgrown with coarse grasses and ferns.

(Left), looking west, possible ha-ha running across the front of the house. (Right) section of walling on east-facing side of ditch.

- Remove vegetation from the ditch. The section in front of the house is particularly thick with reeds and the ha-ha has been planted as a water garden.

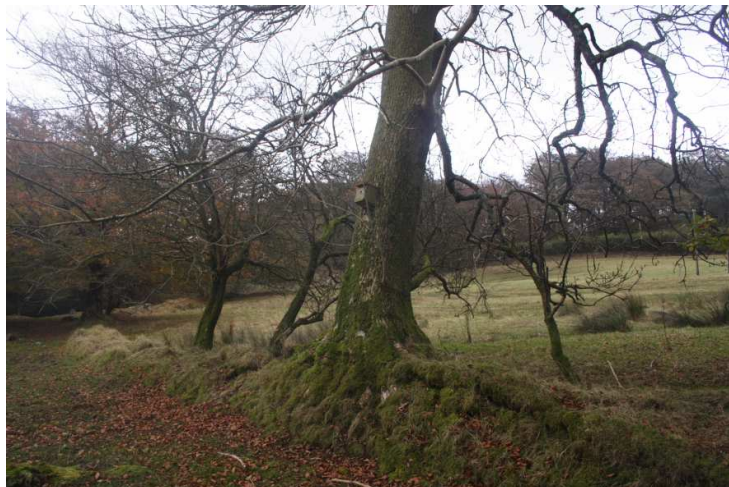
To the north of the house a further earthwork bank branches off from the main bank and ditch, curving around to form the northeastern field boundary. This bank forms the edge of the area that is depicted as being under woodland on the 1887 and 1905 maps and several mature trees still grow along its length. Several large, exposed boulders sit on the boundary bank.

Looking northeast, section of field boundary bank.

- It is probable that the mature trees that grow on the woodland boundary bank represent the remnant of an original hedgeline and, as such, should ideally be retained. However, any restoration of the bank may require some tree removal.

- Monitor the trees that grow on top of the boundary banks and remove any that are in danger of windthrow.
- Remove the silting and vegetation from the ditch, particularly within the area north of the ha-ha to allow excess surface water to drain to the stream. The existing course of the ditch should be followed and the silt accumulation should be removed away from the earthwork so as to maintain as much of the original boundary bank profile as possible.
- If the drainage to the north is rectified then the ha-ha should once again become a 'dry' feature and any accumulated silt can be removed from the ditch, to the level of the original cut.
- Cut back the vegetation within the ha-ha, particularly on the drystone revetment, where the roots should be left in situ and spot treated to prevent re-growth
