# **Penwernhir W/11/3984**

## **Tir Gofal Farm Visit Historic Environment Report**

Report No. 2004/12

Penwernhir  
Tir Gofal Farm Visit Historic Environment Report

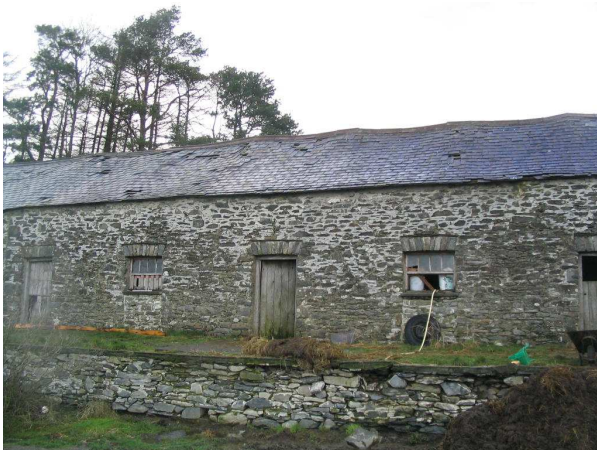
**Plate 1 (left)** *The west elevation of the cowshed*

The cowshed is rubble stone built and bound with lime mortar. The west elevation has evenly spaced openings – alternate doors and windows, with simple stone arches above them. However, the windows seem to have originally been doors which were later half-blocked. Internally the building remains very much a working cowshed, and is used as such by the farmer. Wooden stall partitions run most of the length of the building, with a loose box at the north end. A wooden hay-rack survives in the loose-box. A feeding passage runs along in front of the stalls, on the east side, and a drainage passage also survives behind the stalls, on the west side. The floor is of small, squared tiles, to allow easy drainage and cleaning.

The building is generally in fair condition, but there are a few problems which need addressing. The slate roof is in poor condition, with many slates missing. The landowner also says that there are problems with the timbers in the roof. He is proposing to carry out restoration works through Tir Gofal.

Restoration of this building would be very welcome. Re-slating and replacing unsafe roof timbers should be carried out as a matter of urgency, and the wooden lintel above the cartshed doors also needs replacing. The roof currently has a large overhang and no guttering, and this should be repeated in the new roof.

It is important that the details which characterise this building are not lost or obscured during any restoration works. Any work on the windows should aim to retain and repair the original frames where possible. If new windows are necessary, they should be in the same style as the old ones. The internal details, including flooring, stalls and loose box, should also all be retained as they are an integral part of the character of the building.

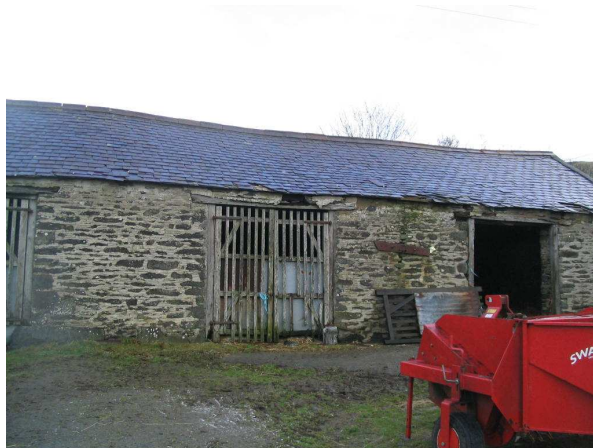
**Plate 3 (left)** Large doorways into the shelter shed

A stone built shelter shed or livestock house, opening into Penwernhir farmstead (PRN 49946). The building is a form of bank barn, terraced into the hillside on the east side. The west elevation has three large doors which lead into three big loose-boxes, divided by stone partition walls with small ventilation slits in them. The building was originally lofted, with a door leading from the south gable straight into the loft.

The building is generally in fair condition, although the roof has lost a lot of slates.

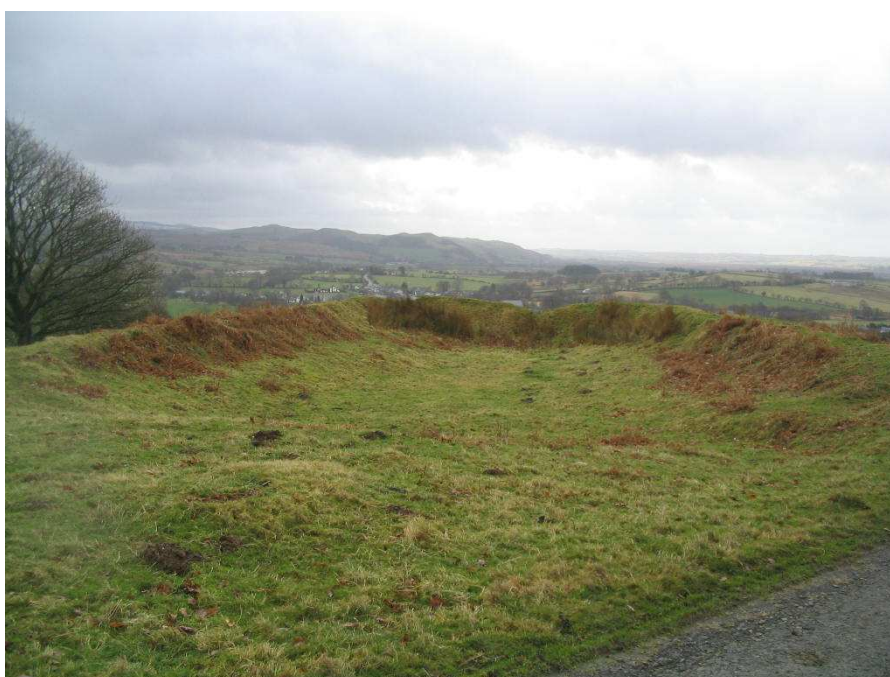
**Plate 5** *Earth banks of the reservoir at Cwmmawr mine.*

The site is in good condition, with a stable turf covering across the banks and in the interior of the tank.

See recommendations made for the mine (PRN 25943) and also section B2 of the Tir Gofal Farm Management Plan (Protection and Maintenance of Archaeological and Historic Features) for general recommendations.

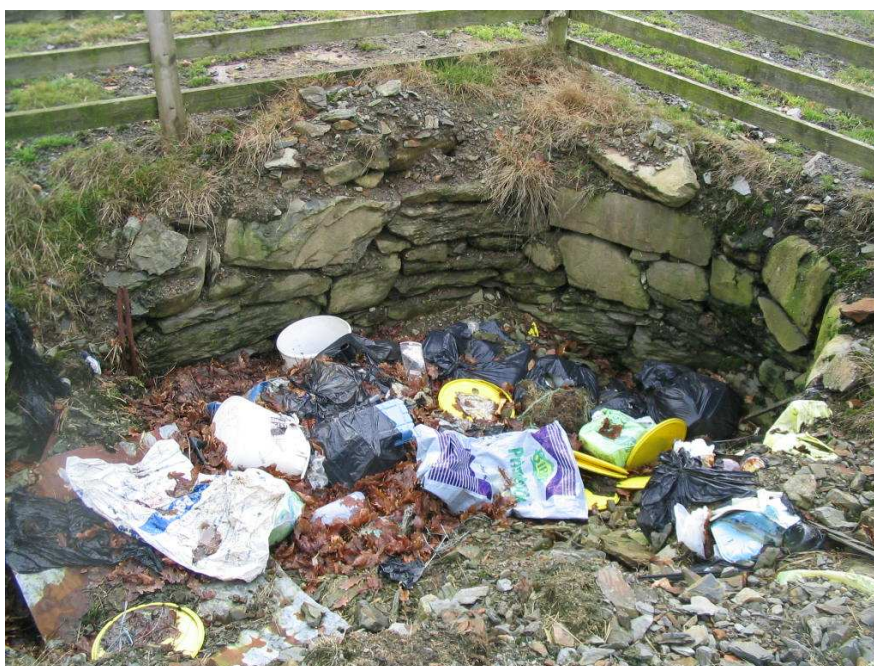
**Plate 6** *A stone-lined shaft, now infilled with modern rubbish and fenced off.*

Only a small amount of the shaft is visible now as much of it has been infilled with modern rubbish – the landowner informed Cambria Archaeology that a previous owner had put a car chassis into the shaft to block it. However, the stone lining visible is in good condition and the site is not overgrown or obscured by the fencing.

See recommendations made for the mine (PRN 25943) and also section B2 of the Tir Gofal Farm Management Plan (Protection and Maintenance of Archaeological and Historic Features) for general recommendations.

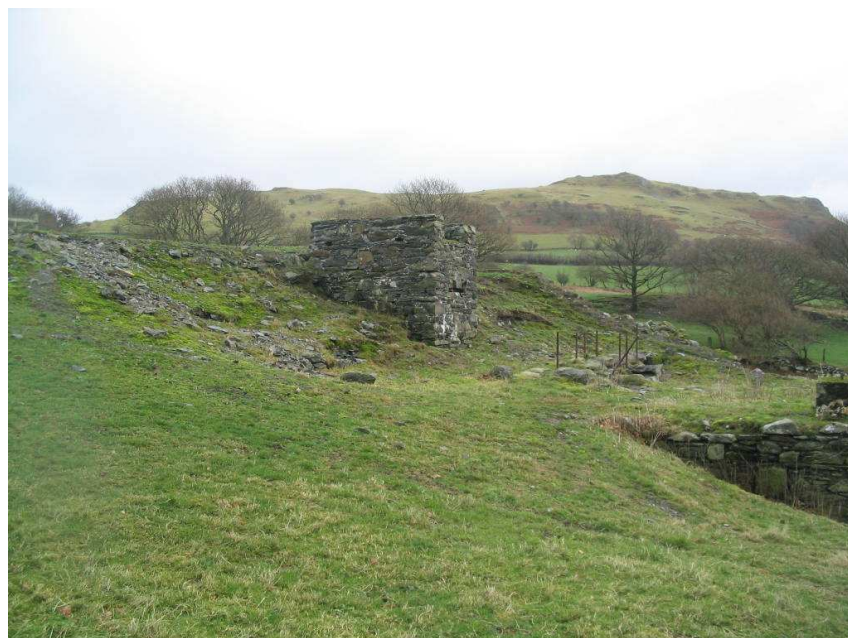
**Plate 7** *Remains of a probable ore processing or crushing plant at Cwmmawr mine. The retaining walls on the right of the picture seem to be part of a loading area.*

The site is likely to have been an ore-crushing and/or processing plant. It is generally in good condition, although the ground in the 'loading bay' is very churned up and poached. Tracks indicate that heavy vehicles are regularly taken into this area, and it may have been used as a silage clamp in the past.

Ground disturbance and vehicle movement in this area should be avoided in order to allow the grass cover to re-establish itself.

See recommendations made for the mine (PRN 25943) and also section B2 of the Tir Gofal Farm Management Plan (Protection and Maintenance of Archaeological and Historic Features) for general recommendations.

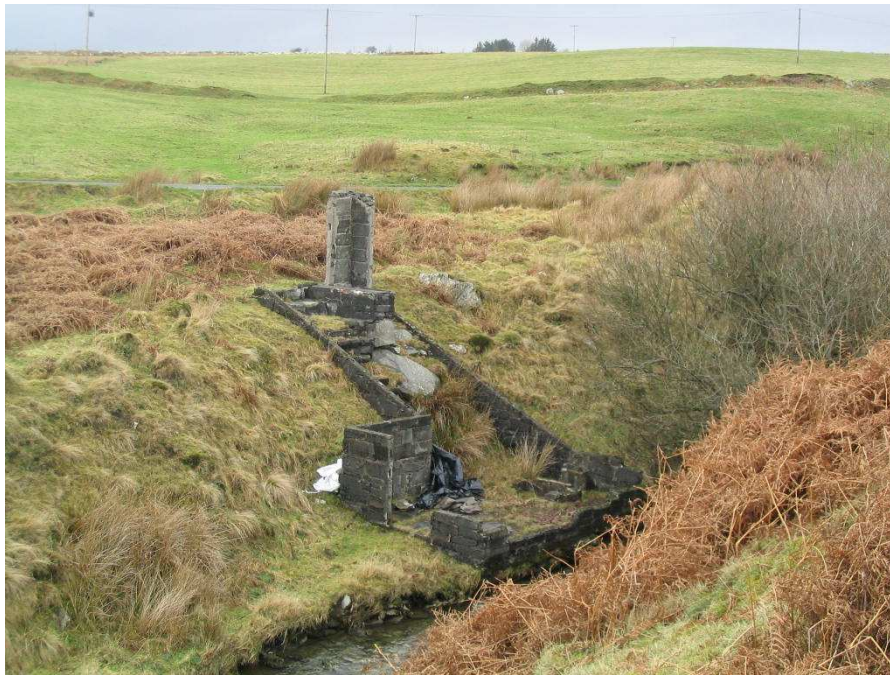
**Plate 8** *Remains of the housing for a turbine, next to a fast-flowing section of the stream.*

The housing is in good condition and seems to be stable.

See recommendations made for the mine (PRN 25943) and also section B2 of the Tir Gofal Farm Management Plan (Protection and Maintenance of Archaeological and Historic Features) for general recommendations.
