Erwbarfe W/11/4046

Tir Gofal Farm Visit Historic Environment Report Call Out

Report No. 2004/04

REPORT NO. 2004/04
PROJECT RECORD NO. 47880

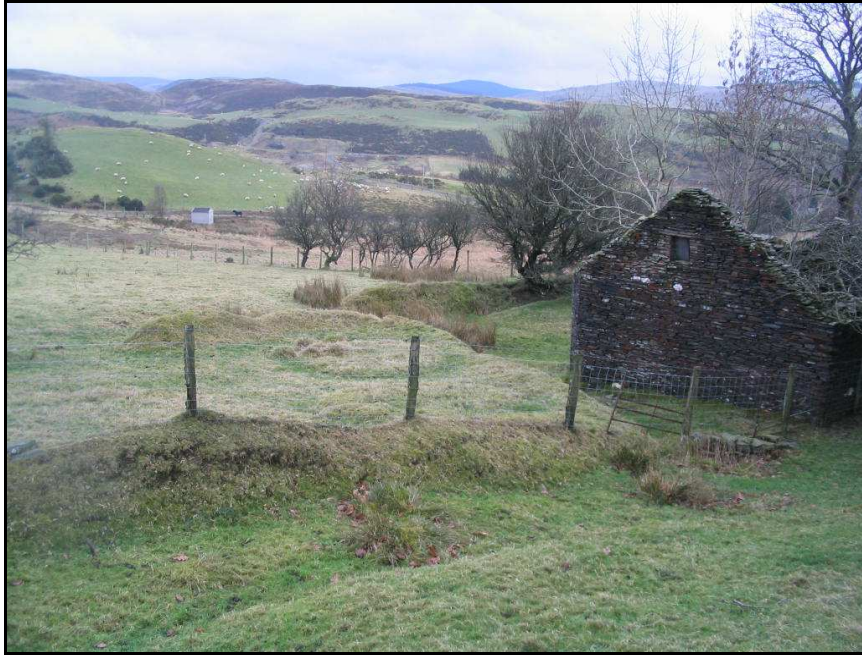
A roughly triangular enclosure to the west of the main range is marked out by low earth banks. The enclosure is slightly raised from the surrounding ground level and contains two circular features at its east end. These are raised, firm platforms around 2m in diameter. They are probably stack-stands, on which hay ricks would have been built.

Plate 2 (above) *The northwest end of the main range of Pengarreg Farmstead. The circular feature in the enclosure to the left of the building is probably a stand, on which a hay rick would have been constructed.*

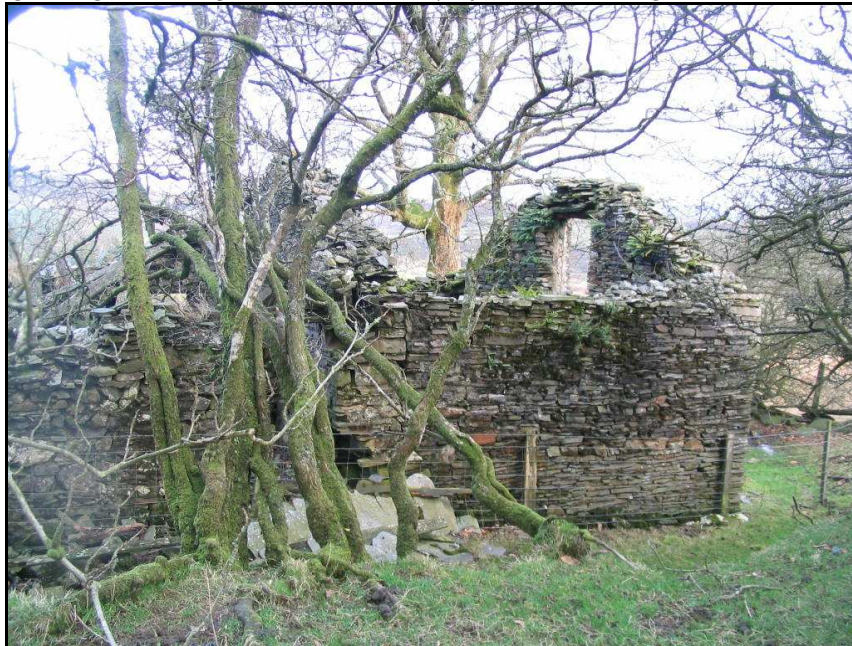
The building seems to be in a stable condition, but trees from the grown-out hedge around the enclosure to the southwest are beginning to rub against the southwest wall. A few trees are growing up inside the ruins of the building. The landowner did not express any intentions to carry out any specific works on this site.

Plate 3 (below) *Trees from the grown-out hedge which surrounded the enclosure south of the building are beginning to rub against the masonry of the main range.*

- i. Branches which are beginning to rub against the stonework of the main building should be lopped off and removed from the site before they cause damage to the masonry.
- ii. The old feeders on one of the outbuildings should be removed.

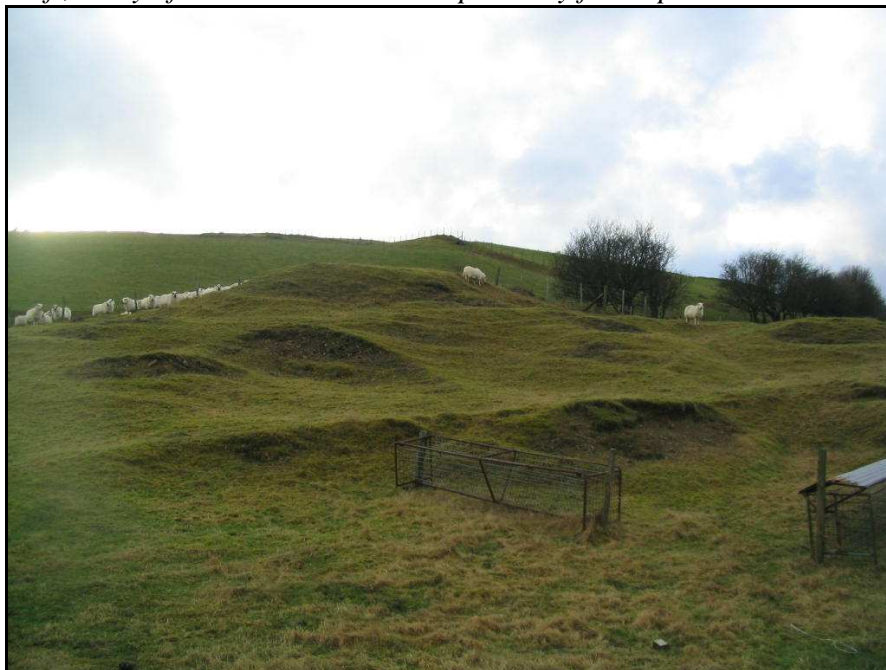
The area of the lead mine is all covered in short turf, and is used as grazing for sheep. Mostly it is in fair condition, but there are a number of clear sheep paths being formed, and these are starting to cause erosion problems where the slight vegetation has been lost. The erosion is most notable around feeders situated just to the west of the track which passes through the centre of the mine. Under Tir Gofal, a possibility has been raised that stock are taken off the mining area, and that heather regeneration is encouraged in this area.

Plate 5 (below) *The disturbed ground within the area of the lead mine. The mound in the middle distance is a shaft, many of the other mounds are probably from spoil.*

Management of this site should aim to ensure that the mine remains a visible feature and does not suffer from erosion. To this end, the proposal to encourage to exclude stock from this site and to encourage heather regeneration is generally welcomed, but there are a number of factors which will need to be borne in mind.

- i. Health and safety concerns. At present, the vegetation is very low and potential dangers (e.g. shafts and levels) are clearly visible. However, any increase in vegetation will reduce the visibility of these sites and make them a potential hazard. Fencing should be avoided wherever possible as it will encourage undergrowth and scrub within the fenced area. However if it is necessary for sites to be fenced off, the work should cause as little ground disturbance and be as visually unobtrusive as possible.

- ii. Stock exclusion will prevent the erosion in the west of the area from worsening, and will allow the very thin vegetation to establish better cover. However, it will also allow scrub and undergrowth to grow up, and these will eventually obscure the site and therefore reduce the ease with which the site can be understood. It is important, therefore, that scrub growth is controlled. This will need to be carried out by hand, and vegetation should be cut at ground level and removed from the site.

- iii. Once an adequate heather covering has been established across the mine, it will probably be necessary to re-introduce a light grazing regime in order to control the height and density of the vegetation and to prevent the sites from becoming completely invisible. Grazing should also negate the need for regular scrub control (see above) in the long term.

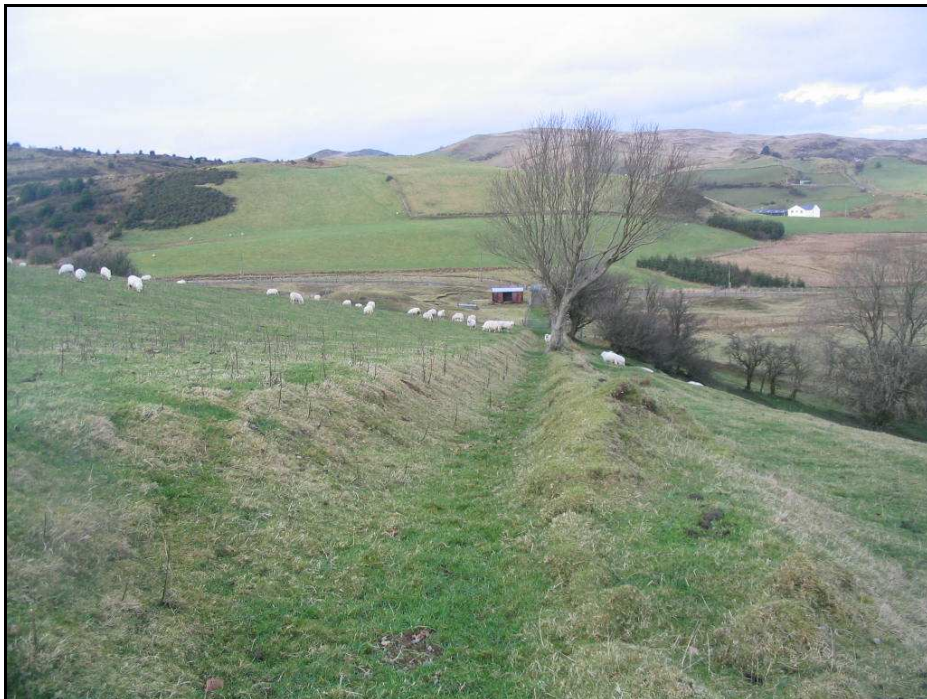
A pronounced trackway leading up the hillslope and consisting of a narrow path between two earth banks. The track is seen on early Ordnance Survey maps and probably served the mines, with an 'offshoot' leading to Pengarreg Farmstead.

Plate 6 *Trackway leading down the hillside towards the lead mines.*

The trackway and field boundaries should be maintained in their current conditions, and should not be removed or damaged.
