Erwbarfe W/11/4052

Tir Gofal Farm Visit Historic Environment Report

REPORT NO. 2004/05
PROJECT RECORD NO. 47883

January 2004

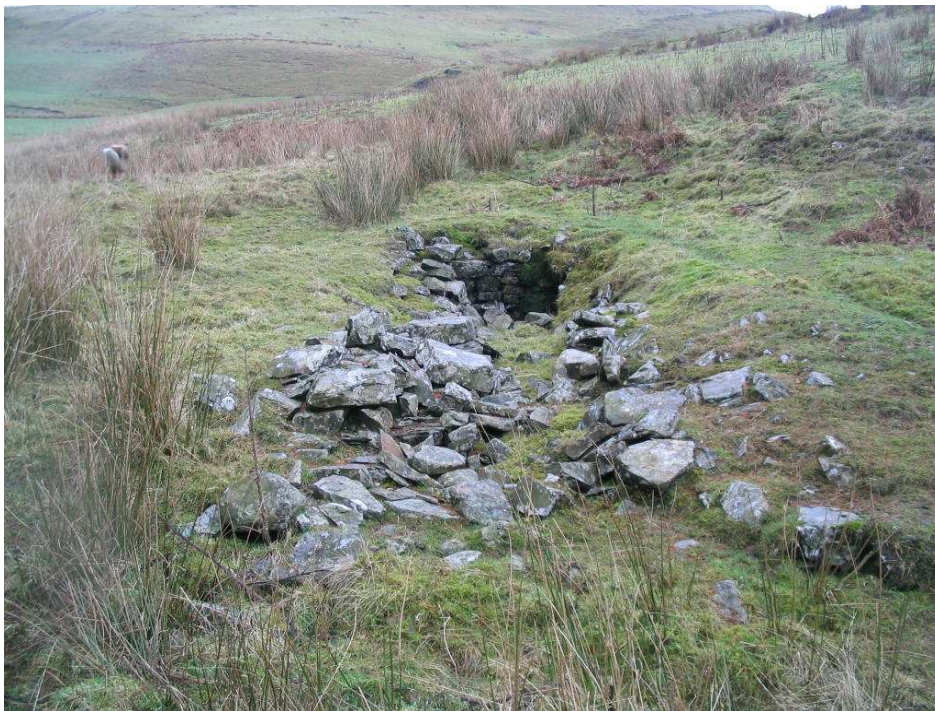
Traces of a small lead mine, marked on the 1891 and 1906 Ordnance Survey maps as 'level'. The remains are on both sides of the stream which marks the farm boundary. A substantial spoil heap lies on the north bank of the stream (outside Erwbarfe), and is surrounded by traces of smaller tips. On the south side of the stream are three open cuts – probably adits – and several spoil tips. One of the cuts has surviving traces of a stone lining, and other building stone is scattered around the area.

The site seems stable, and is probably bracken covered in the summer, though the vegetation was low on the day of the farm visit.

Plate 1 *Some of the lead mining remains by Nant Ysbyty Cynfyn. This cut or adit is partially stone lined and is set in an area full of small spoil tips.*

The feature should be maintained in a stable condition. See section B2 of the Tir Gofal Farm Management Plan (Protection and Maintenance of Archaeological and Historical Features).

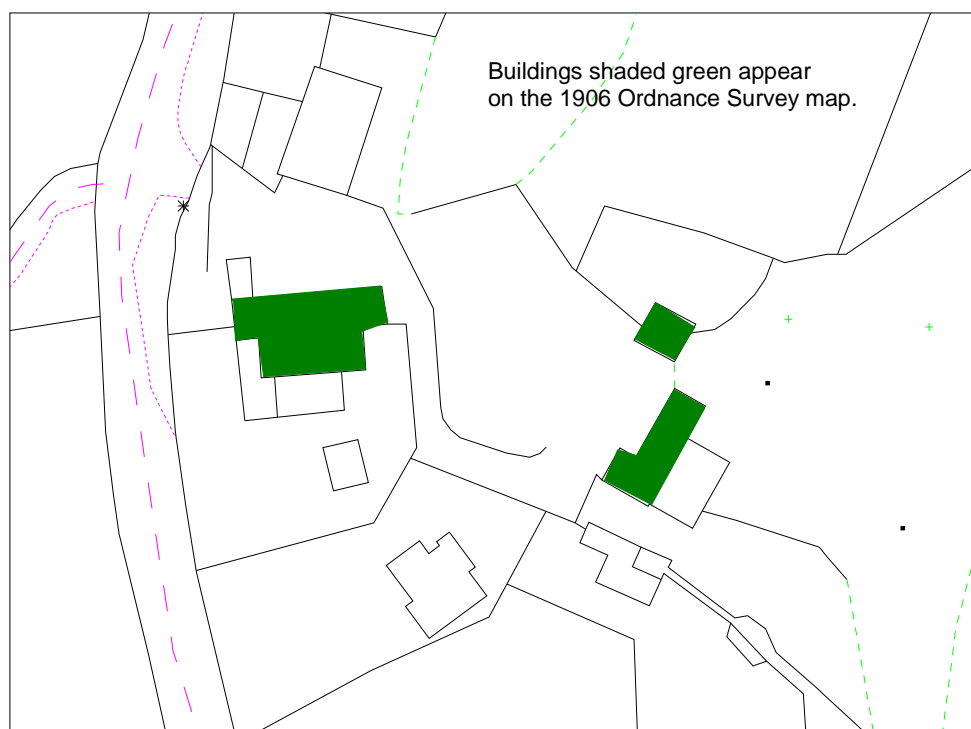
Erwbarfe farmstead is set within the Historic Landscape Character Area of Ysbyty Cynfyn, part of the Upland Ceredigion Landscape of Outstanding Historic Interest. It is one of a number of dispersed farms scattered throughout the area and is shown on the Ordnance Survey drawings of 1820-21 as 'Erw Berfa'. Three buildings are depicted on the 1906 Ordnance Survey map, and are still seen in the present-day layout of the farm. These are the house itself, a barn and an agricultural building which probably originated as a cowshed or a stable.

The surviving buildings are stone built and slate roofed, and appear to be in good condition.

Plate 2 Map showing the layout of Erwbarfe farmstead.

Traditional buildings should be maintained using appropriate materials and techniques. See section B2 of the Tir Gofal Farm Management Plan (Traditional Buildings).

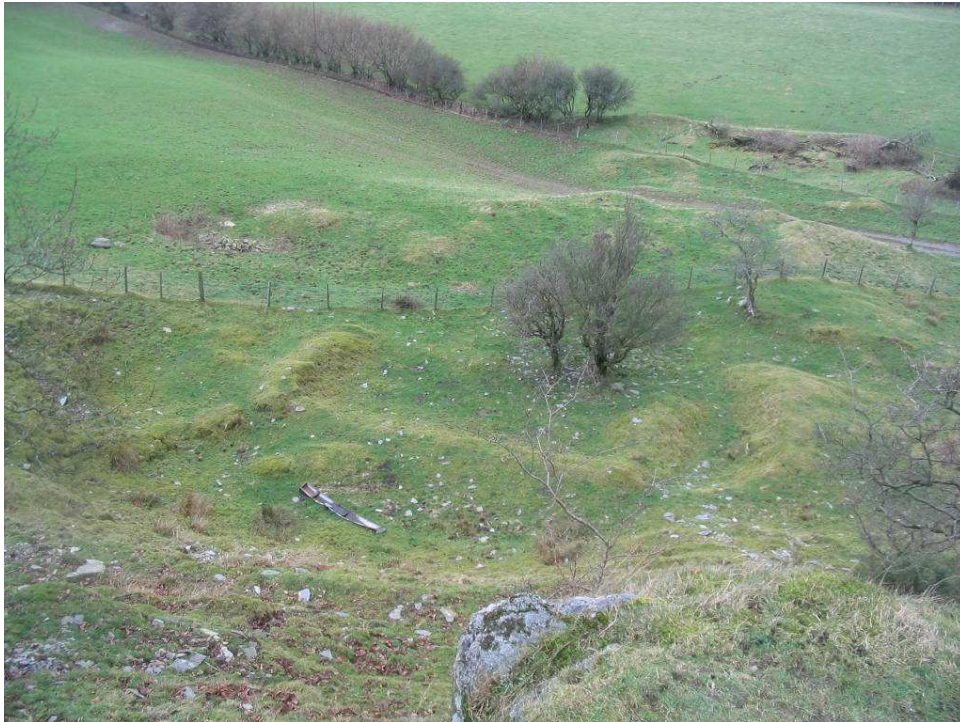
A deserted farmstead site consisting of the farmhouse (PRN 34874), a garden or enclosure (PRN 34875), a sheep fold (PRN 34876) and a possible long hut adjacent to the sheep fold (PRN 34877).

The farmstead is seen on an estate map of 1764 and on the Ordnance Survey surveyor's drawings (1820–21), when it is named as Ty'n Lan Fawr. On the tithe map (1846, Llanbadarn Fawr parish) it is seen to consist of two buildings (PRNs 34874 and probably 34877), but by the time of the first edition Ordnance Survey map (1891) the most westerly (?PRN 34877) had fallen out of use. It is possible that Danylan originated as a *lluest* similar to Banc Erw-Barfe (PRN 34866). This would have consisted of a building (the possible long-hut, PRN 34877) and an enclosure (PRN 34876). Later, the farmhouse and garden were added and at the long-hut fell out of use. The original enclosure associated with the long-hut could then have been re-used as a sheep-fold. The complex survives as a series of earthworks partially terraced into a rocky outcrop. The site is generally in fair condition, although the ground is very wet and there were some signs of poaching. A farm track runs through the northern edge of the farmstead and there are two gateways into adjoining fields situated very close to the site.

Plate 3 Earthworks from the deserted farmstead of Danylan. The farmhouse (PRN 34874) and enclosure/garden (PRN 34875) are in the foreground, with the sheep-fold (PRN 34877) crossed by the fence-line on the far side of the track. The small rectangular feature in front of the fold may have been a long hut (PRN 34877).

The site of Danylan farmhouse, part of a now-deserted farmstead complex (PRN 33194). The farmhouse survives only as a rectangular earthwork, terraced into a rocky hillside. The Nanteos estate maps show that the house was occupied in 1764. See plate 3.

The site of a garden or enclosure, lying just north of Danylan farmhouse (PRN 34874) and part of a now-deserted farmstead complex (PRN 33194). The boundaries of this enclosure survive as low earth and stone banks forming a roughly rectangular 'paddock'. No features were observed inside the enclosure. A slightly sunken track runs between the house and the 'garden'. See plate 3. The earthworks are in good condition and have a stable vegetation covering.

A roughly rectangular enclosure marked as a sheepfold on the 1891 Ordnance Survey map. The fold lies just north of the deserted Danylan farmhouse (PRN 34874) and is part of the farmstead complex (PRN 33194). See plate 3.

The fold is in stable condition, but a modern fence cuts across it.

Management should aim to preserve the whole complex as a visible, stable feature. It should also safeguard buried archaeology associated with the farmstead.

- i. The ground is very wet, and could become waterlogged and poached very quickly. To avoid damaging buried archaeology, the site should only be grazed by sheep (no cattle) and will need to be monitored. Stock should be removed if there is any sign of poaching.
- ii. Care should be taken that the farm track does not encroach onto the site. Heavy vehicles should not use the track or the gateways when the ground is very wet.

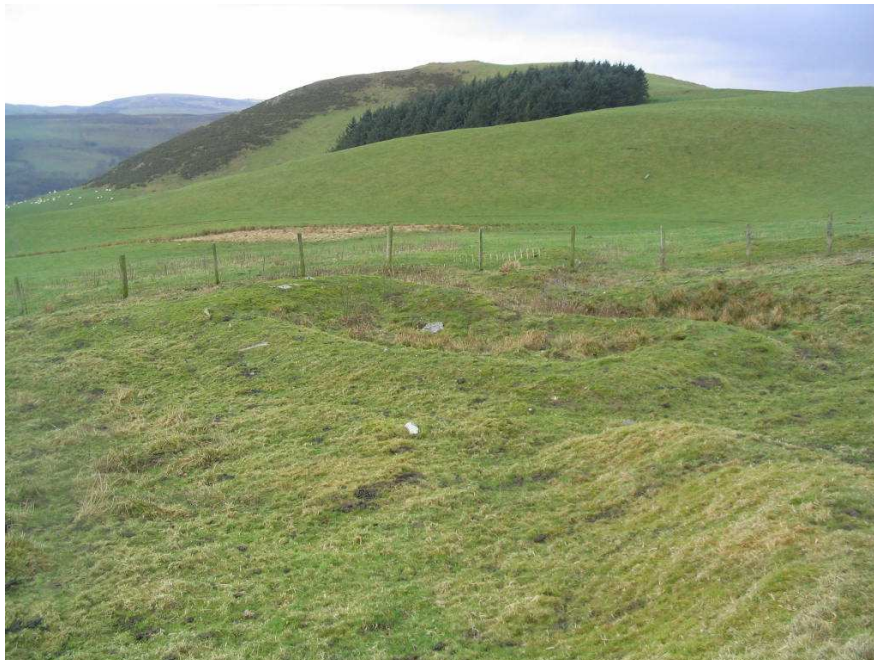
Plate 5 (below) Earthwork showing the long hut (PRN 34867) at Banc Erw-Barfe deserted rural settlement.

Earth and stone banks picking out the 'footprint' of a long hut, part of Banc Erw-Barfe deserted settlement (PRN 34866). The long hut measures around 9m x 5.5m, with an entrance on the north side.

The site is in a good, stable condition.

See section B2 of the Tir Gofal Farm Management Plan (Protection and Maintenance of Archaeological and Historical Features), and the management recommendations made for PRN 34866.
