55 PRIORY STREET, CARMARTHEN (FORMERLY LOWNDES GARAGE)

**ARCHAEOLOGICAL EVALUATION AND WATCHING BRIEF,
APRIL 2003**

Report No. 2003/66

REPORT NO. 2003/66
PROJECT RECORD NO. 48082

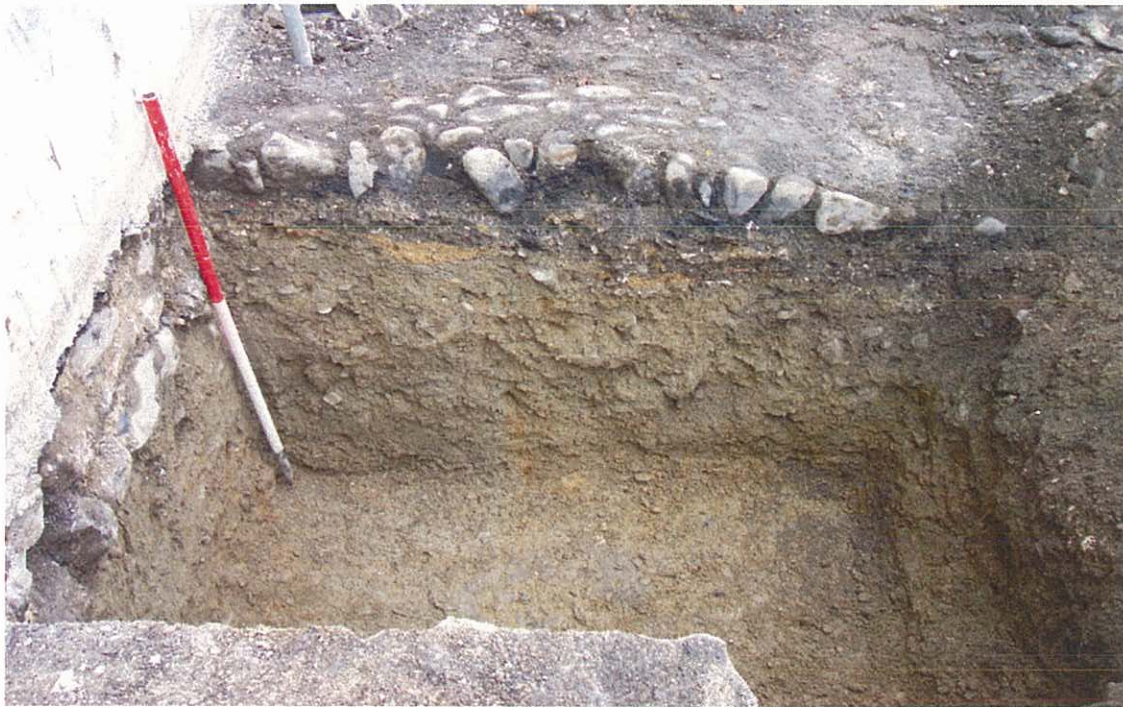
Fig. 3: South facing section of Trench 1

This test pit was located on the western edge of the site, up against the wall of the neighbouring house. Directly below the foundation slab for the garage a small area of *in-situ* cobbling was revealed. This cobbling appeared to run up to the wall and is thought to be the remains of a cobbled access-way between houses. The cobbles were set into soft dark sooty material, in turn lying above a mixed layer of mortar, shale, redeposited natural gravels and clay silt. This layer is presumed to be a make-up layer for the cobble surface. Beneath this layer and the top of natural gravel deposits were some shallow pockets of orange silty clay. These may represent clay filled ruts from before the cobble surface was laid.

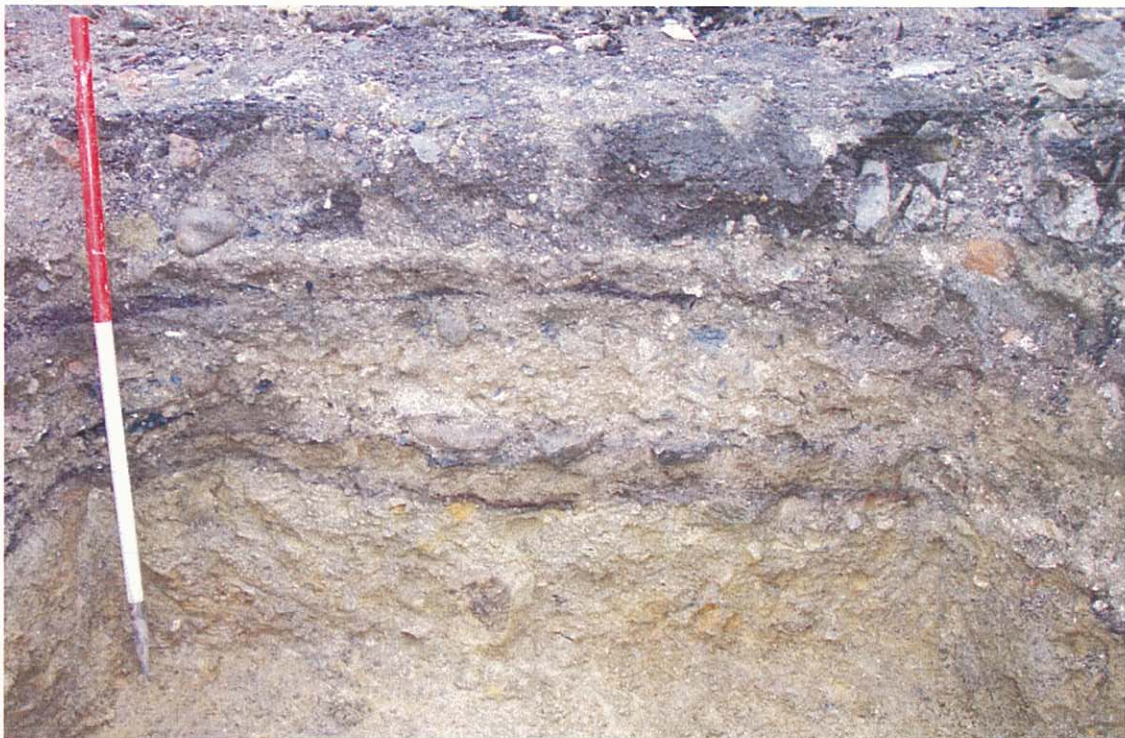
Fig. 5: South facing section of Trench 2

This test pit excavated in the north east corner of the site. Beneath approximately 0.20 metres of make-up deposits, were two layers of mortar rich deposits that are presumed to represent the demolition of the building that stood on the site before the construction of Lowndes Garage. Beneath these was a thin layer of dark brown humic material on top of a layer of grey green silty sand. Compacted into the top of this layer was a patch of crushed clay pipe stems. Although no dating evidence was recovered, this is presumed to be a 19th century occupation layer. Beneath this layer were two more layers of re-deposited natural sandy silts with shale, cobbles and some mortar. These overlay a layer of flat lying stones set into a layer of compact (possibly burnt) shale. This was probably the patchy remnant of a stone surface. No dating evidence was recovered from this horizon so it cannot reliably be attributed to a particular period. Beneath this was a layer of yellow brown silty clay (probably a make-up layer for the stone surface above). Three stake holes aligned approximately at a right angle to the road were identified at this level, but may have been associated with the stoney surface above. Beneath this layer was the top of the natural gravel deposits. This horizon appeared to be a compacted and possibly burnt surface. Although no dating evidence was recovered from this horizon it can be speculated that it may represent the Roman period.

In addition, this street-frontage area was heavily truncated by the insertion of four fuel tanks and the concrete settings for the garage frame. Only in Trench 2 was there any suggestion of a possible Roman period horizon. Since these deposits or their equivalent were not encountered in either Trench 3 or the eastern and northern foundation trenches, it is assumed that this was a small 'island' of stratigraphy that had somehow escaped subsequent truncation.

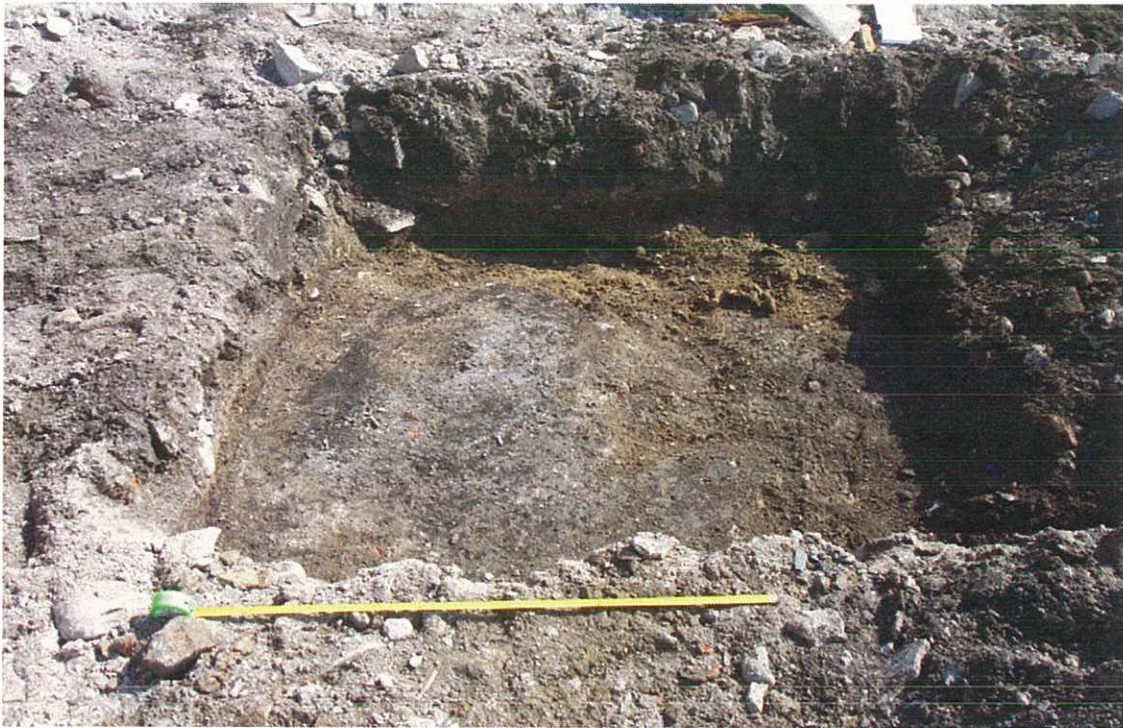
Fig. 7: Trench 2 during excavation, looking east (showing area of crushed clay pipe stems)

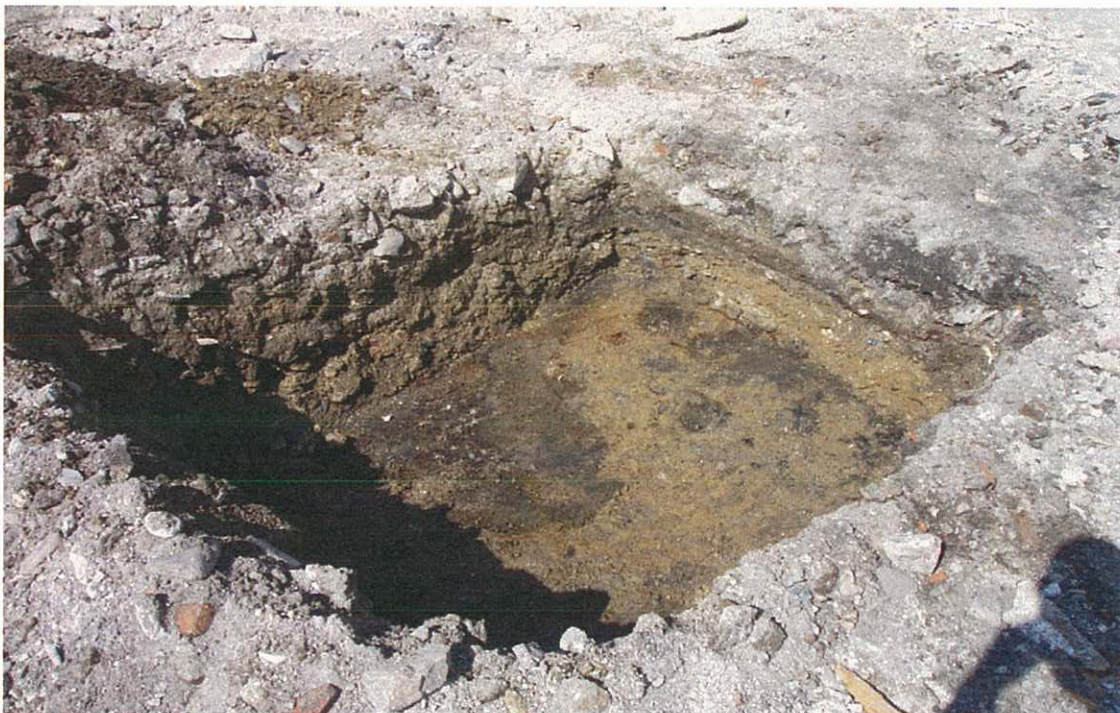
Fig. 8: Trench 2 during excavation, looking north (showing stake holes top right)

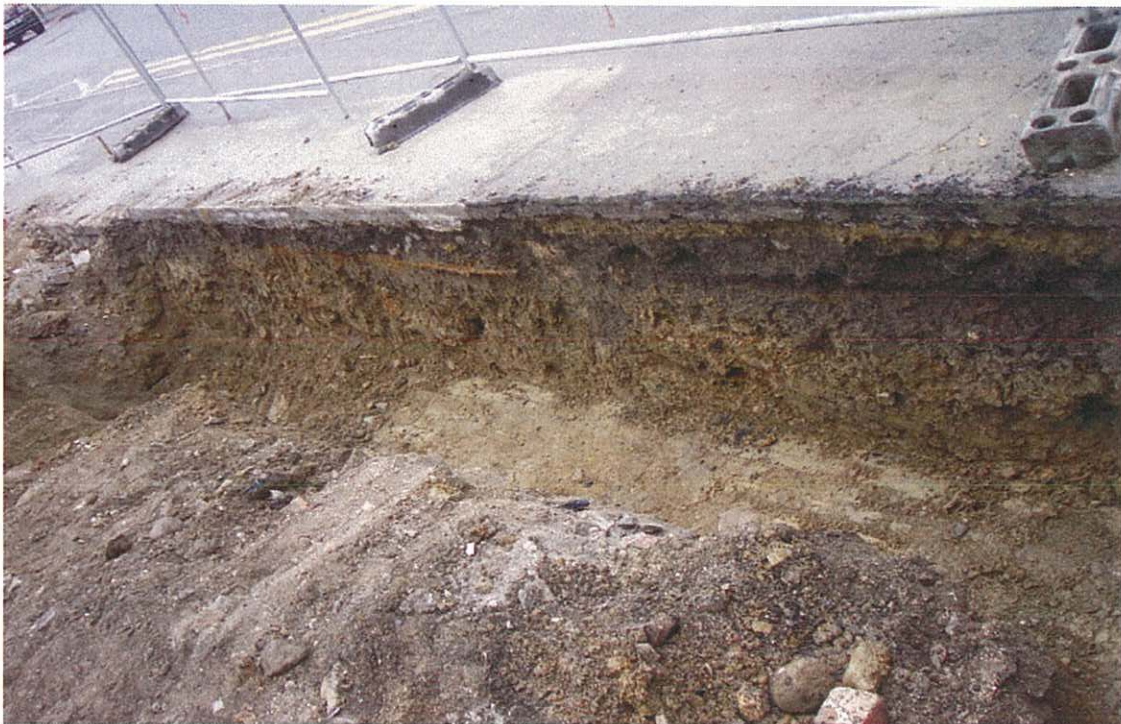
The majority of deposits in foundation Trench 4, along on the street frontage, were truncated by the fuel storage tanks and concrete settings for the steel frame of Lowndes Garage. Surviving deposits were all of post-medieval date, directly overlying natural gravels (Fig. 13).

Fig. 13: Trench 4, the foundation trench along the street frontage, south facing section

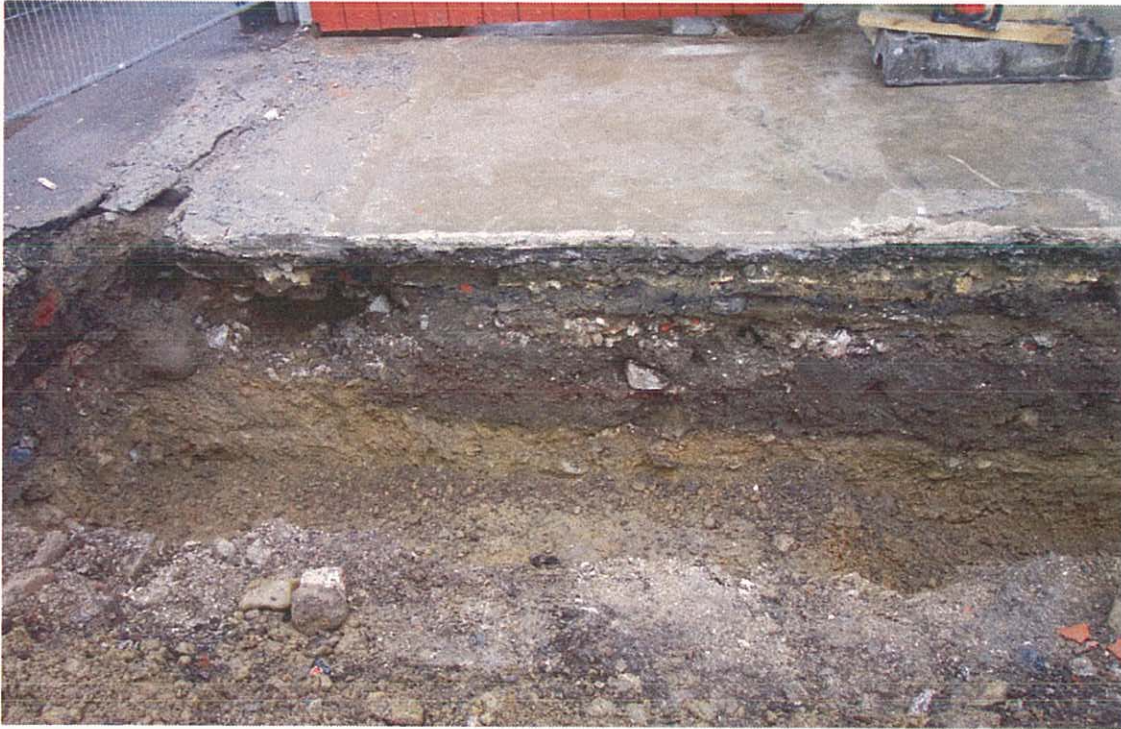
Trench 5, the foundation trench along the eastern edge of the site, also revealed only mixed dark grey silty post-medieval deposits overlying natural gravels and gradually sloping down to the south. The post-medieval material dropped below the bottom of the foundation trench approximately 7 metres from the street front. The top of the gravels appeared to follow the natural contours of the land but the absence of the more complex stratigraphy encountered in Trench 2 suggests that the majority of earlier deposits may have been truncated away before the post-medieval deposits were laid down. No evidence of post-medieval building remains was encountered within the trench (Fig. 14).

Fig. 14: North end of Trench 5, the easternmost foundation trench, west facing section
