CARMARTHEN CASTLE

EXCAVATIONS OUTSIDE THE GATEHOUSE, JUNE-AUGUST 2003

REPORT NO. 2004/22 PROJECT RECORD NO. 48083

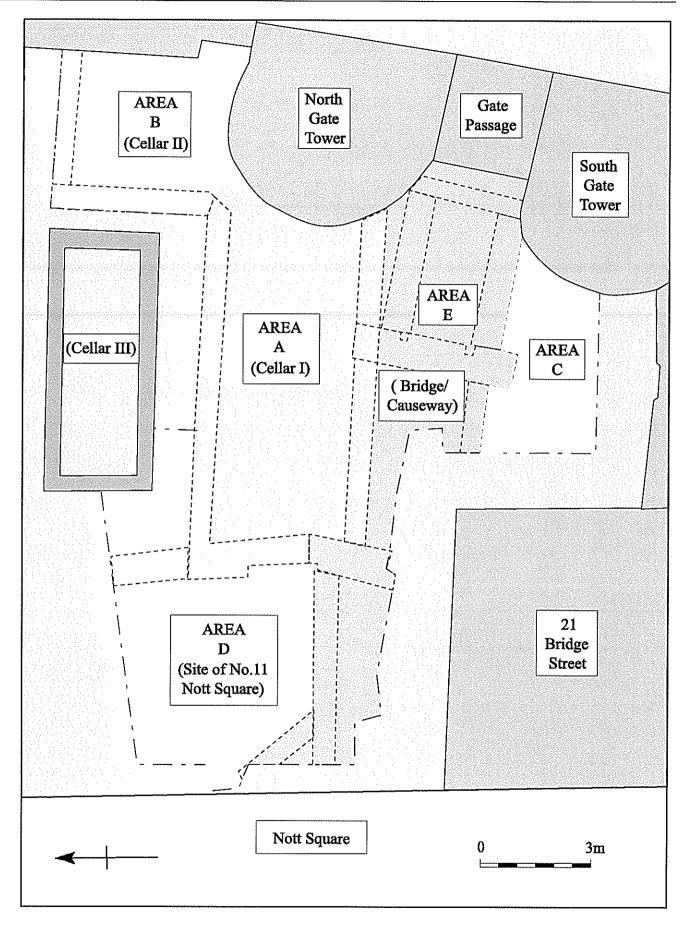
Fig. 2: Plan of Carmarthen Castle gatehouse and excavated area

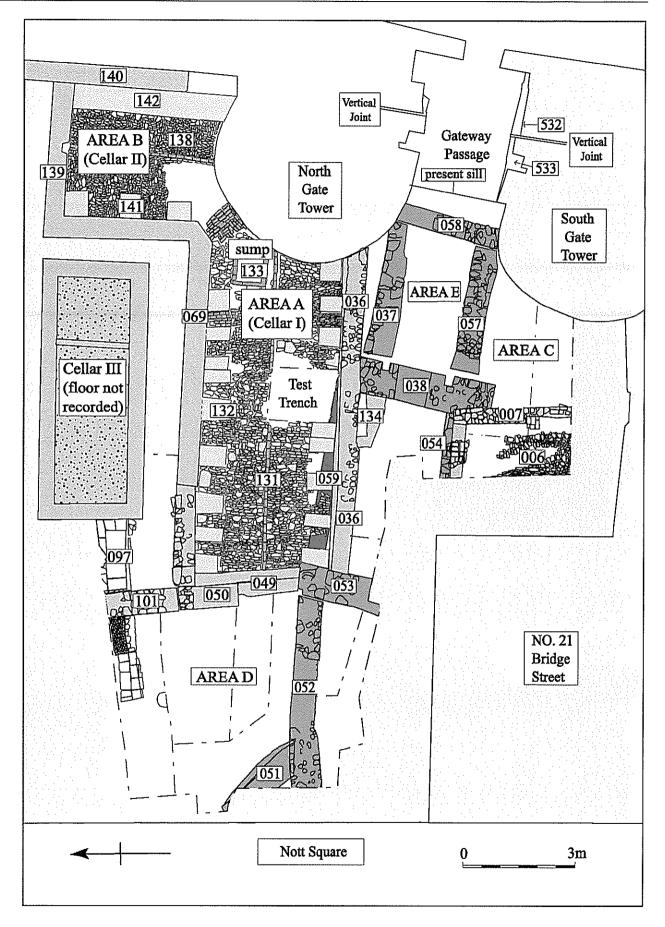
Fig. 3: Composite plan showing excavated areas, cellars and context numbers

The form of the pre-1409 gatehouse is not known. It may have been one of the 'five towers' of the inner bailey mentioned in sources from the mid 13th century onwards. Two windows in the 'tower above the gate' were repaired in 1288-9 (Green 1913, 47-8, citing Pipe Roll 17 Edw. I). It appears to have been a substantial structure by the 1350s, at least, when the then Constable's Chamber - which had a stone-flagged floor - was already being described as lying 'over the large gate' (Green 1913, 63-4, citing PRO, Ministers' Account, 1221, 10). All the surviving detail in the present structure is 15th century and later, but the lost rear section may have incorporated elements of the earlier gatehouse, including the constable's chamber. Indeed, a vertical joint is visible towards the east end of both sides of the present gatehouse passage, perhaps representing the junction of the pre- and post-1409 structures (Fig.3).

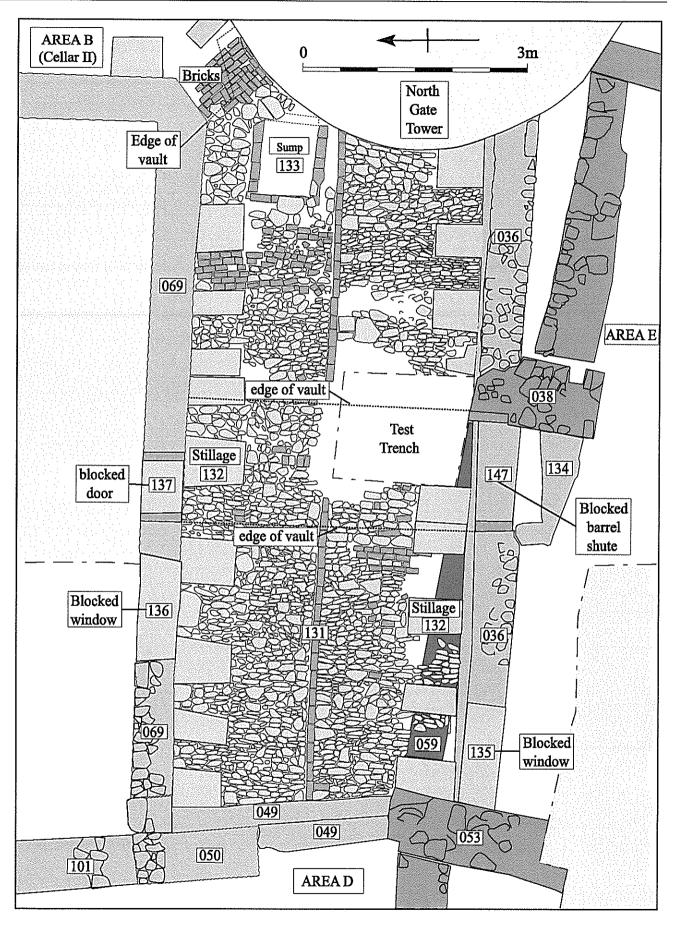
Fig. 4: Detailed plan of Area A (Cellar I)

Area A comprised a large, vaulted cellar, Cellar I, which runs westwards from the gatehouse north tower towards Nott Square alongside, and immediately north of, the line of the medieval bridge/causeway. It measures approximately 9.0m E-W and height of approximately 2.10m to the vault apex (see Fig. 4).

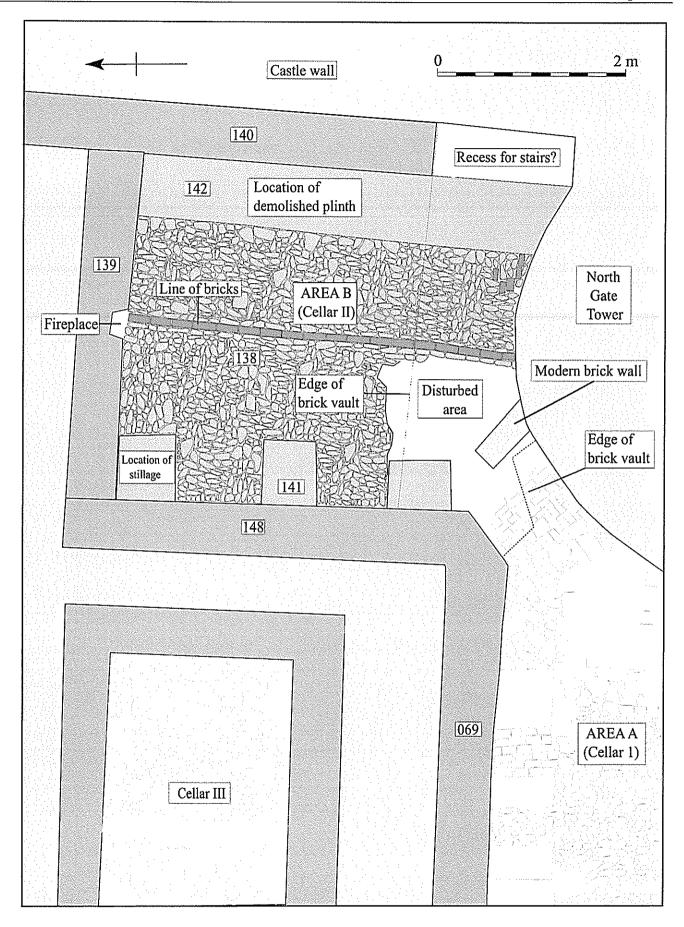
Fig. 5: Detailed plan of Area B (Cellar II)

3.3 Area B (Cellar II) - Fig. 5, Photos 26 and 43

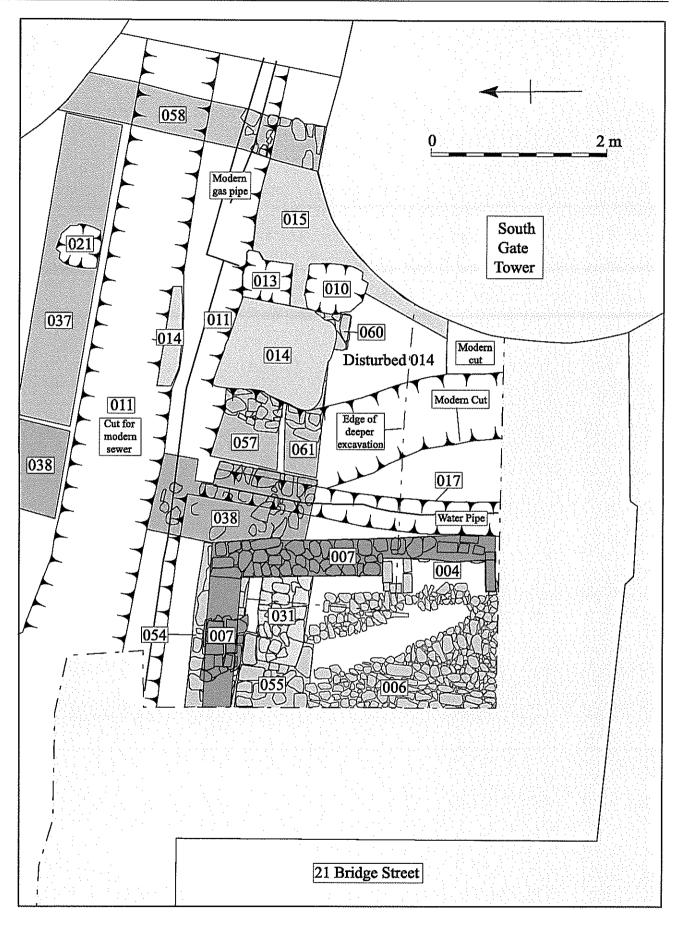
Fig. 6: Plan of Area C (No. 21 Bridge Street)

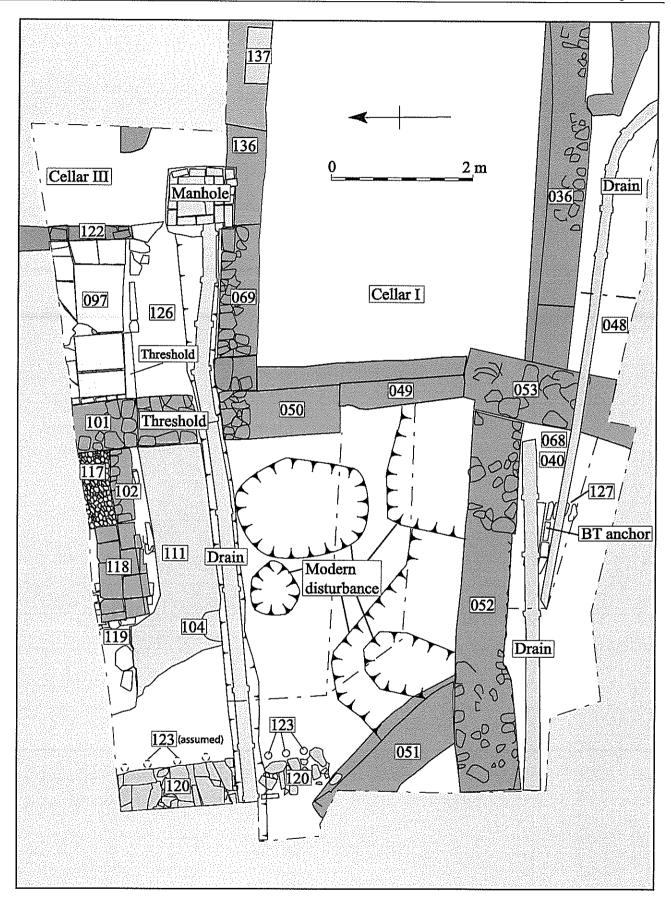
Fig. 7: Plan of Area D (No. 11 Nott Square)

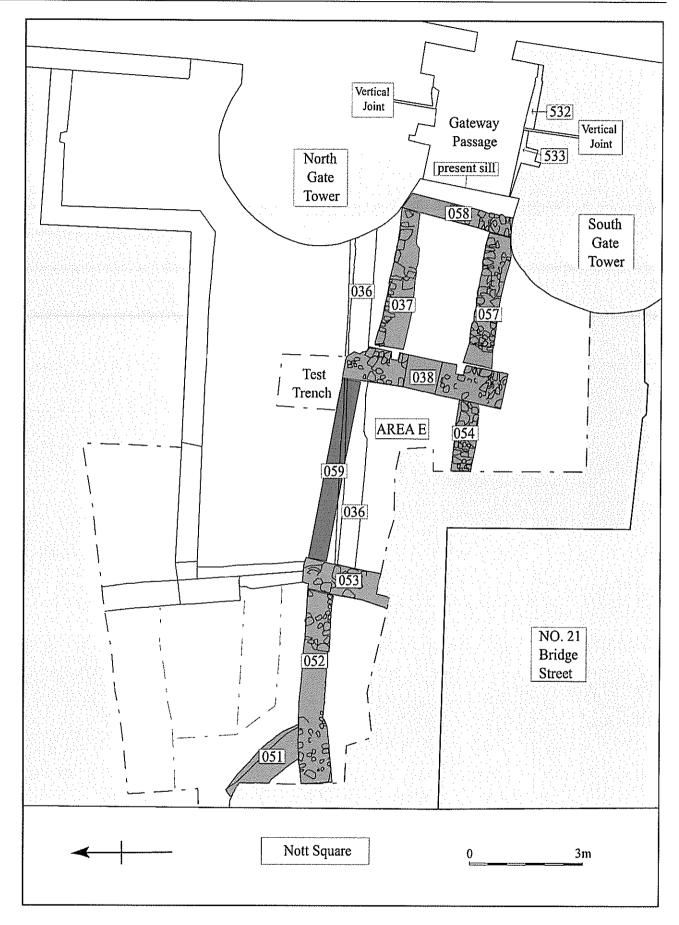
Fig. 8: Plan of all bridge/causeway walls within the excavated area

3.6 Area E (the medieval bridge/causeway) - Figs. 8, 9 and 11, Photos. 9, 39, 44

3.6.1 The bridge/causeway - Figs. 8-11

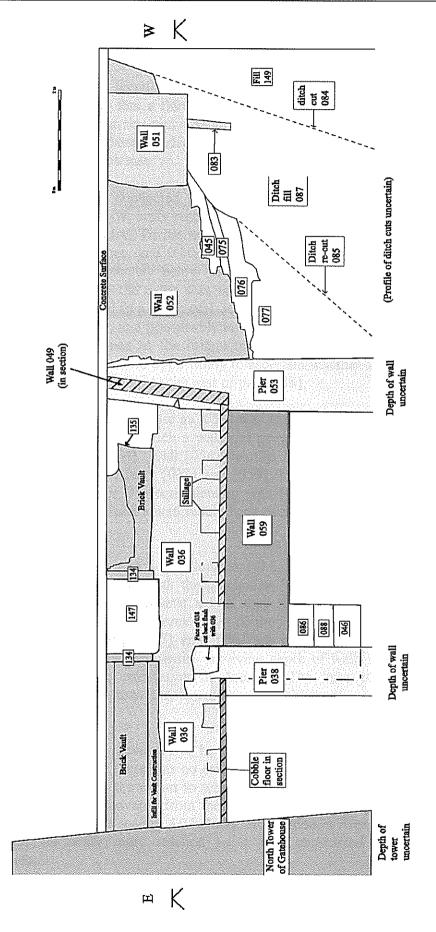
Fig. 9: Schematic elevation of north-facing side of bridge/causeway

The western pier, [053], was not fully exposed in plan, and its full height is not known, having only been exposed to the level of the floor of Cellar I, a depth of 3.0m from the present ground surface. The original dimensions of pier [053] are assumed to be similar to those of pier [038]. Unlike pier [038] its north face is markedly tapered towards the top, diminishing to a thickness of 0.5m. This may be due to a later repair or rebuild rather than an original feature, but if original, it may suggest that this pier once marked the western edge of the ditch. The two piers would have supported decking for a fixed timber bridge, possibly stopping at the eastern pier where a movable drawbridge may have communicated with the castle gatehouse (see section 5.0 below). The slots or chases in the eastern pier may have supported the bridge timbers, but they may have been associated with a drawbridge as no such features

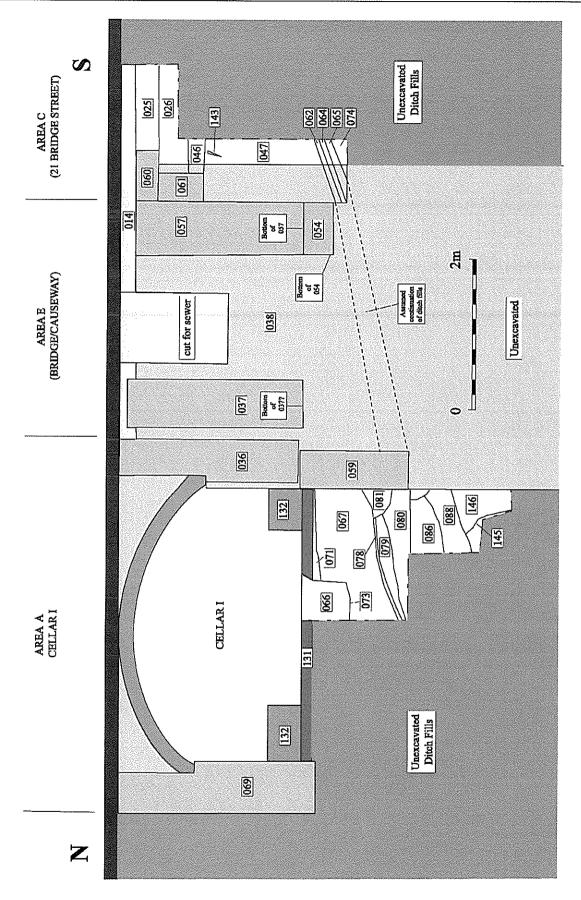
Fig. 10: Schematic north-south section through site, across the bridge/causeway

Street, and associated exterior surfaces. These in turn overlay a sequence of wall remnants built against the south face of the bridge. Beneath these was a sequence of backfill deposits within the castle ditch (See Figs. 10 and 14).

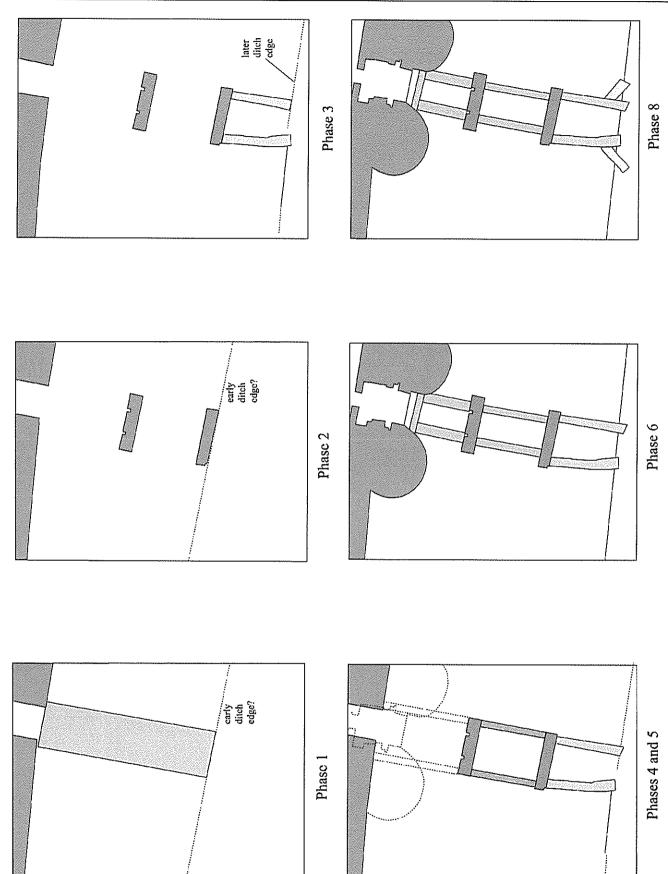
Fig. 11: Proposed Phasing of bridge/causeway (Area E)

The removal of these later contexts revealed the tops of the walls of the medieval bridge/causeway (Photo. 9), and the top of a sequence of deposits representing the backfilling of the medieval defensive ditch. There was no evidence of any earlier structural phases of No. 21 Bridge Street, or of any buildings that may have pre-dated it. The upper backfill deposits were, however, associated with a sequence of apparently truncated stone wall foundations [060], [061], [031], [055], [056], built against the southern face of the medieval bridge/causeway (Photos. 5 and 6). The earliest of these walls, [061] and [056] were most probably the remains of property boundaries or garden walls associated with No.21 Bridge Street. The later walls [056], [031], and [060] were wider, and may have been buttresses to support the side-walls of the bridge/causeway in the later stages of its use. Deposited against these walls were chronologically associated ditch fill deposits [025], [026] and [046] (see Fig.11).

Wall [052] is thought to belong to Phase 3 because it appears to be on a slightly different E-W alignment than the other walls of the bridge and is of superior construction and quality. The small quantity of ceramic material recovered from causeway fill [040], immediately to the south of wall [052] has been dated to the 13th-14th century, but material from the 18th century is also present. If the later material is considered intrusive (not unlikely considering the degree of later disturbance to this area) a 14th century date for the bridgehead construction is entirely feasible. Deposits on the north side of wall [052] date from the 17th century, but, as will be discussed in the next section (5.5), these relatively late deposits may have been deposited after a period in which the ditch was re-cut, effectively removing earlier deposits. Wall [051] is an angled buttress, strengthening the point where wall [052] meets the ditch edge. Although it appears to be of the same phase as [052] it is of a different build. In addition, stratigraphic evidence suggests that this wall is a late addition to the causeway, occurring shortly before the intentional backfilling of the ditch in the 17th century (Fig. 11).

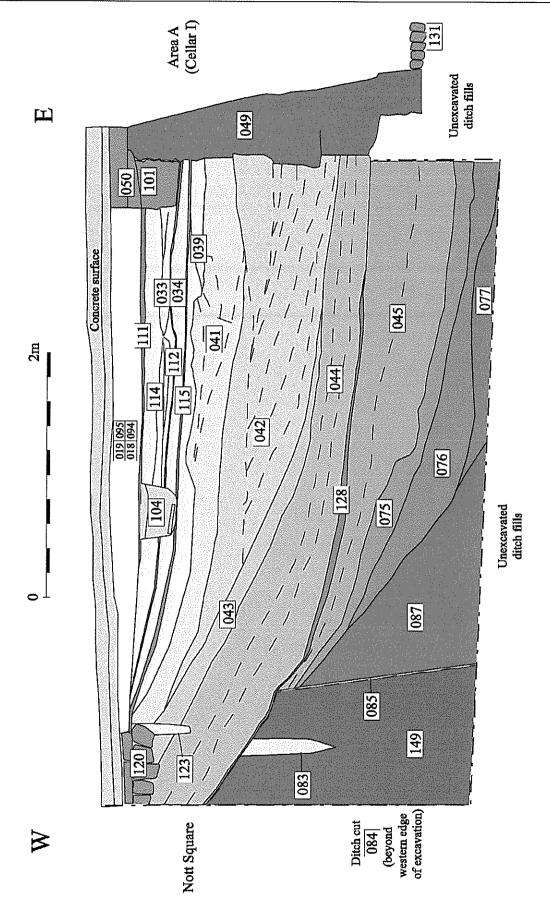
Fig.12: Schematic south facing section through castle ditch deposits in Area D

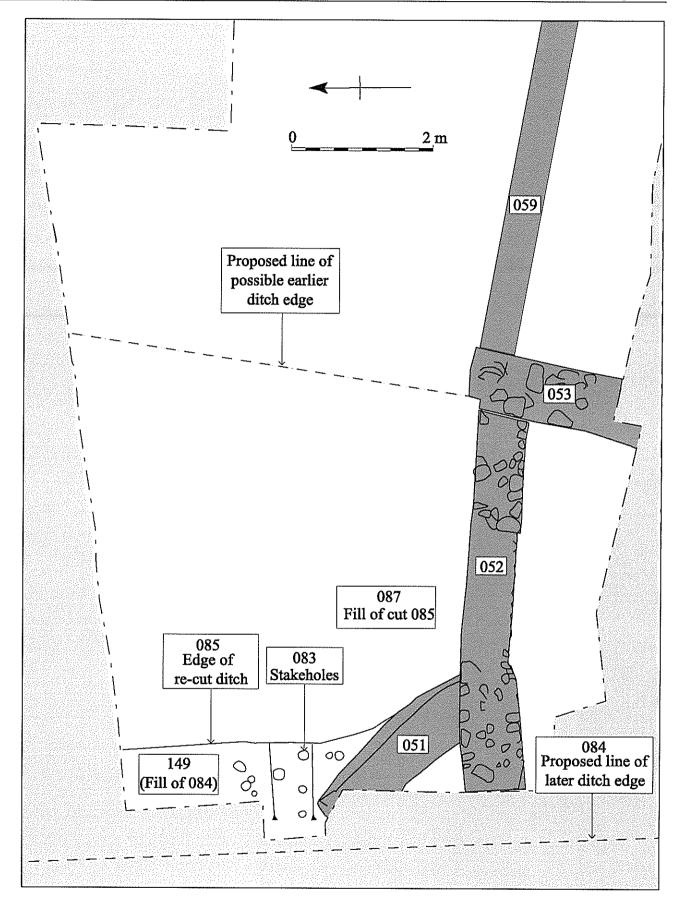
Fig. 14: Plan showing proposed sequence of ditch edges

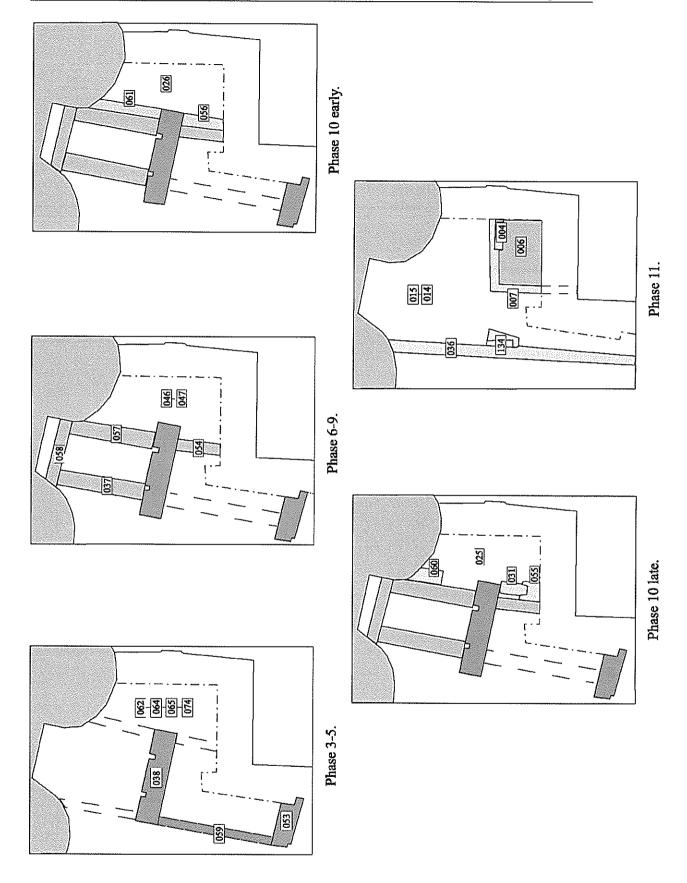
Fig. 15: Wall phases and associated deposits in Area C.

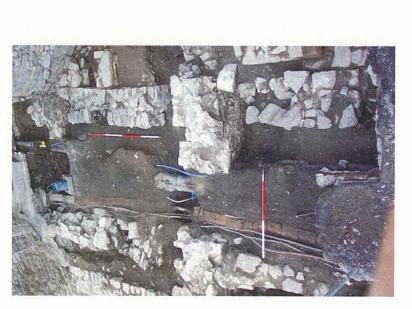
Photo 9: Area E. East end of causeway looking East. Showing walls 038,054,057, 037, 134, 136 (top left), 060 (top right) etc.

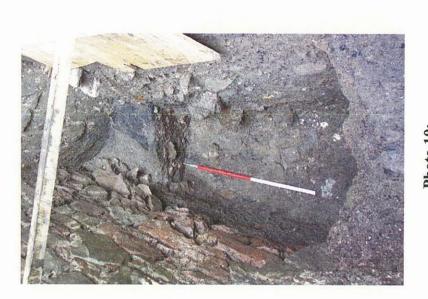
Area C. Showing base of causeway wall 057 (left) with section through deposits 062, 064, 065, 074 (at top). Note red sandstone, possibly derived from 059, and angle of tip lines in fills.

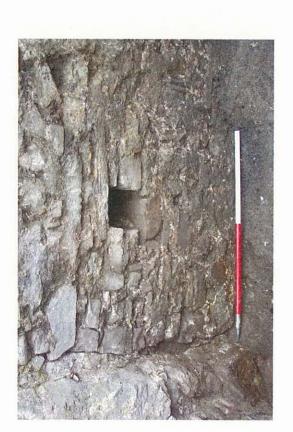
Photo 12: Area D. Wall 052 (053 to left) looking south. Note drainage hole.

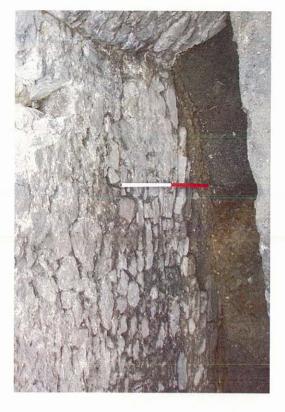
Photo 15: Area D. Wall 052 showing base of wall (051 to right) looking south.

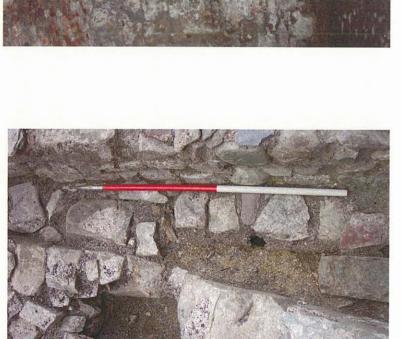
Fhoto 25:
Area E. Facing west. Wall 036 (to right), wall 037 (left), with construction cut 030 and fill 029 (beneath scale) and post hole 021(top left).

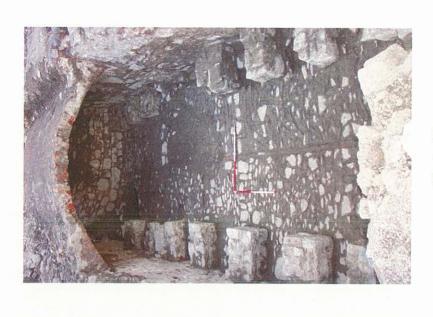
Photo 27:Area A. Cellar 1.Facing east. Stillage 132. Cobbles 131.

The stillages [132] were built on the surface of the cobbled floor. The tops of the stillages show grooves that would have held timber structures upon which beer or wine barrels were housed. The plinths are of differing widths and irregular spacing, suggesting they were built on an *ad hoc* basis as required. Cut into the cellar floor at its eastern end is a red brick lined sump [133]. This feature, and some of the repairs to the cobble floor, attest to drainage problems within the cellar.

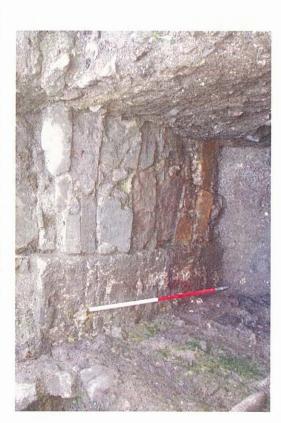
Photo 42: Area A. Cellar I, trial trench, Facing south, showing top bottom of wall 059(right) and pier 038 (left).

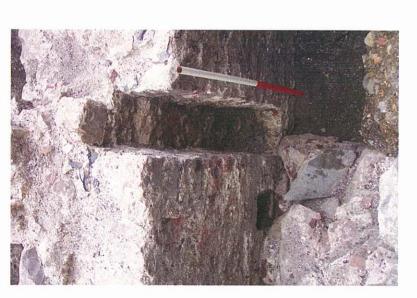
Photo 44:

Area E. East face of pier 038 showing vertical Slot for bridge/drawbridge timber, and square Timber slot to left which runs right through pier. Wall 057 in bottom left of shot.

In this phase, the supports for the timber bridge have been replaced by stone piers. Slots to house the bridge timbers are visible on the east side of [038]. There may have been a third pier to the east of [038], upon which a drawbridge would have rested. Pier [053] may mark the edge of the castle defensive ditch at this time. Evidence for this ditch edge would have been destroyed when the ditch was widened. The form of the gateway is unknown.

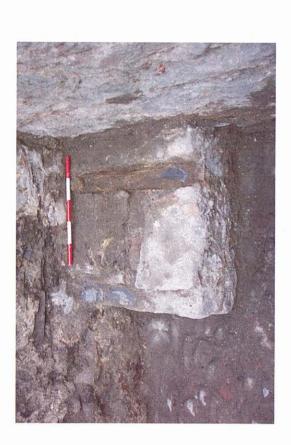
Photo 47: Area A. Cellar 1, facing west. Stillage 132 with timber slots.

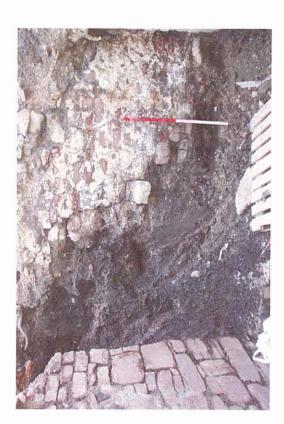
Photo 49: Cellar 3. Facing west, showing remarkably poor Construction of western cellar wall 121, the probable of stairs.

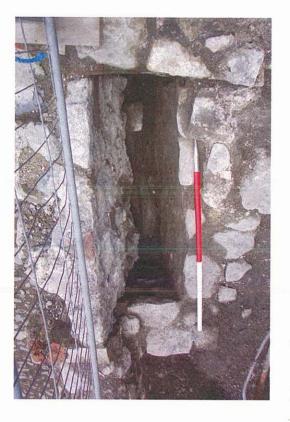
Photo 48: Area E. Blocked up barrel chute 134 in south wall of cellar 1.
