TIR GOFAL MANAGEMENT PLAN: HERITAGE MANAGEMENT INFORMATION HE2

Prepared for:
Pensarn
W/11/4094

Report No. **2004/81**
Project No. **48427**

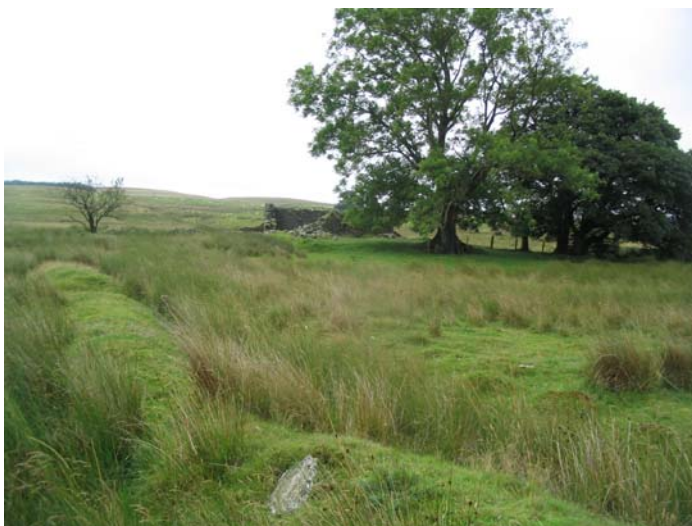
The view south along a relict field bank towards Castell Cottage

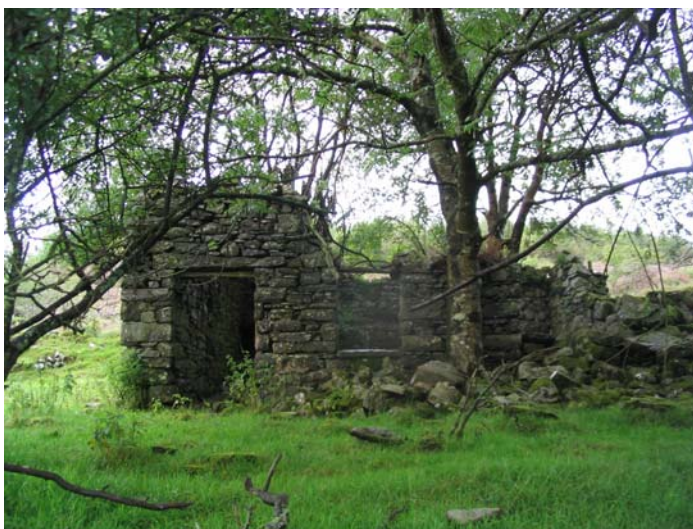
The buildings are now ruinous. The main range, on part of a platform terraced in to the hillslope is roofless. It measures approximately 16m east-west by 6m north-south with walls surviving to full height indicating a one-and-a-half storey design. A fireplace suggests that the west unit, at least served as living space. The outbuilding to the south-west is in a semi-collapsed state. It measures c. 5m north-south by 3m east-west with attached enclosure and may represent a former pigsty. The enclosure walls to the south and west of the buildings survive with the occasional outgrown hedgerow tree. Tree and scrub growth is becoming established around the site which otherwise lies in pasture.

The front (south facing) elevation of Bwlch-y-baedd cottage.

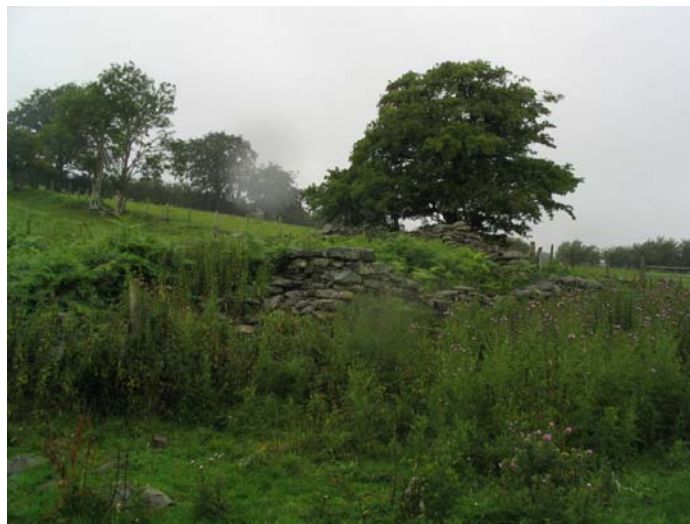
A ruined cottage site on farmland c.1km west of Swyddffynnon. It first appears on the 1889, 1st edition, Ordnance Survey map where it is named "Gwar-helyg." It is of rubble stone and follows a two unit ground floor plan. The cottage remains stand to near eaves height around the north end indicating a one and a half storey design. Around the south end they are diminished with only the low, spread wall footings surviving. The site lies in the corner of a pasture field. It is fenced out and partially overgrown with bracken. No specific management threats were identified.

Looking north towards Gwar-Helyg cottage (now ruinous).

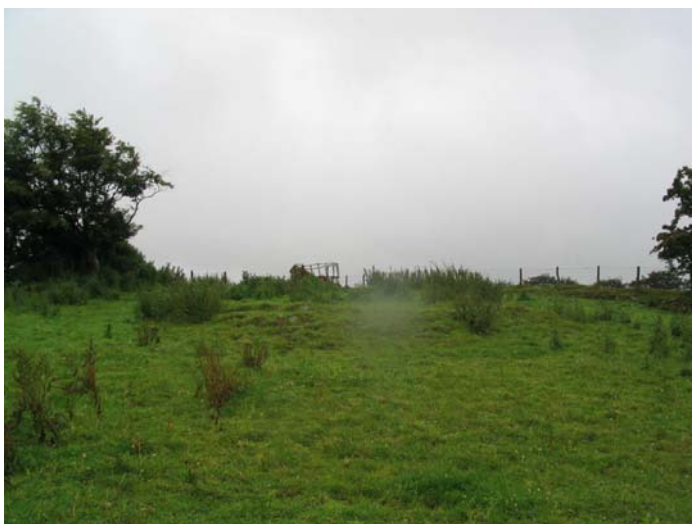
A former cottage site on farmland c.1km west of Swyddffynnon. A building appears on the 1888, 1st edition Ordnance Survey map, named as Gwenhafdre-fach but becomes known as Cynhawdre on the 2nd edition of 1905. A three unit cottage is shown with an outbuilding to the northeast, and surrounding enclosures. The cottage and enclosures have been bulldozed into a large mound with a ring feeder now positioned on what remains of the cottage platform. A platform (c.7m squared) survives where the outbuilding once stood.

The site of Gwenhafdre-fach, viewed from the north-east.

Poaching by livestock around the ring feeder is damaging to earthwork and buried archaeological remains. The feeder should be moved a minimum of 5m away from earthwork traces of any buildings.

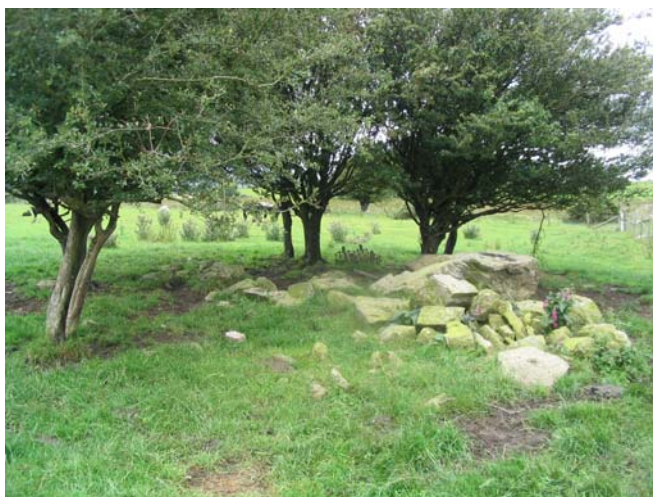
About 6 small round clearance cairns to a maximum diameter of 4m are scattered about this field. They are now covered with scrub and grown out tree growth.

One of the clearance cairns, now partially obscured by scrub growth.
