Felin-y-coed W/12/3884

Tir Gofal Farm Visit Historic Environment Report

Report No. 2004/07

Felin-y-coed
Tir Gofal Farm Visit Historic Environment Report

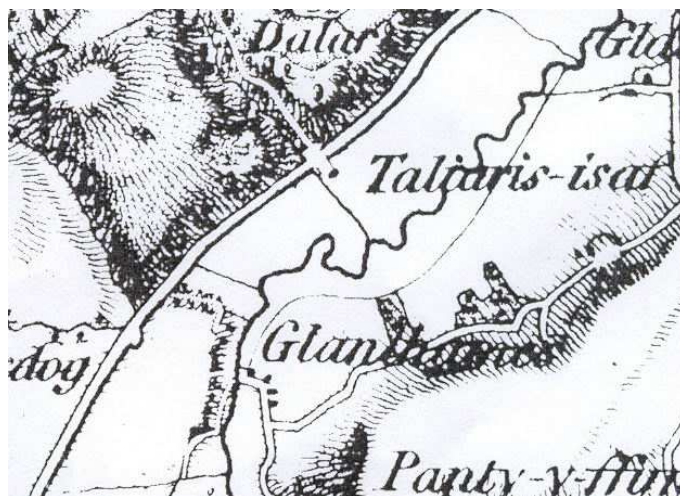
The earliest complete map of the area is the 1 inch to 1 mile Ordnance Survey map of 1831. A leat feeding an unnamed building below Felin-y-coed farmstead provides a likely location for the mill. The same building appears on a map of the Talley Estate in the County of Carmarthenshire, dated 1814. Its position, opposite the river from Glan-thames, puts it outside the estate boundary, and no further information is provided here. Some clarification of the mills associated water management features is given on the 6 inches to 1 mile Ordnance Survey map of 1891. A leat-fed mill pond appears a short distance above the probable site of the mill, the leat can be sourced to the river a little over a kilometre upstream. A brickworks was later established on the site of the former mill, and no surface traces of the mill building survive today. The millwheel is believed locally to have been transferred to Taliaris forge, after the mill at Felin-y-coed fell out of use, and stayed there until the 1940s. The site of the mill lies within an area of light woodland today.

Detail from 1 inch to 1 mile Ordnance Survey map of 1831 showing the leat and probable mill to the south-east of Glan-thames farmstead. Felin-y-coed farmstead (PRN 50006) appears to the east.

Buried archaeological remains of the mill should be protected against damage. Ground intrusive activities and heavy machinery operation should be avoided within the surrounding wooded area.

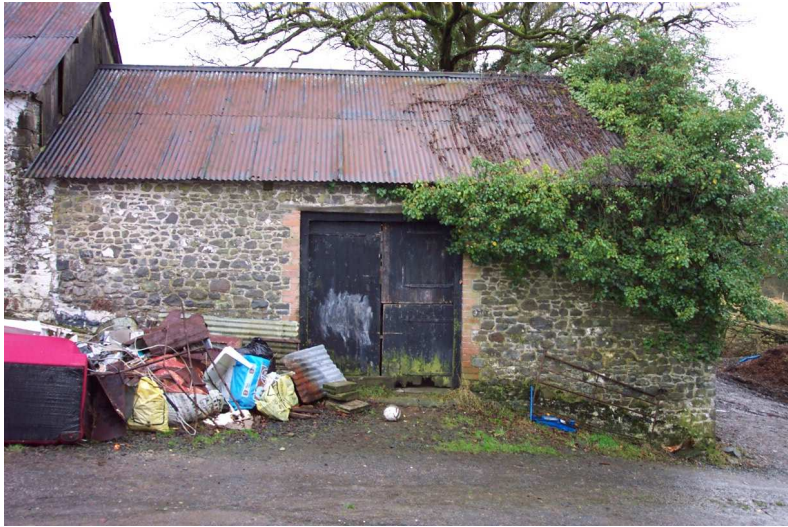
The threshing barn features opposing barn doors, set in the centre of the lateral walls, with storage/ processing areas to either side of the cross passage. The adjoining stables and cart shed are stepped uphill to the east. Some original fixtures and fittings survive and both feature wooden hay racks and stall partitions. A single bay cart shed adjoins the stable to the west. Both the stables and cart shed are lofted, providing storage space for hay or straw. A break in the floor at the western end would have enabled hay to be fed direct to the racks in the stable below.

It is currently weatherproof and relatively stable. An A-frame roof truss has collapsed and is adding weight to the south lateral wall, which is bowing outwards and becoming unstable. Vegetation growth is a more general threat. Ivy, smothering the east and west gable ends, has potential to displace masonry and roof slates. Some young trees are growing near to the southeast corner of the building.

Plate 1- north elevation of the threshing barn at Felin-y-coed farmstead (PRN 50006).

It is proposed that the south wall will be underpinned in order to enhance stability. Such works are potentially damaging to any below ground archaeological deposits. Cambria Archaeology should be contacted if any archaeological features or structural remains are encountered during these works in order to arrange for an appropriate record to be made.

Some of the roof timbers will need to be replaced if the range is to be maintained in a weatherproof condition. Where possible, original roof timbers should be retained, otherwise replacement materials should be considered on a like for like basis.

The corrugated iron roof should be reinstated or repaired where necessary following the restoration works. Re-roofing the range with slate could also be considered, and would enhance the historic appearance of the building and the farmstead as a whole.

The building would benefit from some general maintenance if it is to be kept in a stable condition. Ivy growth on the walls should be cut off at the roots, allowed to die and then removed. Stumps should be spot treated in order to prevent re-growth. This should be followed up by a programme of re-pointing and masonry consolidation in areas where masonry bonds have been weakened by intrusive vegetation growth. Trees surrounding the building should be monitored for signs of instability, and felled or pruned if necessary in order to prevent damage to the roof and walls.

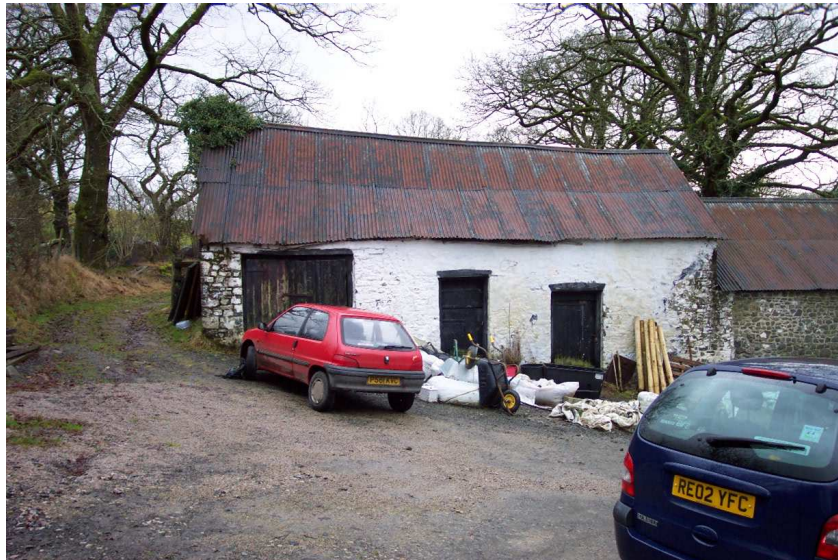
Plate 2- north elevation of the cart shed and stables at Felin-y-coed farmstead (PRN 50006).

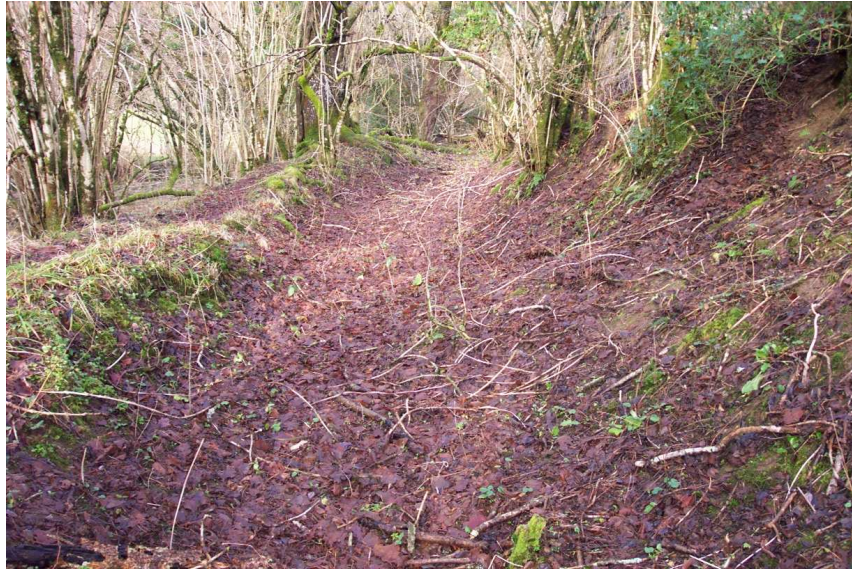
The earthwork remains of an old leat serving the mill pond (PRN 50011) above Felin-y-coed mill (PRN 26595). The leat first appears on the Old Series Ordnance Survey map (1831). It is absent from recent map sources. It can be sourced to the river near Glan-Dulas farmstead, a little over a kilometre upstream. Traces of stone lining are seen at intervals along the leat, which averages approximately 2 metres wide. The leat is interrupted by farm trackways at intervals, and is silted up for much of its length. The northern 400m lie outside of the Tir Gofal farm boundary and were not seen during the archaeological farm visit.

Plate 3- looking east along the leat (PRN 50010).

Surviving sections of the leat should be retained and protected against damage.

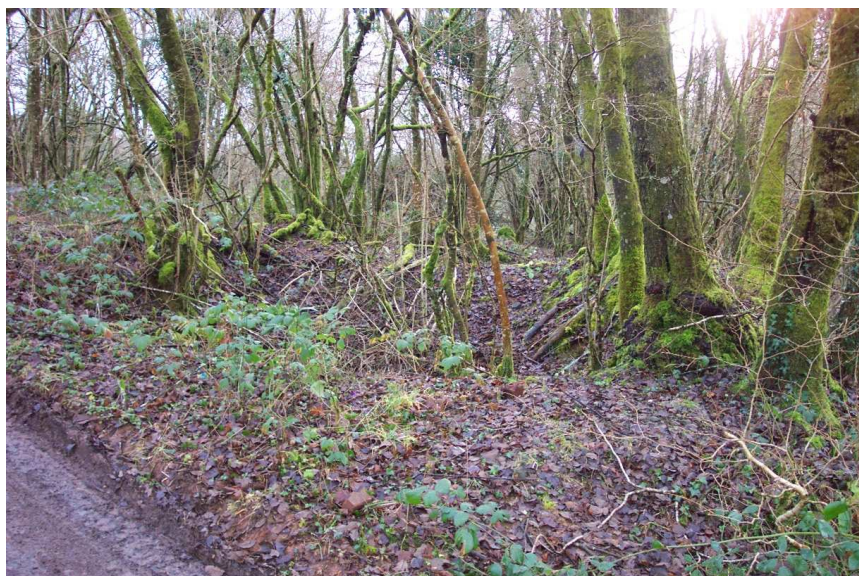
Plate 4- the remains of the possible brick kiln (PRN 50013) associated with Glan-Thames brickworks (PRN 50012).

A possible brick kiln associated with Glan-thames brickworks (PRN 50012). It is set in to a gentle slope on the side of a trackway. It is roughly square in plan, approximately 7m in diameter and defined on all sides by spread earthwork banks, which stand to a maximum height of approximately 1m.

The earthwork remains are now denuded and overgrown. The site lies within an area of scrubby woodland. Trees have become established around the site.

This structure may be of the clamp kiln type. Such kilns would have seen the bricks and pipes stacked apart to allow fire to circulate. The whole would then have been covered with old bricks and earth. The burner then lit and tended the fire (Hammond 1998, 21).

Surviving clamp kilns are rare, and the site should be protected against damage. Trees growing on the kiln should be monitored for signs of instability in future. Any unstable specimens should be felled or pruned in a controlled manner before being allowed to cause damage to earthwork remains by uprooting.

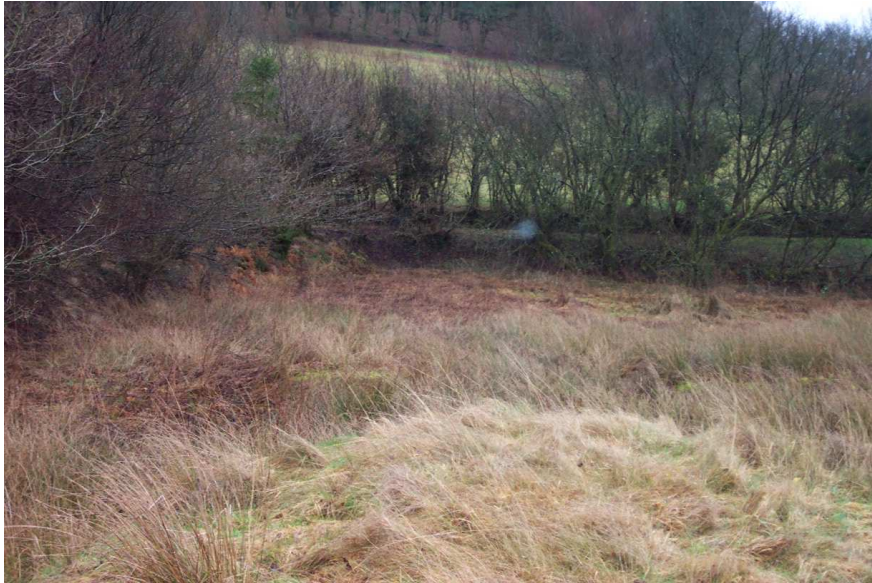
Plate 5- part of the clay pit (PRN 50014) viewed from the north.

A clay pit supplying Glan-thames brickworks (PRN 50012). The clay pit is not marked on any of the historic maps. It appears as a flat bottomed rectangular depression, 1- 2m deep, cut in to a shallow hill slope. It measures approximately 50 by 30m E-W. A wide trackway skirts the north and west sides of the pit. The site lies within a pasture field which is grazed periodically.

The historic appearance of the clay pit should be retained. No ground intrusive activities should be undertaken within this field.
