## Maes Cottage W/12/3905

Tir Gofal Farm Visit Historic Environment Report  
Call Out

Report No. 2003/122

November 2003

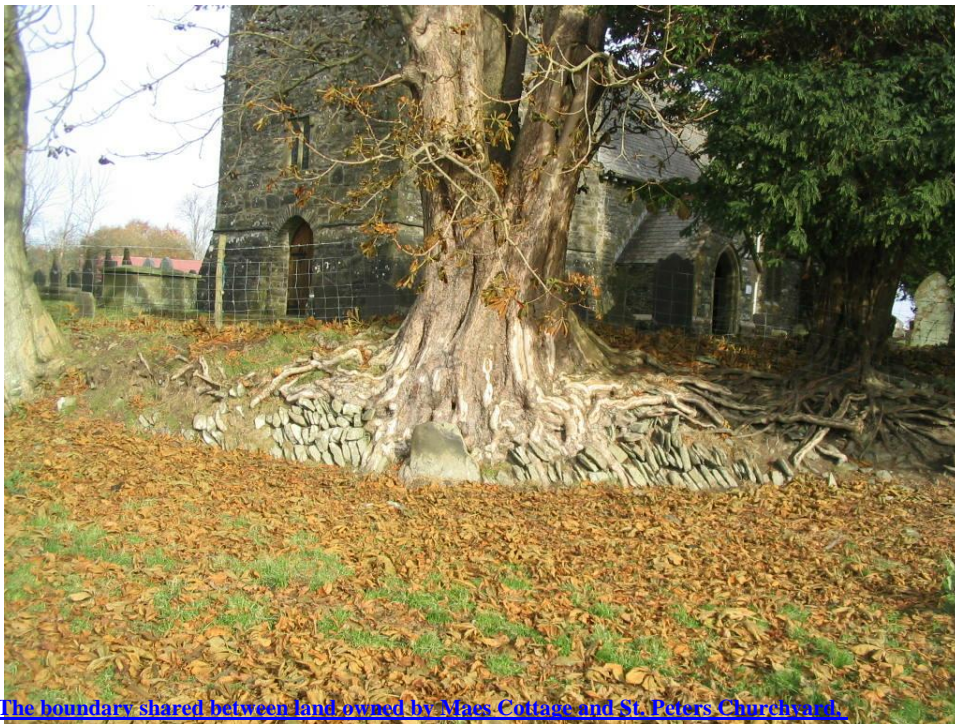
The boundary shared between land owned by Maes Cottage and St. Peter's Church and Eilanybuddr.

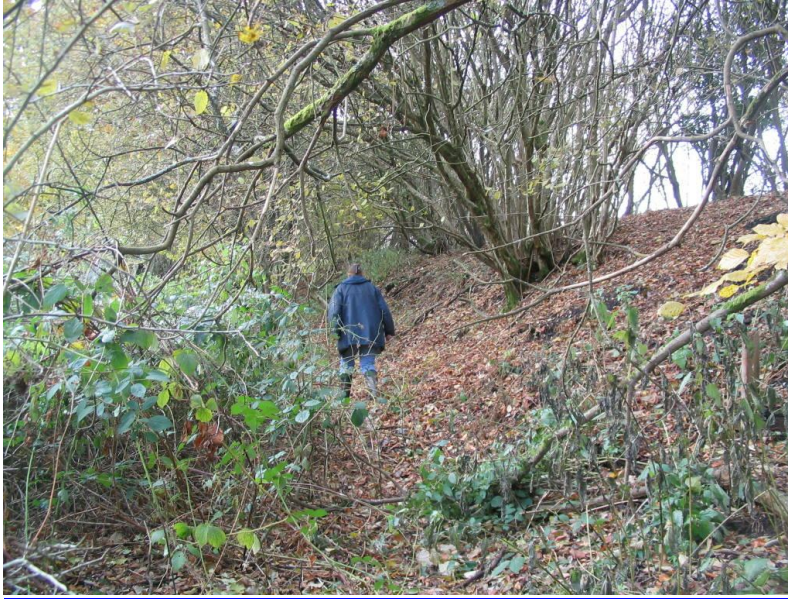
A well-preserved section of the railway embankment runs for around 320m (350yds) along the western edge of this land holding. The shape is still very clear, showing its flattened top and smooth, steep sides. This section of embankment is highest at its north end, where it stands to a height of some 5 – 6m (18 – 20ft). The surface of the embankment is still covered with the stone ballast which was laid around the tracks and sleepers. Original railway post and wire fences run along either side of the embankment.

The site is generally in good condition, though some scrub is growing up in places and a number of semi-mature trees are growing along the top and sides of the embankment. At the north end is a very small conifer plantation which marks the land boundary – beyond this, the embankment has been flattened and survives only as a parch mark in an improved field. Scrub is also partially blocking the ditch and has obscured the culvert.

**Plate 1 (above)** The railway embankment, part of the dismantled Manchester-Milford line.

Some scrub clearance will need to be carried out on this site. Vegetation should be cut at ground level and removed, and care should be taken that the ballast which covers the ground surface is not removed during these works. Trees growing on the sides of the embankment are a concern, since their roots will eventually cause damage to the structure. They are also more vulnerable to wind-throw, since the depth of soil on the sides of the embankment is very shallow. Ideally, most of the young trees growing on the sides should be cut at ground level and removed. The ones growing on the flattened top are more stable, but care should be taken that the top of the site is not allowed to become overgrown and, consequently, impassable. Any trees which look unstable, or which are growing in thick clumps should also be removed and trees which are left in place should be managed to prevent them from becoming unstable. Coppicing may be one appropriate method of woodland management.

-Re-growth of vegetation is likely to be comparatively slow, because of the stone ballast on the ground, but clearance may need to be periodically carried out in the future. If the site shows signs of turfing over, then light grazing may prove a practical way to achieve this in the long term. Future maintenance should aim to keep the site in a stable and visible state.

The survival of the original railway fencing contributes to the significance of this site, and it is important that this is not lost. The majority of the fence posts are now rotten, but the design of the fencing is clear – simple post and wire, with the wires becoming closer set towards the base of the fence. The fencing should be replaced on a 'like for like' basis, using the surviving stretches as a pattern.

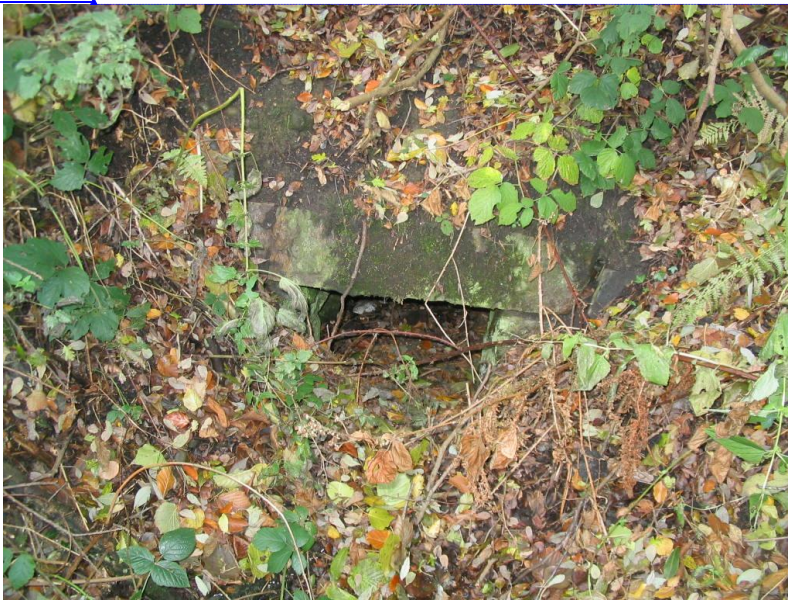
A pronounced ditch runs along the east side of the embankment, then turns sharply and drains into a small, stone-built culvert which runs under the railway embankment. A simple, small footbridge formed of one concrete slab crosses the channel which leads into the culvert. The ditch does not appear to carry on to the south beyond the culvert so must have been put in place to only drain a few exceptionally wet fields.

**Plate 2 (below)** A small, stone-built culvert passing under the embankment, now very blocked with silt and leaves.

The landowner is also proposing to create a pond, and to clear and re-use the ditch east of the embankment, as well as the culvert which it drains into. The restoration of these features would be very welcome, especially since they would be re-used for their original purposes. Clearance of the culvert should be carried out carefully by hand. The depth of the drain is not known at this point, and there is also a possibility that there is a stone lining to the channel leading into the culvert. Any such lining should not be damaged or removed. The channel should be kept within its original cut and care should be taken that only modern silt and rubbish are removed from it – its depth should not be increased.

As far as is practical, the ditch should also be cleared by hand, again taking care that any lining is not disturbed or damaged. The line of the ditch is very clear, and it should not be expanded beyond its original outline or depth – only modern silt should be removed. Ideally, a photographic record should be made of the site during and after clearance, (including more detailed photographs of the culvert and any ditch or channel linings) and a copy of the photographs deposited with Cambria Archaeology.

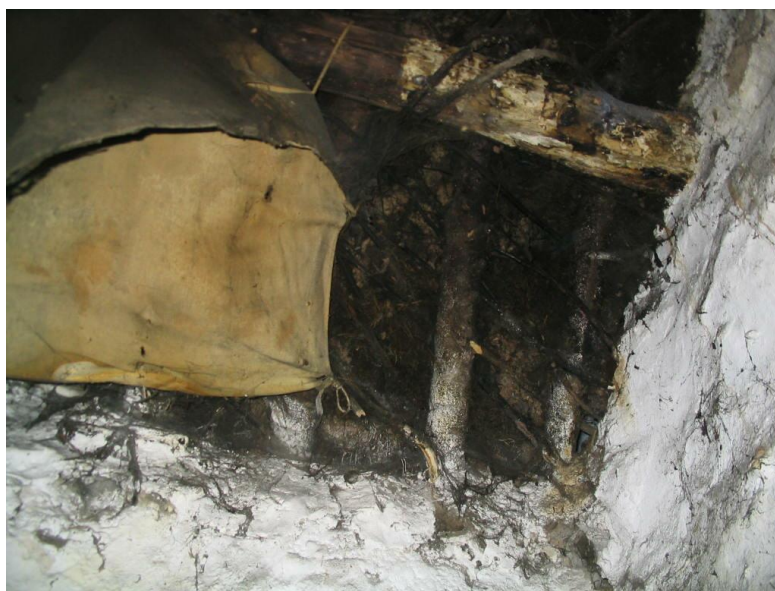
Map evidence suggests that Pen Rhiw cottage was constructed sometime between 1840 and 1886. The cottage is a simple stone-built two-room dwelling with a loft and a fireplace in each gable. It is now roofed with corrugated metal, but some thatch is preserved under this, and from inside it appears that the thatch rests on closely-set branches rather than on rafters. The remains of a piece of cloth are still pegged onto the underside of the roof – this was probably put in place to stop parts of the underthatch from drying out and falling into the room. Thatching in this way is typical of cottages constructed in the 19<sup>th</sup> century by, and for, labourers – it did not require a professional thatcher, and was therefore cheaper and easier to maintain (Wiliam, E:1993:p.21). Another interesting survival is the chimney hood at the north end of the house. Although the fireplace has been replaced with what is probably a bread oven, the chimney hood still survives. It appears to be constructed of wattle and daub, covered in layers of limewash. Again, this was a typical feature of rural labourer's cottages, but is one which very rarely survives.

**Plate 3.** Part of the roof of Pen Rhiw cottage: close set poles taking the place of the rafters with an underthatch woven into them. The cloth would be in place to prevent parts of the thatch from falling into the room.

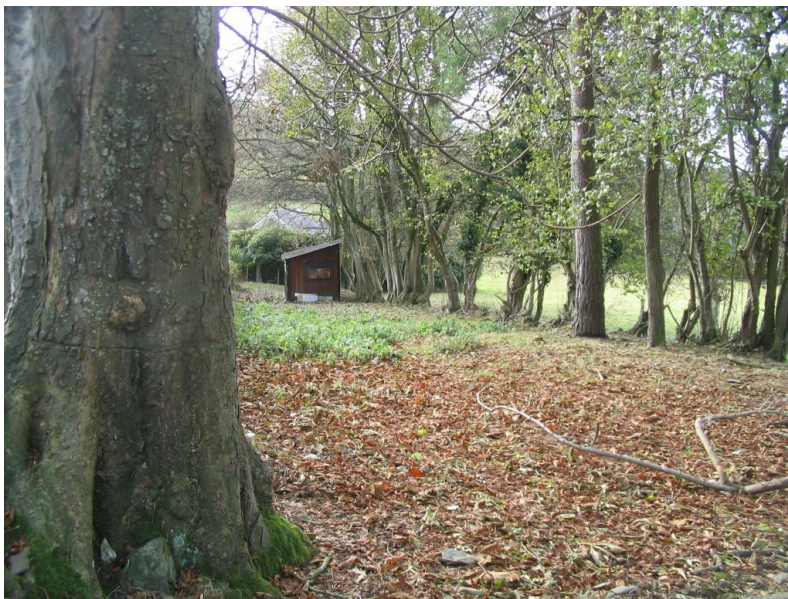
The cottage is in a stable condition, and a line of mature trees marks out the garden. The landowner has expressed an interest in re-instating this boundary.

**Plate 4.** Line of trees marking the edge of the garden associated with Pen Rhiw cottage.

There are no works proposed which affect the building directly, but the garden is an important part of the setting for this typical 19<sup>th</sup> century cottage. The landowner has expressed an interest in restoring the boundary around the garden, and this would be welcomed. It was probably originally a laid hedge, and ideally this would be re-instated, although some of the mature trees may be retained as standards, and incorporated into the hedge.

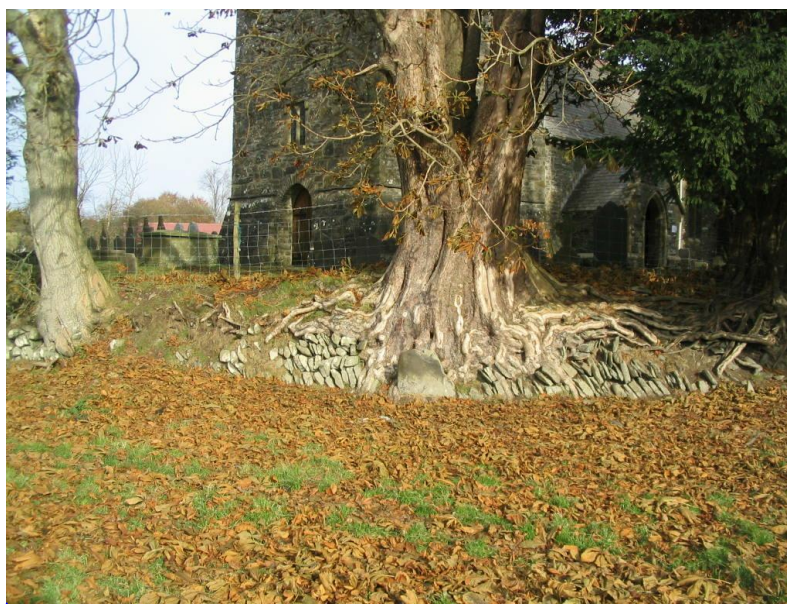
The boundary which survives today is a raised earth bank, topped with mature trees and partially supported by a stone facing on the bank. This is formed of small to medium sized stones which are pressed into the earth bank rather than being a self-supporting wall.

The boundary is in various states of repair – in places, the stonework is almost entirely gone but towards the east, sections of it stand nearly intact. Tree-roots are the major cause of damage to the wall – they are dividing the stonework and pushing individual stones out of the bank. The boundary is no longer stockproof, and gaps between the trees are infilled with wire netting, on both the churchyard side and the field side of the boundary.

**Plate 5.** The boundary shared with St Peters Church, Llanybydder. Tree roots are pushing the stone facing off the bank, and there is little earth left that the stones can be set back into.

There is comparatively little that can be done to restore this boundary now that the trees are so mature. In places, the outside of the bank now has no earth for stones to be set into, but consists solely of tree-roots, and the stone facing in these areas cannot be restored. In other parts the stonework would benefit from the replacement of fallen stones, and if this were carried out on a regular basis it would certainly slow the rate of decay.

In order to make the boundary stockproof, the most practical solution is to put a new fence in place outside the bank. The appearance of the bank would then be maintained, since it would prevent the necessity for small patches of 'infill' fencing between the trees around the churchyard. These could be taken down once the new fence is in place.

It is important that the strip of land between any new fence and the bank is not allowed to become overgrown. It may need occasionally to be cleared of scrub or undergrowth.
