## **TIR GOFAL MANAGEMENT PLAN: HERITAGE MANAGEMENT INFORMATION (HE2)**

Prepared for:  
Glanmynys

Tir Gofal Reference No. W/12/3928

ACA Report No. 2004/111  
Project Record No. 48458

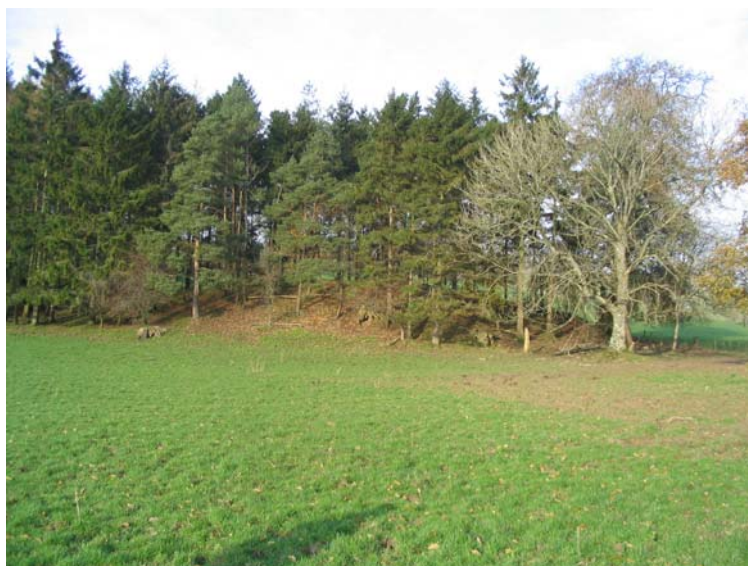
*The medieval motte at Glanmynys (PRN5526 ) overlooks the historic routeway, now the A40*

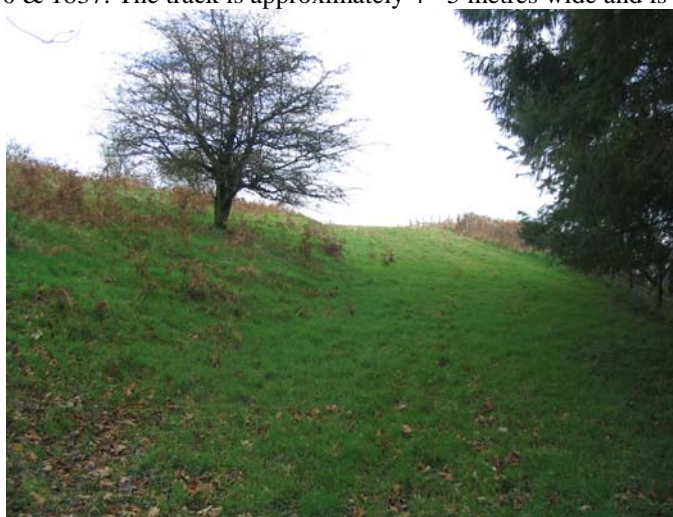
A wide, terraced 'track' skirting the inside of the field boundaries in a large oval encompassing the summit of the hill. This is known as a racecourse, and is identified as such on the Llanwrda Parish Tithe Map and Apportionment of 1840 & 1837. The track is approximately 4 - 5 metres wide and is grass covered.

*The circuit of the racecourse is visible in its entirety as a wide terrace cut into the natural hillside*

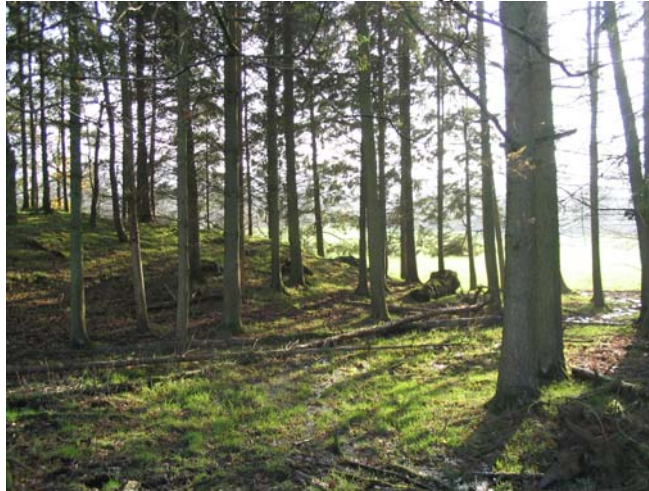
A small castle mound. Glanmynys Motte is a Scheduled Ancient Monument Cm 239. It is portrayed by Cadw description as a Medieval mound. It survives to a height of around 8 metres and a diameter of approximately 30 metres. It appears to have been cut off from the rest of the natural spur to the west by an encircling ditch which was waterlogged at the time of the visit (December 2004). The site lies at the end of a strip of conifer plantation. Some of the conifers are beginning to die back and are gradually disintegrating, but none have uprooted and the site generally seems in a stable condition. It may be necessary, at the five year break of the scheme, to reconsider the management of the site, if the site is threatened by tree fall and root damage. Please consult with Cadw and Cambria Archaeology.

*The medieval motte lies at the end of a natural hillspur, it is now covered with a conifer plantation.*

In addition, the management of the Medieval Motte (PRN 5526, Cm 239) should also be reconsidered at the 5 year break clause of the scheme, to address any problems that may materialise with the maturing plantation cover.

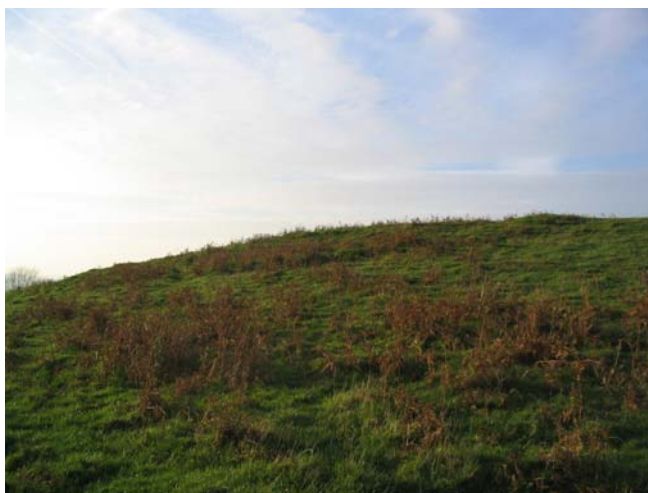
A well defined round barrow, approximately 19 metres in diameter (from top of bank). The bank is c. 0.3 m high with an apparently continuous external ditch 0.3 deep. The centre of the barrow appears slightly uneven and may have been disturbed in antiquity. It is located in a very prominent position with extensive views to the northeast, south and west but its location placed on the break of slope below the summit obscures the view to the north. The barrow is located in permanent pasture with some bracken growing within the bank.

*A round barrow lies just below the summit of the hill with views over to Mynydd Du*

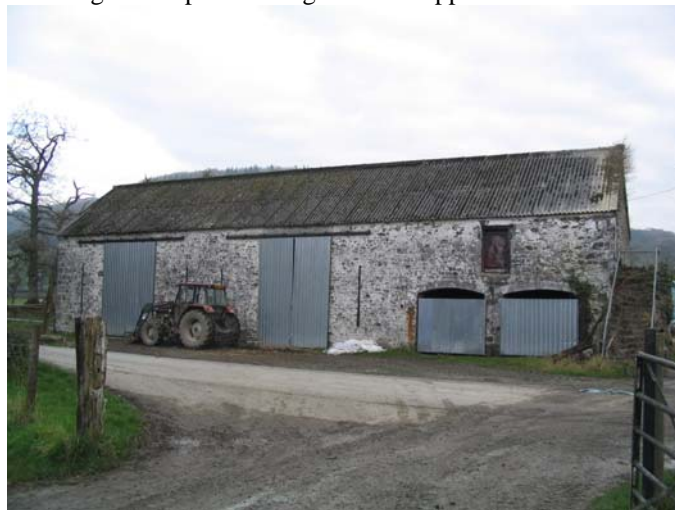
A large barn with two threshing bays at the north end and two cart entrances with loft overhead to the south, accessed from external stone steps at the south gable end. The barn lies adjacent to the roadside. Later modifications to the barn include replacement doors of metal and a roof structure of iron trusses covered with corrugated asbestos. The gable steps are overgrown and appear loose.

*A large barn and lofted cart shed lie beside the road at Glanmynys*

Ideally the vegetation on the gable steps should be removed and the masonry consolidated.

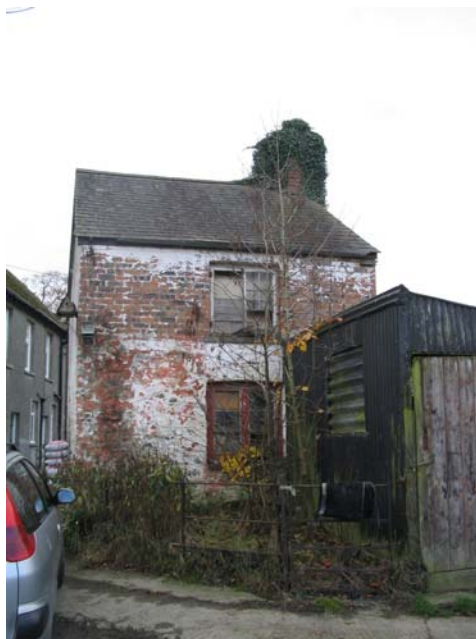
A two storey brick and stone outbuilding, possibly formerly part of the original farmhouse, which has since been heavily modified. The Llanwrda parish tithe map of 1840 shows a building lying at right angles to the roadside in this location. The current building is two storey, one up, one down with a chimney on the southwest gable and a pitched slate roof. It has been extensively rebuilt in brick although much of the southwest gable is composed of stonework. Although the building has been heavily modified at some point in the late 19th / early 20th century it seems likely that it retains elements of a much older building, which was possibly the original farmhouse. More recently it has been used as accommodation, but now is used as a store. The southwest gable is becoming heavily overgrown with ivy which has encroached over the chimney.

*This small brick outbuilding may hold traces within it of the original farmhouse at Glanmynys*

It is recommended that the ivy stems are cut through above root level. The vegetation should then be allowed to die off in place. The roots may be spot treated to prevent regrowth. Ideally further consolidation of the masonry and brickwork should then take place.

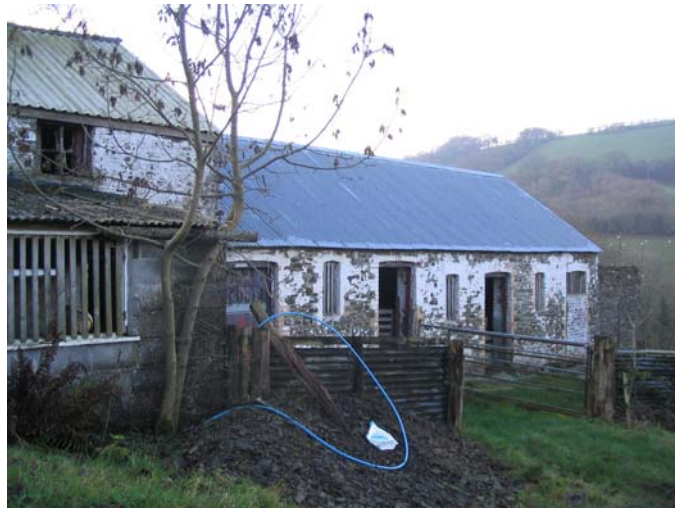
A two storey stone building with a pitched slate roof. Stone arched doorway in north wall and a single small window in 1st floor. Now has a breeze block leanto against the north wall. Possibly originally a stable. A later one storey cow house lies adjacent to it, abutting the west gable end (PRN 51867).

A low stone built cow shed with yellow brick dressings. Butts against the stable to the east. Four evenly spaced doorways face onto the yard to the north, interspersed with window openings. The roof is now covered with corrugated iron.

*The stable lies upslope and a cow shed downslope at Cwmmynys*

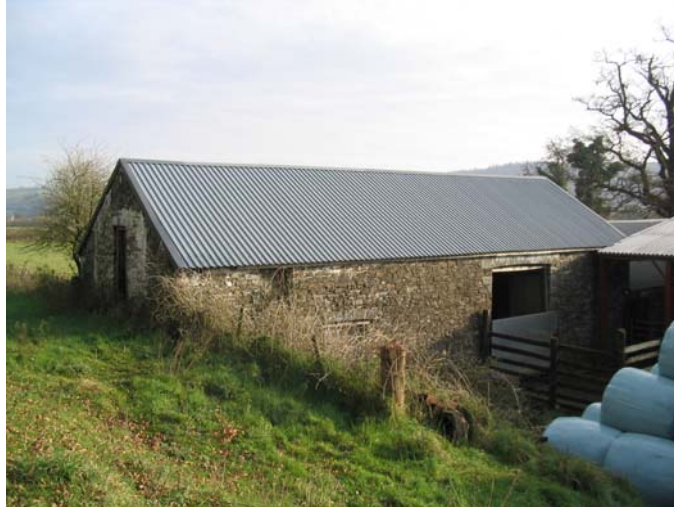
The barn and cow shed survive as a continuous range on the east side of the farmstead and further large sheds have been built against the west side of the cow shed. Both the barn and the cow shed are constructed in local stone with dressed stone openings, the roofs are now covered with corrugated iron. Both buildings are currently in use. The range lies across the slope with the barn at the upper (north) end. A gable end doorway into the loft of the barn is accessed from ground level. At the lower end of the barn is a large threshing doorway. The cow shed has two original doorways and an enlarged doorway at its southern end.

*The barn at Brynteg*
