# **Gilwen Farm W/12/3944**

## **Tir Gofal Farm Visit Historic Environment Report**

Report No. 2004/49

Gilwen Farm  
Tir Gofal Farm Visit Historic Environment Report

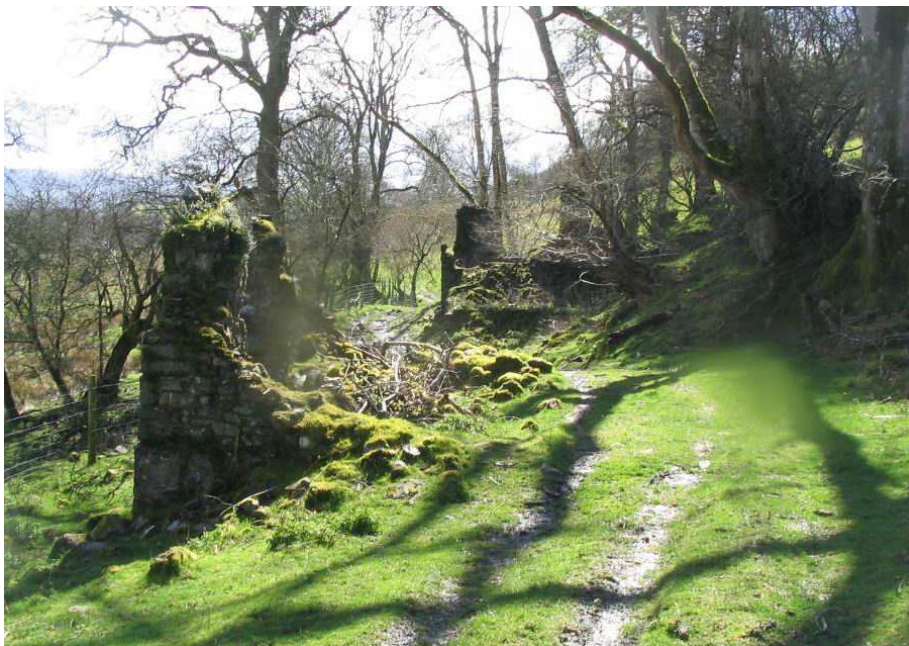
Plate 1- Crincoed cottages (PRNs 21914, 50662) viewed from the north.

A ruinous three unit range with central cottage, on the eastern flank of Fforest Hill. It first appears on the First Edition Ordnance Survey map of 1891 and seems to have replaced an earlier cottage (PRN 50662) a short distance to the north.

It is of rubble stone, formerly with a slate roof and follows a three unit ground floor plan. The cottage stands to near gable height around the corners indicating a one and a half storey design. It features a symmetrical façade with central door and windows to either side and a south gable fireplace. The abutting units to either side are less well preserved and only the low spread wall footings survive.

It lies within a pasture field which is grazed periodically. Some mature trees surround the site. These are in a stable condition and pose no immediate threat to standing structural remains.

The cottage should be maintained in a visible and stable condition. Buried archaeological remains should be protected from damage. The area within 5 metres of the edge of the site should not be used as a location for feeding livestock or subjected to any ground intrusive activities.

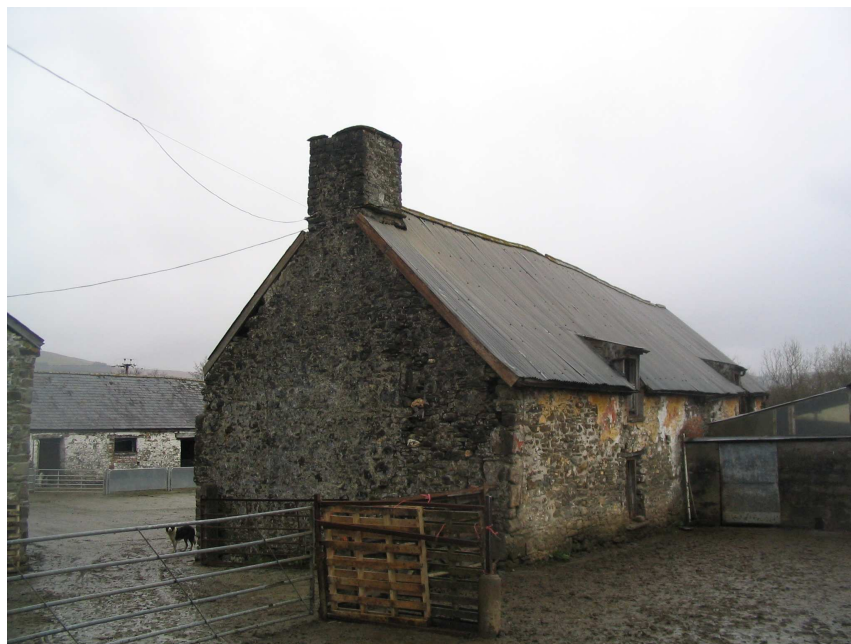
Plate 2- The old farmhouse at Gilwen (PRN 50653)

The old farmhouse at Gilwen farmstead (PRN 50652). It backs onto an L-plan range of agricultural buildings (PRNs 50654, 50655) to complete a three sided yard. It is no longer inhabited and was apparently raised from a cruck truss single storey range in the later eighteenth century. It retains several scarved cruck trusses and is Grade II listed as a rare surviving example of a pre nineteenth century house in the area.

It is of whitewashed (formerly ochred) rubble stone, with a steeply pitched corrugated iron front roof and a slate rear. A stone west gable end stack survives, and the east stack has since been removed. The front wall faces south and features windows at both ground and first floor level; those at upper level with catslide dormers. A door and two windows to the right are obscured by a modern milking parlour. The west gable end is blind and a small loft light is the only opening in the east gable. The rear (north) wall, which faces on to the farmyard features two doors and a window to the left.

It is no longer inhabited, although the west unit of the building houses livestock. The house remains in a reasonable condition and is still weatherproof, although there is localised weathering of the lime mortar masonry bonds, particularly around the west end.

The farmhouse is Grade II listed. Any works that will affect the character of the building will require listed building consent. Further advice can be obtained from the local authority building conservation officer. It should be maintained in a weatherproof condition using traditional building materials and techniques.

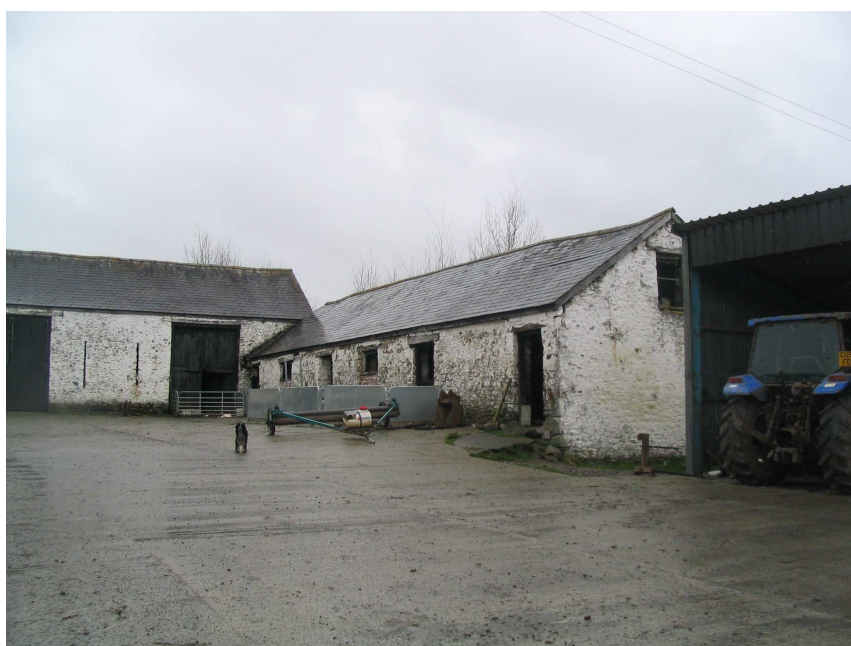
Plate 3- The cow shed and threshing barn at Gilwen (PRN 50654, 50655)

An early nineteenth century cow shed forming part of an L-plan range (together with combination farm building PRN 50655) on the north side of the farmyard at Gilwen farmstead (PRN 50652). It is a single storey building of whitewashed rubble stone and a slate roof. Six doors with timber lintels face onto the farmyard; five to the cow house and a sixth to a separate end stall. The second and fourth doors are part blocked. An additional doorway is in the centre of rear wall. A loft light pierces the east gable end above the end stall (based on Cadw 1995, 29)

The cow shed is Grade II listed for group value with the old farmhouse and threshing barn as a good example of a U-plan farmstead within the region. It remains in a good state of repair.

The landowner has expressed a desire to remove limewash and then repoint the outer walls of both the cow shed and the barn, in order to leave a bare stone finish and eliminate the need for regular limewashing.

Removing the limewash render will alter the historic appearance of the building and will require listed building consent. An application should be made to the local planning authority if this is to be undertaken. Further advice can be obtained from the local planning authority building conservation officer:

Removing the limewash will expose the masonry and lime mortar bonds to erosion, and increase the need for regular repointing. The correct application of an appropriate limewash render mix will give long lasting protection against weathering. Further advice on the selection of an optimum lime mix and its application can be obtained from a specialist on traditional building materials and techniques. A list of contact numbers for building restoration is provided at the end of this report.

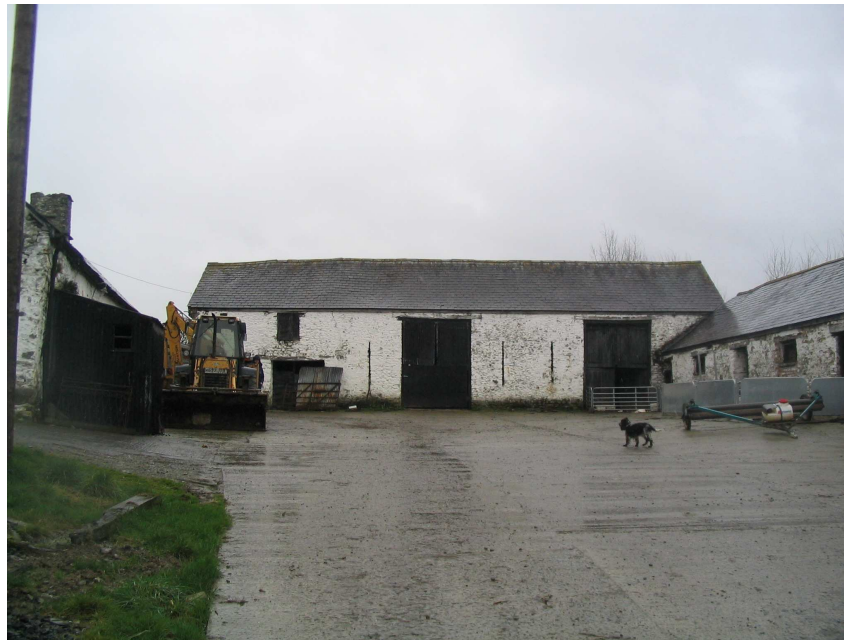
Plate 4- The threshing barn at Gilwen (PRN 50655)

An early nineteenth century threshing barn and lofted cart shed on the west side of the yard at Gilwen farmstead (PRN 50652). It is of whitewashed stone with a slate roof and stands to two storeys. The barn to the right has two pairs of large doors facing each other across two threshing floors. Vertical slits are equally spaced to either side of the doors, and three additional slits are arranged in the north gable end.

The two cart entrances to the left of the threshing barn are separated by a stone pier and have wooden lintels. Access to the upper loft was by a door, although the stone steps have since been lost. A single loft window is situated over the second cart entrance (based on Cadw 1995, 29).

The barn is Grade II listed for group value with the old farmhouse and cow shed as a good example of a U-plan farmstead within the region. Despite the loss of the external stone steps, the barns original appearance remains comparatively unaltered. It is in a good state of repair, although some slates have become displaced on the western pitch.

The landowner has expressed a desire to remove limewash and then repoint the outer walls of both the cow shed and the barn, in order to leave a bare stone finish and eliminate the need for regular limewashing.

Removing the limewash render will alter the historic appearance of the building and will require listed building consent. An application should be made to the local planning authority if this is to be undertaken. Further advice can be obtained from the local planning authority building conservation officer:

Removing the limewash will expose the masonry and lime mortar bonds to erosion, and increase the need for regular repointing. The correct application of an appropriate limewash render mix will give long lasting protection against weathering. Further advice on the selection of an optimum lime mix and its application can be obtained from a specialist on traditional building materials and techniques. A list of contact numbers for building restoration is provided at the end of this report.

Displaced roof slates should be reinstated in order to maintain the building in a weatherproof condition.

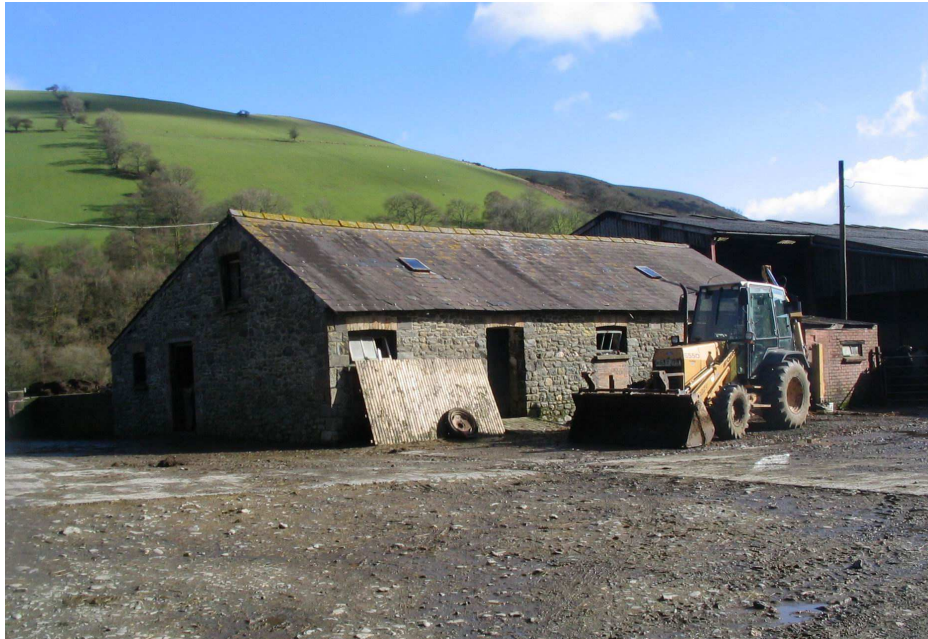
Plate 6- the cow shed at Dyflyn (PRN 50658)

A late nineteenth century cow shed, with loose box and pigsties to the rear, on the east side of the yard at Dyflyn (PRN 50656). It is of stone rubble construction with a slate roof. Five doors with brick heads face onto the farmyard. The first and third doors are blocked, and the fifth is masked by a modern shed. A loft window pierces the north gable end and a door below is a later insertion. The rear outshut includes a loose box and pigsties, probably originally with two or three doors plus pig openings. A date inscription on the west face "GA Rees 1875" provides a date for the construction of the building.

The cow shed remains in reasonable condition, although some roof slates are displaced on the eastern pitch. It retains good historic character, although a partial corrugated covering now detracts from the original appearance at the rear.

The landowner is keen to replace the partial covering of corrugated asbestos on the eastern pitch of the roof with slate. This will improve the historic appearance of the building and is to be welcomed. Displaced slates elsewhere should also be reinstated in order to maintain the roof in a watertight condition. Materials and techniques used should be compatible with those used originally.

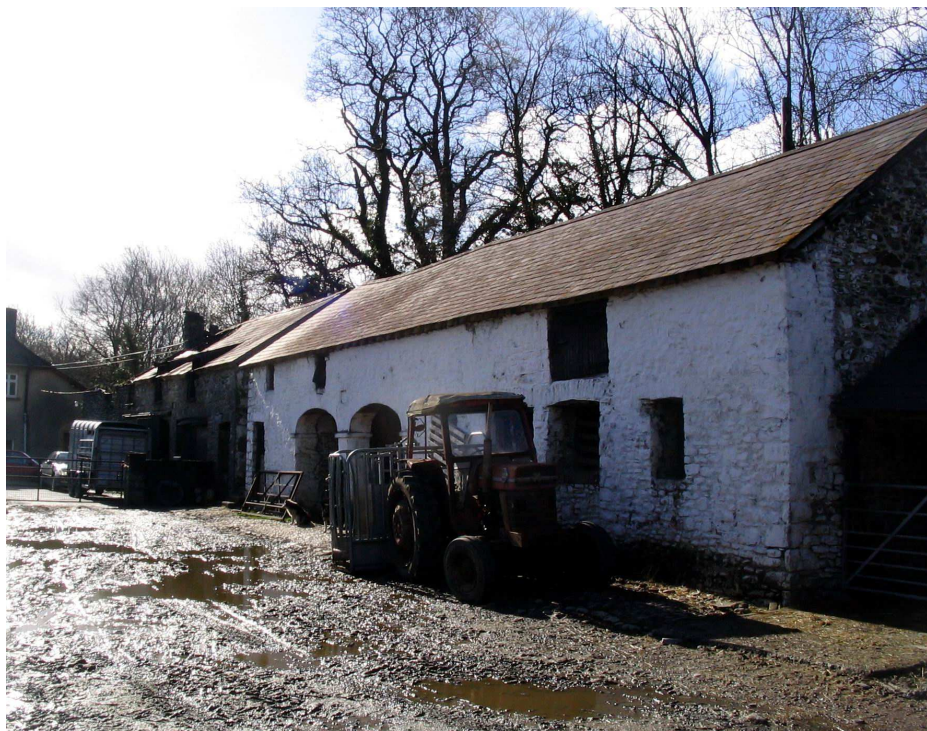
Plate 7- the combination farm building (PRN 50659) at Dyflyn

It is a well preserved example of a type of building which is typical within the region and is currently in a weatherproof condition.

The building should be maintained in a weatherproof condition using traditional building materials and techniques.
