# **Troedyrhiw W/12/3945**

## **Tir Gofal Farm Visit Historic Environment Report**

Report No. 2004/18

February 2004

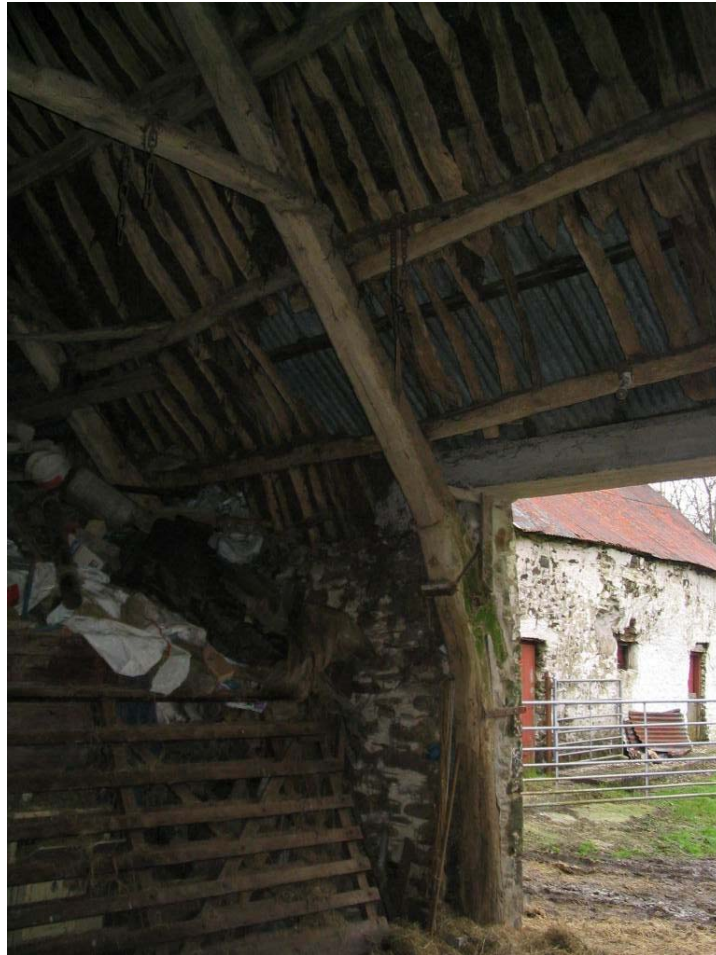
The roof is currently corrugated iron, but it is clear that the barn was originally thatched. The interior of the east side shows areas of surviving thatch supported on split timber palings, but this has been lost from the west side.

The building is generally in fair condition. A small section of the rear of the building (north end of the west elevation) has been recently re-built following a collapse. The re-building is in the original stone, with a cement mortar. The corrugated iron roofing sheets are beginning to lift in places, but the barn is still watertight and the remaining thatch is protected.

**Plate 1** *The interior of the barn, showing the scarfed cruck framing and an underthatch of split palings. The cowshed is visible through the doorway.*

Since the barn is generally in good condition, the priority for building restoration in this farmstead is the cowshed (PRN 50214). However, it is critical that the roof remains watertight in the barn, and if there are any known areas of weakness or vulnerability in the roof, then the metal sheeting should be replaced as a matter of urgency. It should be ensured that the surviving thatch is not damaged during these works and that sufficient overhang is left at the edges of the roof to allow water to run-off without touching the stonework.

Any necessary, routine repairs should be carried out using the original stonework wherever

possible and using a lime mortar. However, repairs to the areas of walling bound with earth mortar will require more specialist advice.

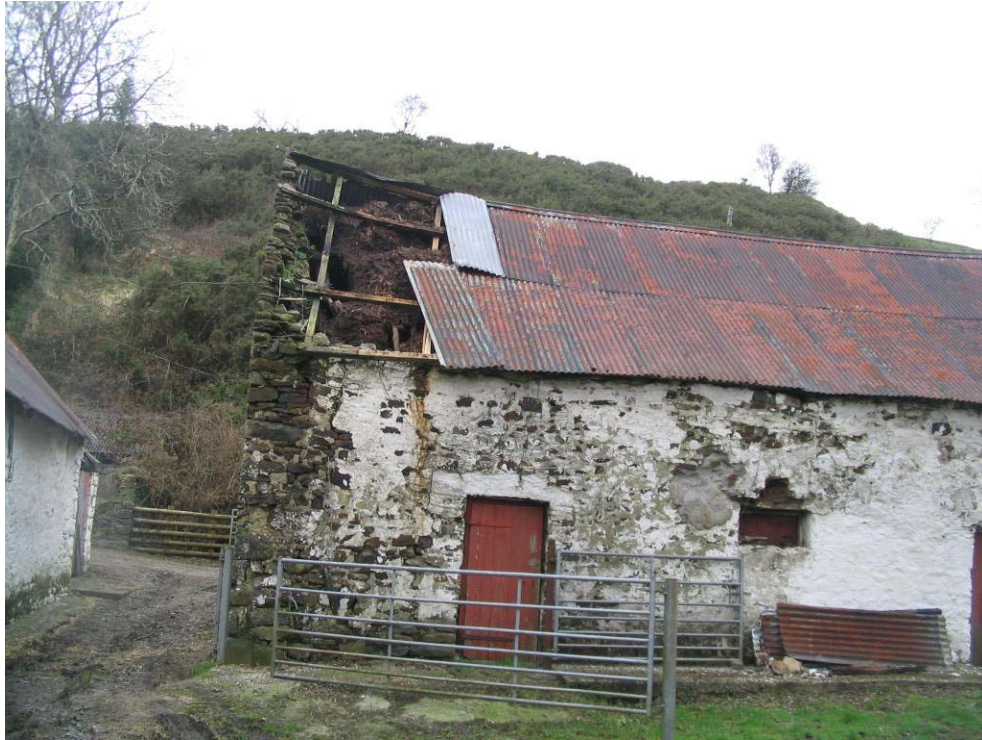
The building is in fair condition, but there are problems which need addressing. The most immediate problem is that the metal sheets at the west end have lifted, exposing the thatch to the elements. Perhaps more seriously, the top of the south elevation has a significant ‘bulge’ outwards above the doors. The west gable is also cause for concern – much of the mortar has been lost at the top, and some areas are now almost dry stone-walling. The top of the east gable has been re-built in the recent past, following a collapse – the re-building used the original stone and a cement mortar.

**Plate 2 (above)** *West end of the cowshed, showing how the metal sheets have lifted, revealing surviving thatch.*

The immediate priority for this building, and for Troedyrhiw as a whole, is to replace the metal sheeting on the roof in order to ensure that the thatch is not exposed. The whole roof-covering needs replacing with new sheets of corrugated iron. It should be ensured that the surviving thatch is not damaged during these works and that sufficient overhang is left at the edges of the roof to allow water to run-off without touching the stonework.

The bulge in the wall above the windows needs to be assessed by a stonemason as a matter of urgency. Some localised re-building may be necessary. The building stone should be re-used, and a lime mortar which matches that used in the original construction of the building. The west gable should also be re-pointed using a lime mortar.

Where repairs have been made using cement rather than lime, consideration should be given to raking the joints out and re-doing the repair work in lime.

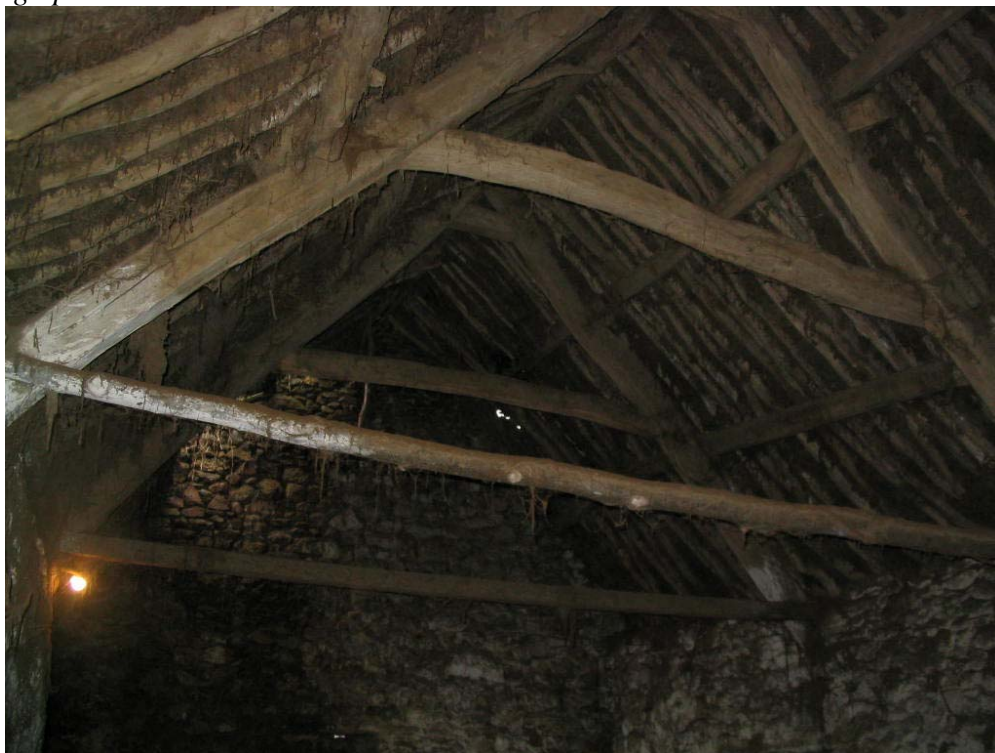
The building is roofed in corrugated iron sheets but, like the barn (PRN 34715), the interior preserves an earlier structure. The roof is supported by upper crucks, and retains an almost complete layer of thatch resting on poles.

**Plate 3 (below)** *Roof structure inside the cowshed. Note that the thatch in this building rests on whole, rough poles.*

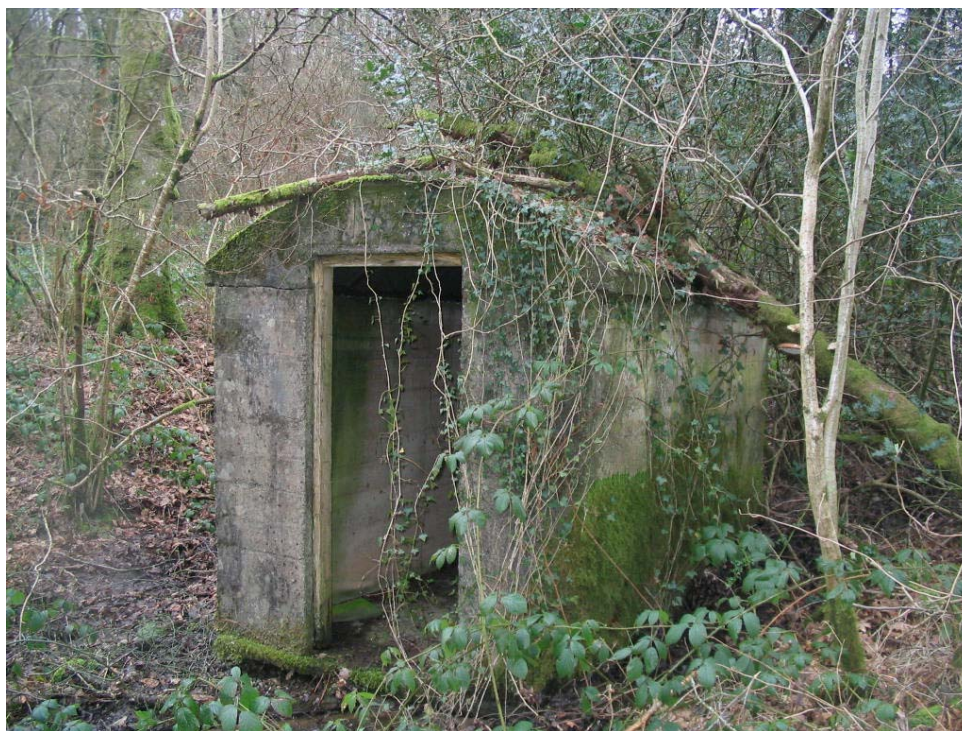
A small explosives store with a single entrance in the east side. The building is made of shuttered concrete on a gravel and concrete base, and has a curved metal roof. The date '1934' is written in the concrete above the door. An iron pipe runs through the rear (west) wall, presumably for ventilation. The store is probably associated with the early phases of the modern quarry (PRN 50217) just to the east.

The building is in ungrazed woodland, and is in a stable condition. There is some dead wood leaning against one side.

**Plate 4** *The explosives store, built of shuttered concrete and dated '1934'.*

See section B2 of the Tir Gofal Farm Management Plan (protection and maintenance of archaeological and historic features) for general recommendations. In addition, the dead wood should be removed from the site, and the store maintained as a visible feature.
