Hengoed W/12/3962

Tir Gofal Farm Visit Historic Environment Report

Report No. 2003/106

Hengoed
Tir Gofal Farm Visit Historic Environment Report

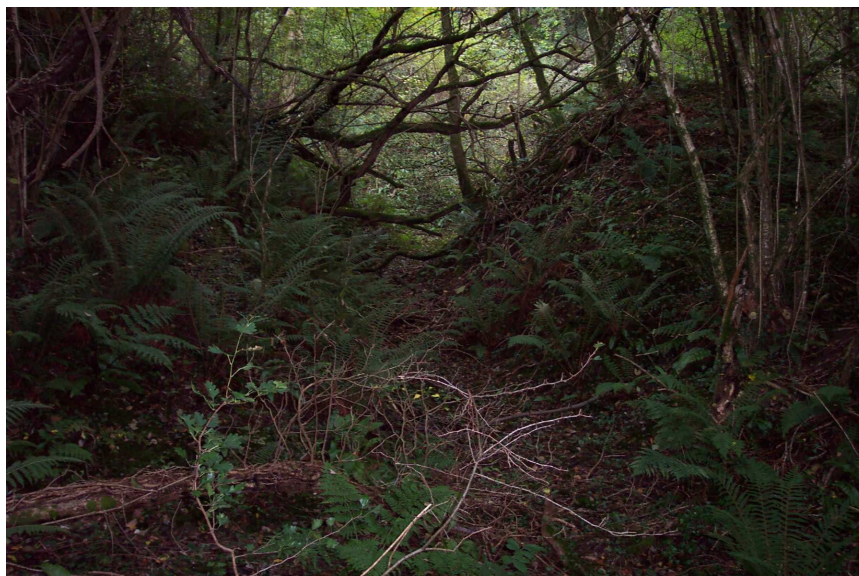
A quarry situated on the western side of the limestone ridge between Pedair-Heol and Meinciau, opposite Hengoed Farmstead. A continuous vertical quarry face spans a length of approximately 80m, and is visible from farmland to the west. A series of spoil tips extend for about 50 metres from the quarry face. Access to the quarry is provided through a short break, perhaps 10 metres long in a line of spoil tips, giving the appearance of a short hollow way. The quarry is long abandoned, and now lies within mature limestone woodland. A fairly large twentieth century quarry (PRN 28315) intrudes into the southern part of this quarry, detracting from its original extent. Agricultural rubbish has been deposited at the north-eastern end of the quarry, including tyres and black polythene. Some of this has been buried recently in the northern part of the quarry, and an area of approximately 20 metres squared is now much disturbed by track machinery. The rest of the quarry is overgrown, undisturbed and free from farm rubbish.

Plate 1- access to the quarry (PRN 30308) is provided through a break in spoil tips giving the appearance of a short hollow way

The quarry and its spoil tips should be retained as a visible historic landscape feature. Agricultural rubbish should be removed from the quarry, and it should not be used as a dump in future. Care should be taken not to damage or erode spoil tips during future machinery activity.

Selective woodland thinning has been proposed within the Tir Gofal scheme. This will benefit the site by opening it up and enhancing visibility.

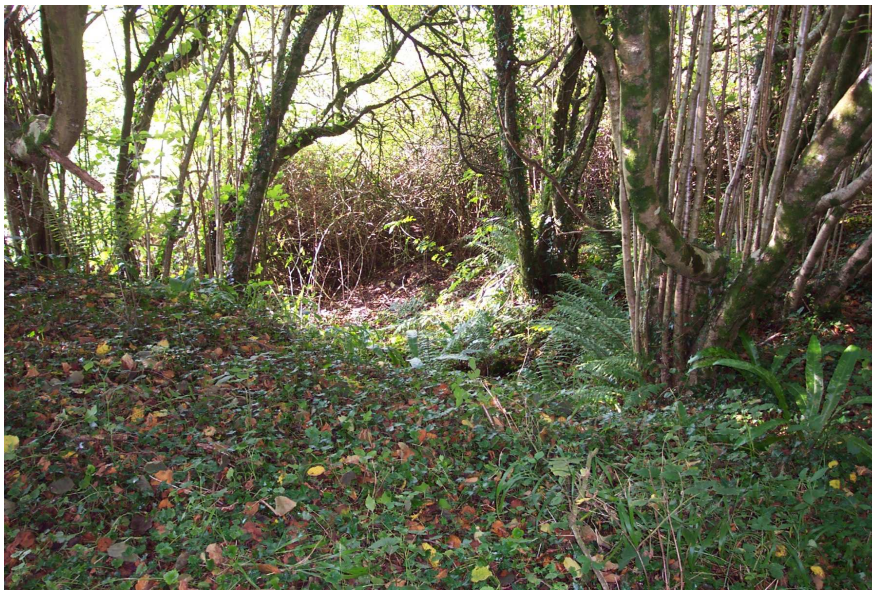
Plate 2- looking east from charging platform towards one of the kiln pots of lime kiln PRN 30311

A line of three possible kilns was noted set into a steep natural earth bank, which faces west onto an improved pasture field. They are equally spaced, set approximately two metres apart. The central kiln is most well preserved, and the partially infilled kiln pot, approximately three metres in diameter can still be discerned. It is penannular in shape, perhaps indicating a single drawing hole in the west. Parallel to this on either side are equally sized penannular depressions, cut into the bank and also facing west. Little of the kiln pot itself survives of these two features, and the example to the south is partially obscured by bramble growth. The earth bank behind the kilns to the east is flattened indicating a characteristic charging platform, which would have enabled loading of fuel and limestone direct into the kilns. Wide earthwork ramps terraced into the side of the bank, and leading up to the charging platform from the field below are visible to either side of the limekilns.

No specific threats were identified from the current management regime. The thick canopy is preventing light from entering the woodland floor, inhibiting scrubby vegetation growth and the environment around the site is stable. Mature trees growing on and around the earthworks appear stable, with none considered to be at risk of falling in the foreseeable future.

If any trees do become unstable, they should be cut off above the roots and prevented from falling naturally in order to prevent roots from uprooting visible, earthwork remains.

Selective woodland thinning has been proposed within the Tir Gofal scheme. The woodland canopy above the limekilns themselves should be retained. It is shading out the site, and

providing a stable environment, which will benefit the survival of these features in the long-term. Some thinning of the younger tree growth may benefit the site by enhancing visibility.

The bramble growth, to the west of the features should be retained. Despite masking the lime kilns from view, it is considered to be a positive benefit. It forms an impenetrable barrier along the eastern side of the field, and is excluding livestock from the wooded area in which the lime kilns lie. In this way it is limiting the risk of erosion to earthwork remains through trampling by livestock. This will also protect further archaeological features, which may be masked by bramble growth such as clinker piles, or raking out pits for example.

It is important that this area of woodland continues to be excluded from livestock in future.

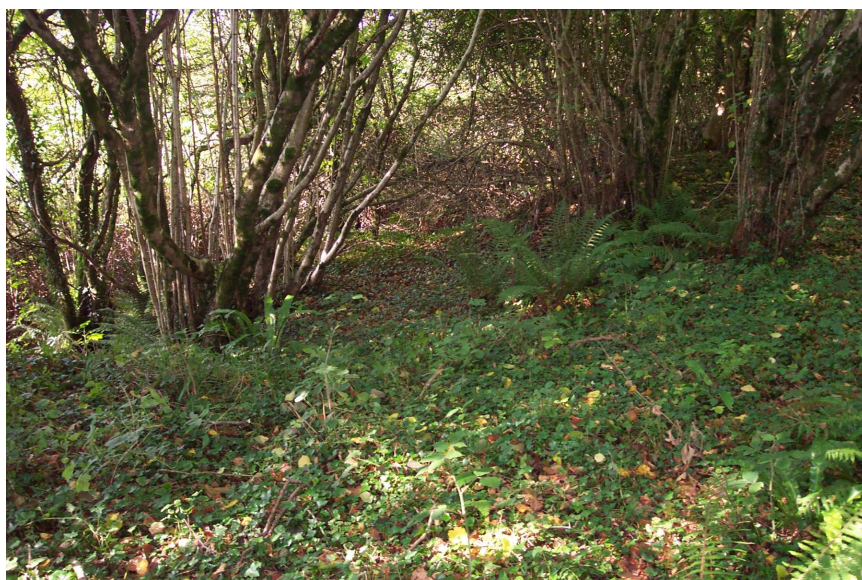
Plate 3- looking northwest down loading ramp from charging platform behind lime kiln PRN 30311

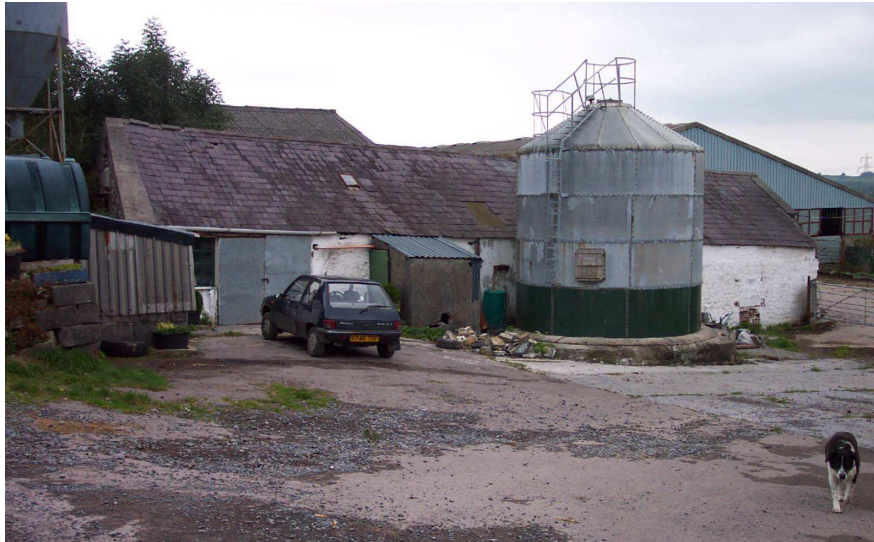
This cow shed defines the northern extent of the farmyard at Hengoed. It is of uncoursed stone rubble construction with a pitched slate roof, and an external whitewash render. It follows an east-west alignment and measures approximately 6 by 20 metres. It is now much modified from its original appearance and has since been converted into a dairy. None of the historic internal arrangements survive and a herringbone milking parlour now occupies the western end of the building. Access was originally provided from the farmyard by at least four narrow doorways. Many of these have since been bricked up, and principal access is now by a wide opening in the rear of the building towards its eastern end. A wide sliding metal panel door towards the west end of the south lateral wall is the main entrance on the farmyard side. A narrow doorway at the top of a steep earth bank in the west gable end would originally have provided access to a loft, although this has since been lost.

This cow shed, which is first shown on the 1848 Llangydeyrn Parish tithe map is likely to be of a late eighteenth or early nineteenth century date. It is currently in a reasonable condition, although some maintenance works are necessary if it is to be returned to a stable condition. Some roof slates are missing whilst many others are loose. The east gable end of the building is a particular concern. A concrete skin above the eaves on the southern pitch has become dislodged leaving the wall tops uncapped and open to erosion. Masonry has become displaced here and water ingress continues to erode lime mortar bonds. Some young trees are growing out of the walls footings at the western gable end of the building. These are also threatening to displace masonry.

Plate 4- looking north towards cow shed PRN 49208

Missing, and loose roof slates should be replaced and stabilised. Unstable and displaced masonry around the eastern gable end of the building should be reconsolidated and re-pointed where necessary. This should be followed up by a more general programme of masonry consolidation. The young trees growing out of the wall footings at the western gable end of the building should be cut off at the roots and spot treated to prevent re-growth.

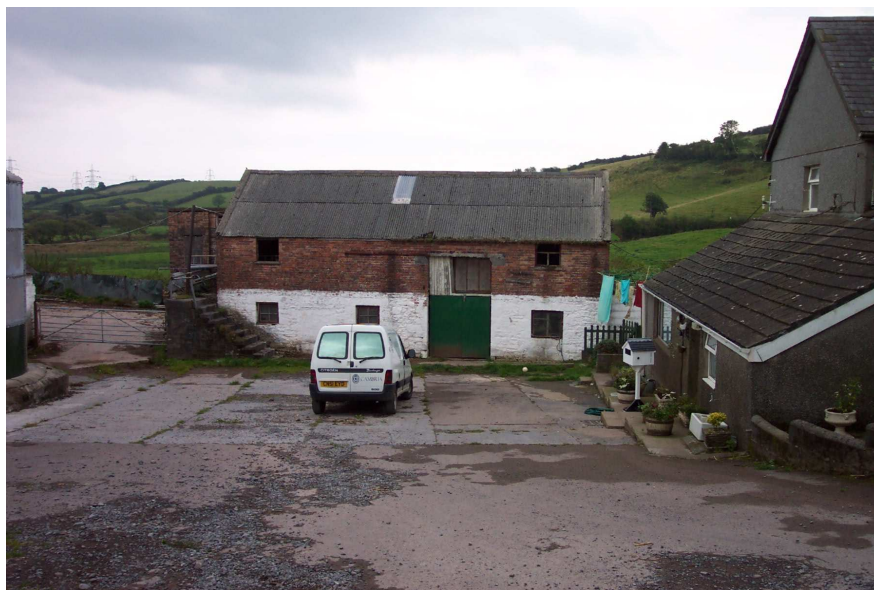
Plate 5- looking east towards combination farm building PRN 49209

This two storey combination farm building defines the eastern extent of the farmyard at Hengoed. It is of stone rubble and brick construction with a pitched slate and corrugated asbestos roof, and measures approximately 18 by 6 metres on a north south axis. Several phases in the construction of the building can be identified, and it appears that an earlier cow shed was extensively modified in the middle of the twentieth century to create a multi purpose agricultural building.

The building is now in a reasonable condition, although requires some attention if it is to be maintained in a stable condition necessary for its long-term survival. The principal threats are from eroded lime mortar masonry bonds in the stone built parts of the building. Part of the outer face of the rubble east lateral wall has collapsed and is a source of structural weakness. Similarly, part of the north wall has collapsed and is undermining the loft steps. Lime mortar bonds are eroded in many other areas of the building. The roof is in a sound condition.

Unstable and displaced masonry should be reconsolidated and re-pointed as necessary. This should be followed up by a more general programme of masonry consolidation as necessary. Materials used should be compatible with those of the buildings original construction.
