Carew Newton Farm W/13/4173

Tir Gofal Farm Visit Historic Environment Report

REPORT NO. 2004/09
PROJECT RECORD NO. 48475

Carew Newton Farm
Tir Gofal Farm Visit Historic Environment Report

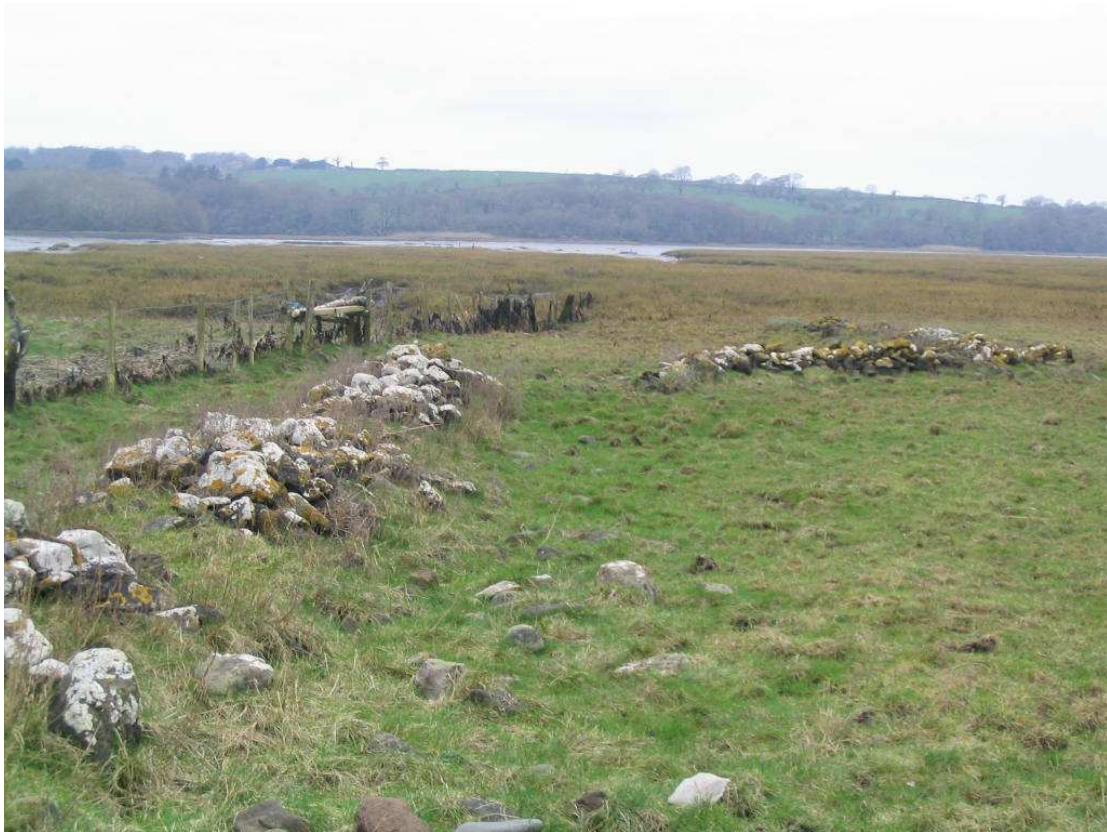
The remains of an irregular field boundary seen on the tithe map of 1838.

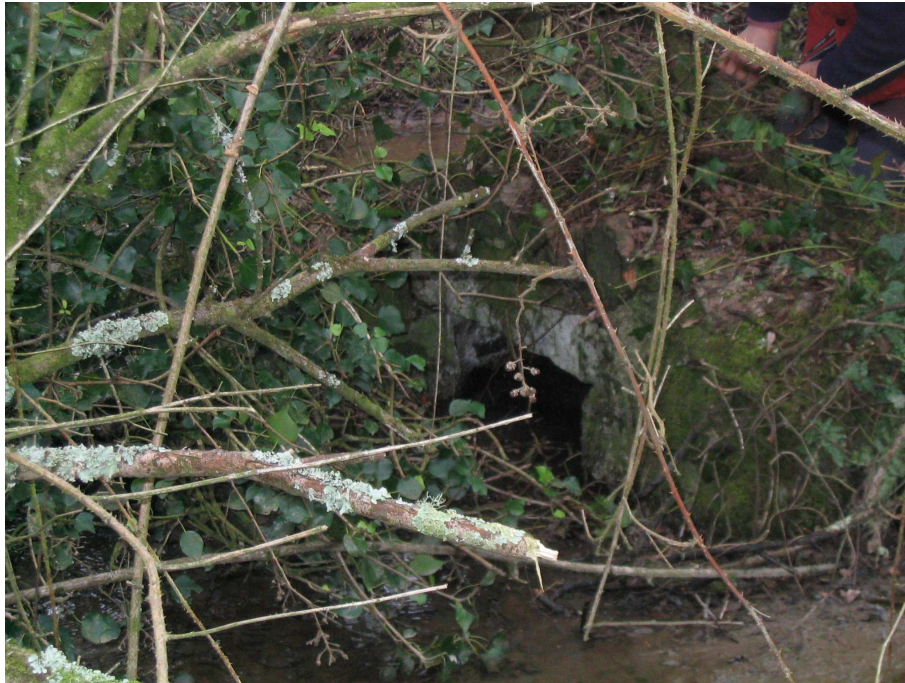
Plate 1 *Russan's Well – now very heavily overgrown, but the stone structure of the well-head still survives.*

A well named on the tithe apportionment (1837) as 'Russant's Well' and on the 1st and 2nd edition Ordnance Survey maps as 'Russan's Well'. The well itself survives in a patch of boggy ground. It is a small, stone-built structure forming a low dome around 70cm high in the middle. On one side at ground level is a squared opening, like a culvert, which is where the water flows from. The well structure is made from large, irregular rubble blocks, probably bound with lime mortar. The only faced stone is around the opening.

It appears that the well has been mended in the past, with newer mortar visible in some of the joints. It is now very overgrown, and vegetation is not only obscuring the structure but also establishing itself in the stonework. The age of the well is not known. It dates to at least the first half of the 19th century, and may be substantially earlier. The name is also of interest – the well was probably named after a person, and Charles (1992:482) comments that both 'Rossant' and 'Russen' were surnames in use in the area in 1670.

- i. The area immediately around the well should be cleared of scrub and vegetation. Larger trees or bushes should be cut off at ground level and treated to prevent re-growth. Cut branches and dead wood should be removed from the area.

- ii. The vegetation growth on the well structure needs to be tackled before it begins to damage the stonework. Vegetation should be cut flush with the stones, and treated to prevent re-growth, but roots should be left in place. This may need to be immediately followed by re-pointing in some areas, using a lime mortar which matches the original construction. The landowner informed Cambria Archaeology that there used to be a wooden 'door' across the entrance at the base of the well. Ideally this would be replaced.

- iii. The area around the well is quite boggy and trampled, as cattle drink from the small pond which has formed here. If scrub control is carried out and the area is made more open, this should help to alleviate the problem. However, the state of the well will need to be monitored to ensure that cattle are not damaging the stonework. If damage is being done, it may become necessary in the future to put temporary fencing around the well structure when livestock are in the field.

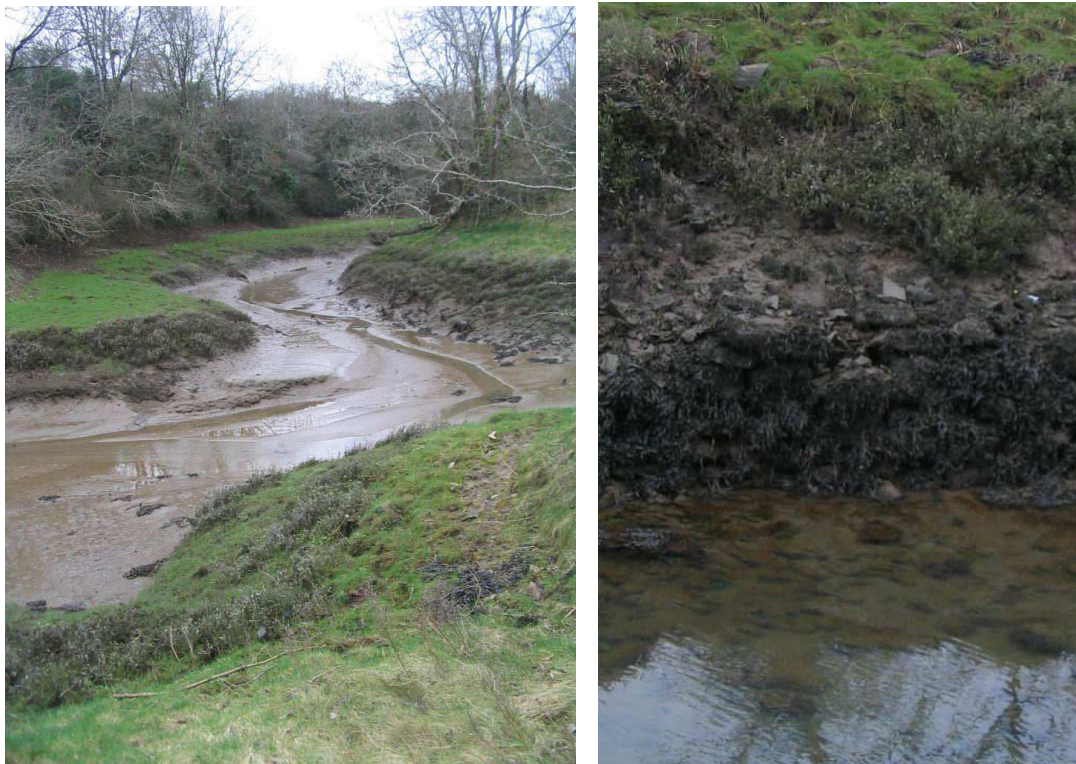
Plate 2 (left) Water channel (PRN 37087) running through Prinkly Quarry (PRN 17916)

Plate 3 (right) Area of stone lining still visible on one side of the channel.

A canalised water channel leading off from the Carew Estuary to serve Prinkly Quarries (PRN 17916). The channel divides into three main inlets, whose centres were dug out and straightened to enable them to be navigable at high tide. Quarries at the heads of these inlets (for example PRN 49953) and along their lengths (for example PRN 49951) could then load limestone at the quarry face, directly onto the boats which were to take the limestone around the coast to north Pembrokeshire.

The channel survives in fair – good condition. A small section of stone facing is still seen along the main length of the channel, showing how the largest faces were supported to prevent mud slipping back from the banks and blocking the channel.

Management should aim to maintain this site in its current condition. In particular, it is important that the areas of stone facing which survive are not disturbed.

- i. The general recommendations for Prinkly Quarry (PRN 17916) suggest that the mudflats around the quarry area should continue to be grazed, in order to keep the vegetation down. Whilst this should not directly impact upon the water channel, it is important that stocking levels are kept low enough to ensure that cattle do not cause any disturbance to the areas of surviving stone lining.

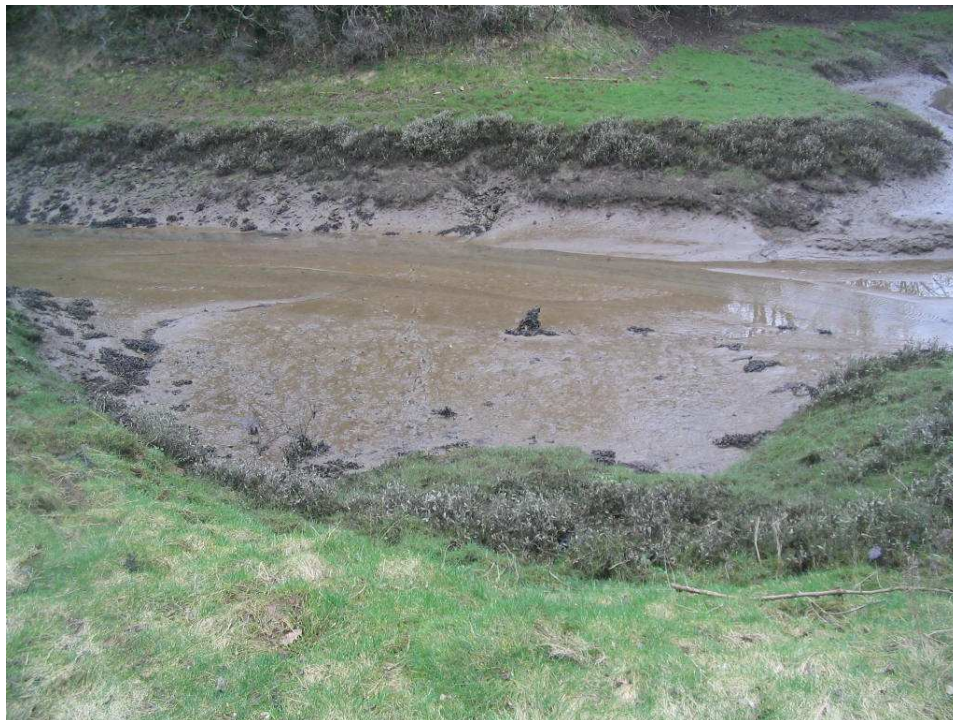
Plate 4 *A possible dock, cut into the side of the water channel (PRN 37087).*

A probable dock site, formed of a shallow cutting in the side of the water channel (PRN 37087). This dock may have re-used and emphasized a natural feature. It would have served a small quarry face (PRN 49951) which is set slightly back from the water channel.

See management recommendations made for Prinkly Quarry (PRN 17916) and section B2 of the Tir Gofal Farm Management Plan (Protection and Maintenance of Archaeological and Historic Features).

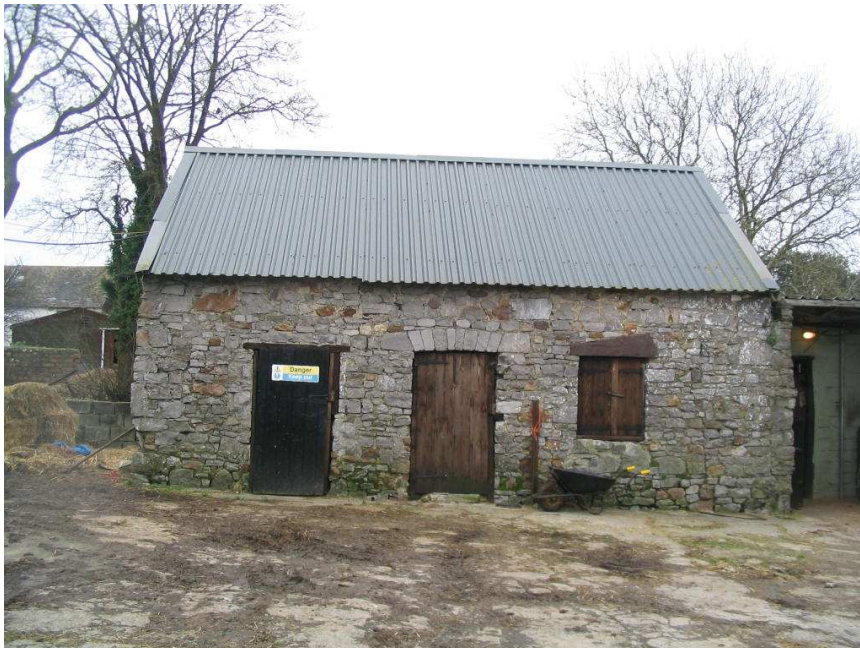
Plate 5 *The old stable, probably the oldest building at Carew Newton Farm.*

The buildings are currently in fair condition. They are roofed with corrugated zinc or plastic, and are all in use.

Traditional buildings should be maintained using methods and techniques appropriate to the building. Section B2 of the Tir Gofal Farm Management Plan (Traditional Buildings) applies.
