Nantfforchog W/12/4003

Tir Gofal Farm Visit Historic Environment Report Call Out

Report No. 2004/22

Nantfforchog Farm
Tir Gofal Farm Visit Historic Environment Report
Call Out

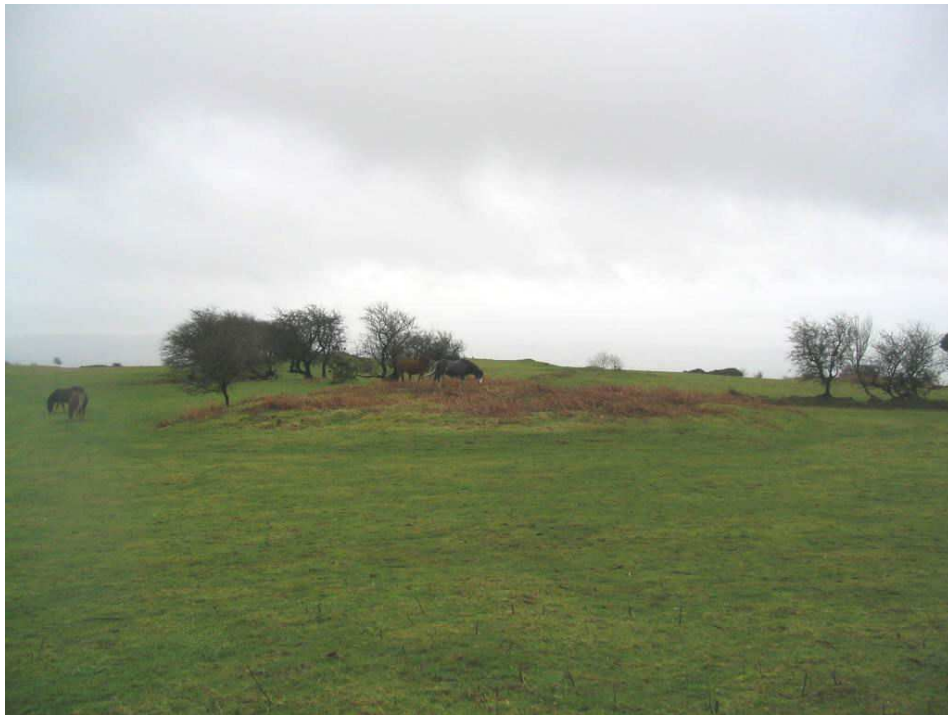
A large mound, Prn 48723, which occupies the high ground at Holding B.

A large roughly circular feature about 27 metres in diameter is situated to the south of this group of features. It has a very uneven surface (see photo on frontispiece) and is covered in bracken. Again there is a great deal of loose stone lying on the ground surface.

These features may contain very fragile and sensitive archaeological layers, and potentially burials or cremations could lie within the mounds. In order to protect these deposits no ground disturbing activities should take place within 5 metres of each of these features, and watering points or feeding stations should be sited well away in order to prevent erosion from livestock. Fortunately, this area is under permanent pasture at present and this landuse is to be continued for the foreseeable future.

It is believed that bracken clearance will be undertaken as part of the scheme, this will be beneficial for these features and the potential archaeology in this area as the rhizomes produced by bracken are thought to be very damaging to below ground deposits.

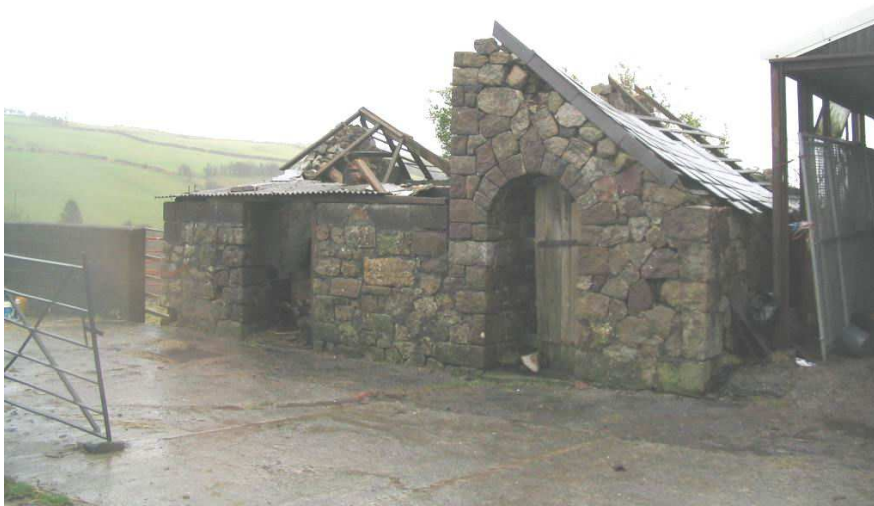
Plate 1 – to the north of the farmhouse is this unusual building, a former pigsty?

The farmstead at Nantfforchog consists of the farmhouse to the east of the farmstead complex and a long combination farm building to the west of the farmyard. To the south of the farmhouse is an intriguing building, possibly a pigsty, which is quite unusual (plate 1), it exhibits architectural pretensions which set it apart from the other farm buildings.

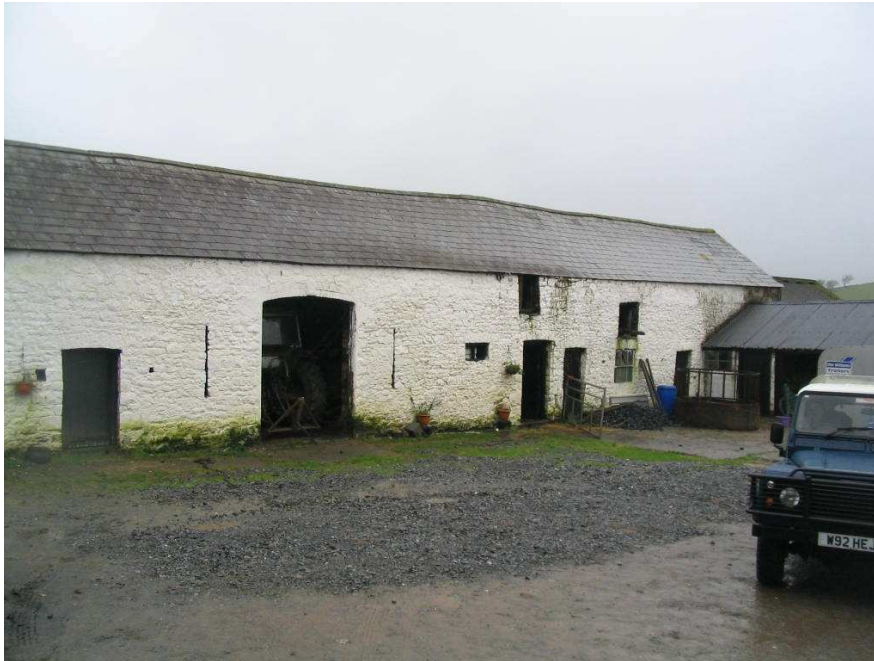
Plate 2 – the combination farm building at Nantfforchog

There are proposals through the scheme to undertake the restoration of the door and window fittings of the combination farm building at Nantfforchog (plate 2). The building is a multi-functional farm building of two storeys that appears to be arranged in four main sections. The north end is somewhat obscured by a low building abutting at right angles, however the low wide doorways at this end (one of which has been blocked to form a window) would indicate the use of this section originally as a cow shed. Adjoining this section on the north side is a taller doorway with a high flanking window which would suggest its original purpose was a stable. Beyond this is an almost full height double doorway, flanked to either side by long ventilation slits; undoubtedly this was the barn used for crop processing. At the very south end of the building is another low doorway with a small ventilation slit which would appear to originally have been designed as another animal house.

The barn is in fairly good condition, the roof appears to be sound and the slates are in good order. The building is still in use, both as an animal house and for storage. The owner has also been undertaking the repair of the loft floor.

There are problems with the doors and window frames however, the owner has replaced some of these not long ago, but the bases of the doors are beginning to rot already. The owner hopes to reinstate the wooden fittings which have been lost including the wooden shutters on the windows and to replace those doors which are beginning to rot. It is hoped that this will be undertaken using trees felled on the farm.

Doors and windows are of great importance to a historic building and their insensitive repair or replacement can lead to the loss of character and authenticity of the building. Wherever possible original doors and windows should be retained and repaired.

Many of the other existing doors on the building are already replacements, which although they appear to have followed in the traditional design of the original fittings, and have reused the original furniture, they have been of insufficient quality to withstand intensive use and harsh weather conditions. These doors and windows, which are not original, should be replaced retaining the existing door furniture (hinges and latches).

New shutters for the first floor openings should be constructed using a simple, traditional design.

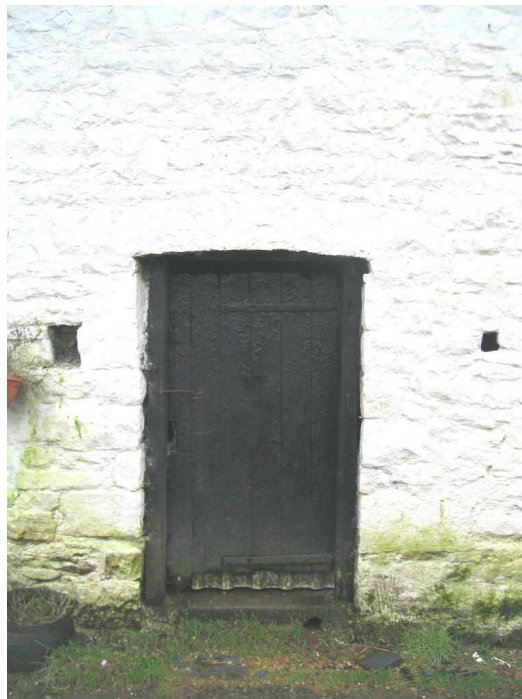
Plate 3 – an original door which survives in the south end of the farm building

There appears to be only one original door which survives at the southern end of the building (plate 3). This door is beginning to suffer some rot at its base where it is continually wet, however in the main the door is still sturdy. This door should be retained and new timber spliced in to the base to make it sound once again.

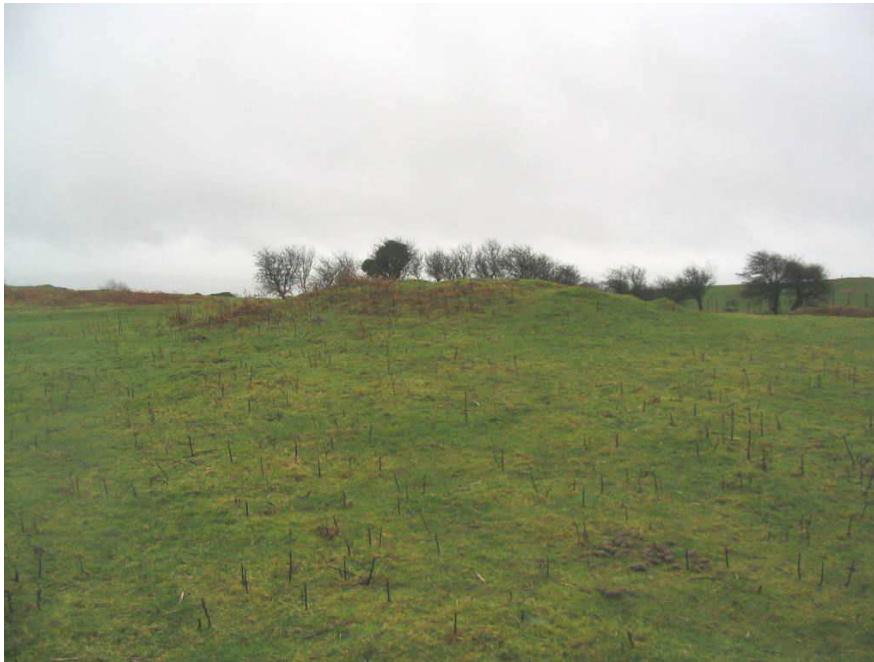
Plate 4 – Prn 48720, an earth and stone mound

A mound approximately 12 metres in diameter and 0.75 metre high. The ground surface of the mound is uneven and consists of a great deal of loose stone, much of it small fragments. Bracken appears to have colonised the mound.

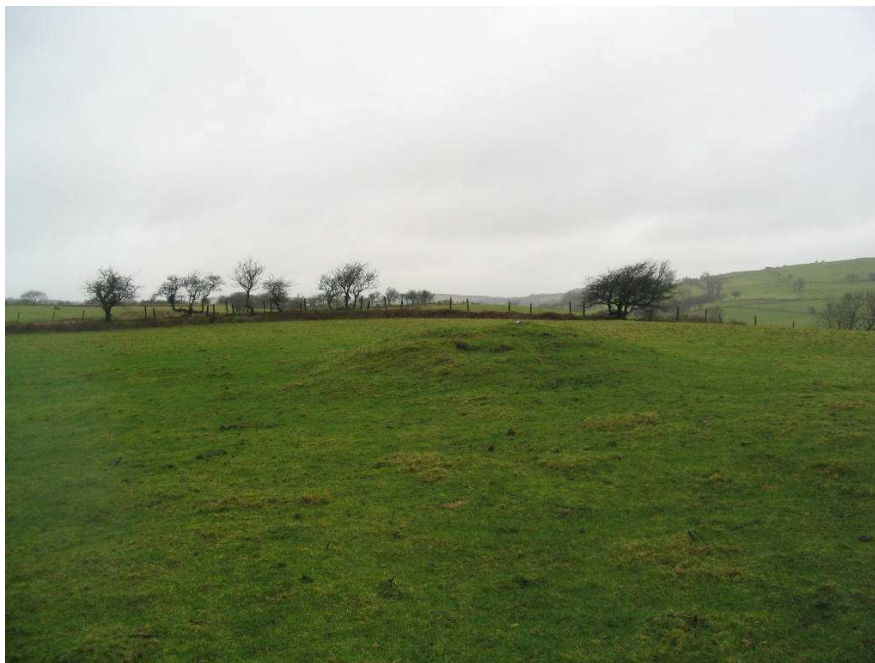
Plate 6 – Prn 48722, largely turf covered and with a fairly smooth profile

East again of the two previous features is a gently raised mound about 0.5 metre high and 10 metres across. The profile of this mound is gentle but pronounced, and the ground surface is slightly uneven. It is mostly turfed, but some stone projects through the grass cover.

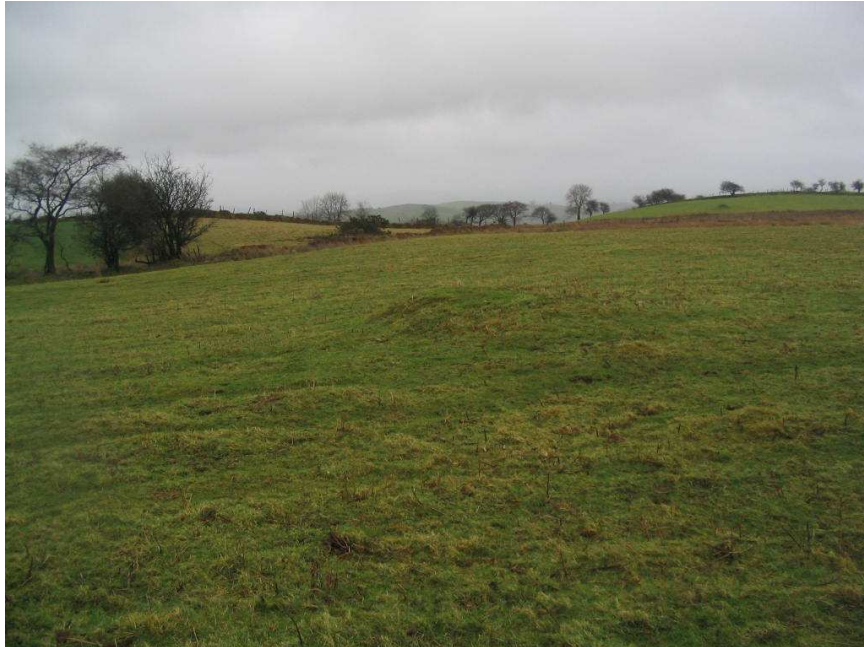
Plate 7 –Prn 48724, the smallest of the mounds in this area

To the north of this group is a small mound about 4 metres in diameter, largely turf covered. This mound is situated on a north facing gentle slope.
