TIR GOFAL MANAGEMENT PLAN: HERITAGE MANAGEMENT INFORMATION (HE2)

Prepared for:
Wernmacwydd
Llanfihangel-ar-Arth, Pencader.

Farm Visited on the
29th April 2004
Tir Gofal Reference No. W/12/4062.
Project Record No. 48508
Report No. 2004/65

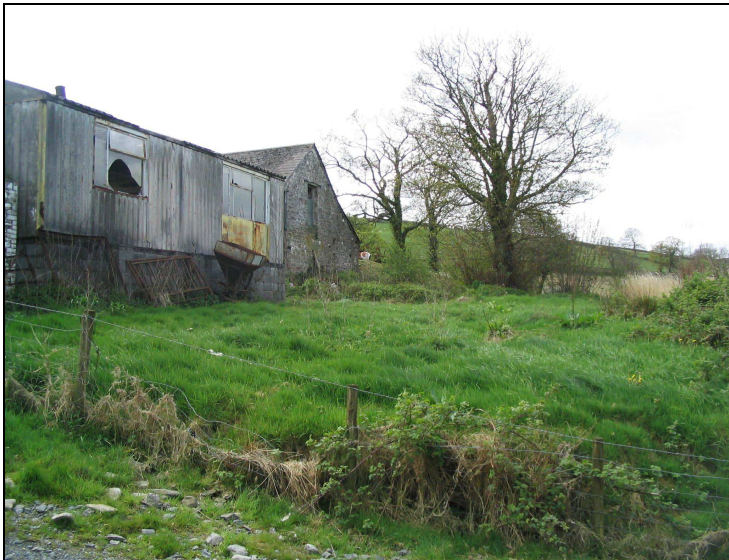
No on Map	PRN	Site Name/type	Period	NGR	Importance (status)	Management
1	50833	Pond	Post-medieval	SN4374 3991	C	Specific see below
Former pond to west of farmhouse, north of barn range. Level platform covered with rushy growth. Marked as site of pond on historic map sources. Substantial embankment on western edge implies possibility of buried features associated with original construction of pond.

<p style="text-align: center;">Site of former pond (to be restored)</p>

The farmer intends to re-instate this pond, which appears on historic map sources. Excavation of the pond should be undertaken with caution in order to protect any remaining structural elements. Care should be taken when excavating near the embankment on the western side of the area, which retained the original pond, and also to retain structural elements, such as dams, walling and timber pilings.

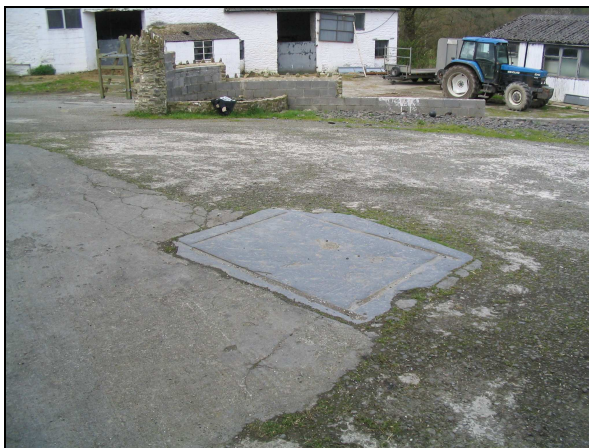
Well in farmyard to west of dwelling, capped with slate slab, internal features not seen. The farmer reported that the structure of this well was very similar to the well described below (PRN 50832). Internal condition unknown, currently protected from damage by capping slab.

Site of well in farmstead

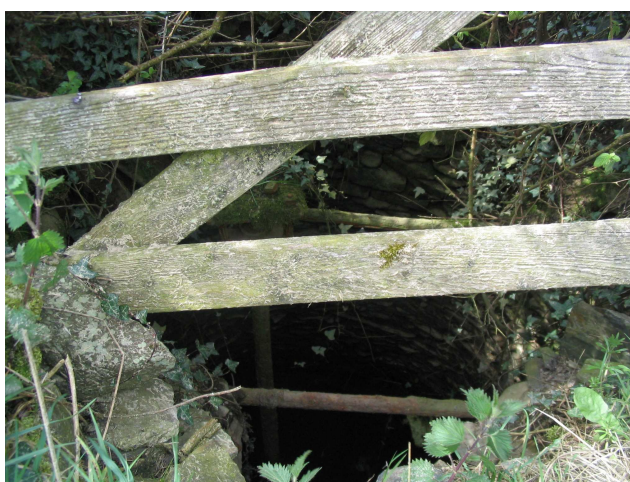
A very finely constructed circular well, located within a field boundary bank. The well is open at the top, with no super-structure, and no suggestion of there having been one in the past. The shaft is carefully lined, with flat platy stones forming a perfect cylindrical shaft, the base of which could not be seen. Diameter c. 0.8m. Depth unknown. The positioning of the shaft on the line of a field boundary bank suggests that the well shaft pre-dated the boundary bank, which was in place by the mid nineteenth century. Currently overgrown by the hedge. Poor visibility, partly due to an old gate, which has been used for stock-exclusion.

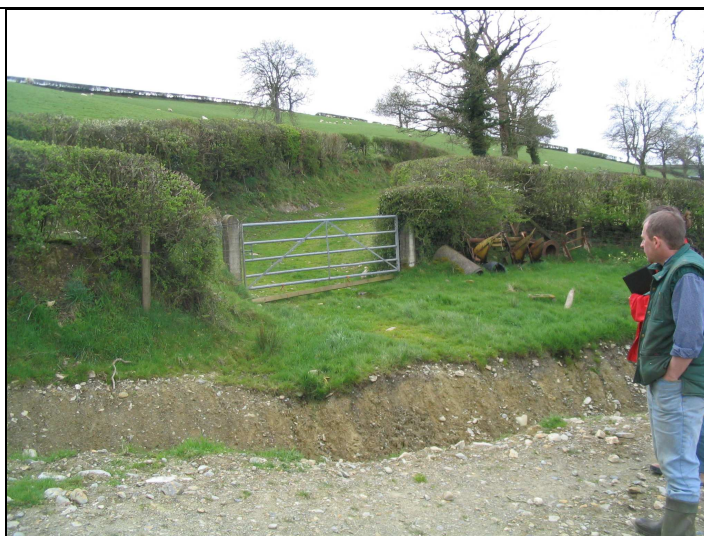
This short length of trackway may once have been part of a longer track linking Wernmacwydd with Blaen Y Waun farmstead to the south-west. The section, which is marked on historic and modern map sources, appears on the ground as a well-defined sunken lane with hedge banks on either side. If it was once part of a longer route, no further remains of this route are now visible within the farm boundary. The length of track still defined by hedge banks should be retained.

End of sunken lane viewed from north

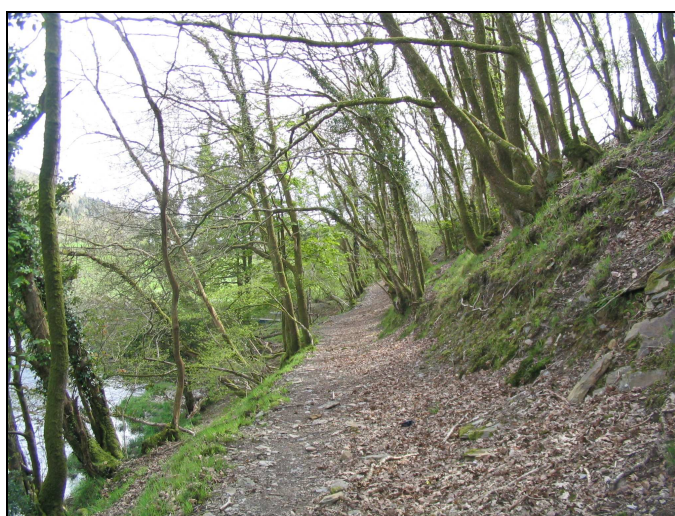
A defined trackway, running through woodland (Allt Wernmacwydd) on steeply rising ground on the south bank of the Teifi. It appears on the Old Series Ordnance Survey Original Surveyor's drawings of 1811-12.

The track is cut into the hill slope, and is now only used as a footpath, although its' width suggests that it may have been used for wheeled vehicles in the past. Management should aim to ensure that the trackway does not become colonised by volunteer saplings, and that it is not lost to bank erosion and collapse.

Trackway running through Allt Wernmacwydd, showing potential problem with erosion.

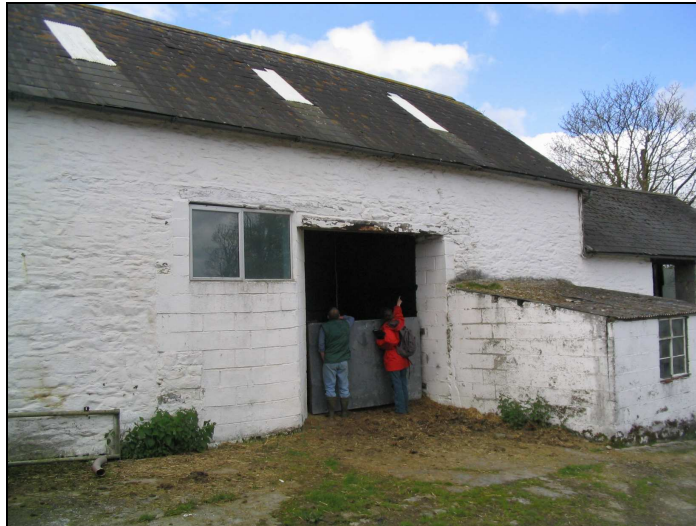
No on Map	PRN	Site name/type	Period	NGR	Importance (status)	Management
	50827	Barn range	Post-medieval	SN4375 3987	C	Generic management recommendations apply
<p>Barn range lying to south-west of farmstead opposite and parallel to farmhouse. This long range, whose core structure is depicted on various historic map sources, is comprised of a central, tall building, orientated north-east south-west, with a lower extension to the north-east end, and shorter wing adjoining north side at right angles. The range follows the contour of the slope, with the north-west end being lower than the south-east end. The gable end of the right-angled wing faces the farmhouse, and has a small window opening to the second floor. These elements are all of rubble stone construction, and roofed with slate.</p> <p>There has been some significant modification to the range, both internally and externally, making it difficult to fully understand the original layout and functions. Breeze-blocks have been used for modifications and additional lean-to structures, which are likely to date from the building's use as a milking parlour by the previous owner. The main entranceway on the north-east side of the central section has been widened in the past (this may have been deliberate, or due to arch collapse), and has subsequently been partially infilled using breeze-blocks. There has also been some modification to the entrance of the lower barn. The height of the doorway has been raised to roof level, and has been edged with concrete blocks. Two further doorways on the north-east side of the building (one in the main barn, and one in the smaller barn) have been infilled using concrete blocks, but both retain their original shape and size. The central portion of the barn has been re-roofed in the past, and has lead/ tin(?) covers over what may have been lights, or ventilation openings. The entire building is whitewashed and in a reasonable, weatherproof state of repair.</p>

Central portion of barn showing modified entranceway

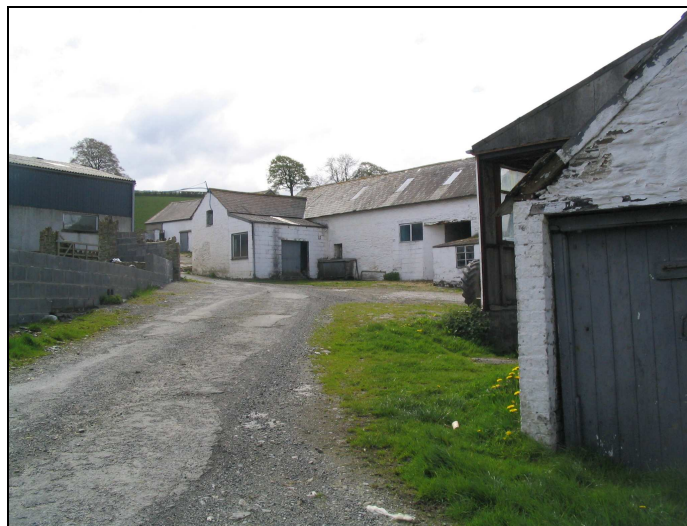
Barn range viewed from north, showing stone built wing at south-east end and breeze-block extensions.

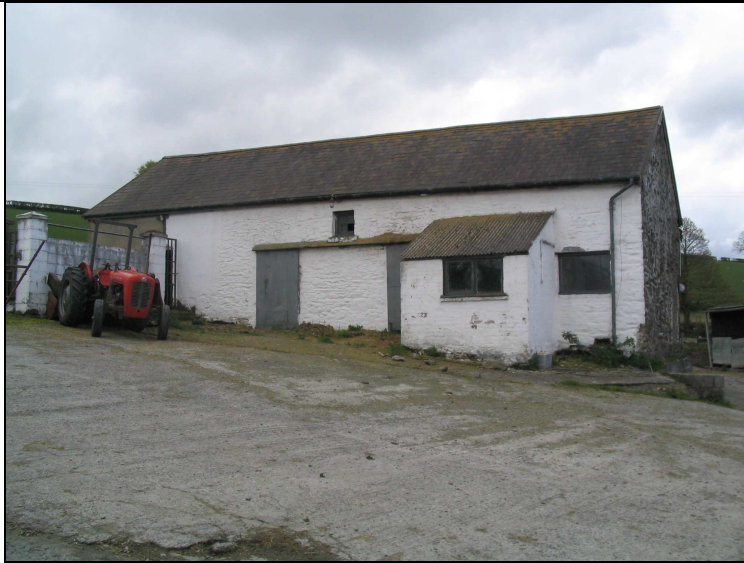
Small barn range to south of farmhouse. Single unit, constructed of rubble-stone, white-washed and roofed with slate. Internal arrangement not seen. Much of original fabric intact, but slight modification to north-east side of building, with addition of brick-built lean-to, and concrete mounting for sliding doors.

Barn range viewed from north

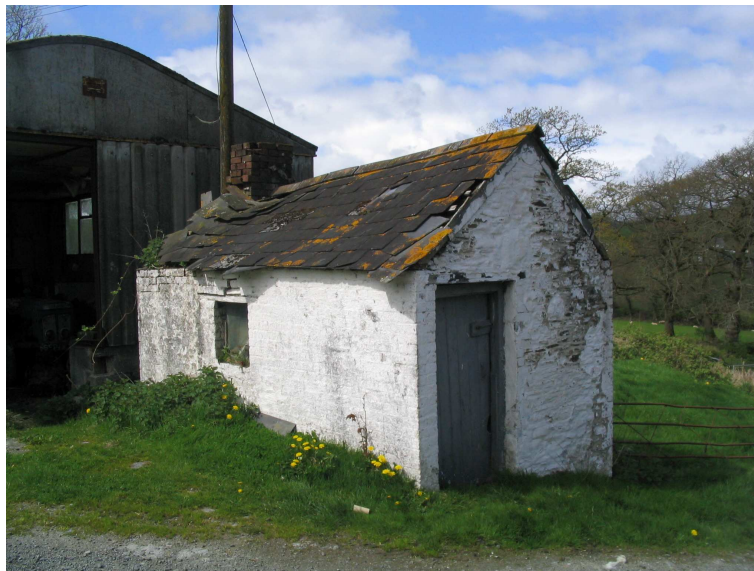
Small building, part rubble stone, part red brick construction, with offset door at front (north-east gable end), and brick chimney at rear (south-west gable end). The south-east wall is completely constructed of brick, and has a small central window opening. This appears to be a brick rebuild of an earlier stone building of unknown function. The rebuild incorporating a chimney suggests a domestic function, and the farmer thought it might have been a wash-house. The building is in a poor state of repair, and is in need of re-roofing.

Possible former wash-house, showing chimney to rear.

The farmer wishes to demolish this building. Ideally it should be retained because of its' group value as part of the historic farmstead. The roof is in need of repair if the building is to be prevented from becoming more dilapidated. Some consideration may have to be given as to how best the building can be re-used and maintained as a functional element of the historic farmstead.

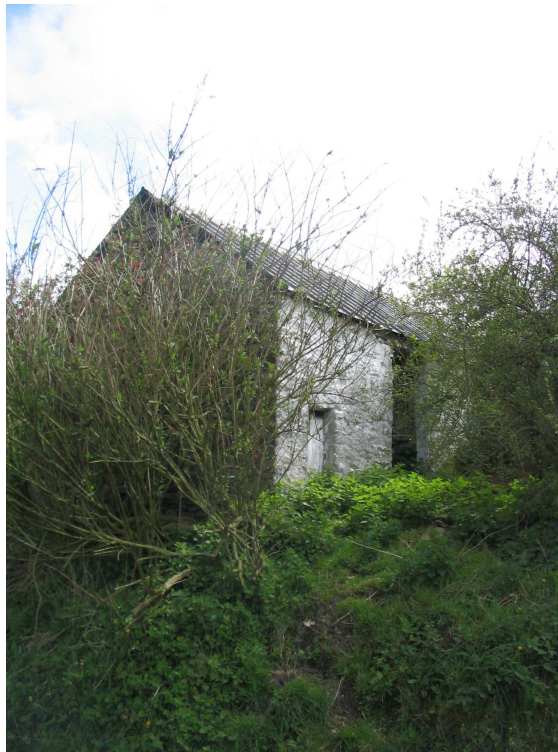
Small square building, rubble stone construction with central door to front (south-west wall). Also low boarded entrance-way to left of door. Currently used for storage, it has been re-roofed with corrugated plastic. Access not gained - external appearance suggests that the building is in a reasonable condition, and is weatherproof.

Pigsty viewed from the trackway to the west
