Tir Gofal Farm Visit Historic Environment Report

Report No. 2004/44

REPORT NO. 2004/44
PROJECT RECORD NO. 48881

Kingston
Tir Gofal Farm Visit Historic Environment Report

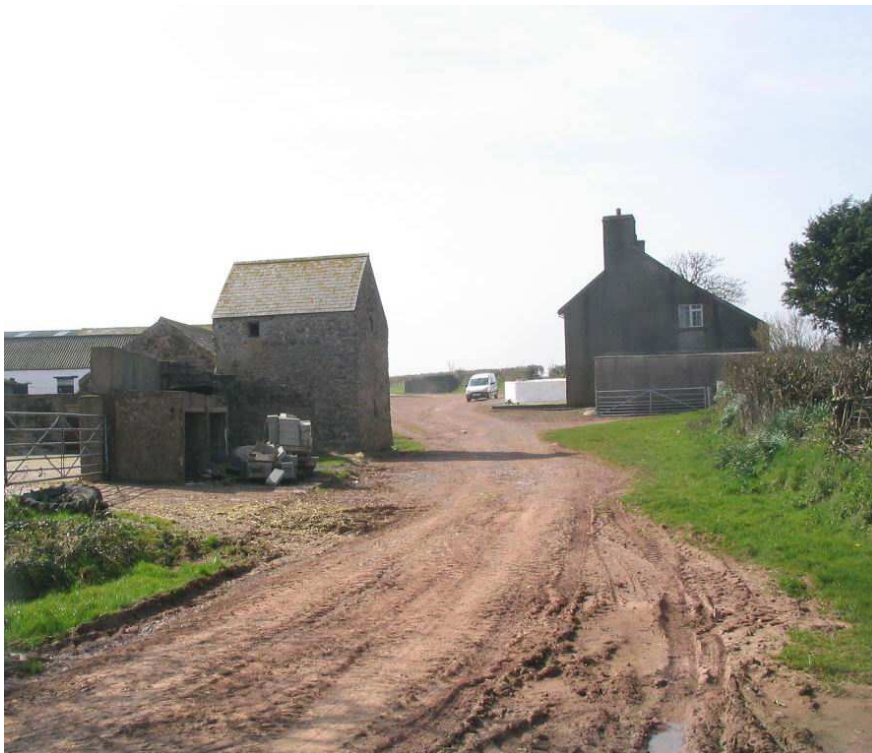
*Prn 48753 – Kingston Farmstead, the old farmhouse to the right
and the medieval tower house to the left*

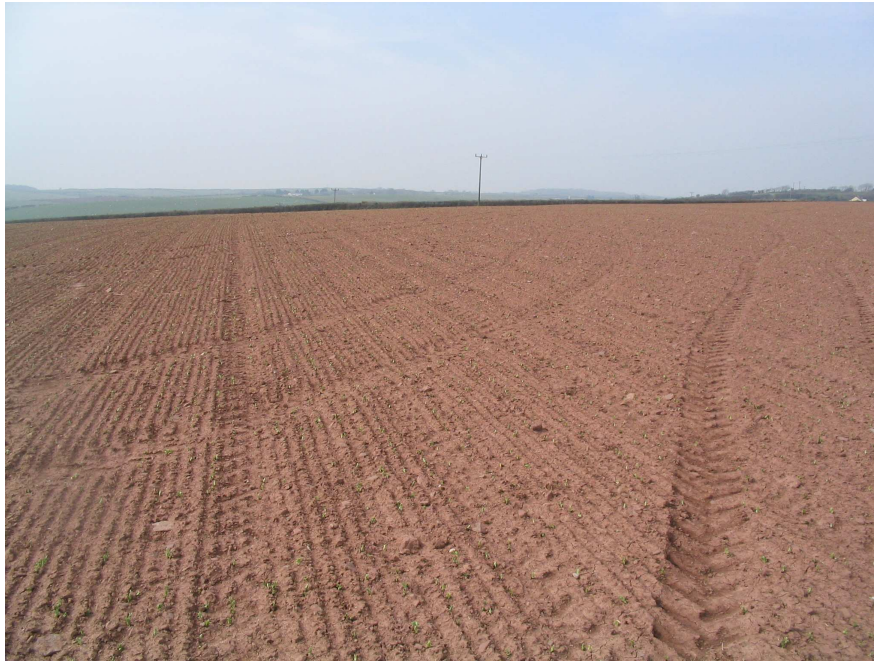
This field had been ploughed and sown at the time of the visit, and the earthwork remarked on nearly 20 years previously appears to have been almost completely ploughed out. This field is under crop rotation and is therefore regularly cultivated. Undulations in the field may mark the site of the enclosure, but the site is almost impossible to pinpoint.

Prn 583 – a circular earthwork was identified in this field some years ago, however the upstanding remains of this feature have been ploughed out.

It appears that the upstanding remains of this hillfort/enclosure have been completely ploughed out. It is possible, however, that some archaeological deposits, particularly negative features – those which have been cut into the subsoil – may survive below cultivation levels. These features may contain valuable information about the date and purpose of this enclosure which is little understood at present, therefore, in order to protect this site care should be taken not to exceed current ploughing depths.

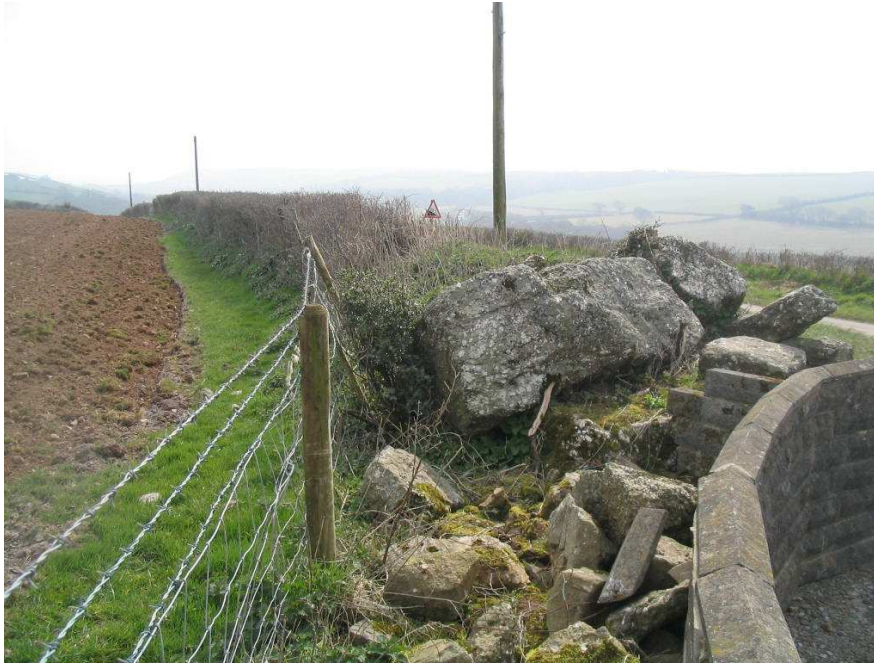
The monument appears to be in a stable condition however unfortunately this remarkable feature

is rather obscured and is easily missed due to the encroaching vegetation and also the proximity of other, later features around it. In addition a number of loose stones from field clearance along with general detritus kicked up from the adjacent public road have increasingly obscured the monument.

Prn 584 – Kingston Neolithic chambered tomb found between the entrance drive to Kingston farm, a hedgebank and an adjoining field.

The vegetation which is growing over the monument should be cut and carefully removed taking care not to cause damage or dislodge the stone beneath. The roots should be left in place and spot treated to prevent regrowth.

It is important that the margin of cultivation is enlarged to the north, currently ploughing is occurring approximately 1.5 metres from the capstone. Ideally there should be a margin of at least 5 metres from the monument in which a permanent stable grass sward should be established. This could be achieved by moving the fenceline to the north of the scheduled area and at least 5 metres from the edge of the monument (the erection of a new fenceline within the scheduled area will require scheduled monument consent, obtained from Cadw). If the fenceline is moved then adequate provision should also be made for the maintenance of the area between the monument in order to prevent this area becoming overgrown with scrub and brambles.

Ideally the entrance drive wall which sits against the western edge of the feature should be shortened in order to give greater visibility of the monument. This would greatly enhance the appearance of the monument. The existing wall is suffering from cracking and loose coping stones and will undoubtedly require maintenance work in the near future, this would provide an excellent opportunity to reduce the length of the wall giving 3 or 4 metres of clear space around the burial chamber. The improvement of the visibility of the chambered tomb would provide an impressive feature to mark the entrance for Kingston farm.

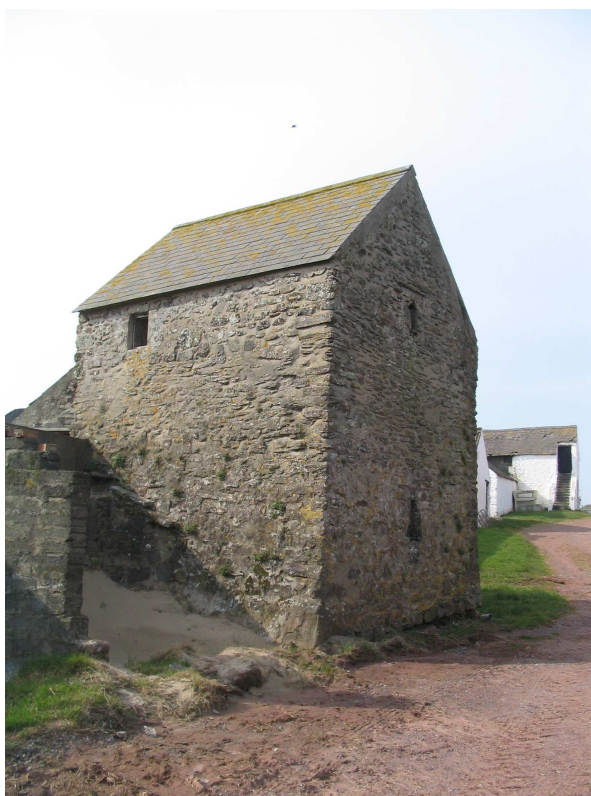
The building is in a reasonable state of repair, the roof appears to be in a good, waterproof condition and while some vegetation is growing in the masonry on the north gable wall, this is of a fairly non-intrusive nature and does not appear to be a threat to the stability of the structure, probably thanks to the yearly removal of vegetation currently undertaken by the farmer. Internally, within the ground floor, a stone appears to have fallen from the northern wall face. The stone lintel above the doorway has also cracked although this doesn't appear to have

happened recently. The doorway in the first floor holds a wooden plank door, which has rotted from the base upwards and the door frame appears loose, although close inspection was not possible.

Prn 8811 – the tower house found at the eastern edge of the farmstead

Ideally the walls should be kept free from vegetation, this should continue to be undertaken on a regular basis, and may benefit from the use of a suitable herbicide (in consultation with the Tir Gofal Project Officer).

The roof should be regularly inspected and loose slates should be refixed where necessary.

Repointing should be undertaken where the existing pointing has become loose or if the pointing has weathered to a depth equivalent to the width of the masonry joint. Repointing should be carried out using a lime based mortar rather than cementitious.

The wooden door on the first floor should either be repaired and matching wood spliced in where the old wood has rotted, or, if this is not possible, then a new door should be made up, which should follow the design and construction of the existing door. The existing door furniture (the latches and hinges) should be reused.

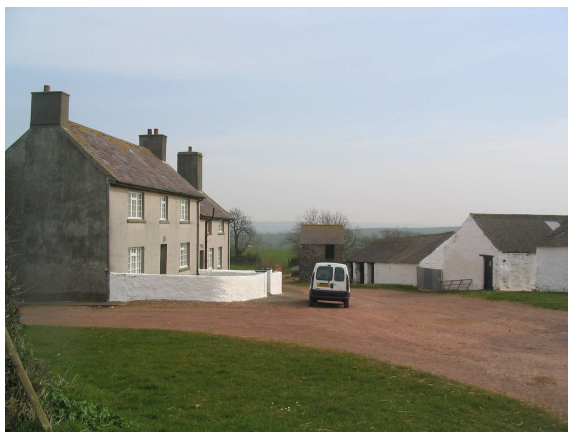
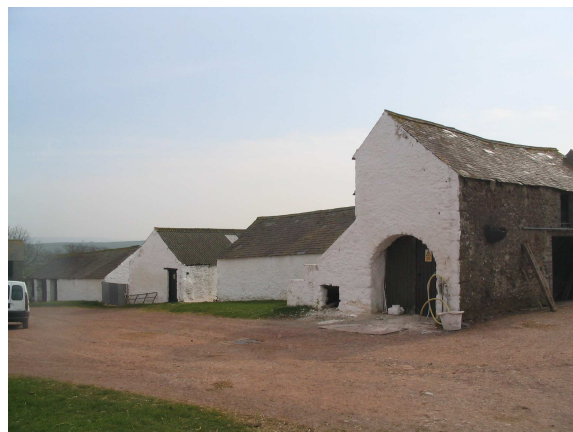
Prn 58753 – the historic farmstead viewed from the west, showing the old farmhouse (now holiday accommodation) to the left, the tower house in the centre beyond the van, and the range of farm buildings to the right which make up Kingston farmstead.

It is hoped, whatever the future holds for the farmstead, that the buildings can be sympathetically managed to retain their historic character, and until the fate of the buildings is decided they should continue to be maintained using appropriate traditional materials.

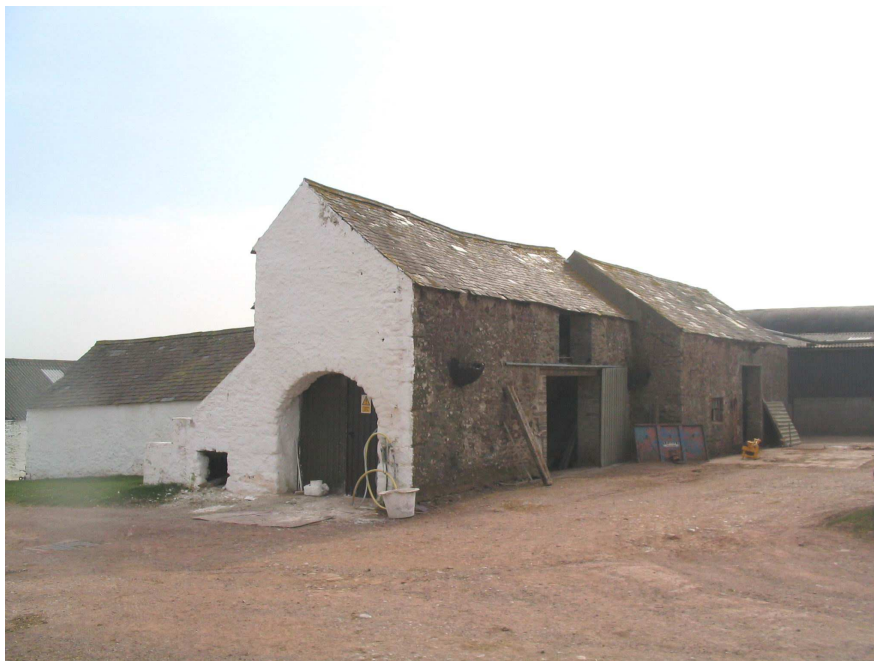
The condition of the roof on this building is of some concern, the northeastern side of the roof in particular has lost a number of slates and water has been gaining access to the timber structure beneath. In addition the roof appears quite uneven suggesting that some of the structural timbers may be failing.

Prn 48757 – the nearest building is the two –storey barn at Kingston which will undergo restoration and roof repairs

It is hoped that through the scheme this barn may be subject to restoration and the roof repaired and reslated. These works should endeavour to repair and retain the roof trusses and other structural elements of the building, replacement should be a last resort. As far as possible the roof should be restored on a like for like basis, using the same methods and materials as those employed in the original construction.

In addition it is recommended that an archaeological record is made of the building prior to the works commencing. Please consult with Cambria Archaeology when a schedule for the works has been agreed in order that an appropriate record can be carried out in advance.

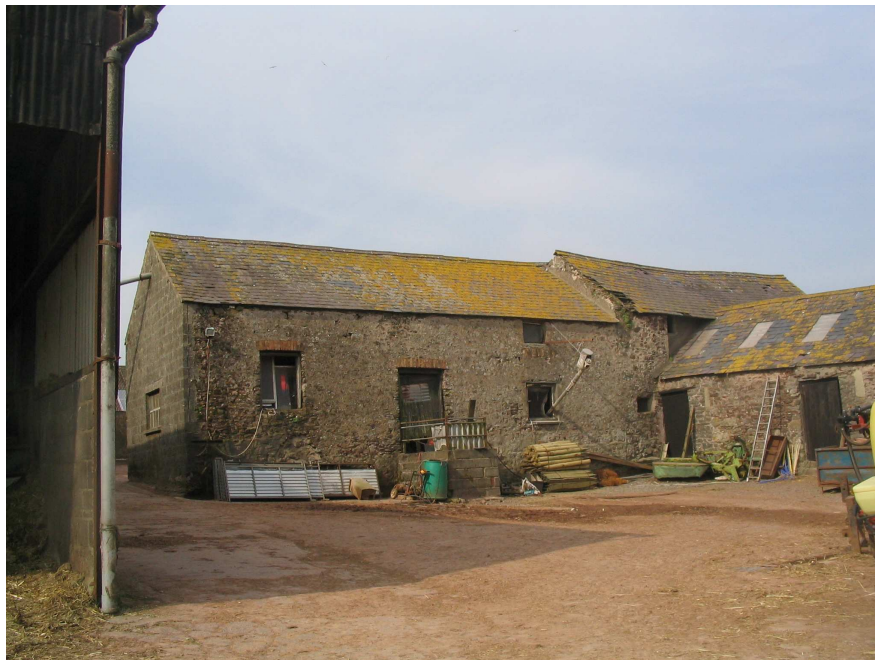
To the south of the barn and granary (Prn 48757) is an additional later barn constructed against the southern gable. This building is also two storey, but slightly wider than its northern neighbour and constructed in rubble stone with a slate roof. The long southwestern facing elevation has a large three quarter height inserted doorway and an inserted window. The opposite wall has a central doorway flanked by two windows, one of which has been lowered in the elevation.

Prn 48758 – the northeast facing wall of the later barn at Kingston, this barn is currently being used as a grain store and a workshop

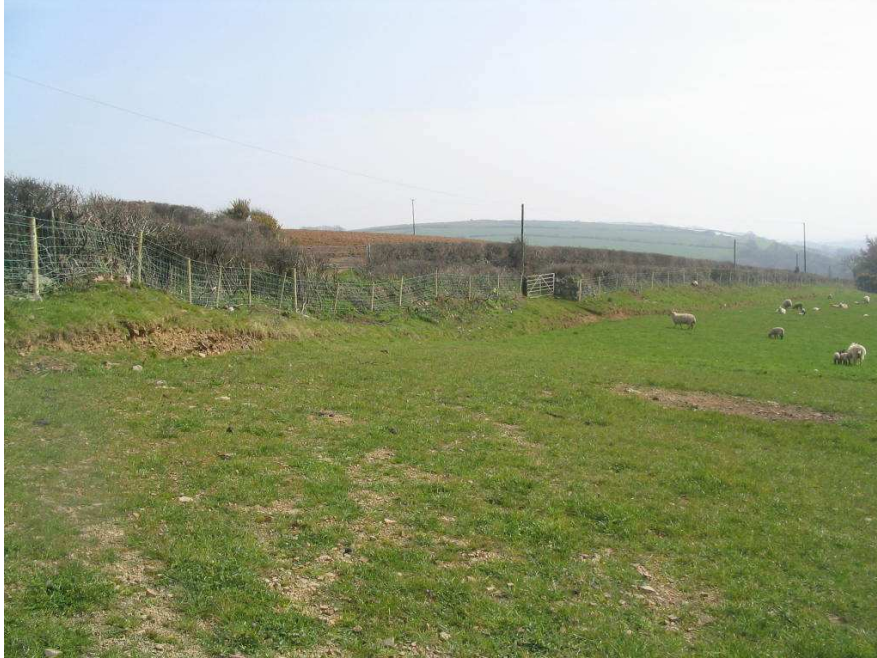
Today there is no visible trace of it on the ground. This field is regularly ploughed and it is noticeable that there must be a great deal of soil movement down the slope to the south, as there is a plough scar of about 0.3 metres deep below the hedge line. There are traces of stone lying in the hedgebank and a stone gateway is visible. The owner relates that when ploughing this field there is a large amount of stone in the ploughsoil.

Prn 48760 – the site of Delgate cottage lies near to the current hedgeline

It is likely that much of the remains of this cottage have been lost through regular ploughing and cultivation, coupled with the erosion of the soil down the southern slopes. Ideally present cultivation depths should not be exceeded in order to retain any negative features which may be cut into the underlying subsoil. It is also possible that remains of the cottage may lie within the field margin to the north, this should be retained and left undisturbed.
