Pensarn W/13/4053

Tir Gofal Farm Visit Historic Environment Report

Report No. 2003/129

Pensarn
Tir Gofal Farm Visit Historic Environment Report

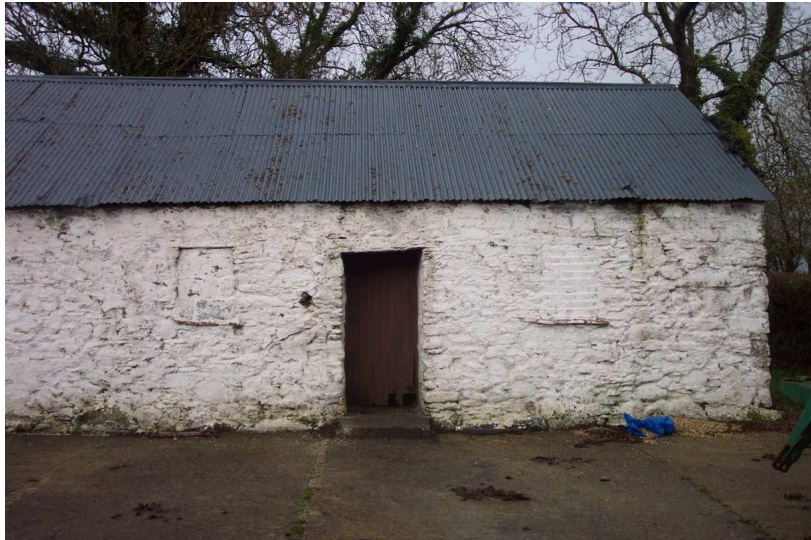
The cottage is now in a relatively stable condition, although ivy growth is now obscuring part of the east gable end. The corrugated iron roof sheets are beginning to rust allowing water to penetrate in places.

Plate 1- part of south elevation of cottage (PRN 49783)

The corrugated iron roof panels are corroded and in need of replacement. Re-roofing the building with slate has been suggested. Like the neighbouring cottage, the cow house was probably thatched originally. It is felt that a slate roof would alter the character of the building in an inappropriate way. Re-instating the roof with corrugated iron is considered to be most appropriate in this instance.

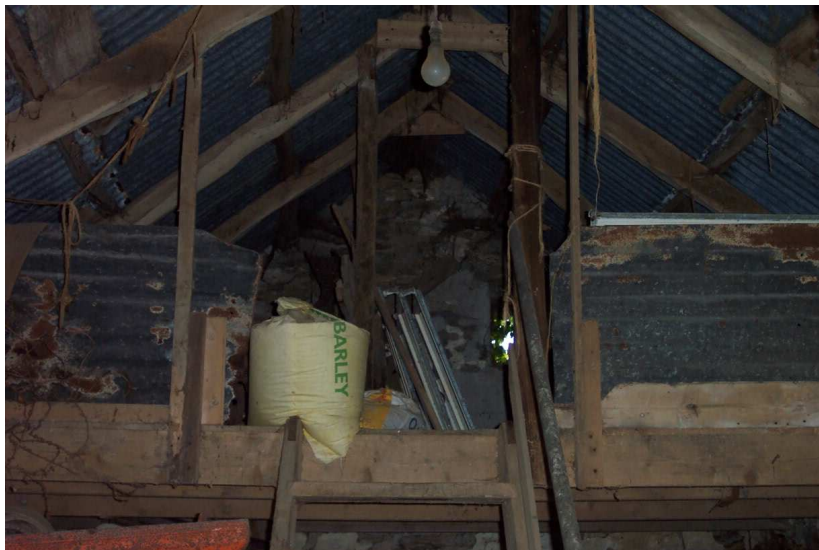
This century has seen several modifications to the cottage. The windows in the front wall have been bricked up and corrugated iron has replaced the original roof covering. The interior has also been modified, and a modern loft over the eastern end of the building has replaced the original loft. No original internal arrangements survive.

Plate 2- interior of cottage (PRN 49783). Note the original roughly finished roof timbers. The present loft is a recent addition.

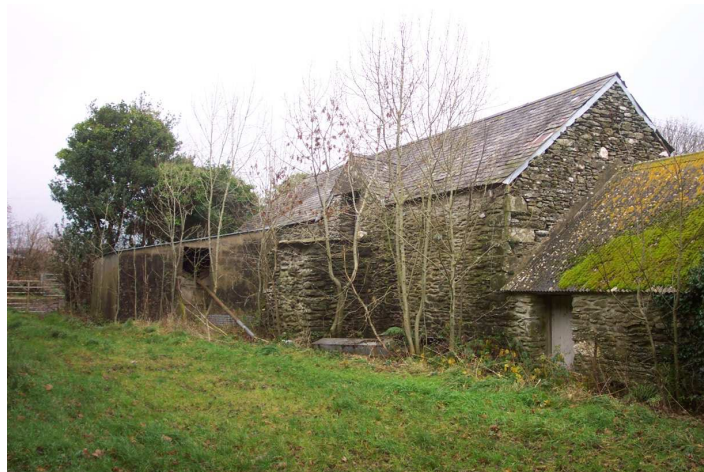
Plate 3- the rear of combination farm building (PRN 49805) and cow shed (PRN 49806) at Rhostwarch farmstead (PRN 49804)

This building is a particularly fine example of its type. It makes an important contribution to the farmstead and should not be allowed to fall into disrepair. It is presently in a reasonable condition, although some action is required if it is to be maintained in a stable condition in the long term. Vegetation growth on or near the structure is the principal threat. Ivy now masks much of the north gable end, and young trees have become established in the footings of the rear wall. Matures trees are growing near to the northwest corner.

The building would benefit from some active management if it is to be maintained in a stable condition in the long-term. Any trees growing near to the building should be monitored for signs of instability and felled or pruned if necessary in order to prevent damage to the building. The ivy growth on the walls should be cut off at the roots, allowed to die and then removed. Stumps should be spot treated in order to prevent re-growth. This should be followed up by a programme of re-pointing and building consolidation, using a traditional lime mortar mix, in areas where masonry bonds have been weakened by intrusive vegetation growth.

The building should continue to be maintained using materials and techniques, which are compatible with those of its original construction.

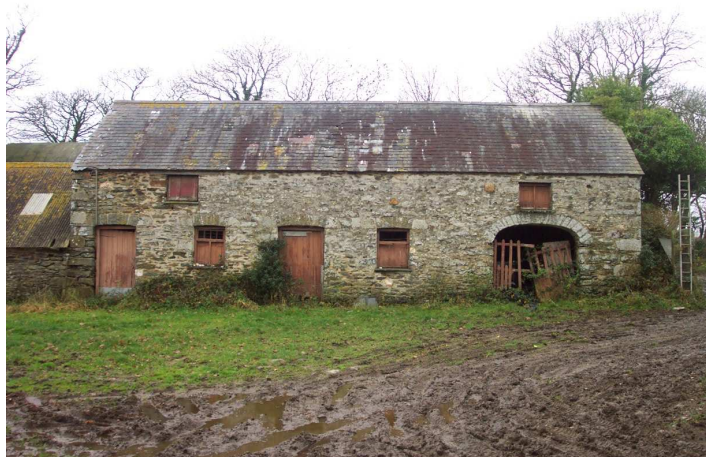
Plate 4- front elevation of combination farm building (PRN 49805) at Rhostwarch farmstead (PRN 49804)

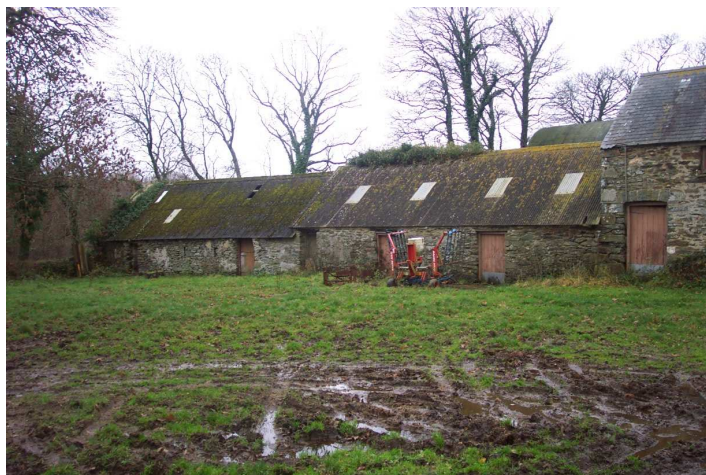
Despite the modifications to the interior of the building and the replacement roof. The cow house remains a well preserved example of its type. Its importance is enhanced by its status as part of a complete range of contemporary date. It is presently in a reasonable condition, although some action is required if it is to be maintained in a stable condition in the long term. Ivy is smothering much of the rear wall and creeping inside under the roof eaves.

The building is comparatively unmodified from its original appearance and is a fine example of its type. Its importance is enhanced by its status as part of a complete range of contemporary date. This is recognised by its Grade II listing. It is presently in a reasonable condition, although some action is required if it is to be maintained in a stable condition in the long term. Heavy ivy growth is obscuring much of the rear wall and the south gable end.

Plate 5- cow shed (PRN 49806) and cow shed? (PRN 49807) at Rhostwarch farmstead (PRN 49804)

The building should continue to be maintained using materials and techniques, which are compatible with those presently used.

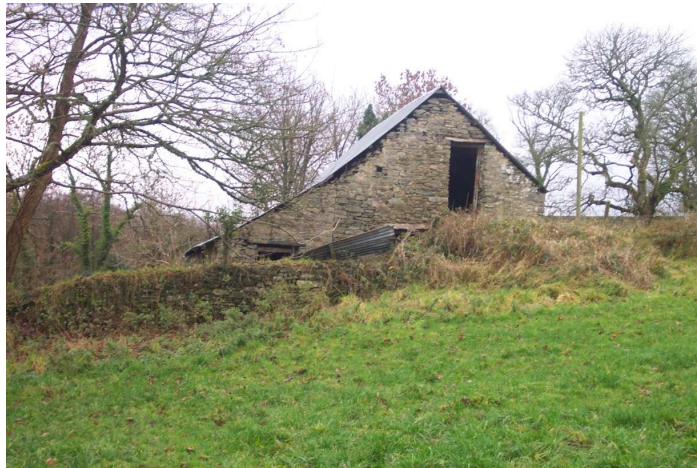
This building is comparatively unmodified from its original appearance and provides an important record of the development of Rhostward farmstead. It remains in a reasonable condition, although lime mortar bonds are washed out where water has penetrated under the roof eaves. The stone steps are also unstable.

Plate 6- looking west towards farm building (PRN 49808)

Although this building is not listed itself, it falls within the curtilage of the Grade II listed farmhouse and is subject to the same controls. The building should continue to be maintained using materials and techniques, which are faithful to those of its original construction.

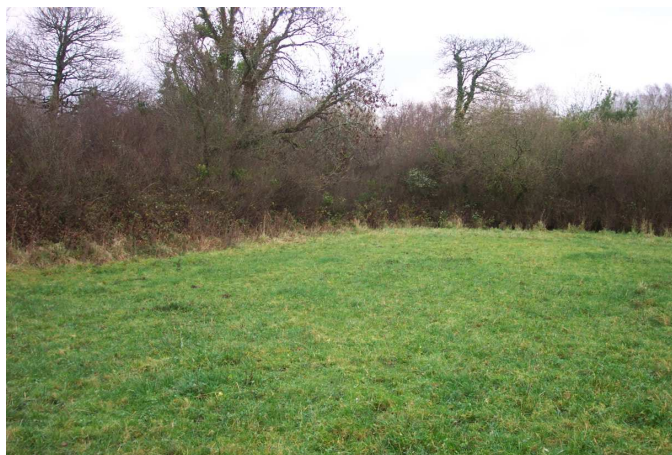
Plate 7- looking east towards the former cottage site PRN 49816

Although no above ground traces of the cottage survive, there is potential for buried archaeological remains here. In order to protect buried archaeological remains, no ground intrusive activities should be undertaken within 10 metres of the site specified.

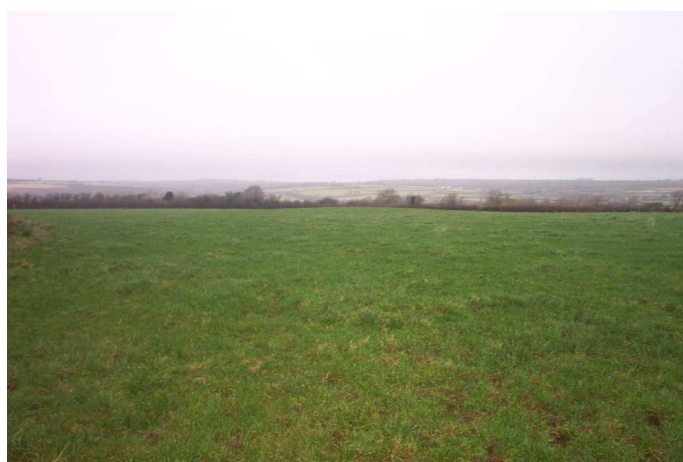
Plate 8- looking north towards round barrow PRN 49818

The mound lies within an improved pasture field, which is ploughed periodically. Past ploughing events have revealed that it is largely made up of medium sized stones. This is in contrast to the rest of the field, which is largely free of such inclusions. No sign of any boundary features or other associated earthworks was observed.

Ploughing is eroding the profile of the round barrow and damaging below ground archaeological remains. In order to minimise the risk of further damage, plough depth should not be increased.

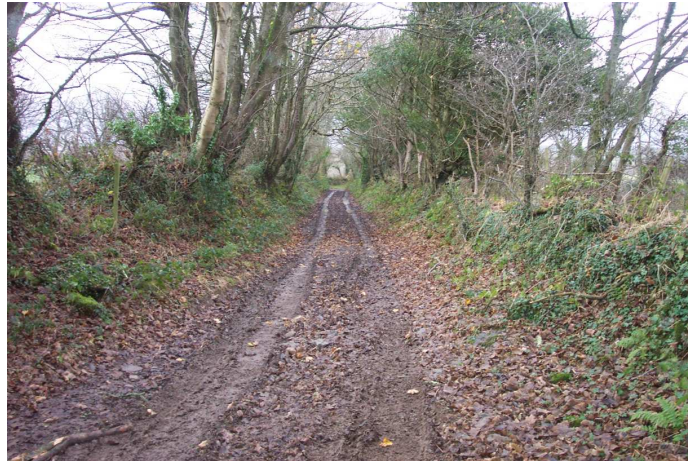
Plate 9- trackway (PRN 49820) looking southwest

The trackway should continue to be maintained for use as a farm trackway.

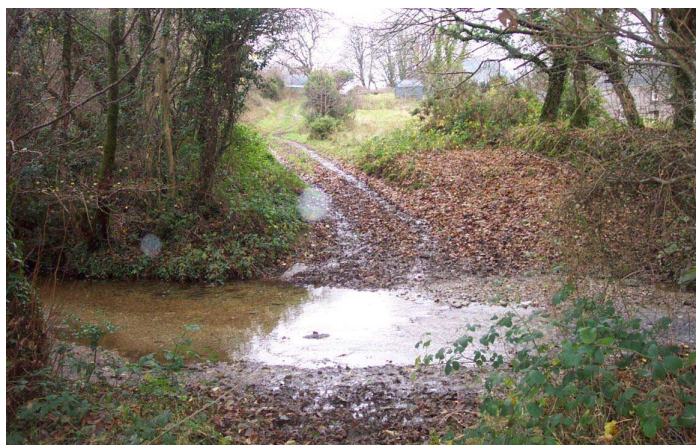
Plate 10- looking north from ford (PRN 49822) towards Rhostwarch farmstead (PRN 49804).

The ford should be retained for use as part of the farm trackway. The profile of the river banks here should be retained.
