Ysgubor-wen W/13/4028

Tir Gofal Farm Visit Historic Environment Report Call Out

REPORT NO. 2003/133
PROJECT RECORD NO. 48886

Ysgubor-wen
Tir Gofal Farm Visit Historic Environment Report
Call Out

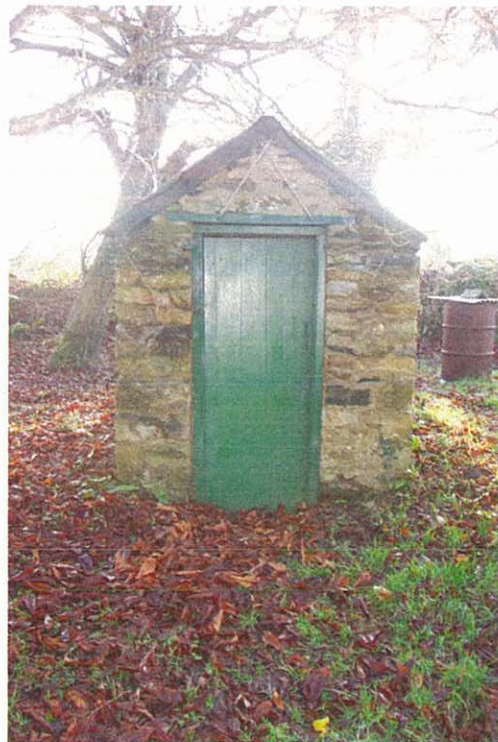
The shed is square in plan, and measures approximately 2.5 E-W by 2.5 N-S. It stands to a maximum height of around 2.5m with a pitched roof. Modern corrugated sheeting has replaced the original roof covering, which was of slate. The walls are of stone rubble construction; lime mortar bonded with roughly squared quoins.

Access is provided in the north wall through a wooden panel door. All other faces are blind with the exception of the west wall, which is pierced by a small glazed rectangular window, just below the eaves. The existing door and window openings appear to be primary features of the building. The roof timbers may also be original. Some of the original roof slates and ceramic ridge tiles now lean against the rear wall of the building. The floor is of rammed lime mortar and the building interior is whitewashed. There are few clues as to its original function. Its location in the garden enclosure could suggest storage for garden implements. Although a simple and unremarkable building, it is an important feature of the garden and is worthy of retention.

Plate 1- front (north) elevation of the garden shed.

The shed is currently redundant, although in a reasonable condition. Ivy growth on all faces of the building threatens to weaken lime mortar masonry bonds. The rubble walls are generally stable, although lime mortar bonds are washed out in places. Some stone has become displaced in the north wall by the door opening. The floor inside is becoming eroded and broken up.

The ivy growing up the south gable end of the building should be cut off at the roots, allowed to die and then removed. Stumps should be spot treated in order to prevent re-growth. This should be followed up by a programme of re-pointing and building consolidation in areas, where masonry bonds have been weakened by intrusive vegetation growth. Lime mortar should be used for re-pointing and masonry consolidation.

The landowner is keen to replace the original slate roof. This is to be welcomed as it would restore some of the lost historic character of the building. Original roof timbers should be retained as far as is practically possible. A desire to replace the floor has also been expressed. Any replacement materials should be compatible with those of the buildings original construction. In this instance lime mortar would be the preferred material.

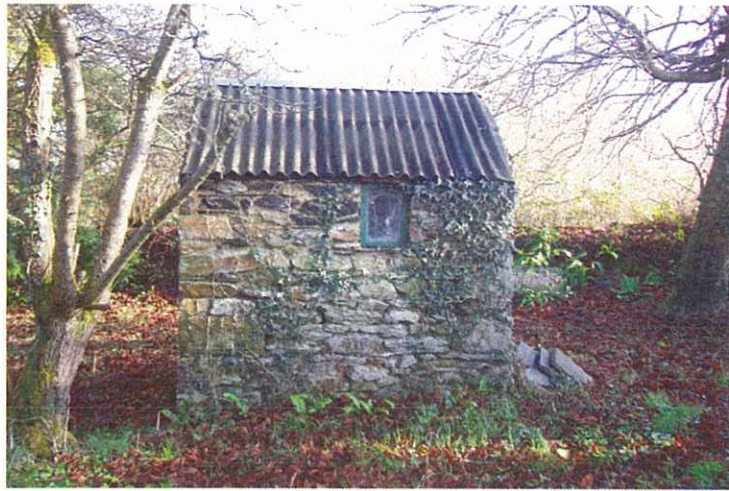
Plate 2- west elevation of the garden shed.

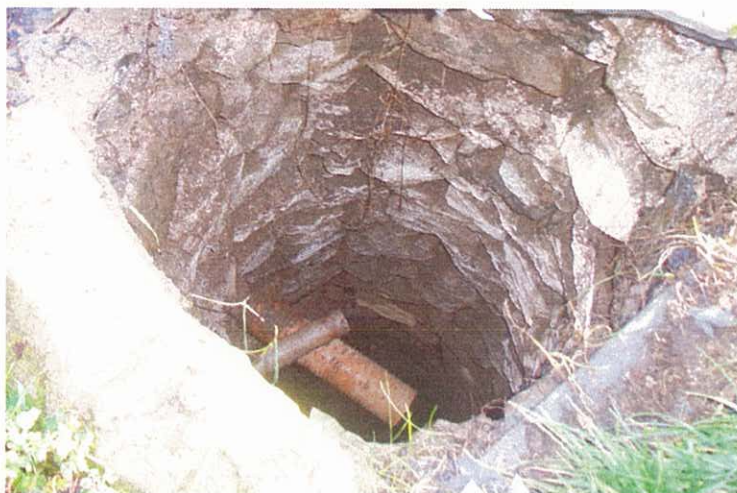
This well lies a few metres to the east of the farm buildings at Ysgubor-wen. It is circular, and stone rubble lined, approximately 1 metre wide and about 12 metres deep. It is absent from the 1891, 1907 and recent map sources, and may have been overlooked by the Ordnance Survey. Given the absence of any specific information on the well, it cannot be known when it was constructed. It could be contemporary with other elements of the farmstead, which are at least of a mid-nineteenth century date.

Plate 3- the well interior.

The stone rubble outline of the well is now capped with concrete at ground level. A slate slab now covers the opening. Nothing remains of the original well head.

The landowner is keen to undertake restoration works to the well, specifically by projecting the stone rubble lining a short distance above ground level. Following this, it is proposed that the well will be capped in the interests of safety.

We have no information on the original appearance of the well head, with which to inform a restoration project. In the absence of such information it is recommended that the well should be capped at ground level.
