Castle Villa W/13/4118

Tir Gofal Farm Visit Historic Environment Report

Report No. 2003/100

REPORT NO. 2003/100
PROJECT RECORD NO. 49073

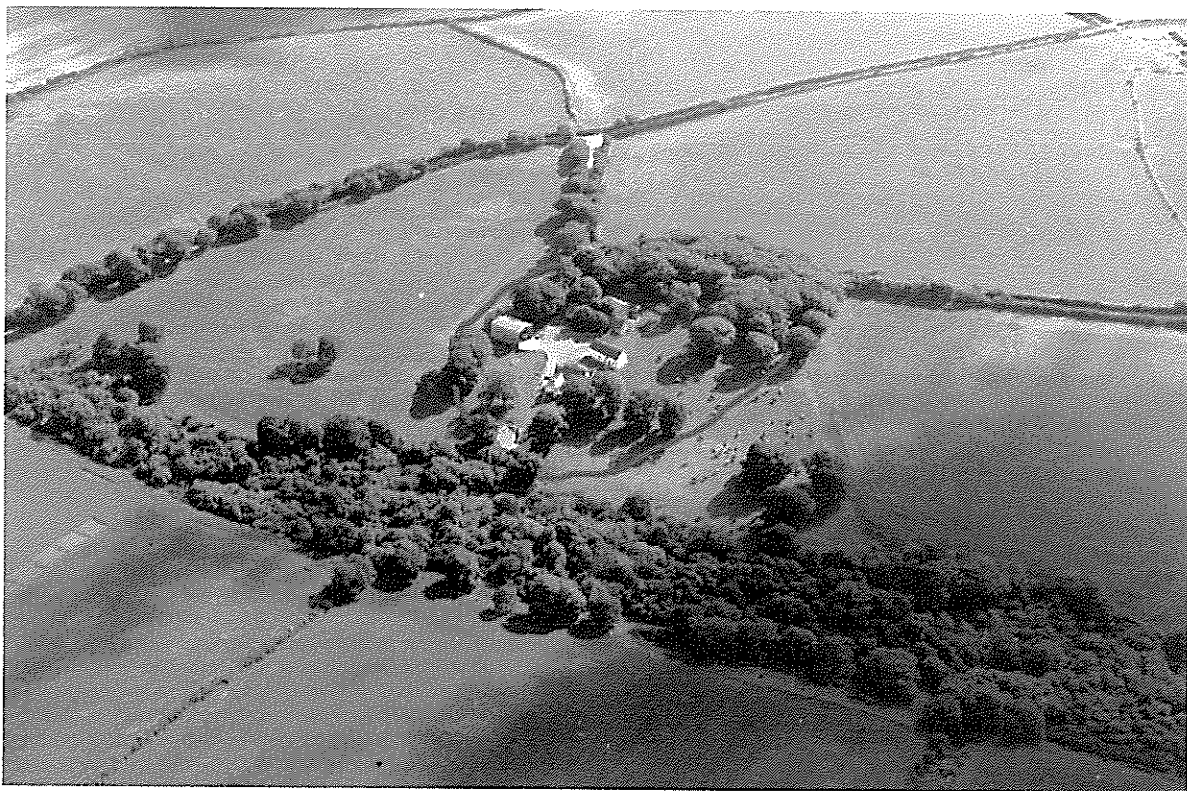
AP Meridian/DAT/James/1991/AP91-72.3/SM8827

Plate 1 (above): Aerial photograph of Cas Wilia hillfort (PRN 2767). Half of the earthworks survive in the trees just above the farmstead. The rough shape of the rest of the hillfort can be picked out by the scattered mature trees which form a curved shape around the farm. An estimate of the shape has been marked on the photograph above.

The remains of a small multivallate hillfort. The west side consists of two concentric well-preserved banks and ditches and a third, outer scarp which has been partially incorporated into a later hedgebank. The east side of the site has been mostly destroyed, and the farmstead of Castle Villa (PRN 49141) now occupies the area which would have been the interior, and the east defences of the hillfort.

The site is abruptly truncated at its east end, the earthworks have been cut through and levelled, and few traces of them remain. A slight hollow in the field north of Castle Villa Farm is probably all that remains of the inner ditch. The hollow passes between two mature trees which stand on raised 'islands' of ground left by the plough. These trees may mark the position of the hillfort's banks. Aerial photographs may help to indicate the approximate original shape of the hillfort – remnants of tree planting follow a distinctly curved outline around the farm (see plate 1).

The outer bank on the north side of the site runs immediately adjacent to a modern field boundary and several cattle water troughs are situated along the fenceline. The ground around these troughs was disturbed on the day of the farm visit and could become heavily waterlogged in the winter. Although the troughs are outside the scheduled area they should, ideally, be moved to prevent poaching and damage to the ground surface in these areas. Hillforts often hosted settlements just outside the defences, and there is still the potential for associated buried archaeology to survive. If this field is to be used for arable, then ploughing should penetrate no deeper than it has in previous years. An unploughed margin of at least 5m should be left along this northern edge of the hillfort. Under the Tir Gofal scheme, the farmer is proposing to plant broadleaved woodland in several areas of the farm, including a block east of the hillfort. Due to the potential for the survival of buried remains in the area of the hillfort, no planting should be carried out within 10m of the boundaries marked on plate 1.

The outer bank on the north side of the site runs immediately adjacent to a modern field boundary and several cattle troughs are situated along the fenceline. The ground around these troughs was disturbed on the day of the farm visit and could become heavily waterlogged in the winter. Although the troughs are outside the scheduled area they should, ideally, be moved to prevent poaching and damage to the ground surface in these areas. Hillforts often hosted settlements just outside the defences, and there is still the potential for associated buried archaeology to survive. If this field is to be used for arable, then ploughing should penetrate no deeper than it has in previous years. An unploughed margin of at least 5m should be left along this northern edge of the hillfort. Under the Tir Gofal scheme, the farmer is proposing to plant broadleaved woodland in several areas of the farm, including a block east of the hillfort. Due to the potential for the survival of buried remains in the area of the hillfort, no planting should be carried out within 10m of the boundaries marked on plate 1.

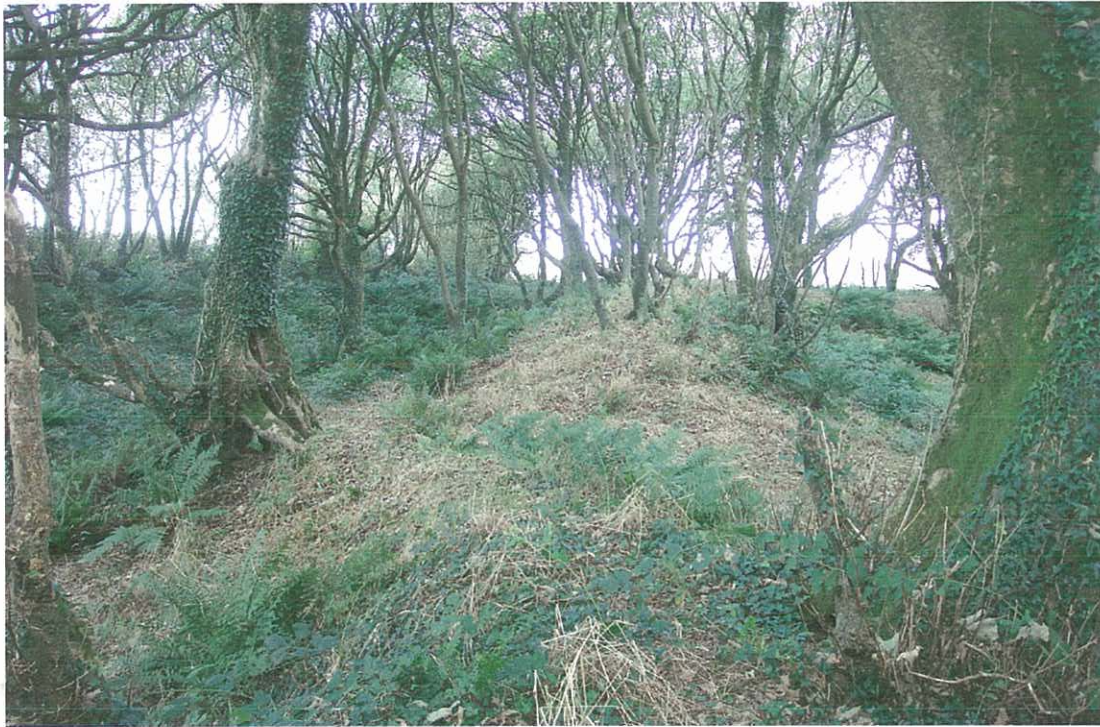
The surviving banks and ditches are very well defined, with the banks standing up to 2m in places. In general, the earthworks are more pronounced on the south side of the site. An entrance or passageway runs in a straight line from the southwest, through the banks and ditches to the interior of the hillfort. It is not clear whether this is an original entrance or one which was cut through at a later date – a detailed survey of the earthworks may help to clarify this question. Traces of other internal features are also visible – a low bank runs across the outer ditch in the south, and on the north side the inner bank has a more complex structure, possibly dividing into two.

This section of the site is under woodland, and is generally stable. Mature trees grow along the banks, whilst the ditches are covered in light undergrowth and bracken. In general, the site is accessible and the current management regime seems to suit it very well. In a few places – most notably the flattened area inside the inner bank – the bramble growth is heavier. There are a number of active burrows within the site, and the material coming out of them shows the banks to be constructed of a fine silt and clay soil with a large proportion of stone.

Plate 2 (above): *The middle of the three banks at Cas Wilia hillfort (PRN 2767).*

In general, the west side of the site is in very good condition. The current management (ungrazed and unfenced woodland) suits the site very well and has resulted in a vegetation cover of woodland without excessive undergrowth or brambles. Active burrows are a concern, but are not, as yet, a major threat to the site.

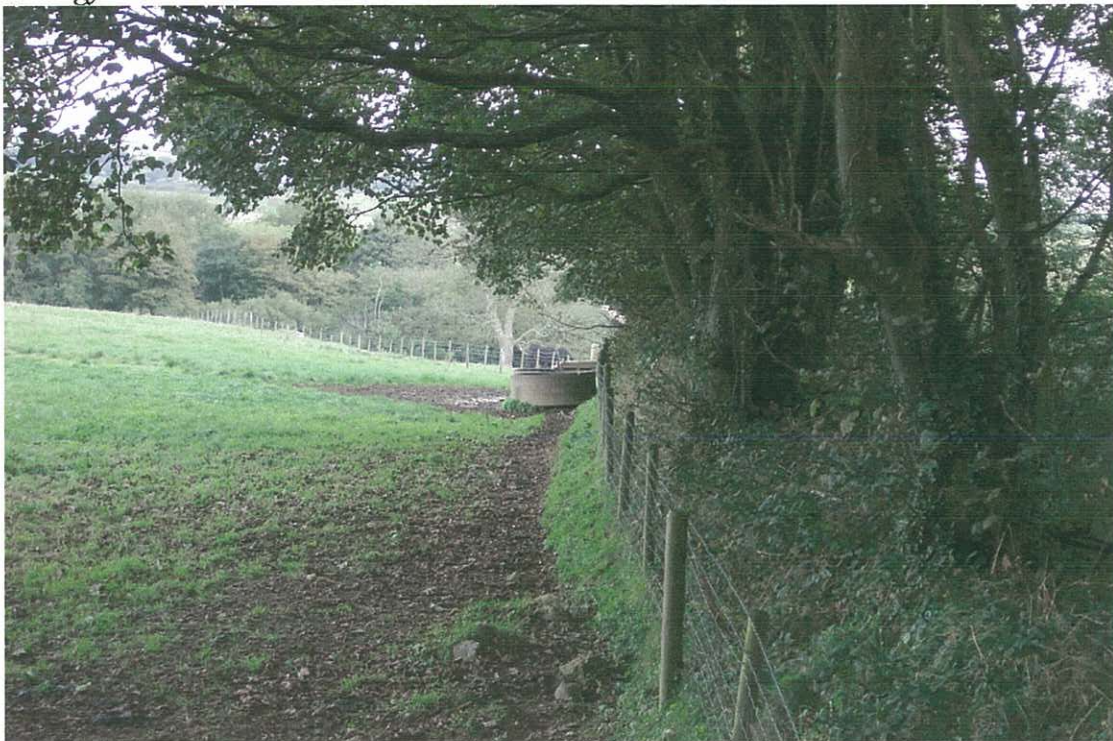
Plate 3 (below): *Cattle water troughs situated along the fencline which marks the northern edge of Cas Wilia hillfort. Excavated examples of multivallate hillforts like this one often show domestic buildings directly outside the defences, and there is the potential for buried archaeology to survive here.*

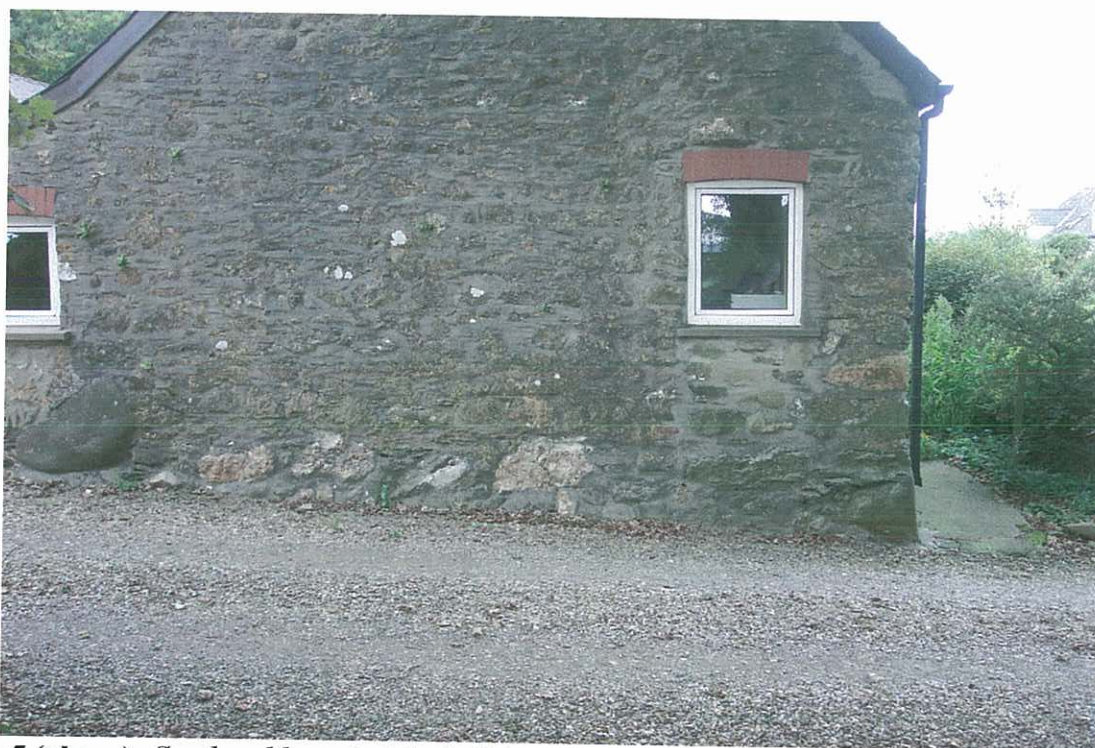
An interesting feature of this building is the stonework at the base of the walls which is much more irregular than the higher courses and contains a number of large boulders. There is also a very thick batter. These features suggest that the walls of the cowshed may originally have been clom – an earth and straw mixture which was often supported on a boulder plinth. It is difficult to estimate when clom came into use, but it was widespread throughout Wales until the 19th century. The origins of this building are also difficult to pin down. The shape and possible clom construction suggests that there is a possibility that it originated as a longhouse – a combination building housing livestock and people under one roof. This would imply an early date, and may suggest that this building substantially pre-dates the others.

Plate 5 (above): *South gable end of the holiday cottage (PRN 49140) which is probably a converted cowshed (PRN 49139). The base of the wall is constructed of large, irregular boulders and is very different to the rest of the wall. This may have been the stone base for clom walls.*

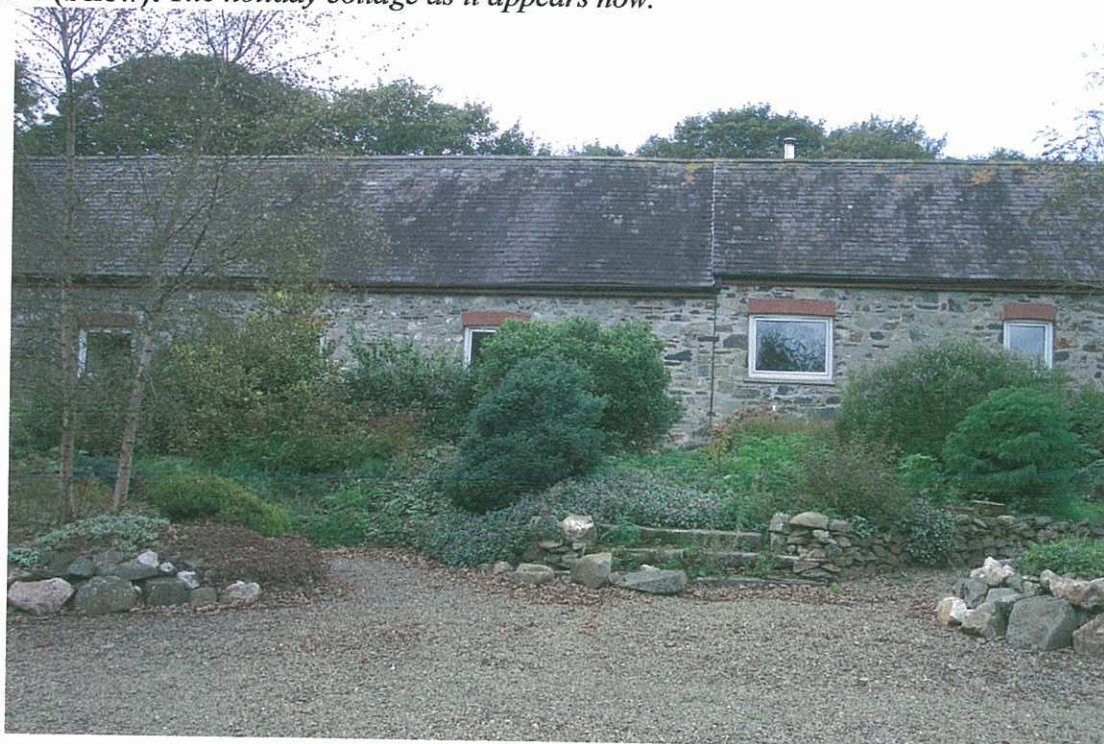
Plate 6 (below): *The holiday cottage as it appears now.*

It is stone-built and slate roofed, with regularly spaced windows along its length. Although the windows themselves are new, the ones in the long walls appear to respect the original openings. The south gable contains two windows which may replace earlier doorways.

The building is now in use for accommodation and is therefore excluded from the Tir Gofal scheme.
