# **Morvil W/13/4091**

## **Tir Gofal Farm Visit Historic Environment Report**

Report No. 2003/118

Morvil  
Tir Gofal Farm Visit Historic Environment Report

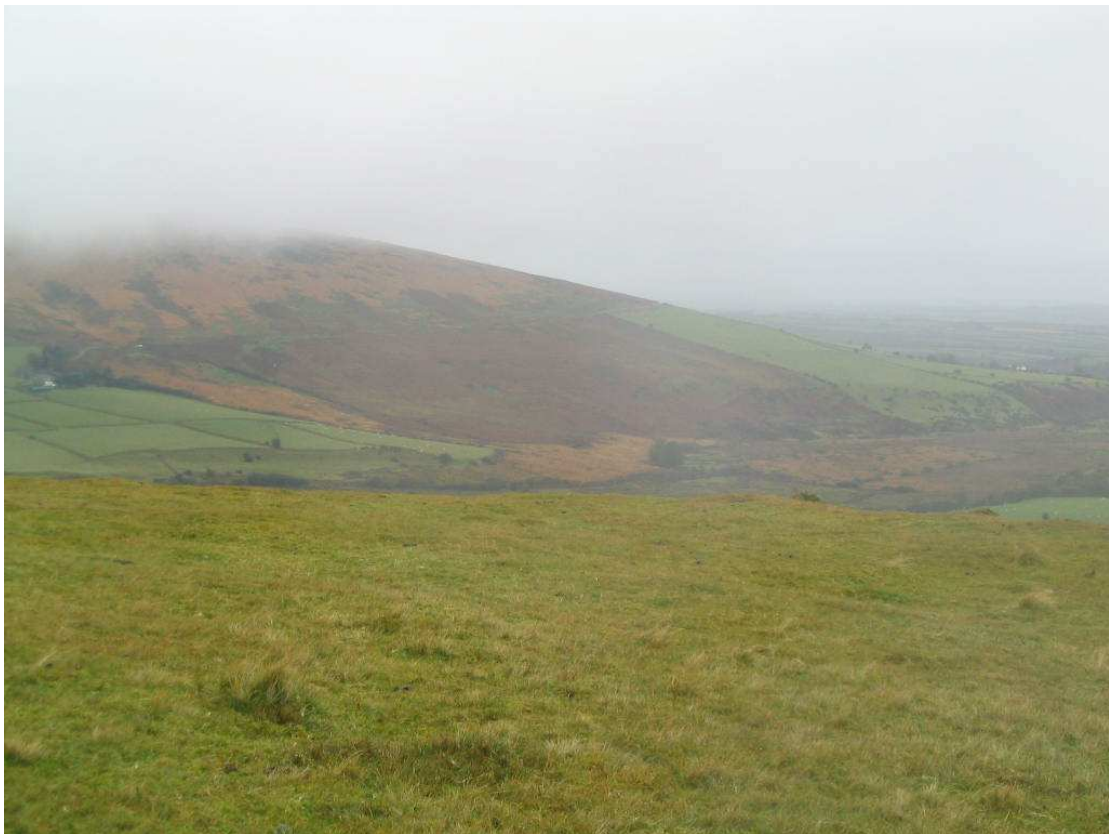
**View to the south from inside an earthwork enclosure (PRN 1556) on Mynydd Morvil.**

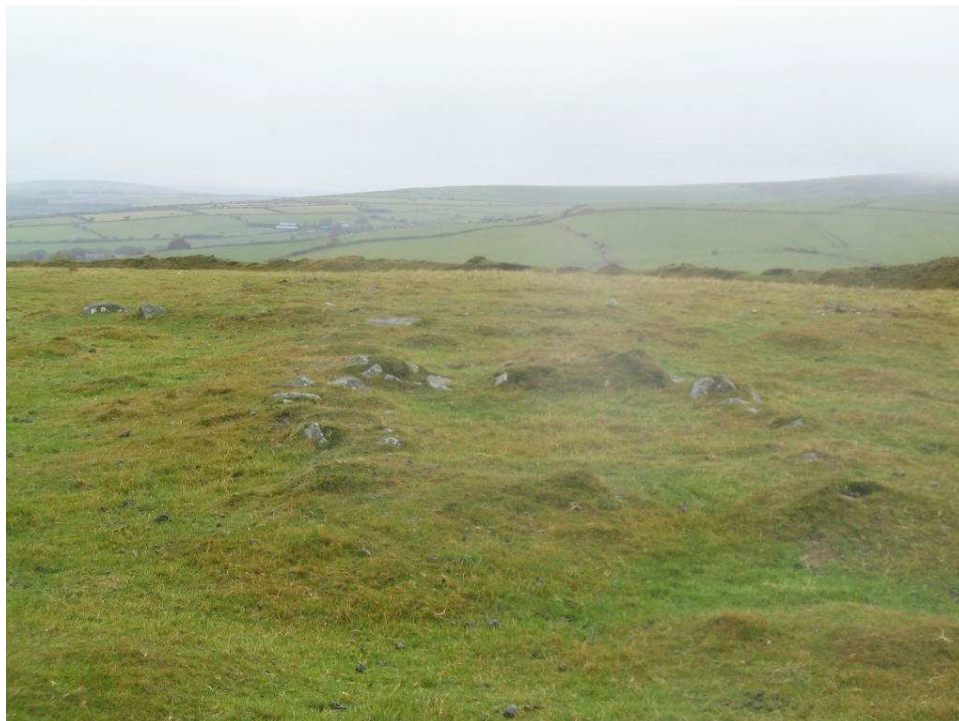
A clear earthwork on open ground on Mynydd Morvil. The remains of a rectangular long hut about 5m x 3m are seen as low earth and stone banks. No internal divisions are visible. Adjacent to the west end of the long-hut is a sub-circular feature also picked out in stone. This may represent an animal pen.

**Plate 1** A long hut (PRN 1523) on Mynydd Morvil. The rectangular feature in the foreground is the long hut, another feature immediately behind may represent the remains of an animal pen or similar.

The site is under no threat and seems to be stable. The current management regime of light grazing suits it well and should be continued. No animal feeders should be placed in or near the site. A track runs just north of the site, and care should be taken that the track does not divert from its current route and encroach onto the land immediately surrounding this feature.

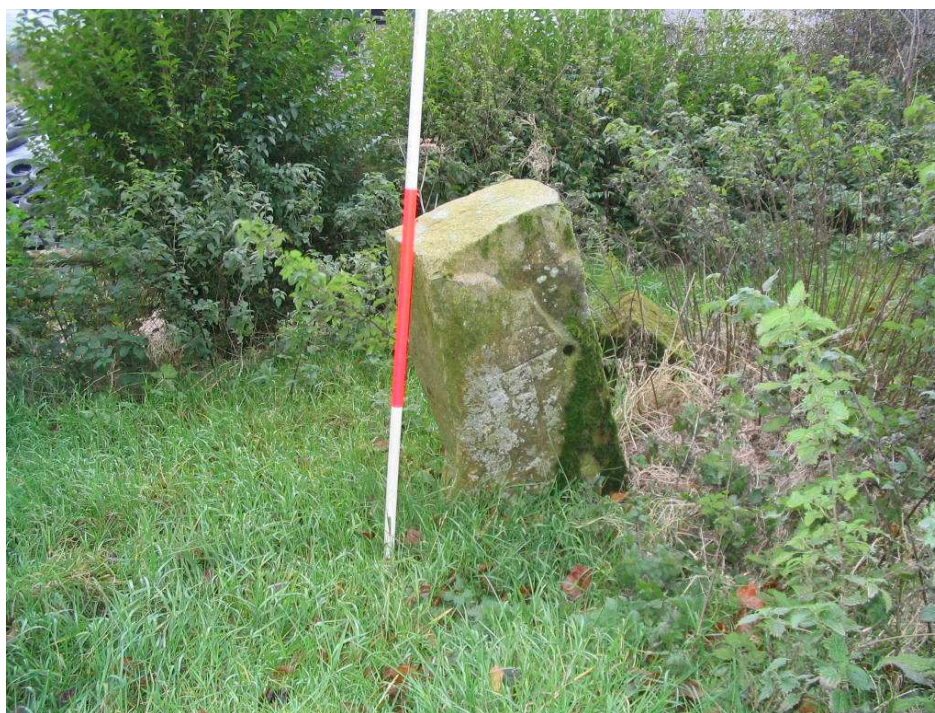
A cross-inscribed stone set in Morvil churchyard (PRN 46838), one of two monuments (PRNs 1525 and 1526) which make up SAM Pe235. One side of the monument bears a carved cross inside a ring, and the stone itself has been shaped into a rough pillar. A hole about half-way down the stone indicates that it has been used in the past as a gatepost. It may not, therefore, be in its original position. It is in a good, stable condition.

**Plate 2** *Cross inscribed stone (PRN 1525, SAM Pe235) in Morvil churchyard (PRN 46838).*

It should also be ensured that the monument remains visible, is not obscured by vegetation and that it does not sustain any damage from tree-branches falling or rubbing against it.

It is recommended that the churchyard is fenced off and used as a small ‘paddock’ for light grazing by lambs and sheep. This will help to maintain a smooth grass covering, and will also prevent scrub growth. For detailed comments see the management recommendations made for the churchyard (PRN 46838).

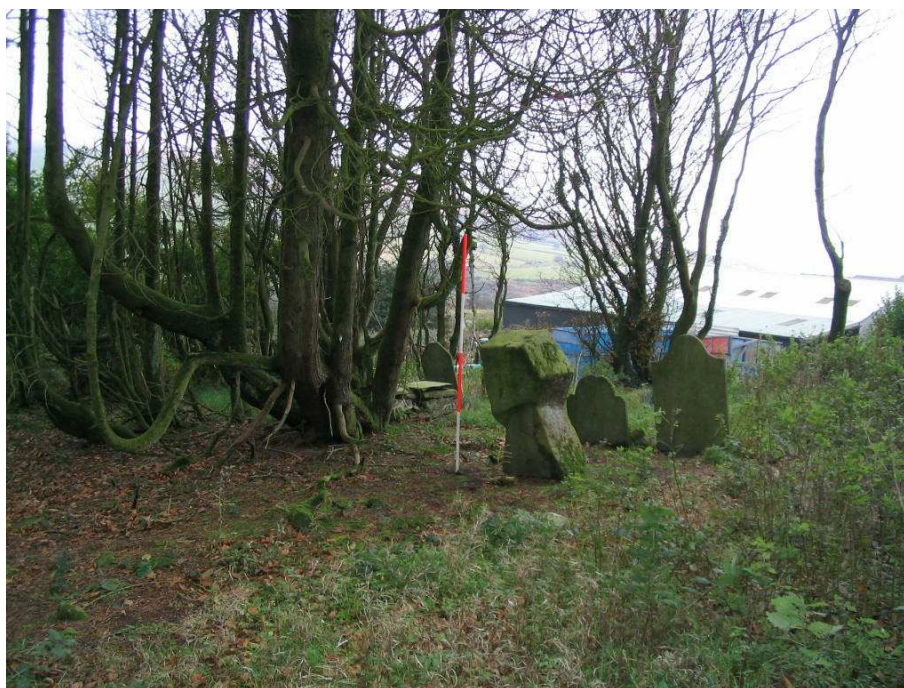
A cross-inscribed stone of uncertain date, one of two inscribed stones (PRNs 1525 and 1526) which make up SAM Pe235. The stone may be unfinished – it is a rough, uneven shape, partly worked with a flat top and a triangular base. A simple cross is marked on one side only. The carving is very weathered and difficult to make out. The stone is in a stable condition, and stands in the churchyard (PRN 46838) associated with Morvil Parish church (PRN 7562).

**Plate 3** *Cross inscribed stone (PRN 1526, SAM Pe135) in Morvil churchyard (PRN 46838). The cross is very weathered and faint.*

It should also be ensured that the monument remains visible, is not obscured by vegetation and that it does not sustain any damage from tree-branches falling or rubbing against it.

It is recommended that the churchyard is fenced off and used as a small ‘paddock’ for light grazing by lambs and sheep. This will help to maintain a smooth grass covering, and will also prevent scrub growth. For detailed comments see the management recommendations made for the churchyard (PRN 46838).

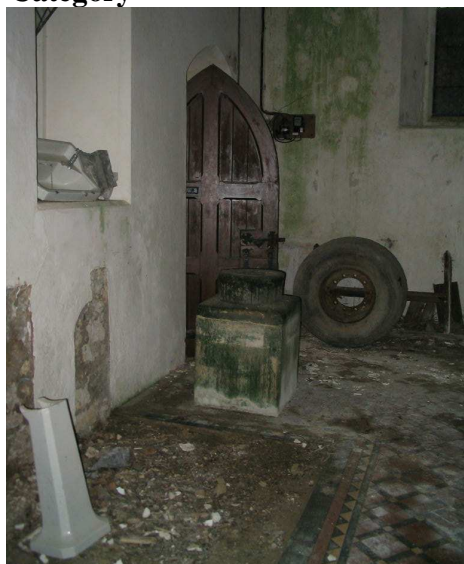
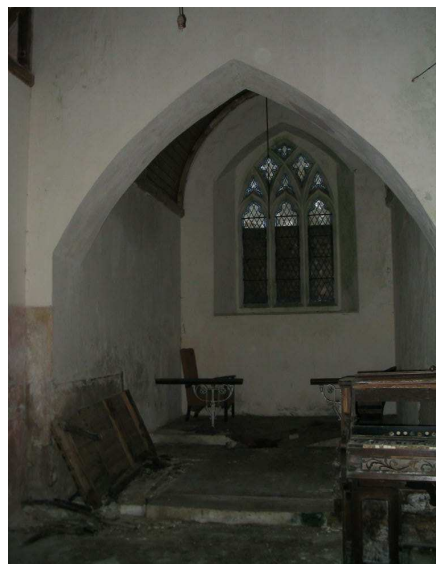
The church building is now derelict but is in a stable condition. The roof on the main building is generally watertight, although a few slates are missing, but the porch roof has now gone. Most of the internal fixtures are also gone, although a large stone font remains, as does the alter rail and some sections of a tiled floor remain, marking where the aisle ran.

**Plates 4 and 5** *The interior of the church (PRN 7562). A few original features remain – the main door, the stone font by the door, and some of the aisle floor tiles (left) and the altar rail (right).*

The owners have been maintaining the church in a stable condition, and this should be continued. Materials and techniques which match the original construction of the church should be employed to carry out future repairs and maintenance work.

On the day of the site visit, the possibility was raised of using the church for agricultural purposes – fencing the churchyard and using it for grazing, and maybe using the church for a lambing shed or similar. Bringing the building back into use in this way would help to ensure that it was maintained, and would therefore be encouraged. However, if livestock were to be kept within the building, it would be desirable to cover the remaining tiled floor sections (preferably with rubber matting) and to situate animal pens off the tiles, in order to protect the remaining flooring from damage.

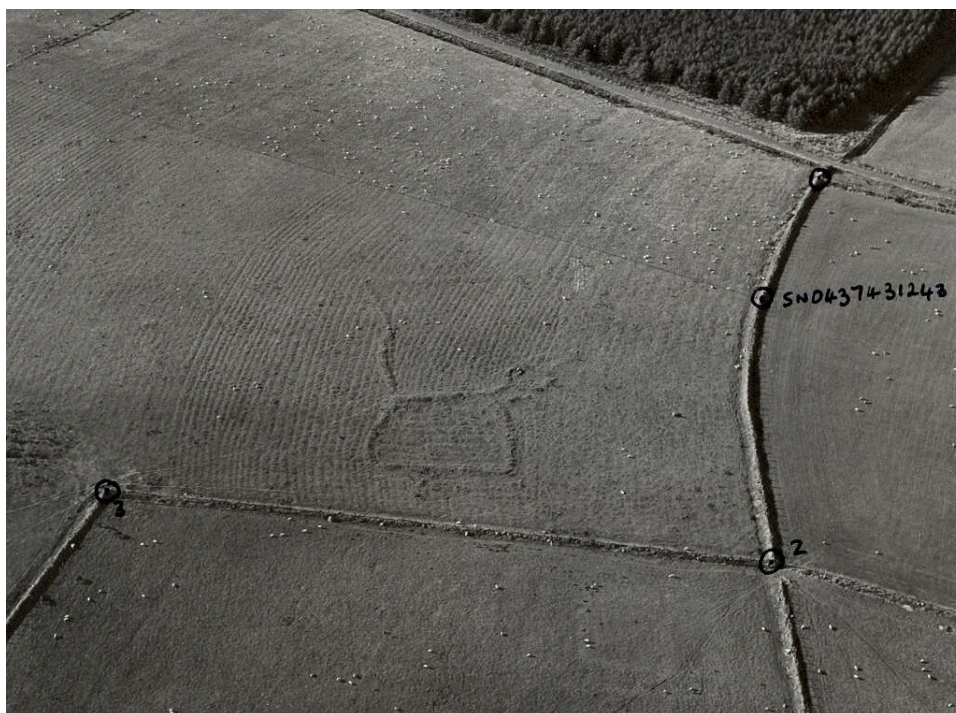
The remains of a deserted settlement lie on southeast facing slopes of Mynydd Morvil. This is an earthwork site, with probable enclosure walls and a possible building foundation picked out in earth and stone banks, around 0.25m high. Aerial photographs clearly show the form of the site. The most immediately noticeable feature is a roughly rectangular enclosure. To the east of this is a much smaller curved shape, marked out by stone footings. On the aerial photographs this appears to be circular, but on the ground it has a much more 'squared' feeling, though with rounded corners. These two features are linked by a small 'passage', again marked out by stone footings.

**Plate 6** Aerial photograph showing the shape of the deserted settlement (PRN 14344)  
Mm Ap Oblique/DAT/James,TA/1989/AP89-184.31

If anything further is known about this site, then please contact Cambria Archaeology. The site is well-preserved and should be maintained in its current condition. No ground intrusive works should be carried out in the vicinity of the site, and animal feeders should not be placed near the earthworks. The ridge and furrow earthworks in the field surrounding the settlement should not be disturbed.

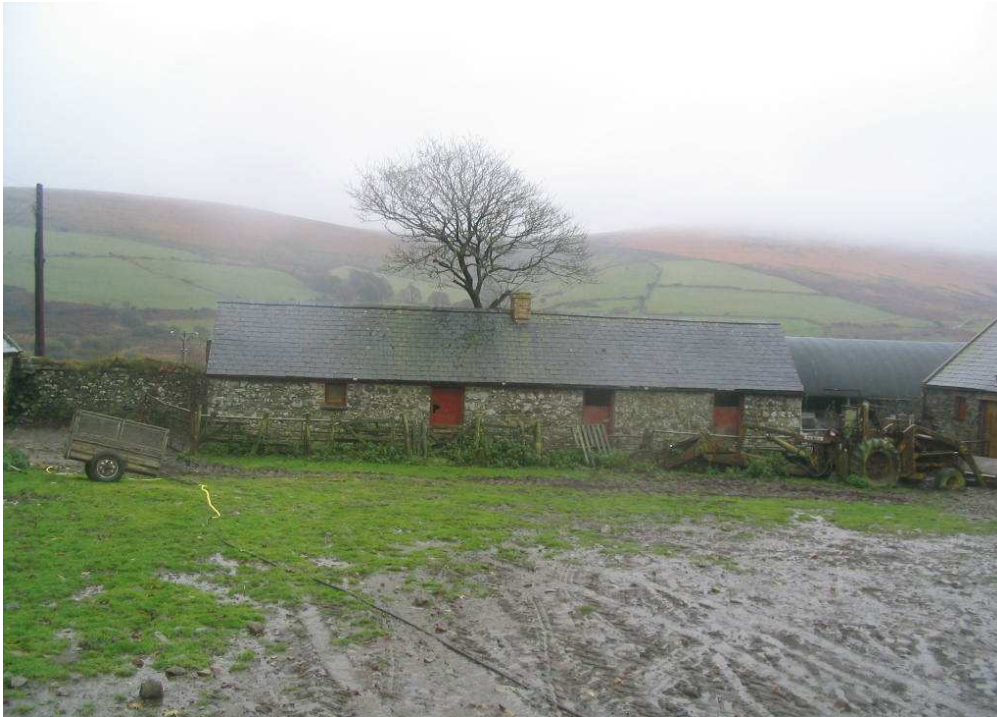
A brick chimney in the centre of the piggery indicates the presence of a boiling room within the piggery. These were used for the preparation of swill and animal feeds. Pigs were often fed on the waste from the dairy, and in planned farmyards it is very common to have the piggery and dairy as close together as possible (Darley,G:1981:p.87). In this case, the piggery is next to the cowshed (PRN 49699), and this may have housed a dairy and/or milking parlour at its south end. The building is currently in good condition, and the roof appears to be sound.

**Plate 7** *Piggery (PRN 49700). Part of the planned farmyard at Morvil (PRN 49698).*

The building is well maintained, and care should be taken that future repairs continue to use materials and techniques which match as closely as possible those used in the original construction.

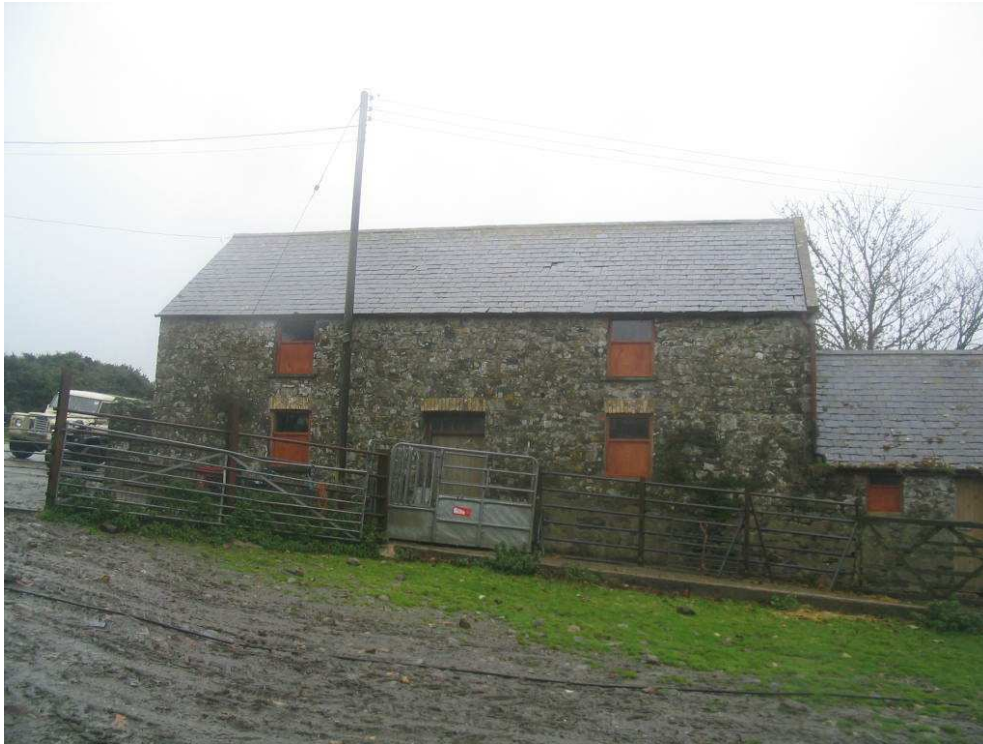
In construction, the building closely resembles many of the other buildings on the yard being of rubble stone with lime mortar, slate-roofed, and having some of the openings picked out with brick decoration. It appears to be in good condition.

**Plate 8** *Stables at the north end of the combination farm building (PRN 49701). The upper storey probably housed a granary, accessed by steps in the north gable.*

The building is well maintained, and care should be taken that future repairs continue to use materials and techniques which match as closely as possible those used in the original construction.

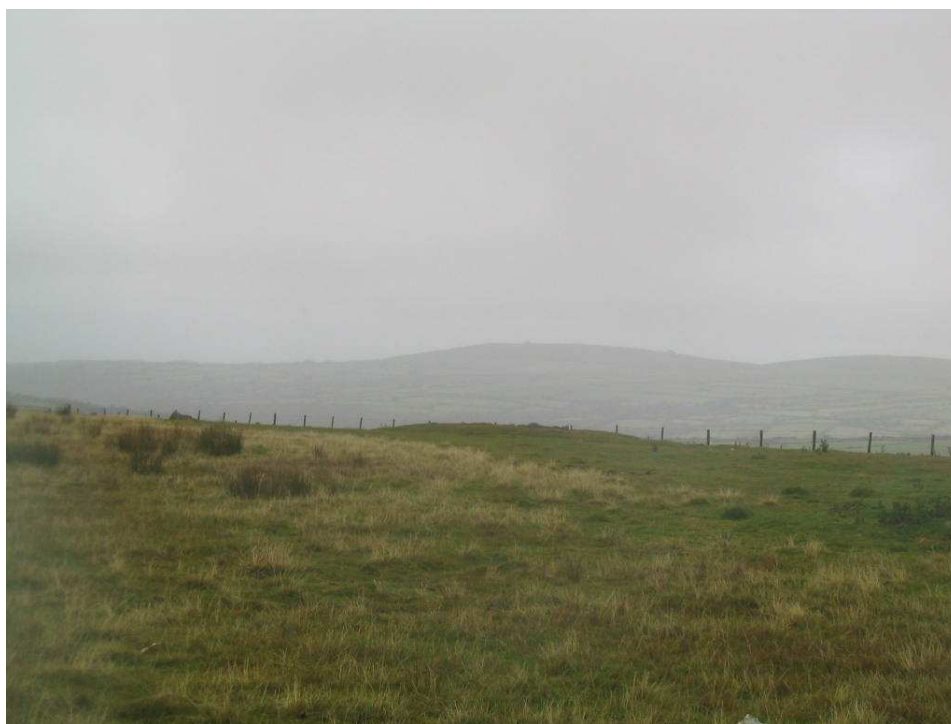
The mound has some damage – a hollowed out ‘scoop’ in the top has revealed the stone interior. The whole area is also covered with ridge and furrow earthworks (PRN 49707), indicating that it has been ploughed at some point in the past.

**Plate 9** *View of a possible round barrow (PRN 49703) – picture taken from the site of the other possible barrow (PRN 49704).*

The site is under no immediate threat, and should be maintained in its existing condition. No ground intrusive works should be carried out in the vicinity of the site and the ridge and furrow earthworks in the field surrounding the barrows should not be disturbed.
