The Shell House at Cilwendeg, Boncath, Pembrokeshire.

An archaeological investigation August 2003

Report No. 2003/109

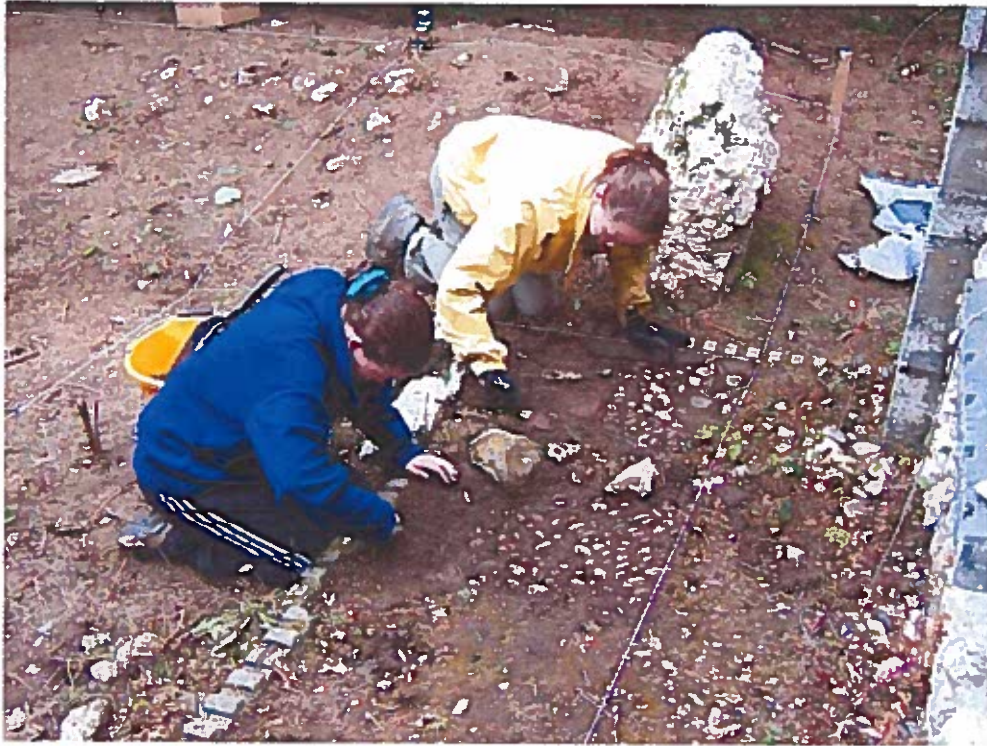
The cobble apron (1011) in front of the building was overlain by a thin layer of silty loam (1007) much of which had been trodden into the surface between the cobbles. This overlying material was gridded and excavated and small quantities of coloured glass and other material were collected. The majority of the coloured glass fragments were green although small quantities of blue, purple and orange glass were also recovered. The exposed cobble surface comprised small white or light coloured cobbles set within diagonal lines of darker grey cobbles. The surface was edged with slate kerbs with a notched decoration (Plates 1 and 2). Traces of four pillar bases, which presumably supported the roof of the verandah, were identified at the front of the cobble apron. These comprised a double brick cement foundation that, in two cases, were overlain by a notched slate block with a central spindle hole.

Plate 1 The cobble apron (1011) during excavation

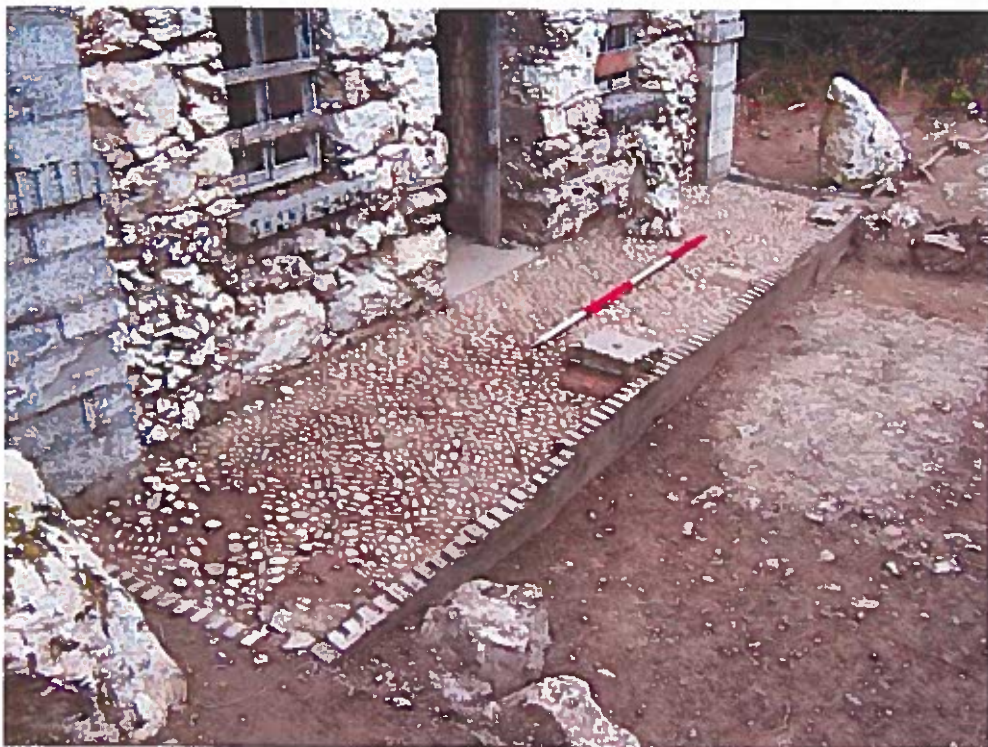
Plate 2 The cobble apron (1011) after excavation (looking northeast)

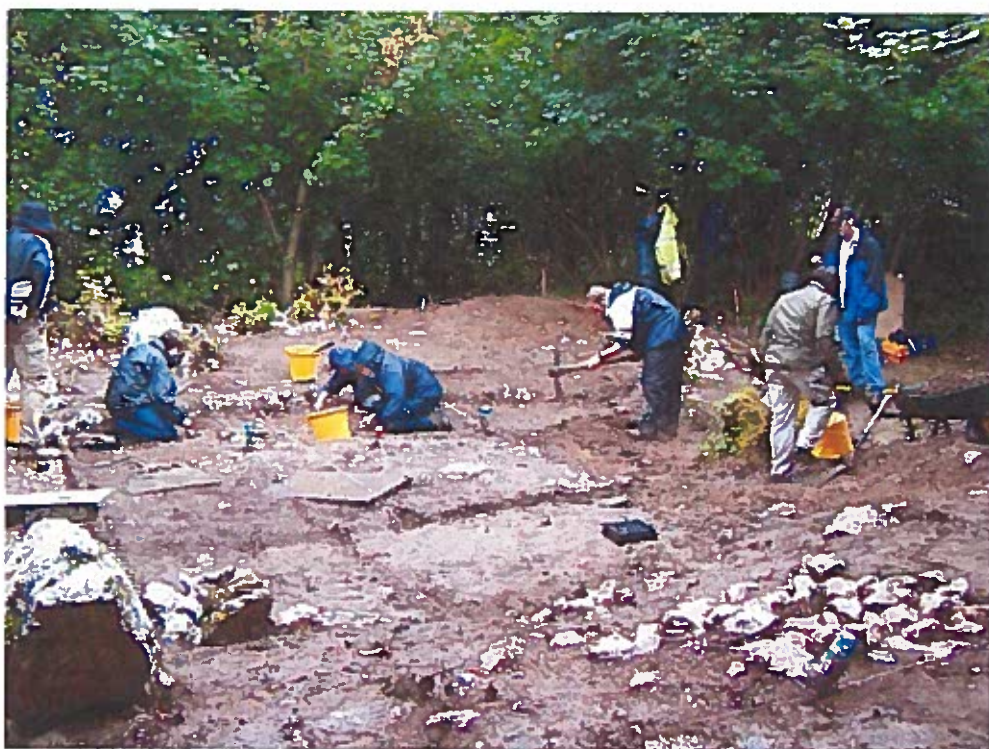
The forecourt area in front of (i.e. south of) the cobble apron was overlain by a series of plaster and soil dumps (1002, 1008, 1009 and 1010) forming a deposit up to 0.2m thick. The area to the northeast of the forecourt, adjacent to the building, contained a higher proportion of plaster fragments and shell debris (1008). All these dumps were systematically excavated and the finds collected and recorded using the 2m grid. Numerous lumps of plaster were collected from these dumps and examined. Many of the fragments had wooden lath impressions on the reverse side suggesting they originated from the ceiling of the Shell House rather than from the walls. Of these, three of the larger fragments had shells attached to the smooth face suggesting that part at least of the ceiling was decorated with shells. Three shell types were identified on these fragments of possible ceiling plaster – cockles, mussels and limpets. None of the possible ceiling fragments had any indication of a curve that might be suggestive of a domed ceiling. However, all the fragments were very small and none were more than 0.2m long. Several large slate slabs were recovered from the plaster dumps including one large piece (visible in Plate 3). These clearly originated from the roof of the verandah.

Plate 3 - The forecourt during excavation

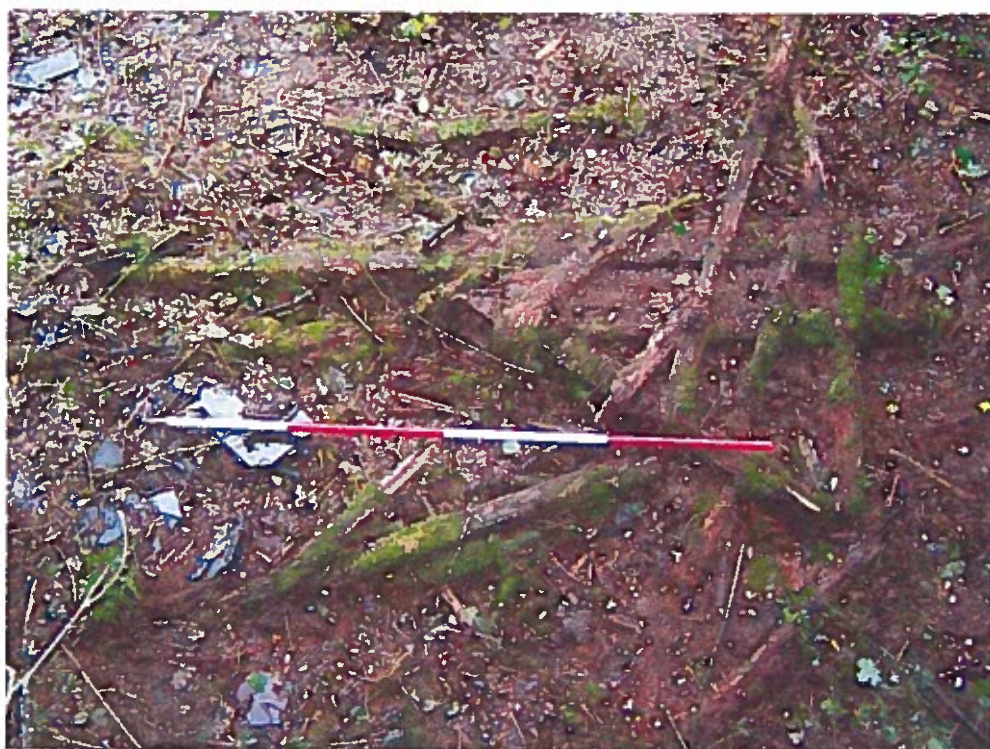
Further information, relating to the roof and possibly the ceiling, is provided by the dump of timber to the northeast of the building (Plate 4). An attempt was made to lift these. However, the material was so fragile that the elements were recorded (Archive Drawing No. 8) and left *in situ*. Several of the timbers clearly still articulate with each other and give an indication of the original pitch of the roof prior to its replacement in 1991.

Plate 4 - The dump of roof timber (1016)

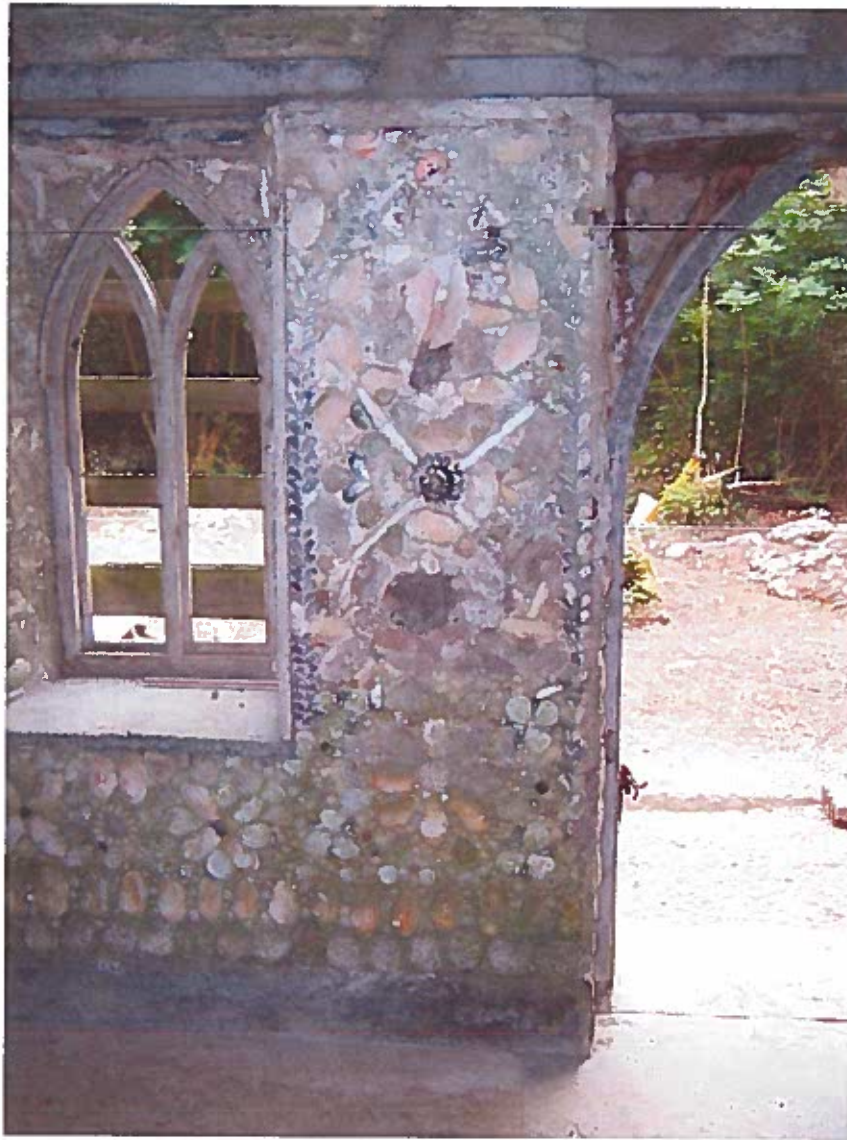
An estimate of the percentage of original shells surviving on each panel is indicated in Table 1. A drawing at 1:1 was made of Panel 1 and parts of Panels 4 and 5. The major shell types on Panel 1 were counted and an estimate was made of the total number that would have originally been present (Table 2). By combining the recorded elements of Panels 4 and 6 it was possible to obtain a similar estimate for a composite side panel (Table 3). These allowed an estimate of the average number of shells of the major shell types by square meter. By multiplying this by the total area of shell panels (20.55sq m) the estimated total numbers of shells originally required for the Shell House walls was 13, 502 (Table 4). Of course this assumes that the proportion of shell types present was consistent throughout all the panels. However, it could be seen that this was not always the case. For example the large oval otter shells were over-represented on the corner panels. Nevertheless, it does give an indication of the large number of shells that were needed.

Plate 5 - Shell Panel 1 to the east of the doorway

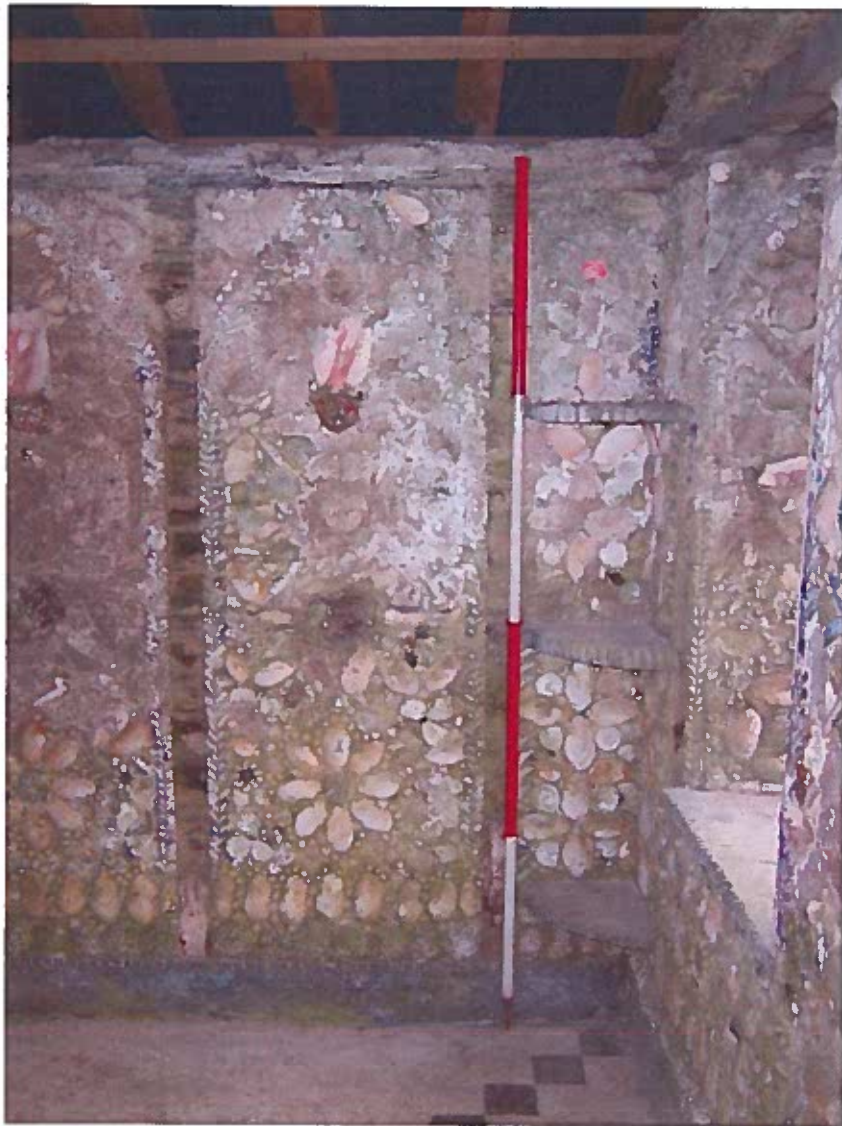
Plate 6 - Shell Panel 4 in the east wall

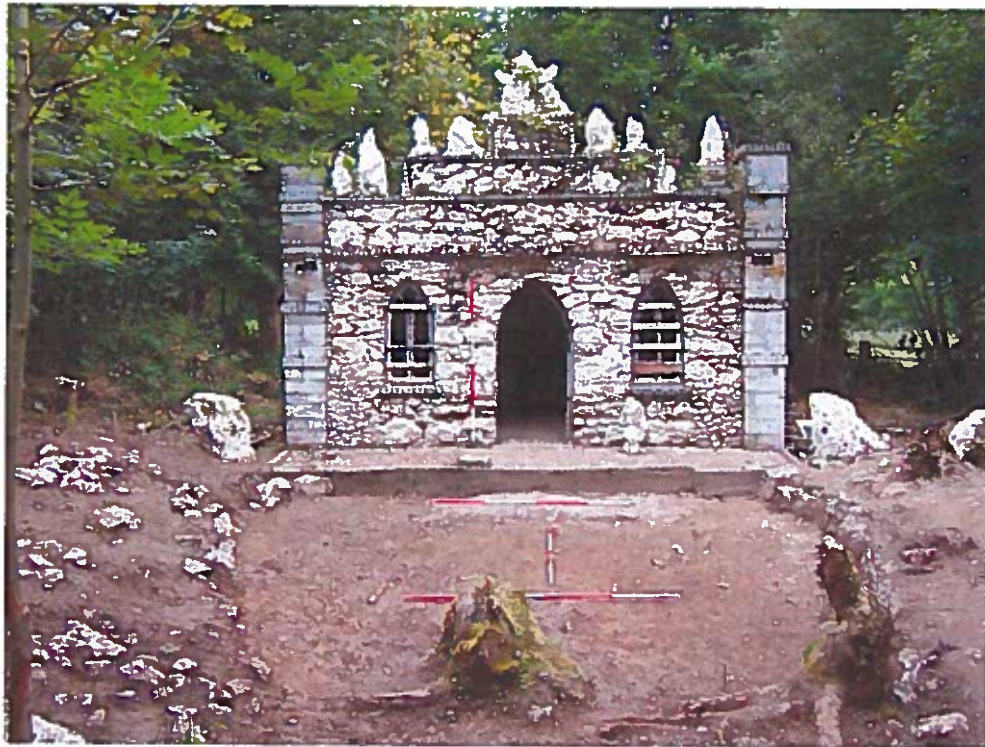
To either side of the forecourt were raised earth banks (1013 and 1014) associated with areas of small, angular quartz boulders. These areas of quartz formed what appeared to be small, irregular-shaped rockeries. The inner face of each of the two banks was defined by a row of larger quartz boulders (1017 and 1018) forming a kerb either side of the forecourt (Plates 7-9).

Plate 7 - The forecourt after excavation looking north

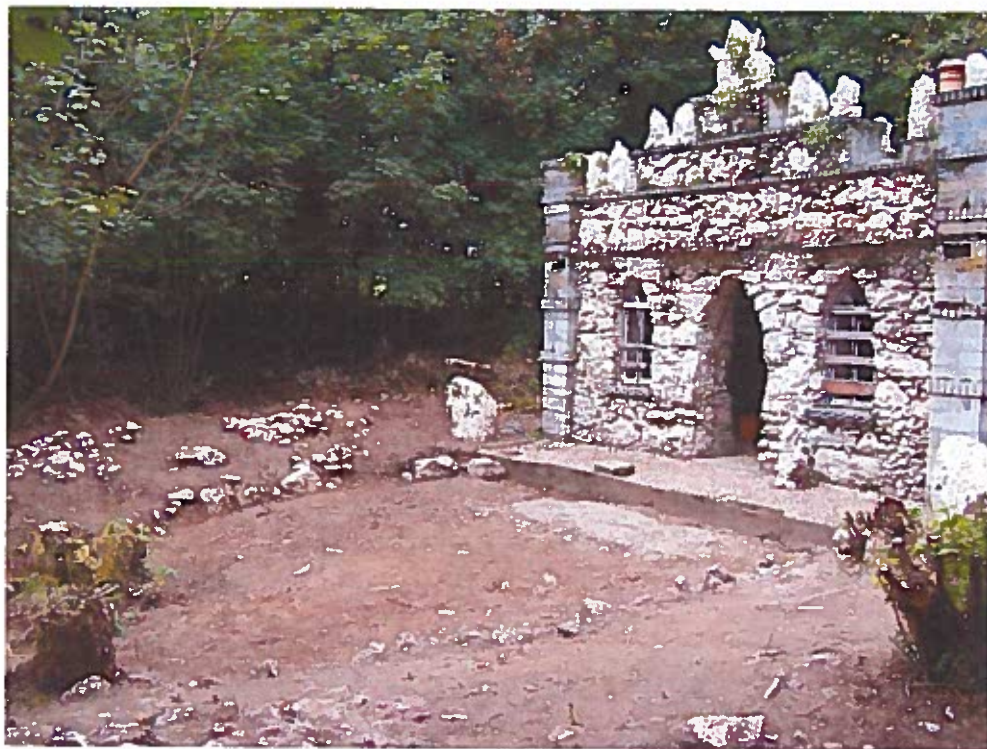
Plate 8 - The forecourt after excavation looking northwest

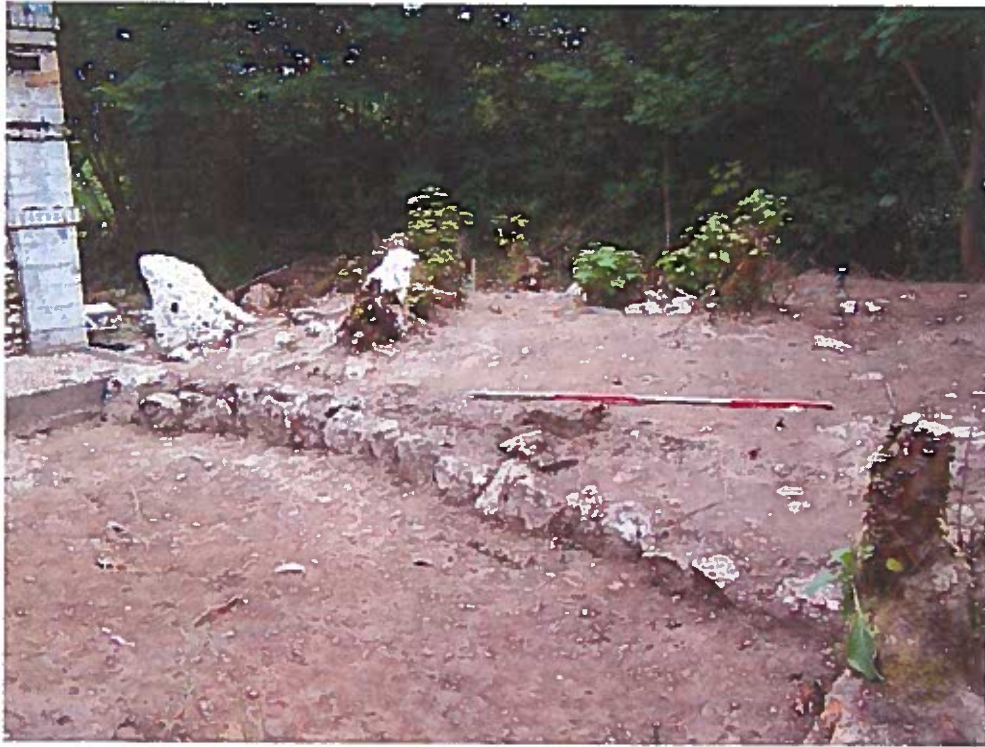
Plate 9 - The east rockery (1014) and kerb (1018) looking northeast

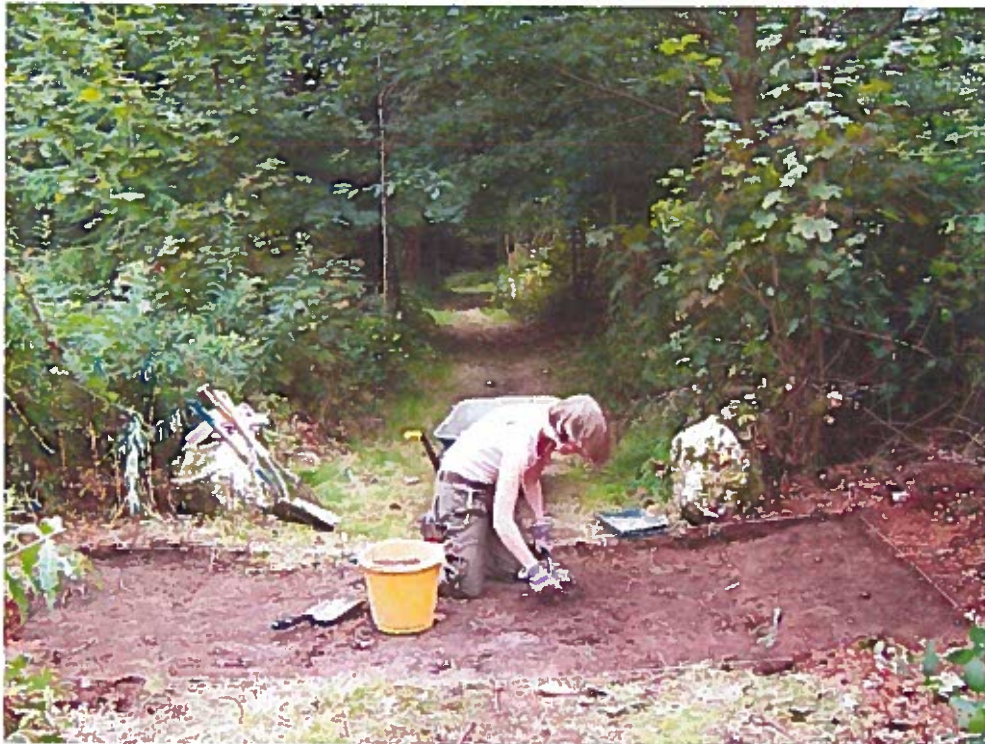
The approach path was excavated at two locations. In Area 2, immediately to the south of the forecourt, the path comprised a thin layer, approximately 2m wide, of small slate fragments (Fig. 2, 1016). This surface widened as it entered the 'mouth' of the forecourt (1015). However, there was no evidence for the slate surface of the path to the north of the large tree stump that lay just beyond the southern entrance to the forecourt. In Area 3, located approximately midway along the access path to the Shell House, the gravel surface of the path was again approximately 2m wide with no evidence for any flanking kerb (Plate 10).

Plate 10 - The pathway in Area 3 during excavation
