TIR GOFAL HISTORIC ENVIRONMENT: CALL OUT VISIT

Prepared for:
New Shipping Farm
W/13/4309

Part of the registered parkland of Upton Castle

Report No. 2004/78
Project No. 49483

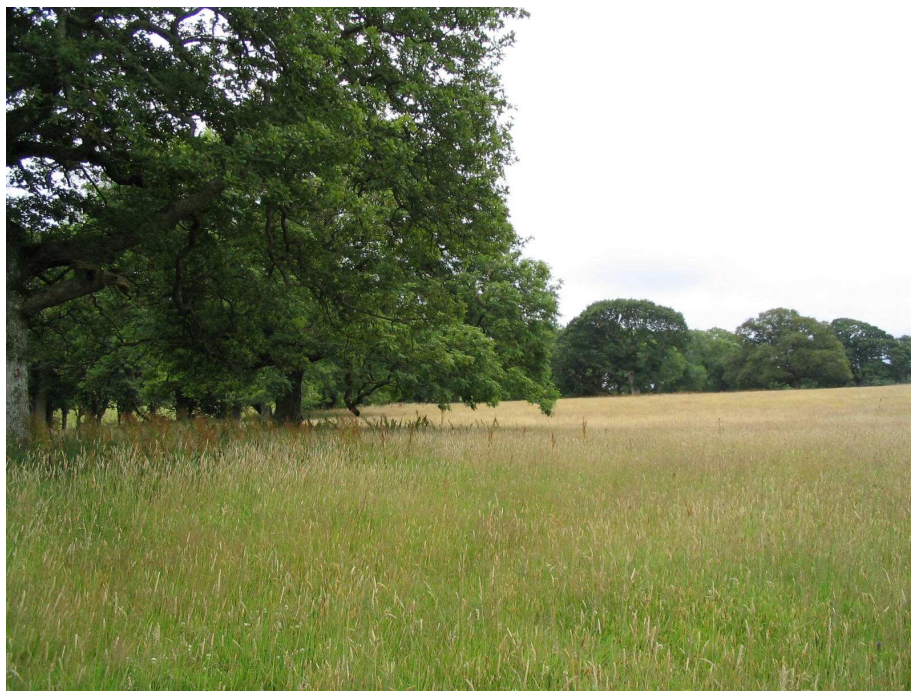
The northeastern part of the holding, which falls within the registered area of parkland, is a tongue of land which incorporates a ridge sloping gently down towards the Carew river. This area is currently under pasture in the main, but large swathes of woodland occupy the eastern and southwestern fringes of the land parcel. The woodland is unenclosed and is grazed from time to time, it is characterised by mature oaks with the occasional self sown ash and cherry interspersed. The extent of the woodland appears to echo that which is shown on the 1st edition Ordnance Survey map of 1866. Unfortunately, however, some of the mature oaks have recently been lost in bad weather and gaps are appearing in the woodland canopy. Other mature specimens are also showing signs of wear; large boughs have been lost and there is evidence of others which have broken. No tree planting appears to have taken place in the past as there is little evidence of young trees to replace the older generation.

Upton Castle Parkland, this area is characterised by swathes of deciduous woodland framing the open field.

It is clear that the condition of the parkland tree planting is beginning to deteriorate and that the stock of mature and veteran trees is gradually diminishing. This loss of trees within the parkland will lead to the eventual degradation of the parkland quality in the long term. In order to avoid the loss of parkland character, it has been proposed, through Tir Gofal, to undertake tree planting in this area. This would be of great benefit to the long term survival of the parkland, but should be done with great care to maintain historic parkland character.

It is proposed that the 1st edition Ordnance Survey map should be used to guide the extent of the tree planting. The map clearly indicates the extent of the woodland planting in the 3rd quarter of the 19th century, and this corresponds to the planting which can be seen today. The tree planting should target those positions where trees have been recently been lost and those trees which are damaged and appear to be nearing the end of their natural lifespan.

The species of trees which should be planted should reflect the species profile which is represented in the existing woodland. It is recommended that individual tree guards are used for the newly planted trees to offer protection against stock. This would be preferable to fencing out the entire woodland area as this might encourage more invasive tree species and other vegetation taking hold. Grazing of the parkland would suppress the growth of other species in favour of those which have been planted and would therefore help to retain the character of the parkland.

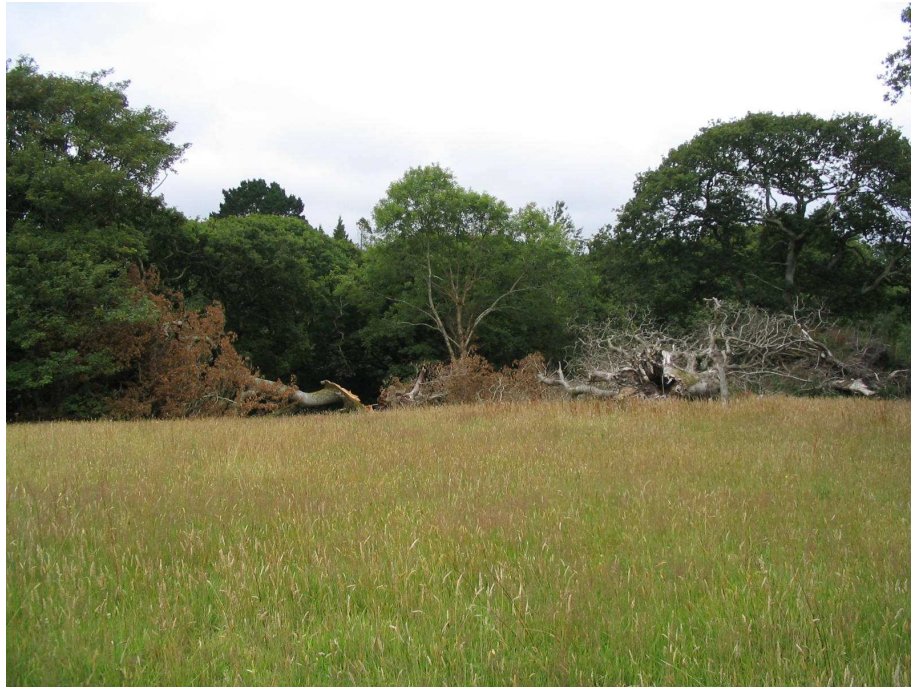
Several mature parkland trees have fallen in recent bouts of bad weather

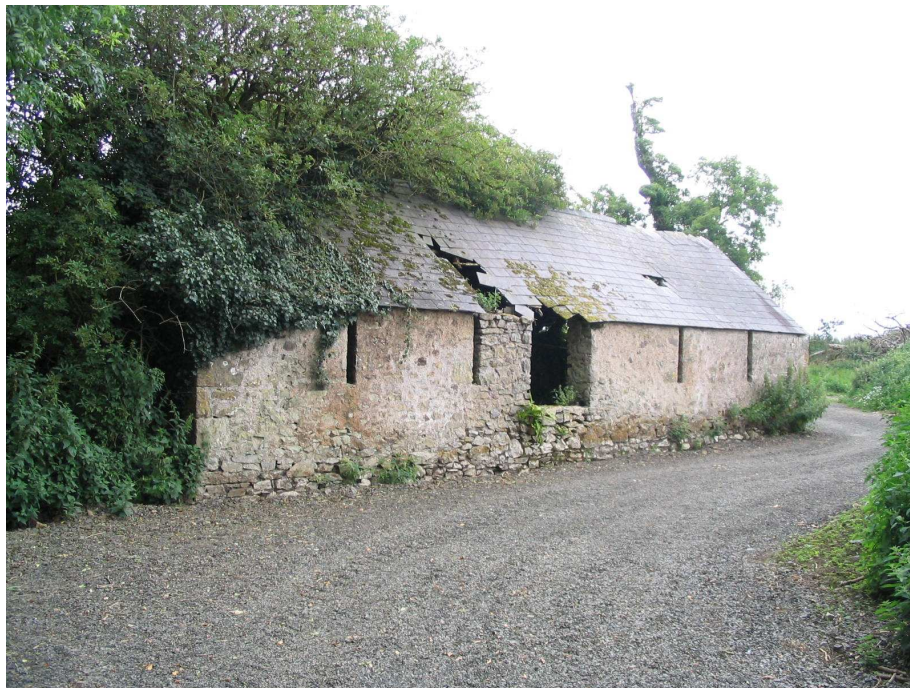
The condition of the building is poor. The orchard to the west and south of the building has become heavily overgrown and a number of trees are weighing on the roof on the west side. Ivy has encroached over large areas of the roof. In addition many slates have slipped, and in places the roof covering has been lost completely. The north gable end is also of some concern; the stonework above the doorway appears very unstable, probably partly due to the disintegration of the timber lintel.

The cow shed at New Shipping farm, this building is threatened by encroaching vegetation and is no longer weatherproof

It is proposed through Tir Gofal to repair this building and bring it back into use. This proposal is to be welcomed; in its present condition the building is unfit to use and if its current rate of decline is not stopped it will become little more than a ruin in a very short space of time. It has been proposed to reuse this building as a machinery shed, this will have the unfortunate consequence of necessitating a larger double doorway being inserted into the north gable end. However this seems to be an appropriate

It is recommended that the work is carried out as soon as possible as parts of the building are in a very fragile state. If work cannot be carried out before the winter then efforts should be made to remove as much of the vegetation which is loading onto the roof and walls, as possible. Ivy should be cut through above ground level, but it is advisable to leave it in place until consolidation works can be undertaken. As much of the historic fabric of the building should be retained as possible, including the hay rack and manger. New works should be carried out using traditional materials, which match the character of the historic building.

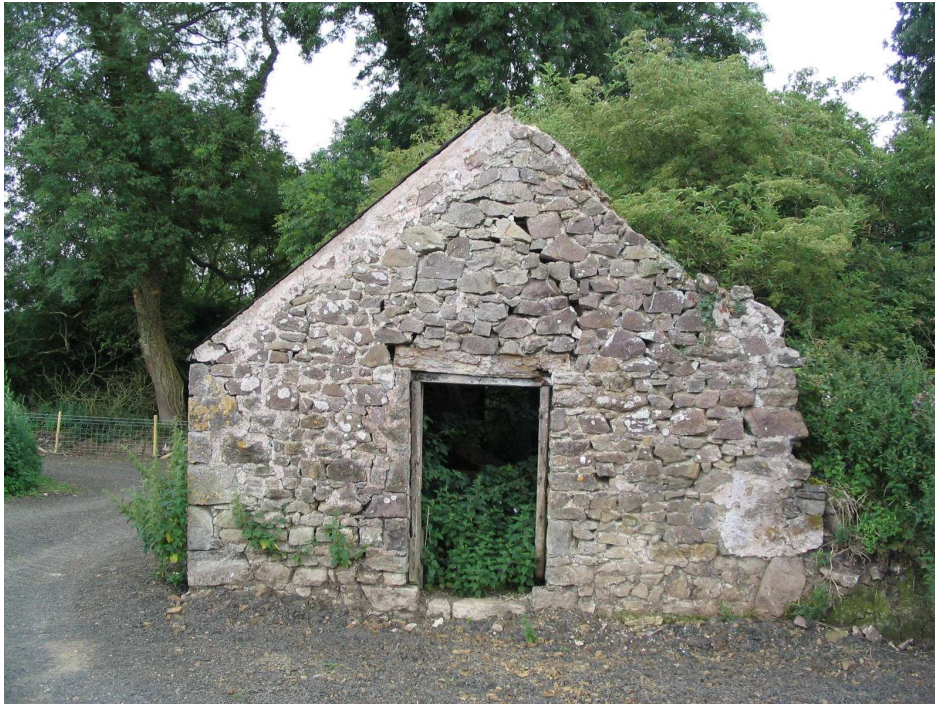
The masonry of the north gable wall is unstable, particularly above the doorway.

course of action if the future of the building is to be secured. The north gable wall will require some intervention anyway due to the unstable masonry and if a larger doorway can be introduced sympathetically using traditional materials then the overall quality of the building should not be severely compromised.

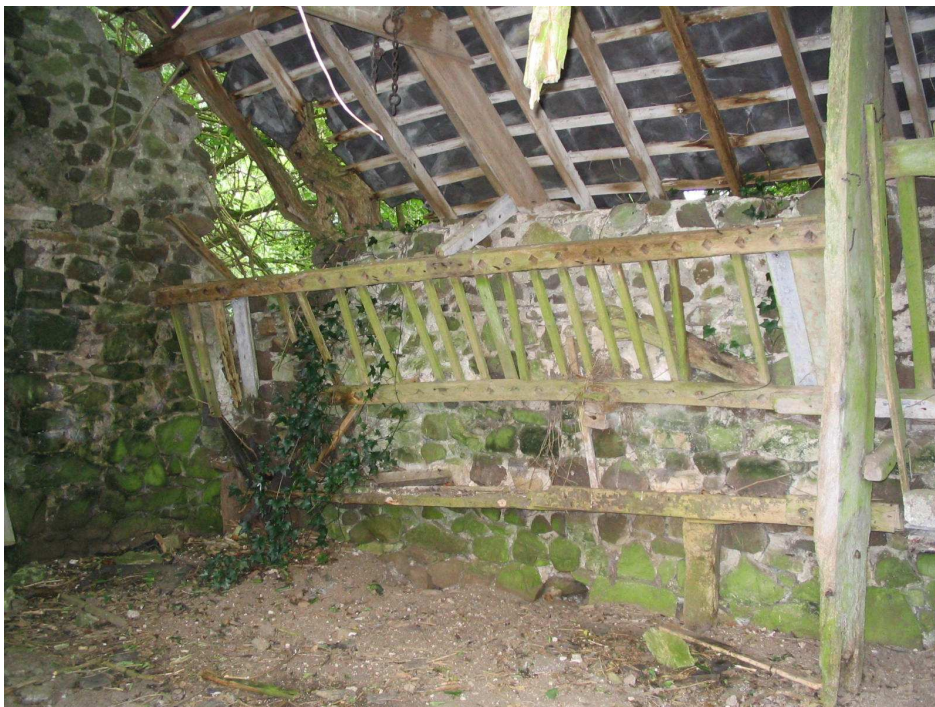
Internally the wooden fixtures survive, here the wooden rails of the manger have been reused.
