## **TIR GOFAL MANAGEMENT PLAN: HERITAGE MANAGEMENT INFORMATION (HE2)**

**Prepared for:  
Treginnis Uchaf**

**Tir Gofal Reference No  
W/13/4977**

**ACA Report No. 2005/14  
Project Record No. 49520  
Prepared by  
Helen Milne**

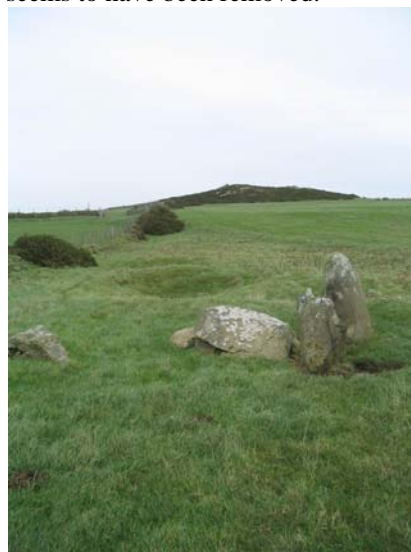
"The remains of a possible chambered tomb beside a stone faced bank west of Lower Treginnis. There appear to be three upright monoliths about 1.1m, 0.8m and 0.5m high and two slabs (or possibly one broken) on the ground. The published description suggests two uprights only but the third stone seems to be part of the original structure (Freeman 1976, 27). Several other large stones were noted in the vicinity. The tomb appears to occupy an area measuring approximately 3.5m by 3m. The original description indicates that the tomb is located in a hedge but this seems to have been removed.

**SAM PE 421 looking east**

archaeological importance. This is a Scheduled Ancient Monument (SAM PE421)" (Plunkett Dillon & Latham 1989, 12-13; NT Ref 83536). The site has been well maintained, and is clearly visible from the public footpath which crosses the site. *Visited* 21/01/2005 (HGM)

ii) Control any regeneration weeds, scrub, sapling growth on the monument by adopting a suitable grazing regime. If this is not possible, or proves ineffective, regeneration shall be re-cut to ground level annually, leaving roots in situ. Work should be undertaken when conditions are dry and debris should be removed from the scheduled area;

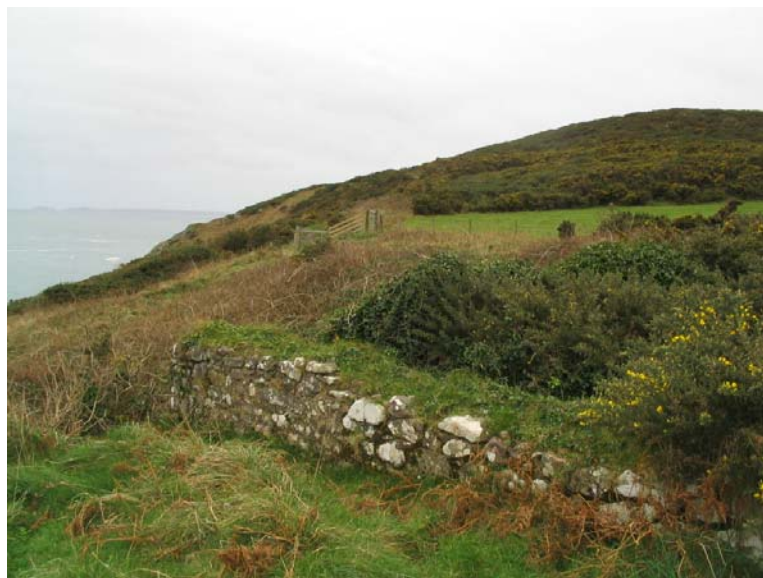
A small mill fed by a stream leading from a dammed pond on the cliffs south of Lower Treginnis farmhouse. The former mill pond is shown on historic maps, but has now been extended into a large irrigation pond. "The mill stream now runs beneath the building to emerge in the eastern corner but originally the water must have been carried along a raised channel probably of wood. The mill building structure measures approximately 6.2m by 8m with neatly constructed walls c. 1.5m - 2m high and 0.5m wide. The mill wheel appears to have been housed in a section at the eastern end of the building. The mill is not marked on the Tithe Map of 1838 but is listed in an 1885 Bill of Sale suggesting that it was constructed in the middle decades of the 19th century like most of the Lower Treginnis farm buildings" (Plunkett Dillon & Latham 1989, 10; NT Ref 83531).

The farmer remembers that this used to be a furze mill. Gorse was an important fodder crop, particularly for horses, and was often specially grown for the purpose. At Treginnis, the field to the south of the mill has gorse growing in it which is taller than the scrubby gorse common to the rest of the area. This is French gorse (eithin man in Welsh), and the farmer remembers that this particular gorse was brought down to the mill to be processed, where it had to be bruised and crushed to make it fit to eat. Water-driven mills such as this one would have used heavy metal spikes to crush the gorse. This site is right next to the Pembrokeshire Coast Path, but is currently heavily overgrown with bramble, ivy and other vegetation, which minimises visibility. *Visited* 21/01/2005 (HGM)

**The site of Melin Treginnis looking south, showing scrub incursion.**

This site is heavily overgrown with bramble, ivy and other vegetation. Vegetation clearance is recommended on this site to improve visibility, and prevent further structural damage to the remains of the mill.

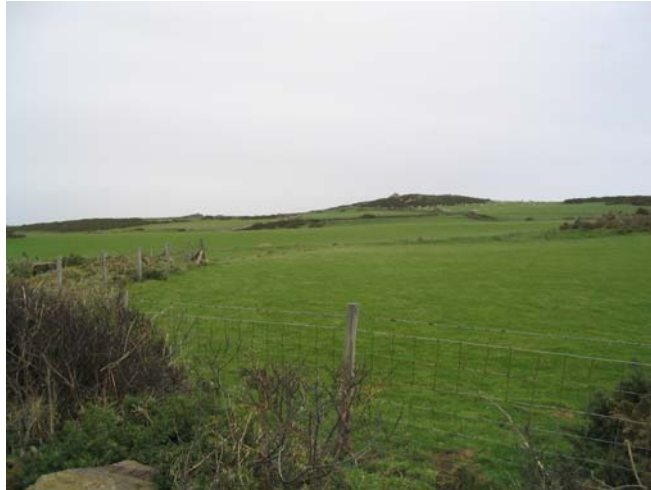
"A group of ruined field banks located near the tip of the Treginnis peninsula. Up to 2m wide, the banks are heavily overgrown with much protruding stone and most are backed by lynchets up to 0.75m high. The date and function are unknown. They are not marked on the Tithe Map or any of the O.S. maps. The layout does

not suggest an open field pattern but they could represent piecemeal enclosure of rough grazing possibly dating to the medieval period. Alternatively, they could be much older as they also resemble the prehistoric fields found on St. David's Head and Skomer Island. However, any interpretation of these ruined boundaries should be treated with caution as ruined field banks on the neighbouring Porth Clais property were found to date to the latter half of the 19<sup>th</sup> century " (Plunkett Dillon & Latham 1989, 16). In 1989 the banks were recorded by the National Trust as overgrown and apparently stable with some erosion scars present. The relationship between these banks and the recently identified defended enclosure (see PRN 53086) is very interesting, but is not fully understood at present, and there is scope for further investigation. *Visited* 21/01/2005 (HGM)

**Ruined field banks at the tip of Treginnis Peninsula, looking east.**

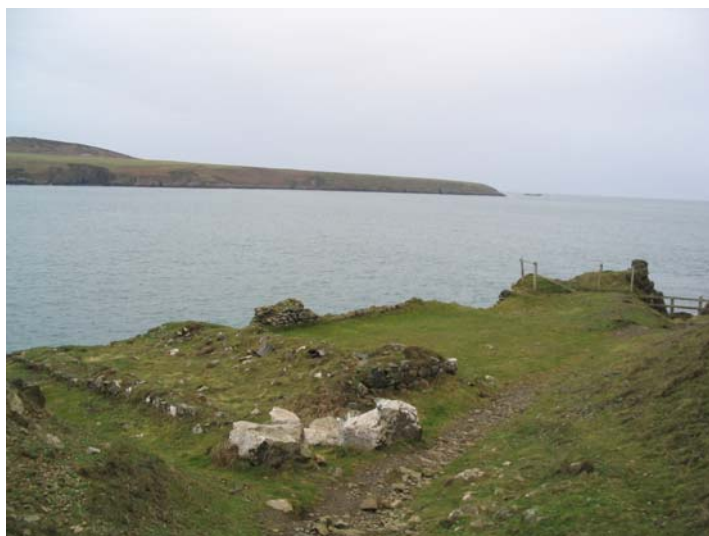
Mine on very edge of cliff. Foundations of two stone buildings are present, a small quarry and a shaft approximately 10m deep. A track leads down to the workings. The site is eroding into the sea. Two small buildings named Cuba marked on the St Davids Tithe map. Murphy 1996

**The southern-most building at Cuba Copper Mine, with the fenced off remains of the shaft in the distance, looking north-west.**

"At the base of the cliff at the western tip of the Treginnis peninsula are the ruins of two buildings and a shaft, the remains of a copper mine listed as Cuba in the 1838 Tithe Schedule. The southern of the two buildings measures approximately 8x5m but the western end of the structure has fallen away into the sea.

The walls are at the most 1m high and 0.5m wide. A wall running along the edge of the cliff for about 20m connects this structure with the second building. Here only the northern and parts of the western and eastern walls survive. Most of the building appears to have fallen into a sea cave which may have been enlarged as part of the mining process. A vertical shaft lies just south of the second building. The extraction of copper at this location began in 1829 and continued on an irregular basis throughout the 19th century" (Plunkett Dillon & Latham 1989, 12-13; NT Ref. 83535). The mine was little changed from the above descriptions during the archaeological farm visit (2005). The exposed nature of the location, and some light grazing by sheep and ponies means that the site is easily visible from the coast path. However, erosion is continuing, making safety a concern. *Visited 21/01/2005 (HGM)*

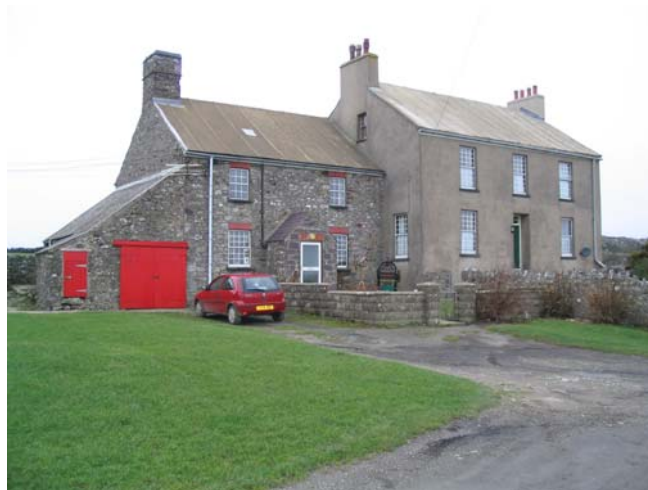
**Treginnis Uchaf Farmhouse**

A date plaque above doorway inscribed "Built/by/John Mortimer Esq/in 1854". Stone rubble walls courses of brick openings for dovecote at eaves. "Attractive farmhouse and farm buildings known as Upper

Treginnis. The structures are arranged around a rectangular yard with the main house in the north-eastern corner. Like Lower Treginnis map evidence suggests that the farmyard was laid out in its present form in the middle of the nineteenth century. However the Tithe Map shows that there were two houses in this area in 1838; one apparently in the middle of the present day yard and the other called Trevarchan located at the eastern edge. Both houses have completely disappeared with no evidence of any masonry remaining on the ground. It seems likely that the owner of Upper Treginnis bought Trevarchan and demolished the house possibly at the same time as he built himself a new house and yard" (Plunkett Dillon & Latham 1989, 21). Evidence detailed above, indicates that there were formerly two farmhouses within the steading area of the present Treginnis Uchaf. This suggests that there may be buried evidence of walls within the farmyard, and that this area therefore has high archaeological potential. Visited 21/01/2005 (HGM)

The farmstead is of considerable architectural interest. Buildings are grade II listed by Cadw. The following management recommendations may apply. *Visited* 21/01/2005 (HGM)

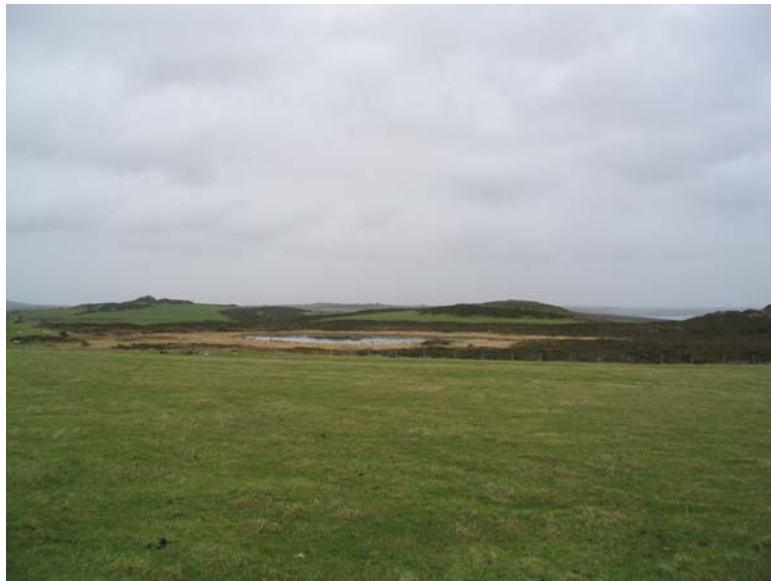
This is a large pond, now used for wild-fowling. It may have been larger and deeper in the past, as at the northern end there is a solid and well-built earth embankment, which is substantially higher than the present water level. The first edition Ordnance Survey map appears to show the dam, but also shows a similar water level to the present one. This implies that the pond had lost water by this time, and that the dam pre-dates the late nineteenth century, perhaps by a significant length of time. *Visited 21/01/2005 (HGM)*

**Pond 52,036 looking east**

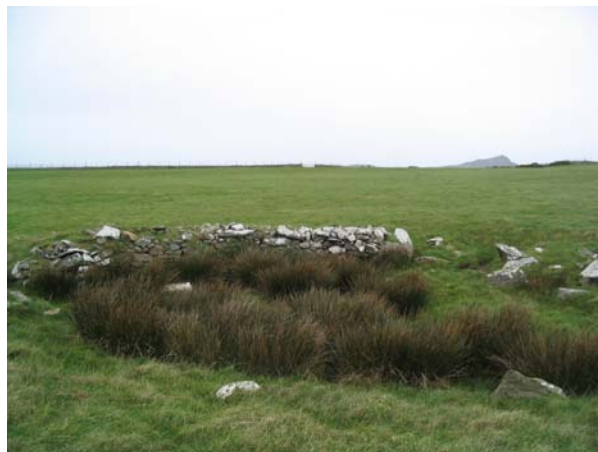
A circular pond c. 9m in diameter, now dry. A drainage channel leads off to the south, and the farmer thought that it had been drained in the 1970s. The pond is well constructed with large, squared stones lining the sides. At the time of the farm visit, the stone lining on the westerly side of the pond was relatively intact, but the more easterly side had suffered some collapse. The pond is not overgrown under the current management regime of light grazing, and should be maintained in this stable condition. *Visited 21/01/2005 (HGM)*

**Pond 53,084 looking west**

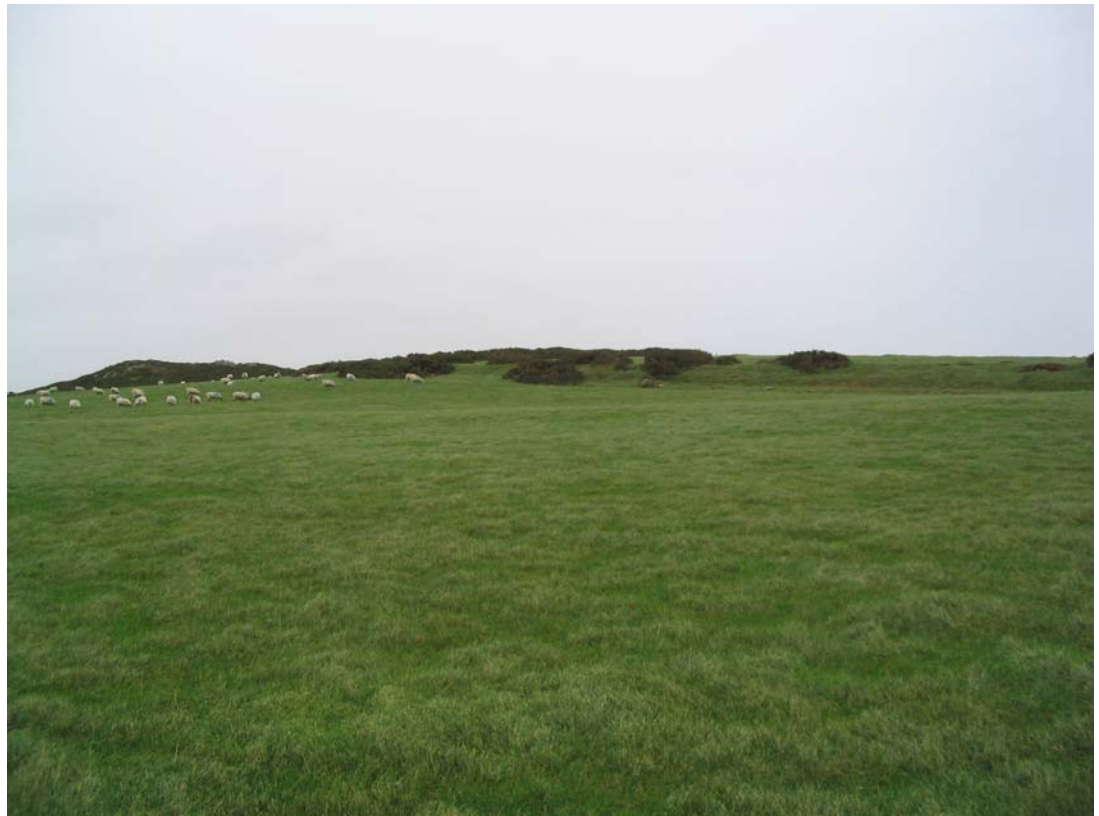
Defended enclosure, date currently unknown, but likely to be of pre-historic origin.

Aerial photographic evidence confirms that features previously thought to be field boundaries (see PRN 14,268), form an enclosed area defined by stone and earth banks on the south-western portion of the Treginnis peninsula. The enclosure uses the natural topography of the land, lying on a saddle of high ground between two rock outcrops (carns). Viewed from the south-western side, the enclosing banks are imposing. The main enclosure measures c. 230m lengthways (between the two rocky outcrops), and c. 50m across (between the two constructed banks), and represents an excellent vantage point on the peninsula, which is higher than the surrounding land.

**The northern end of the main enclosure, viewed from the west.**

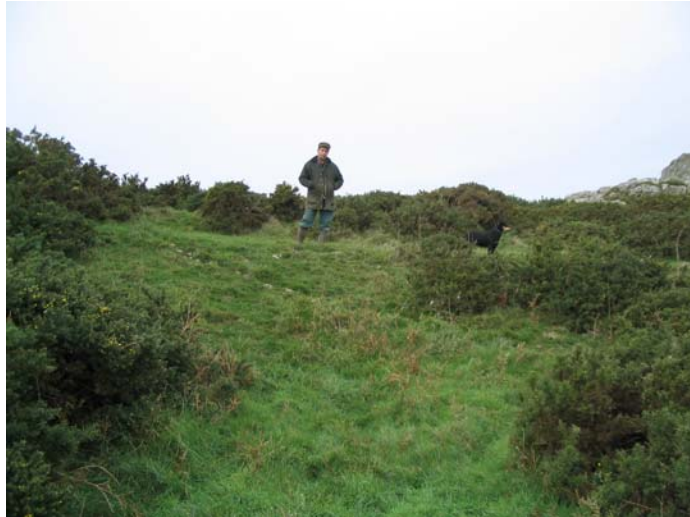
A further enclosure, perhaps forming a northern annexe to the main enclosure, was suggested by evidence viewed during the Tir Gofal farm visit, and this seems to be substantiated by aerial photographic evidence. Aerial photographs of this part of the promontory show faint lines of possible banks/ ditches extending north from the main enclosure, heading towards a third rocky outcrop. On the ground, a very substantial bank consisting of heaped loose stone with a flattened top, has been identified. The bank lies on steeply sloping ground, on the south-eastern side of this northern rocky outcrop, and runs almost parallel to a surviving field boundary. The land upslope of this bank is not suitable for ploughing, making it unlikely to be a lynchet. The size and location of the bank strongly suggest a defensive function. The general area is heavily overgrown with gorse at present.

**Substantial bank on the eastern side of the third rocky outcrop –  
Evidence of a possible annexe to the north of the main enclosure.**
