**TIR GOFAL MANAGEMENT PLAN:
HERITAGE MANAGEMENT INFORMATION
(Call Out)**

**Prepared for:
Cefnbenydd**

**Tir Gofal Reference No:
W/12/4595**

**Report Number: 2005/8
Project Record Number: 49550**

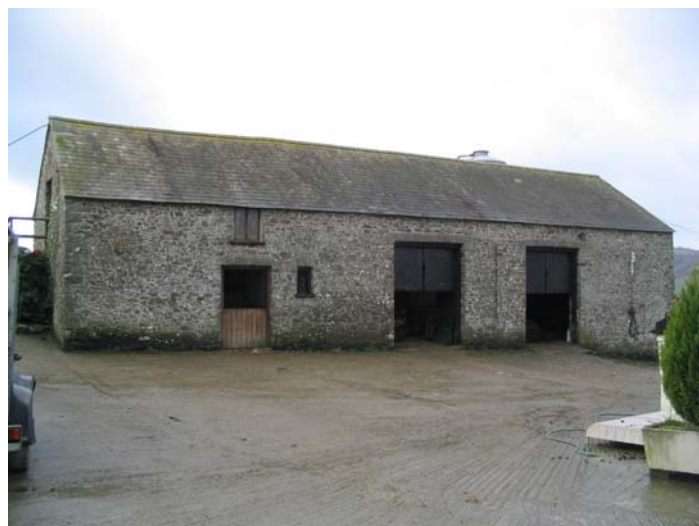
The barn is a large, long range built down the slope. It is constructed out of local rubble stone but has masonry dressings, including flat stone arches. The pitched roof is covered with slate. The southern end has a stable with a loft overhead. Access is gained by external steps against the gable end. The loft, now used as a workshop, was used for accommodation for farm worker(s), and the present owners remember tongue and groove partitions lined with wall paper (now removed). Below, the stable is entered by one large doorway; a small shuttered opening flanks the doorway to the right. Inside the stable some wooden stalls survive.

The lower, northwestern end of the barn is open to the roof, with two sets of double doors. Smaller, opposing doorways survive in the rear wall (southwest) and ventilation slits in the lateral and gable walls. Although the Tithe map of 1837 clearly indicates a building in this location this must have been demolished and replaced by the current barn which has a datestone 'Built 1872'. Stone cobbled flooring survives in both of the threshing bays.

The barn is a historically interesting and an aesthetically pleasing building. It is a fine example of a 19th century stone built barn of this area which has undergone little significant change during its lifetime and retains many of its original features. It is for this reason that any alterations or modifications should be very carefully undertaken in order to retain its historic integrity.

The large barn at Cefnbenydd reflects the size and prosperity of the farm

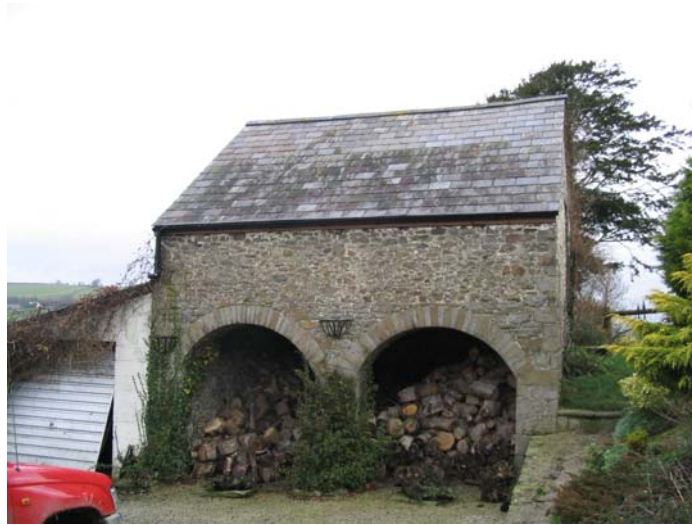
The cart shed at Cefnbenydd Farm

The cart shed is a small, squarish lofted building, with a pair of arched stone cart entrances. The height of the building appears to have been raised, as the stonework of the 1st floor is more course, and is largely made up of rubble. This rough stonework would previously have been covered with a render or limewash finish but this has recently been removed from the southwest facing elevation. Access to the 1st floor is gained through a doorway in the gable end, reached from the higher ground level. The roof is pitched and slated.

The cart shed is a small but impressive building; with high quality masonry detailing including fine stone arches over the cart entrances. Although modest in size it has architectural aspirations and would appear to have been built, along with the barn, as part of a large scale investment in the farmstead.

The present owners also hope to undertake some repairs to the cart shed, repairing both the floor and also re-slating the northeast side of the roof. Again these repairs to the cart shed should endeavour to retain as much of the historic structure as possible, preserving the historic character of the building.

When reslating the roof, care should be taken to remove the maximum number of old slates in order to reuse as many as possible. New slates should match the type, colour, texture, size and thickness of the existing ones. New slates can be mixed with old ones across the roof.

Repairs to the floor should also endeavour to reuse as many of the existing floorboards as possible. It is understood, however that the joists may need to be replaced in order to strengthen the floor.

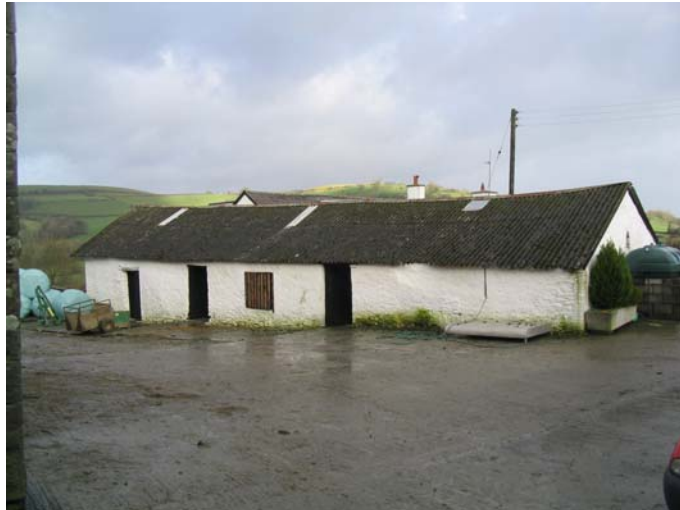
The cow shed at Cefnbenydd appears to be the earliest surviving farm building

A long, low cow shed lies parallel to the barn which has stalls to accommodate 21 beasts. The cow shed is rubble stone built with a whitewash finish all over. The roof is pitched and covered with corrugated asbestos sheeting. This building demonstrates an interesting history, it has had many changes and modifications over time, but these changes have left their imprint in the building. Originally the building was thatched and constructed with jointed cruck timbers, with a heavy post embedded into the wall and a further heavy timber which formed the roof truss jointed into it. At some point the timbers have been cut off at the wall and the cruck blades have been reused to form the present roof trusses. Horizontal beams, also sawn off at the wall, indicate that the building was originally lofted.

Although this building is perhaps the most modest and visually least impressive in the farmstead complex, archaeologically it is the most interesting. It retains evidence of a earlier traditional construction which, although once very common, is now a very rare unusual survival.

Cracking in the northwestern gable suggests that there is some instability in the structure at this end. It is recommended that structural works to the building are considered in order to stabilise the building. This should be carried out maintaining as much of the historic fabric as possible, using appropriate techniques and materials.

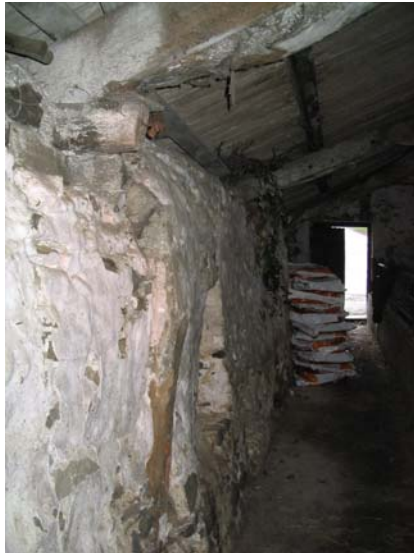
The remains of crucks are embedded into the wall of the cow shed, having been cut off against the wall face.
